Midwest Guardrail System for Long-Span Culvert Applications

MIDWEST ROADSIDE SAFETY FACILITY

MwRSF Research Report No. TRP-03-187-07

November 16, 2007

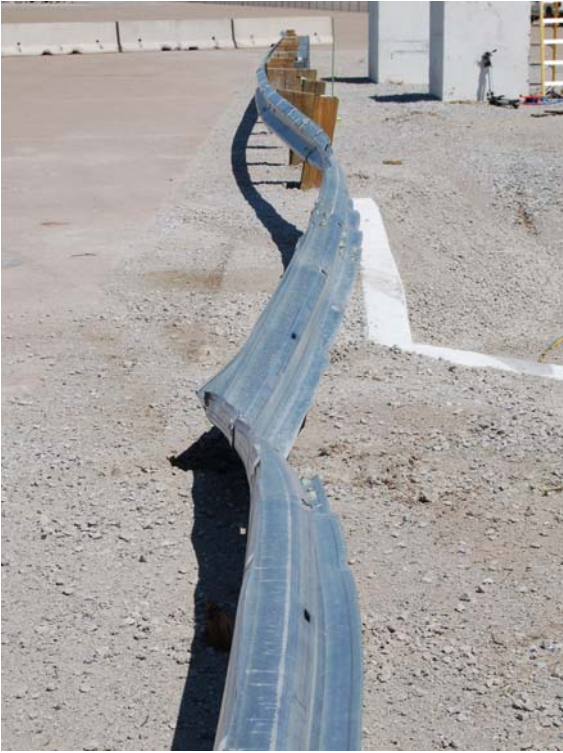
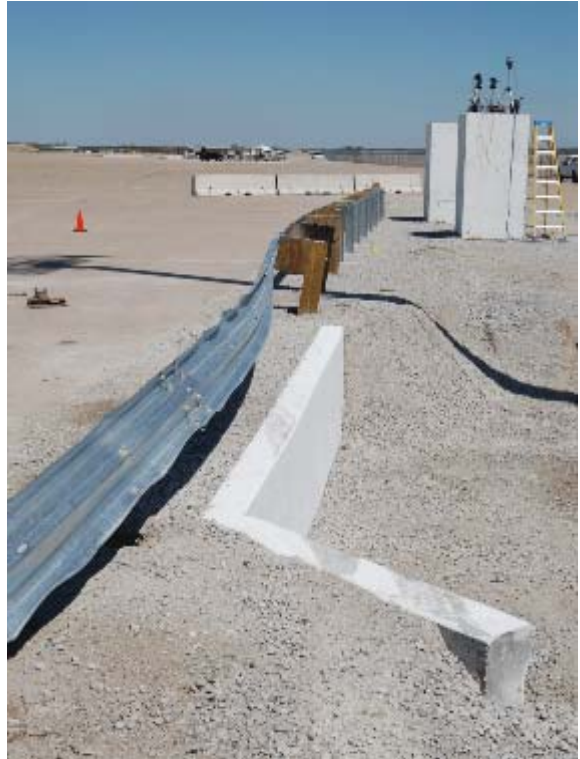
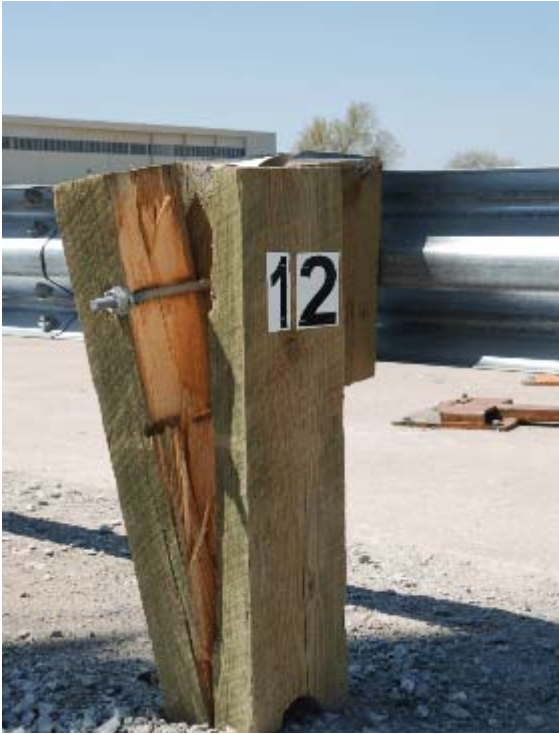
Figure 32. System Overall Damage, Test No. LSC-1

As shown in Figures 32 through 36, damage to the barrier was moderate, consisting mostly of deformed W-beam, contact marks on a guardrail section, and deformed and fractured guardrail posts. The W-beam damage consisted of contact marks and deformation and flattening of the impacted section between post nos. 13 and 20. No indications of rail rupture or tearing were visible on the W-beam. The W-beam rail was pulled off of post nos. 2 through 9. Three CRT posts, post nos. 14 through 16, were completely fractured, while CRT post nos. 12 and 13 were rotated backward. Steel post nos. 17 through 20 were bent and deformed backward and downstream. Neither significant post damage nor deformations occurred to the remaining posts in the system. The maximum lateral permanent set rail deflection was approximately 724 mm (28.5 in.), 1,905 mm (75 in.) upstream of post no. 14, as measured in the field. The maximum lateral dynamic post and rail deflections were 1,205 mm (47.4 in.) at post no. 16 and 2,343 mm (92.24 in) at the centerline of post no. 15, respectively, as determined from the high-speed video analysis. The working width of the system was 2,373 mm (93.43 in.), as determined from the high-speed film analysis.

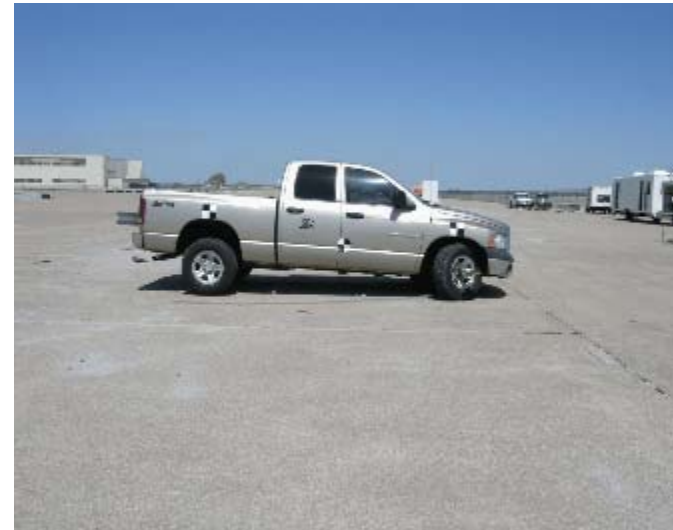
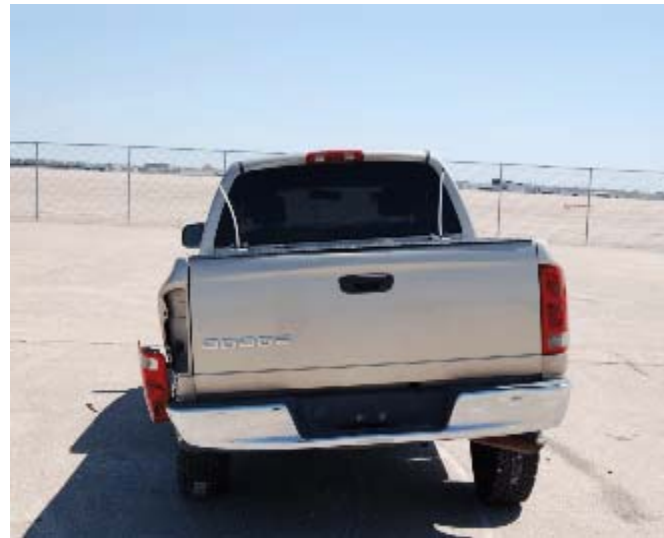
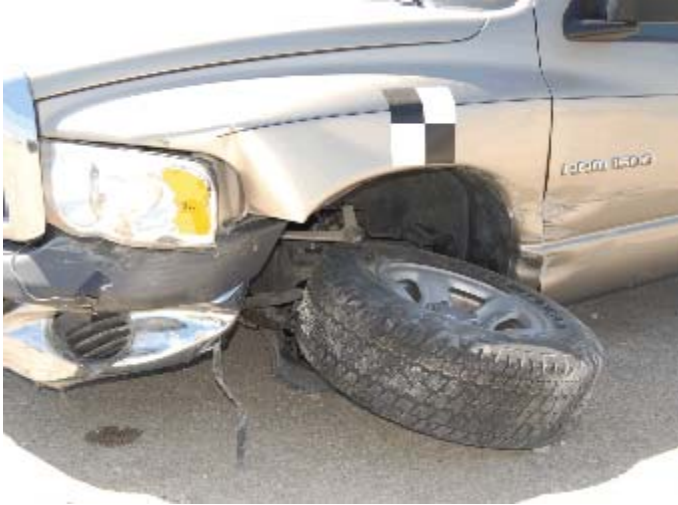
Figure 37. Vehicle Damage, Test No. LSC-1

Exterior vehicle damage was moderate, as shown in Figures 37 and 38. The left-front quarter panel was crushed inward, and the left side of the front bumper was also bent back toward the engine compartment. The left-front wheel assembly was disengaged from the upper and lower control arms but remained attached to the steering linkage. The left-front tire was still

inflated. Some deformation and damage were noted on the left-front suspension components. Contact marks and minor deformation were found along most of the lower-left side of the pickup truck. The left-rear quarter panel and the left corner of the rear bumper were dented as well. The left-rear taillight was disengaged from its housing. Interior occupant compartment damage was minimal, as shown in Figure 39 with a maximum vertical deformation of 19 mm (0.75 in.) measured near the right side of the driver-side footwell on the floorpan.

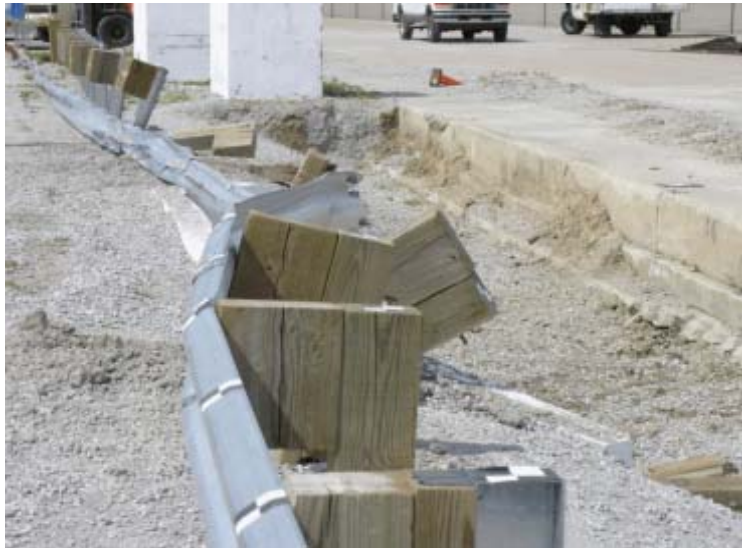
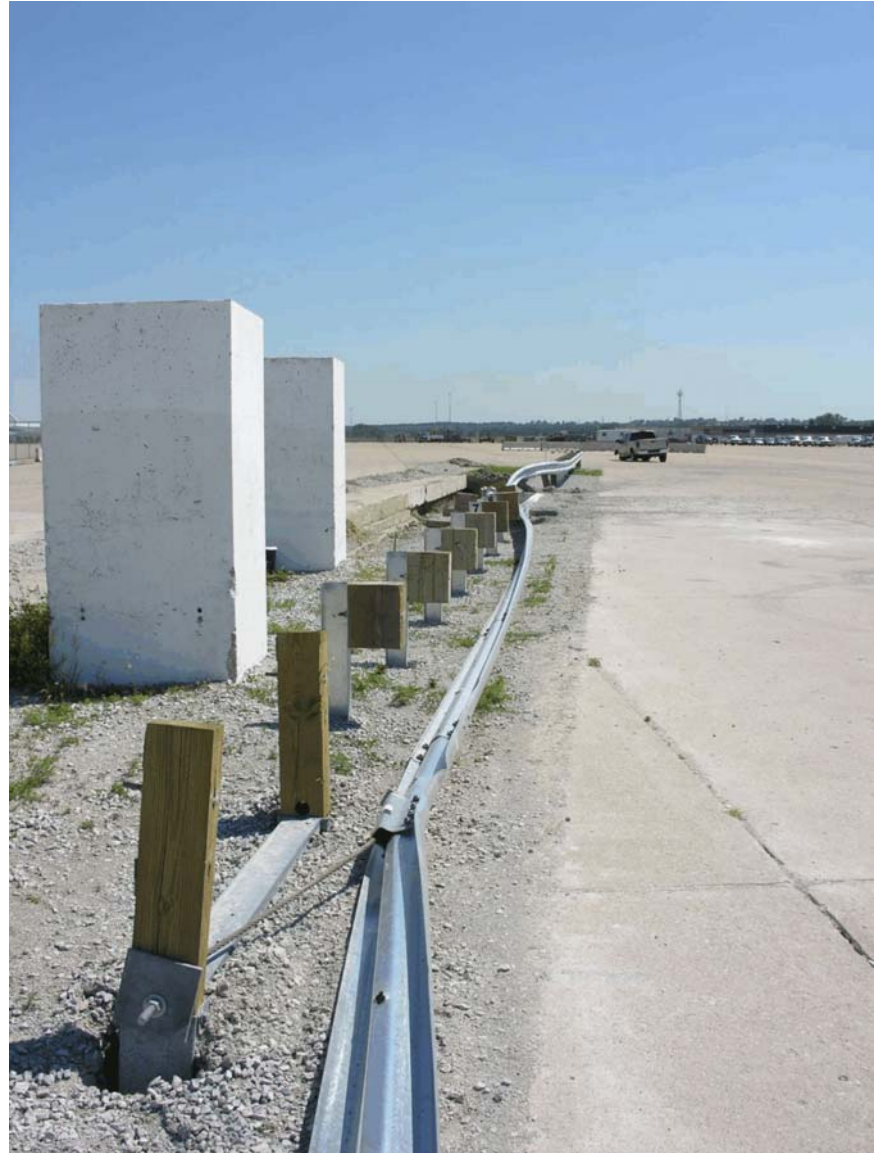
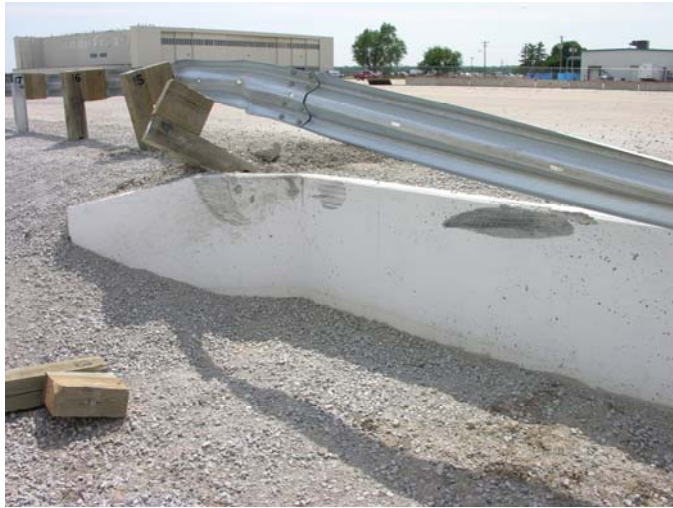
Figure 59. System Overall Damage, Test No. LSC-2

As shown in Figures 59 through 63, damage to the barrier was moderate, consisting mostly of deformed W-beam, contact marks on a guardrail section, and deformed and fractured guardrail posts. The W-beam damage consisted of contact marks and deformation and flattening of the impacted section between post nos. 10 and 16. No indications of rail rupture or tearing were visible on the W-beam. The W-beam rail was pulled off of post nos. 1 through 14. Two CRT posts, post nos. 11 and 13, were completely fractured, while CRT post nos. 12, 14, and 15 were rotated backward in the soil. Steel post nos. 9 and 10 were bent and deformed back and downstream. No significant post damage or deformations occurred to the remaining posts in the system. Contact marks and concrete spalling were visible on the top of the culvert headwall as well as on the downstream wingwall, as shown in Figure 60. The maximum lateral permanent set rail deflection was approximately 1,372 mm (54.0 in.) at 3,810 mm (150 in.) downstream from the centerline of post no. 13, as measured in the field. The maximum lateral dynamic post and rail deflections were 1,186 mm (46.7 in.) at post no. 12 and 1,968 mm (77.5 in.) at 1,905 mm (75 in.) downstream of post no. 13, respectively, as determined from the high-speed video analysis. The working width of the system was 2,133 mm (84.0-in), as determined from the high-speed video analysis.

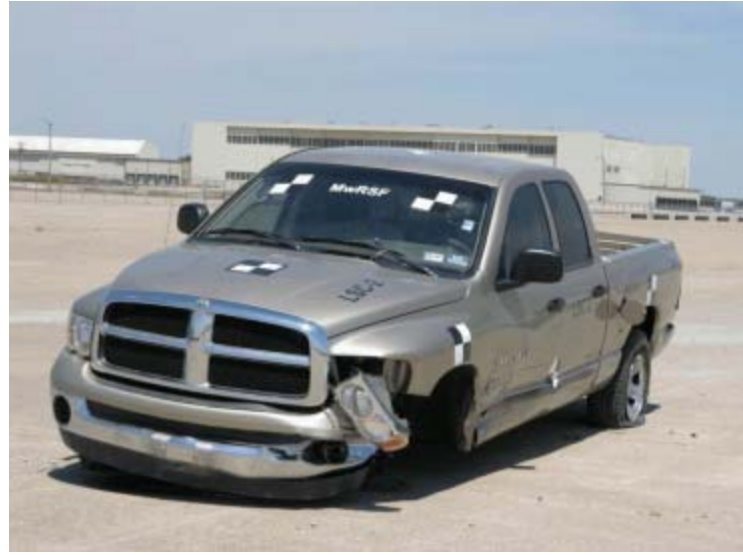
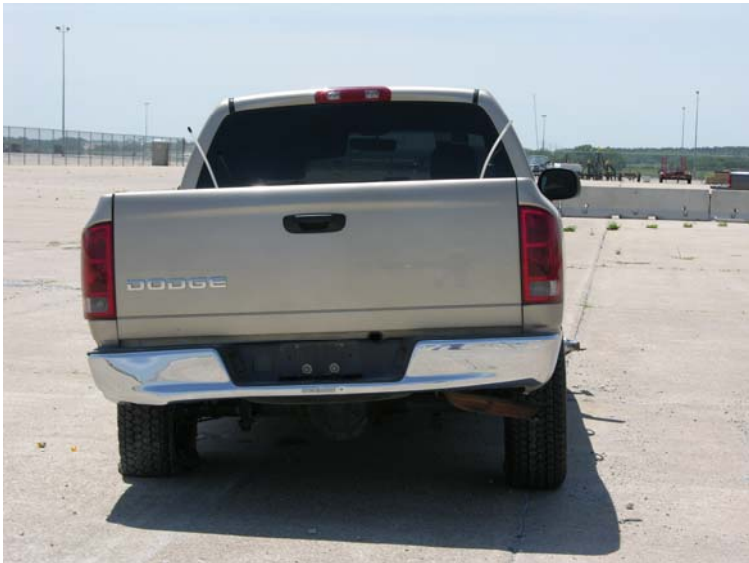
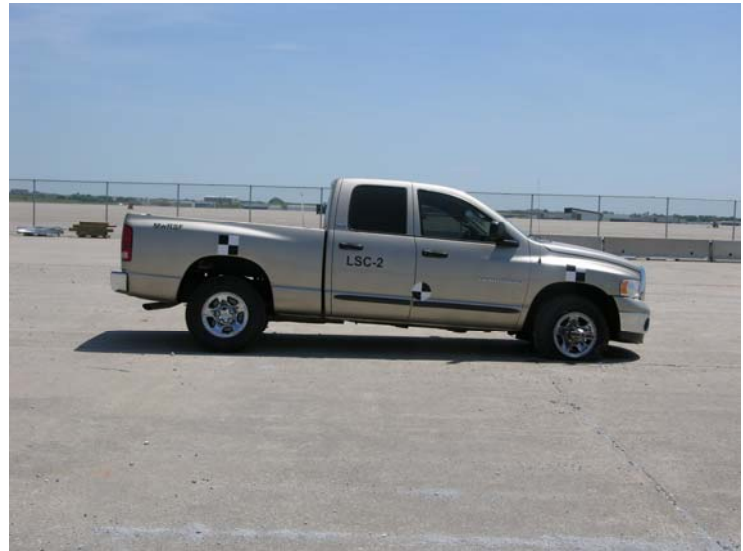
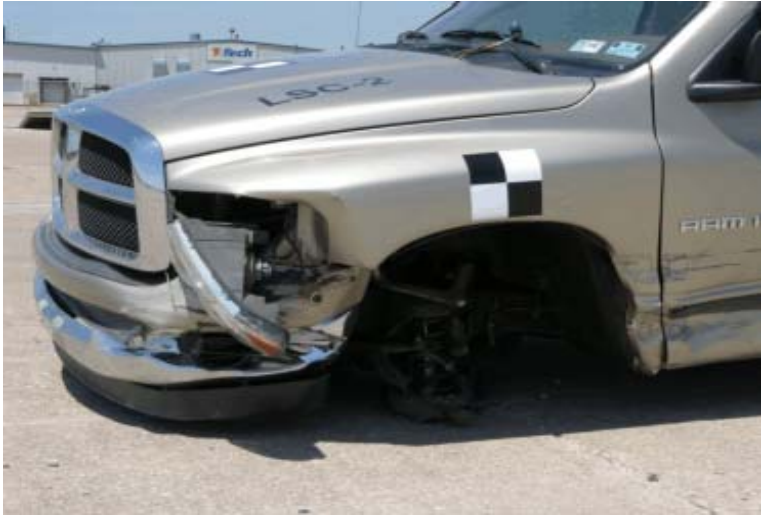
Figure 64. Vehicle Damage, Test No. LSC-2

Exterior vehicle damage was moderate, as shown in Figures 64 through 66. The left-front quarter panel was crushed inward, and the left side of the front bumper was also bent back toward the engine compartment. The left-front wheel assembly was completely disengaged from the axle, suspension, and steering systems. Some deformation and damage were noted on the left-front suspension components, including the upper and lower control arms, the stabilizer bar, and the joints connecting the suspension components. Contact marks and minor deformation were found along most of the lower-left side of the pickup truck. The left-rear quarter panel and the left corner of the rear bumper were dented as well. The left-rear tire was deflated, and the right-front tire de-beaded from the rim. Interior occupant compartment damage was minimal, as shown in Figure 67, with maximum lateral deformations of 19 mm (0.75 in.) measured near both the right and left sides of the driver-side footwell on the floorpan.
