MASH EVALUATION OF TxDOT HIGH-MOUNTING-HEIGHT TEMPORARY WORK ZONE SIGN SUPPORT SYSTEM

Test Report 9-1002-15-8

**TEXAS A&M TRANSPORTATION INSTITUTE
COLLEGE STATION, TEXAS**

TEXAS DEPARTMENT OF TRANSPORTATION

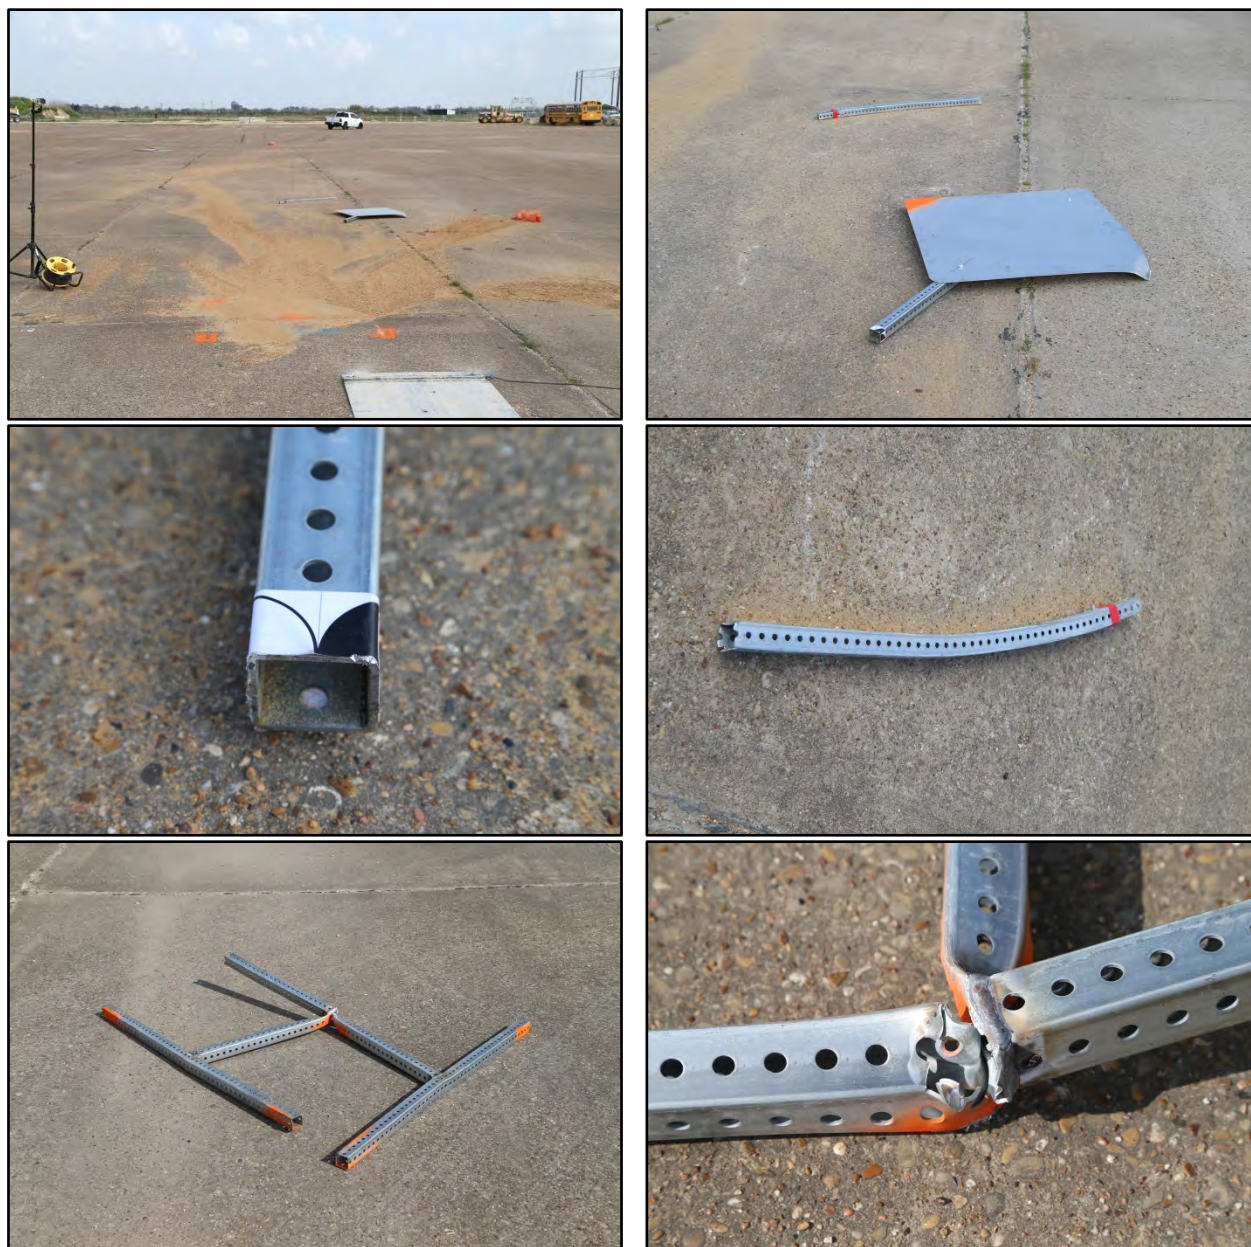
Figure 5.4. Option A Temporary Work Zone Sign Support after Test No. 490026-2-1.

Figure 5.4 shows the damage to the Option A temporary work zone sign support. The sign panel and a portion of the upright came to rest 20 ft downstream of impact and 6 ft to the right of centerline of the impact path. The lower section of the vertical support post fractured 24 inches above grade and the fractured section came to rest 29 ft downstream and 5 ft to the right of centerline. The H-shaped base with the remaining piece of the lower section of the vertical support post came to rest 98 ft downstream of impact and 12 ft left of centerline of the impact path.

Results: The Option A temporary work zone sign support released and fractured into three pieces. The sign panel and the attached upper section of the vertical support post contacted the roof of the 2270P vehicle causing a 16-inch long scratch that ended in a 5-inch long tear on the outer surface of the roof at the rear of the cab. This was determined to be of concern for potential intrusion into the vehicle. (FAIL)

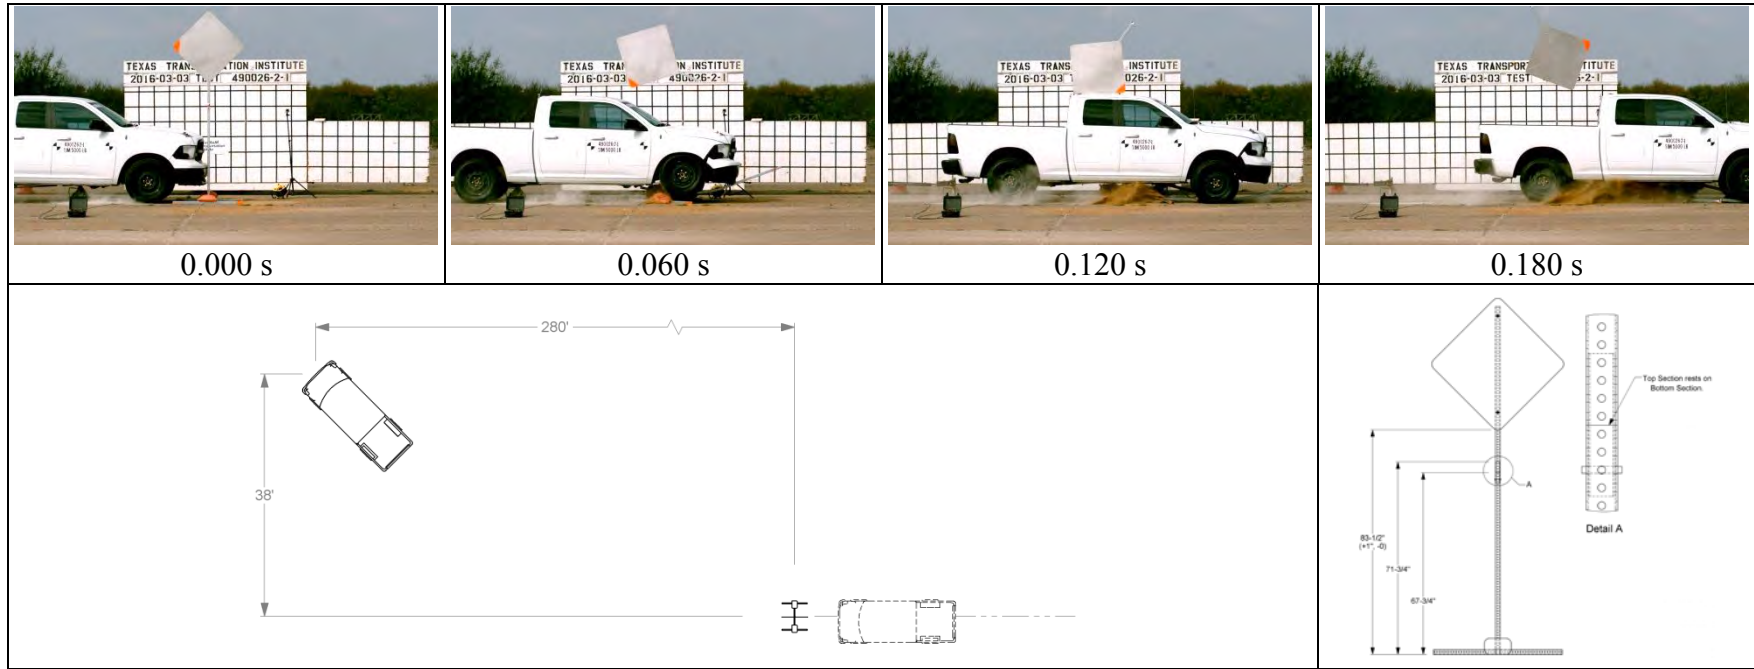
Figure 5.7 provides a summary of the results of the test. The slip connection incorporated into the vertical support post of the Option A temporary work zone sign support allowed the top of the system to release from the lower section of the vertical support post and base as intended. The corner of the sign panel impacted the vehicle roof, and no tear occurred with this first impact. However, as the vehicle continued forward, the sign panel continued to rotate and impacted the rear of the roof causing a 5-inch long tear in the exterior of the roof. The tear did not extend into the occupant compartment, but did cause a 1-inch dent in the interior roof panel at this location of the right rear passenger compartment. Due to the extent of the external roof tear, the Option A temporary work zone sign support was judged to have potential for intrusion into the occupant compartment.

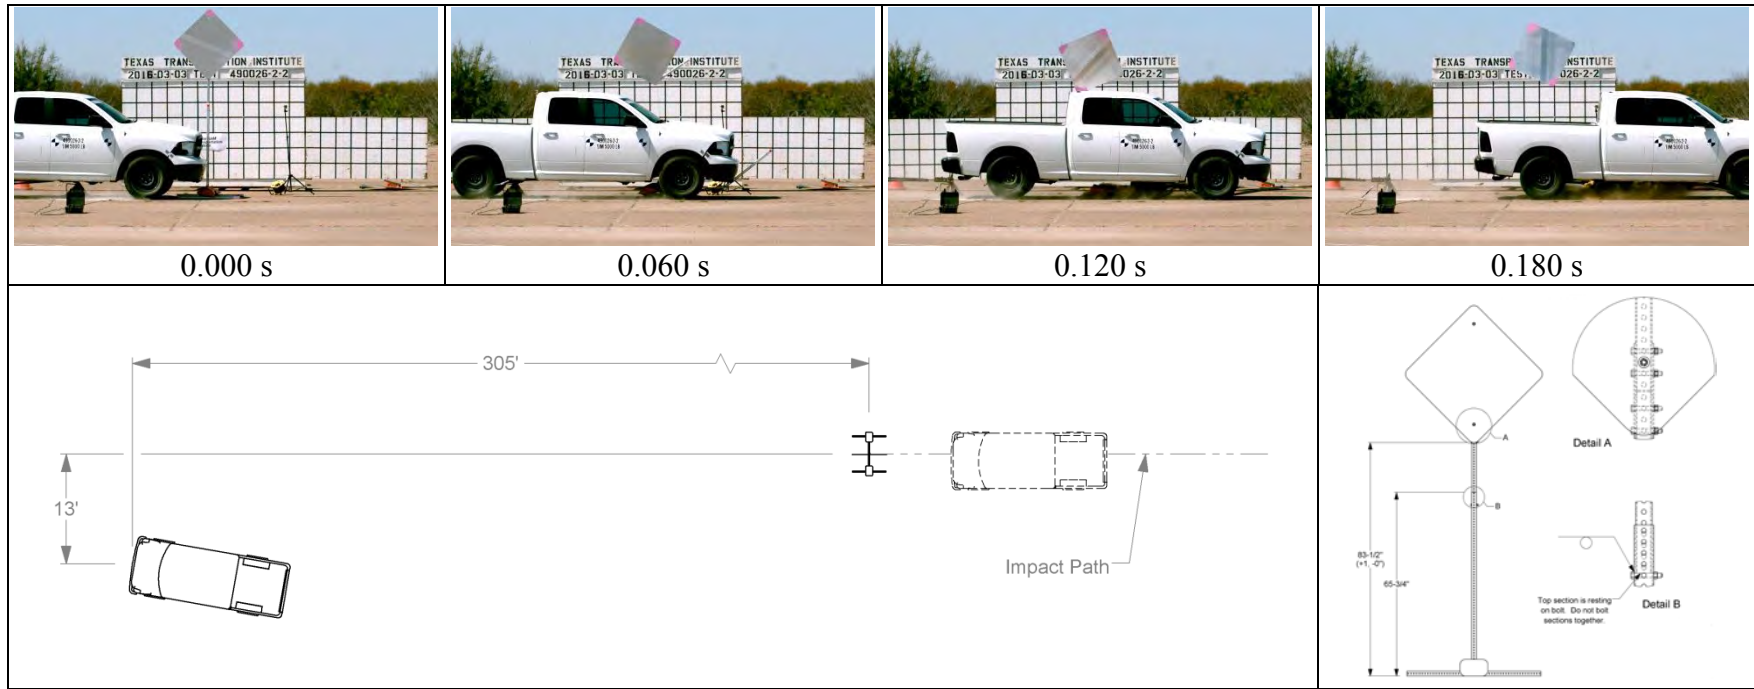
Figure 6.7 provides a summary of the results of the test. The slip connection between the bottom and middle sections of the vertical support performed as designed and released the middle and upper sections and sign panel from the lower section and base. The fuse plate between the upper and middle sections of the vertical support activated as designed. Although the sign panel impacted the roof, this contact did not result in any tear or penetration of the roof. The slight roof deformation that occurred was within *MASH* criteria.

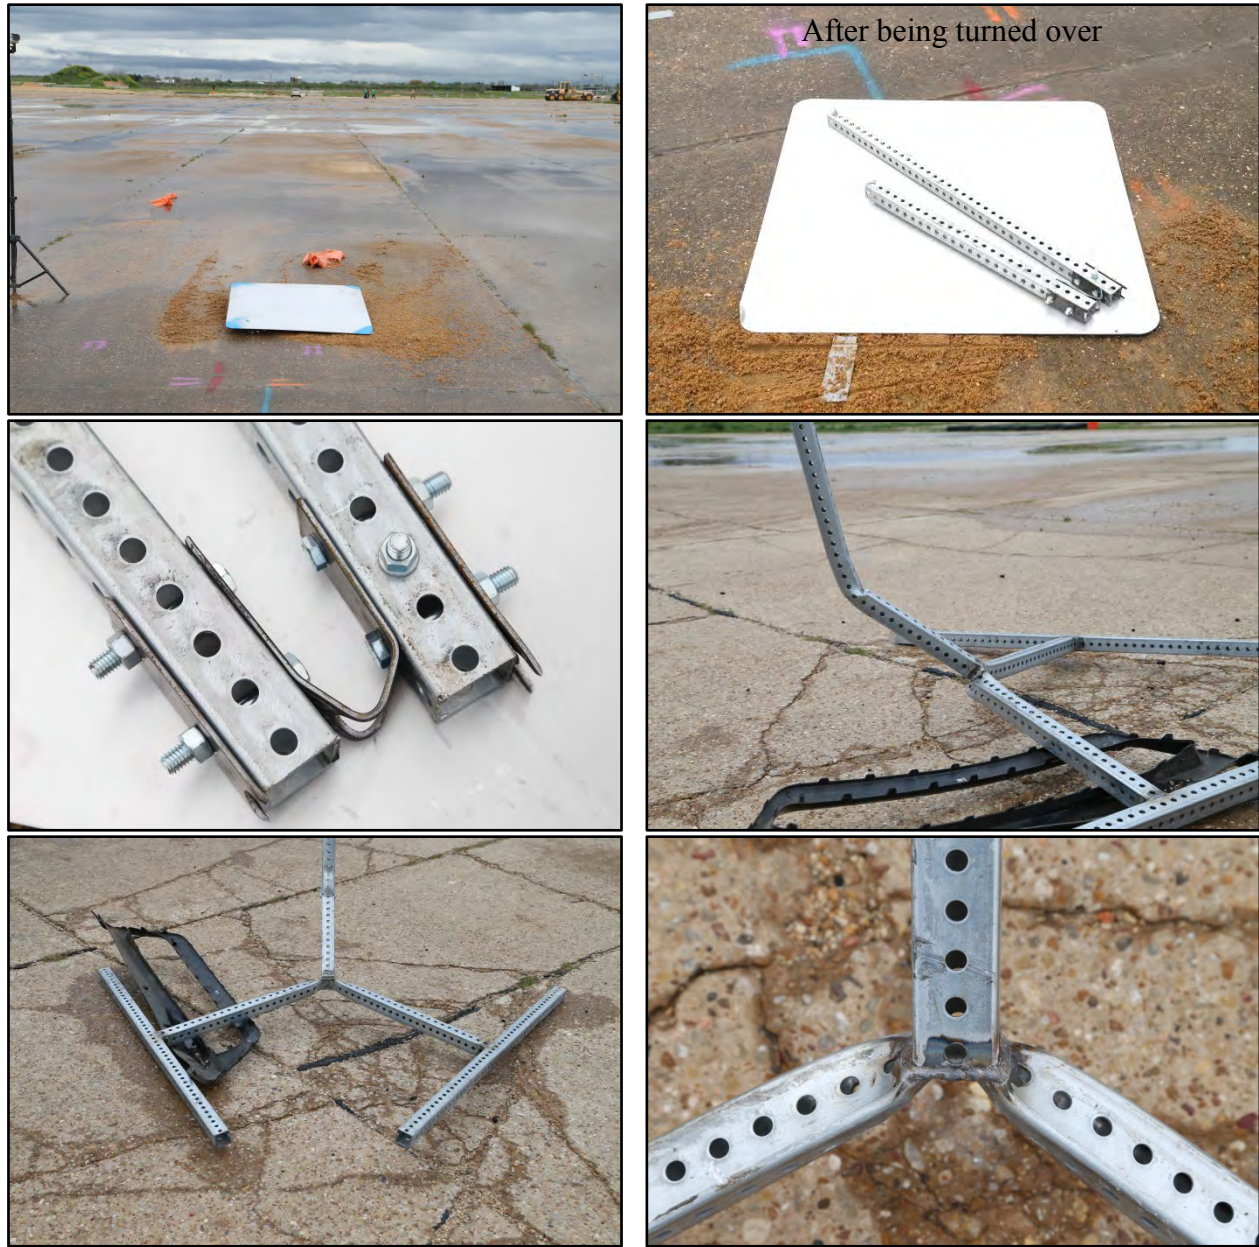
Figure 6.10. Option B Temporary Work Zone Sign Support after Test No. 490026-2-4.

Figure 6.10 shows the damage to the Option B temporary work zone sign support. The sign panel and middle and upper sections of the vertical support came to rest 3 ft downstream of impact and on the centerline of the impact path. The fuse plates connecting the middle and upper section of the support were activated. The remainder of the temporary work zone sign support rode along with the 1100C vehicle. As the vehicle came to a stop, the support slid ahead of the vehicle and came to rest 483 ft downstream of impact and on the centerline of the impact path. The lower section of the vertical support was bent at bumper height.

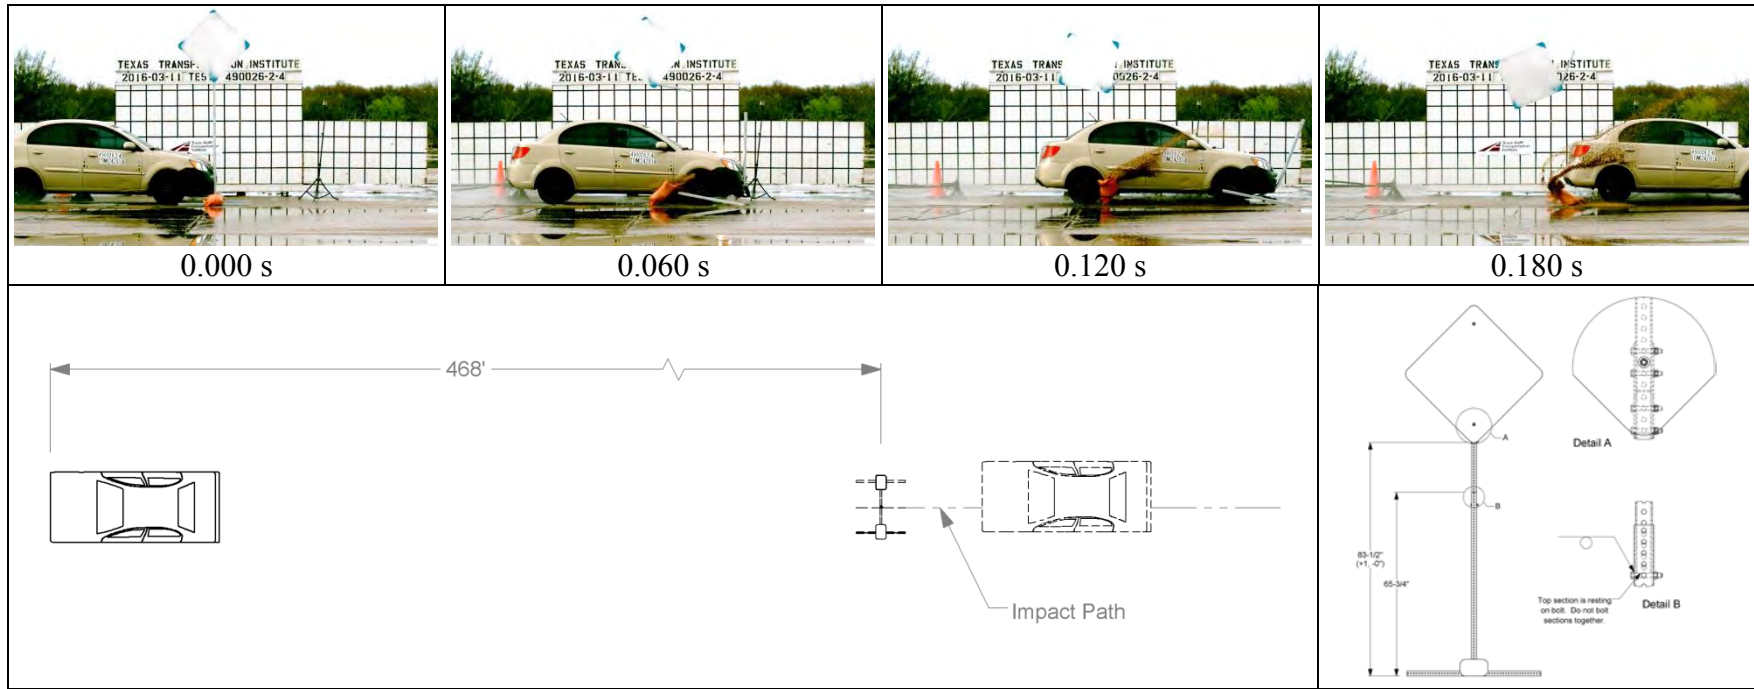
Figure 6.13 provides a summary of the results of the test. The slip connection between the bottom and middle sections of the vertical support performed as designed and released the middle and upper sections and sign panel from the lower section and base. The fuse plate between the upper and middle sections of the vertical support activated as designed. There was no secondary contact between the sign panel and the roof of the vehicle.

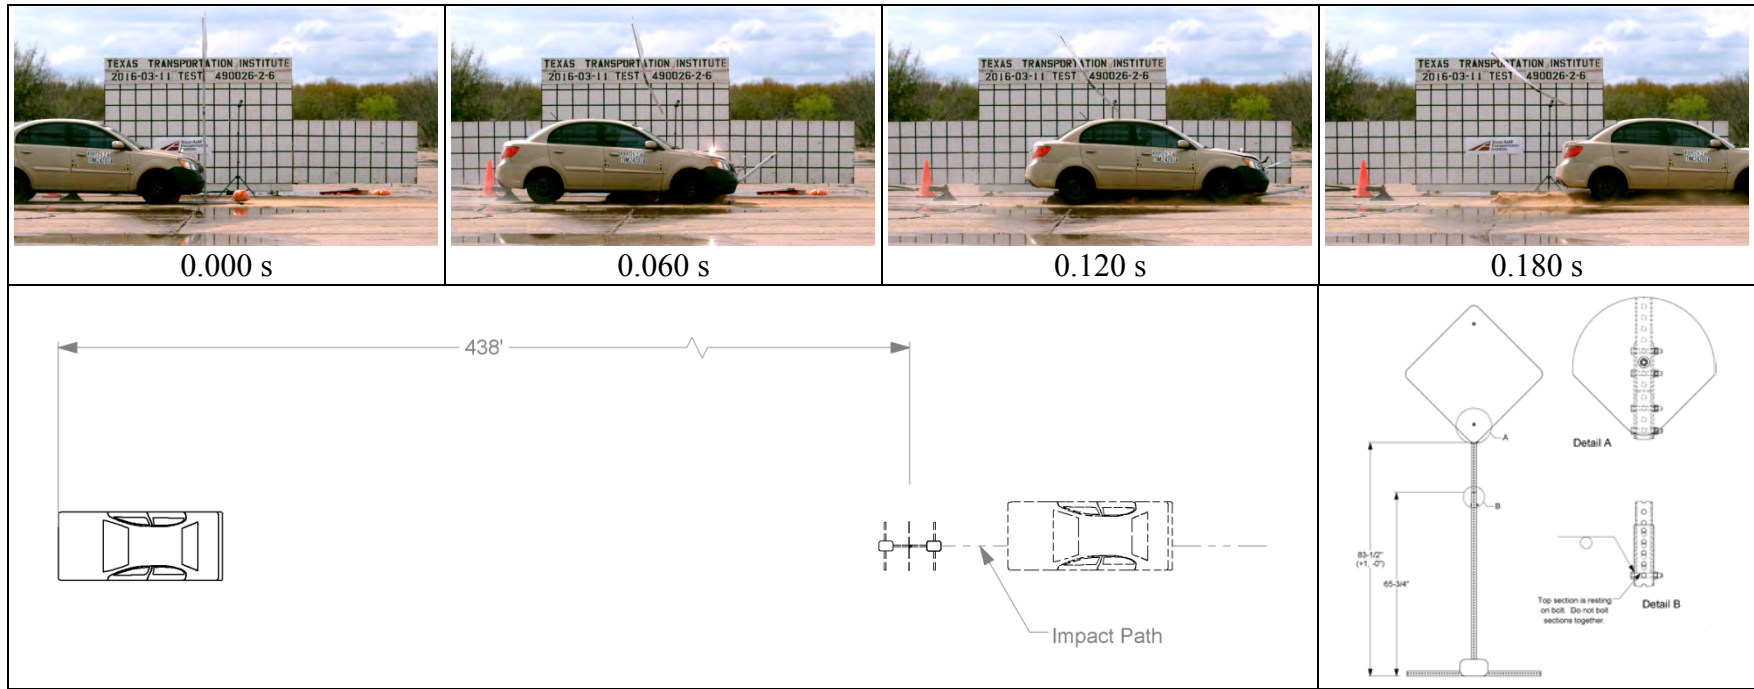
Figure 6.19 provides a summary of the results of the test. The slip connection of Option B temporary work zone sign support performed as designed and permitted the top of the system to release from the lower section. There was no secondary contact between the sign panel and the roof of the vehicle.
