DOWNSTREAM ANCHORING REQUIREMENTS FOR THE MIDWEST GUARDRAIL SYSTEM

MIDWEST ROADSIDE SAFETY FACILITY

MwRSF Research Report No. TRP-03-279-13

October 28, 2013

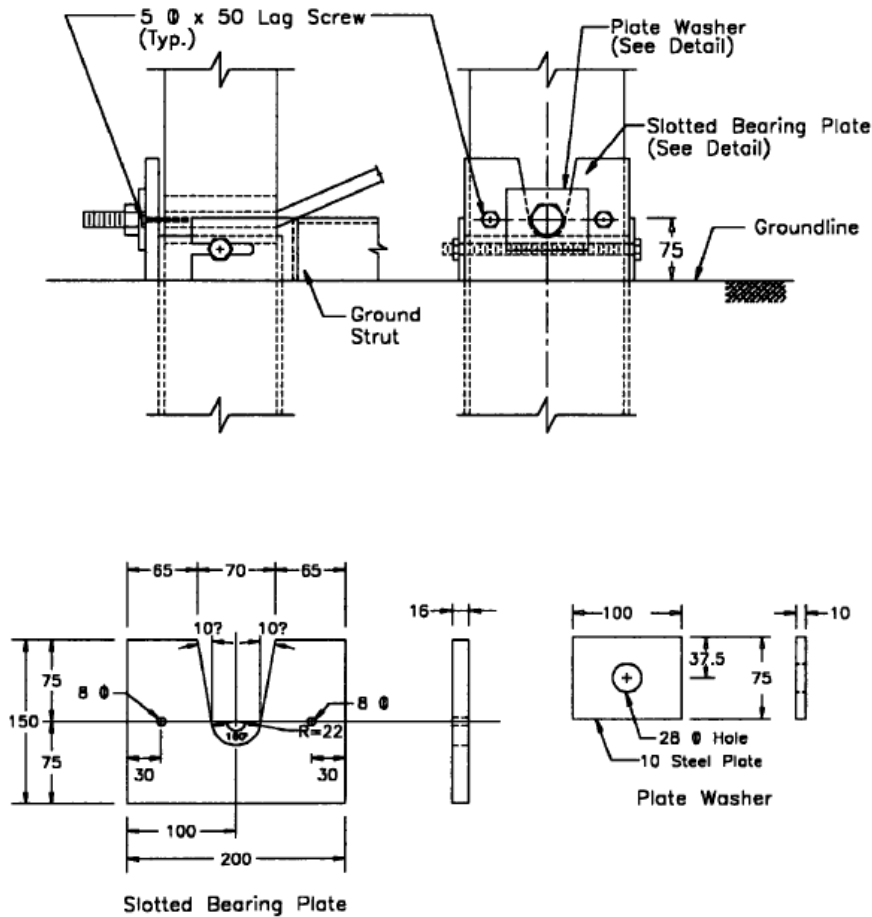
Figure 1. SRT End Terminal Slotted Bearing Plate [12]

A reverse-direction impact with an SRT terminal caused a pickup truck to yaw and eventually roll over due to cable anchor entrapment and snag with the vehicle suspension [12]. In addition to increased instability, any snag associated with the cable anchor could lead to unacceptable ridedown decelerations. In order to reduce the propensity for bearing plate snag on a vehicle's suspension, designers of the SRT installed a slotted anchor plate secured to the end post with two screws to cleanly release away from the post after post fracture. This slotted bearing plate is shown in Figure 1. The slotted anchor plate cleanly released away from the anchor cable during a reverse-direction impact, thus leading to acceptable performance of the end terminal system.

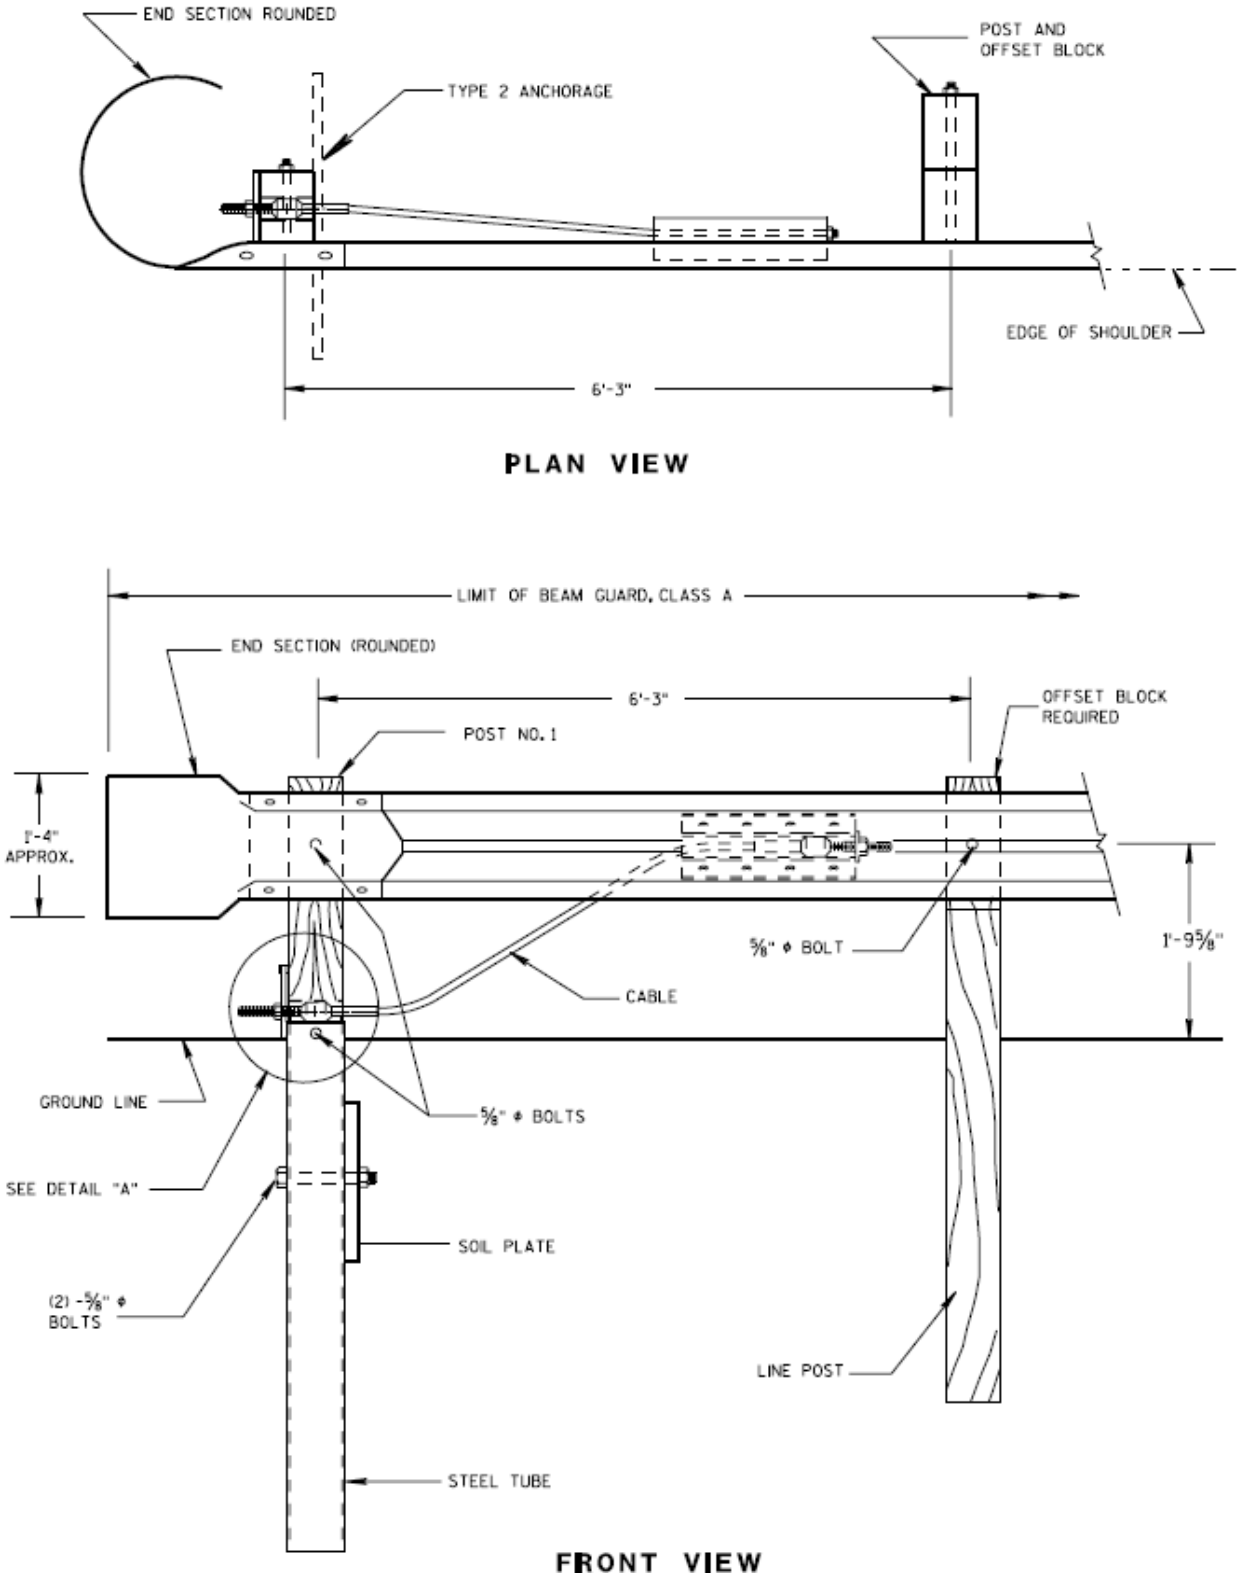
Figure 2. BCT Post Trailing-End Terminal Adopted by Wisconsin DOT [25]

able to release in a controlled manner if a vehicle wedged under and/or snagged on it. As such, there are concerns for excessive vehicle snagging on the cable anchor for this specific type of configuration.

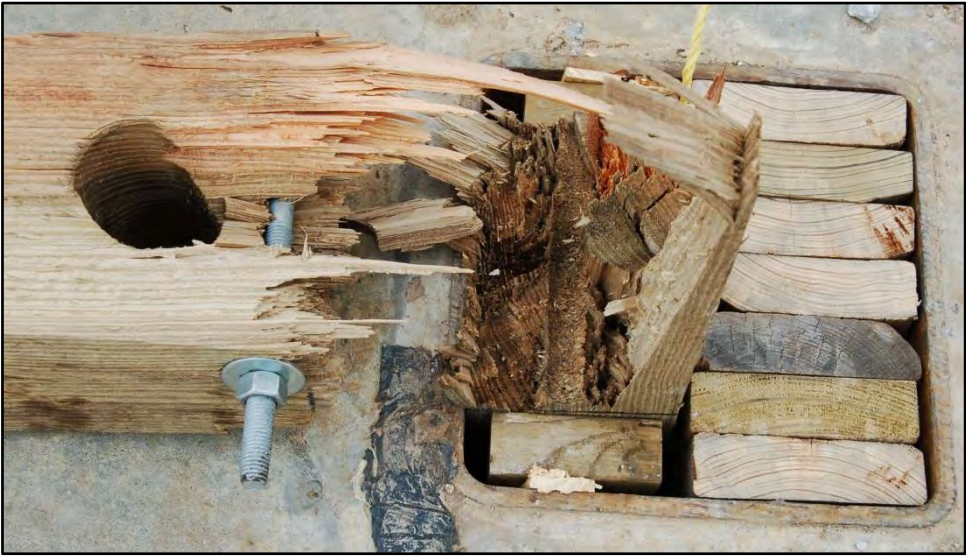
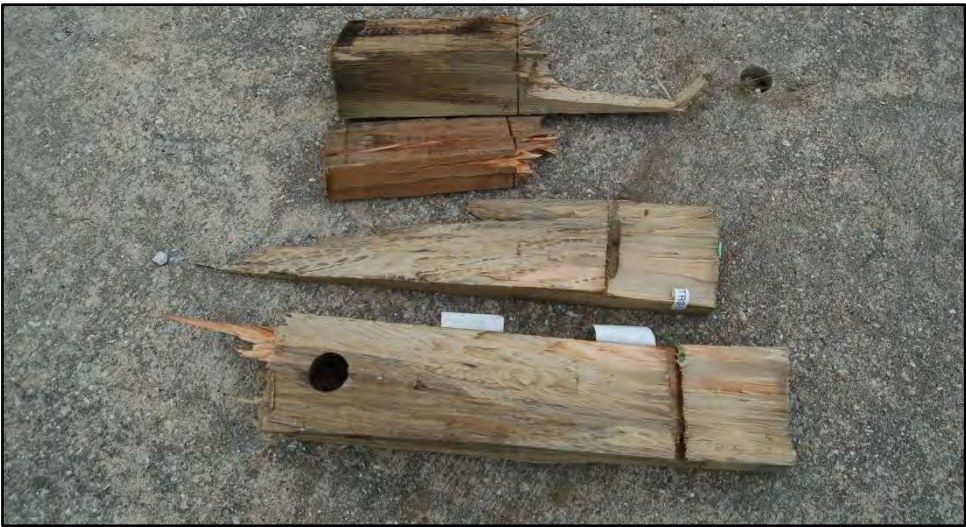
Figure 18. Time-Sequential and Post-Impact Photographs, Test No. BCTRS-1

During test no. BCTRS-1, the eccentric bogie head impacted the protrusion mounted on the left side of the 5½-in. x 7½-in. (140-mm x 191-mm) BCT wood post at a speed of 15.6 mph (25.1 km/h), which caused multiaxial loading, consisting of longitudinal shear, weak-axis bending, and torsion. Time-sequential and post-impact photographs are shown in Figure 18. After initially bending, the post split into two pieces along a fracture plane which was nearly perpendicular to the bogie vehicle's direction of motion. The fracture started at the top of the post and moved downward, but the split terminated above the through-hole at the ground line. At 0.046 sec, the bogie impacted the second portion of the post, which subsequently fractured at the ground line at 0.066 sec.

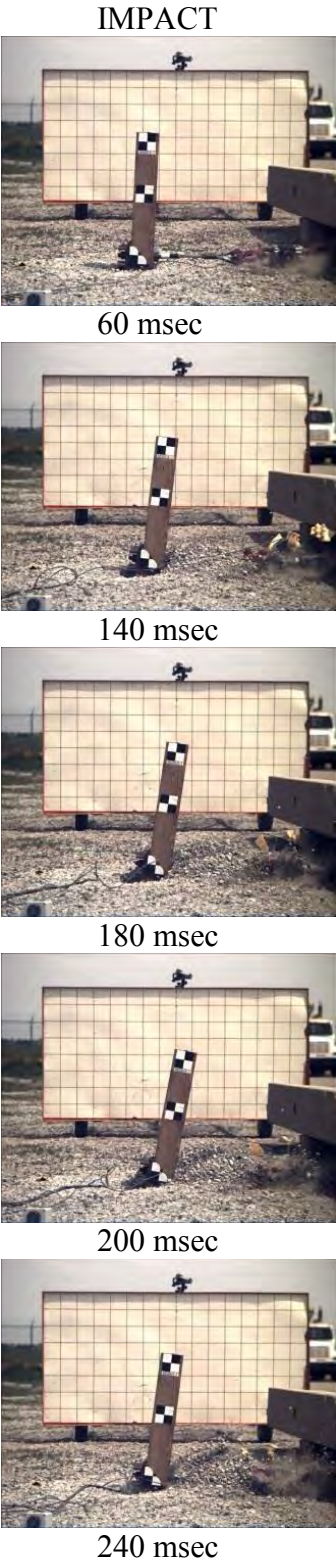
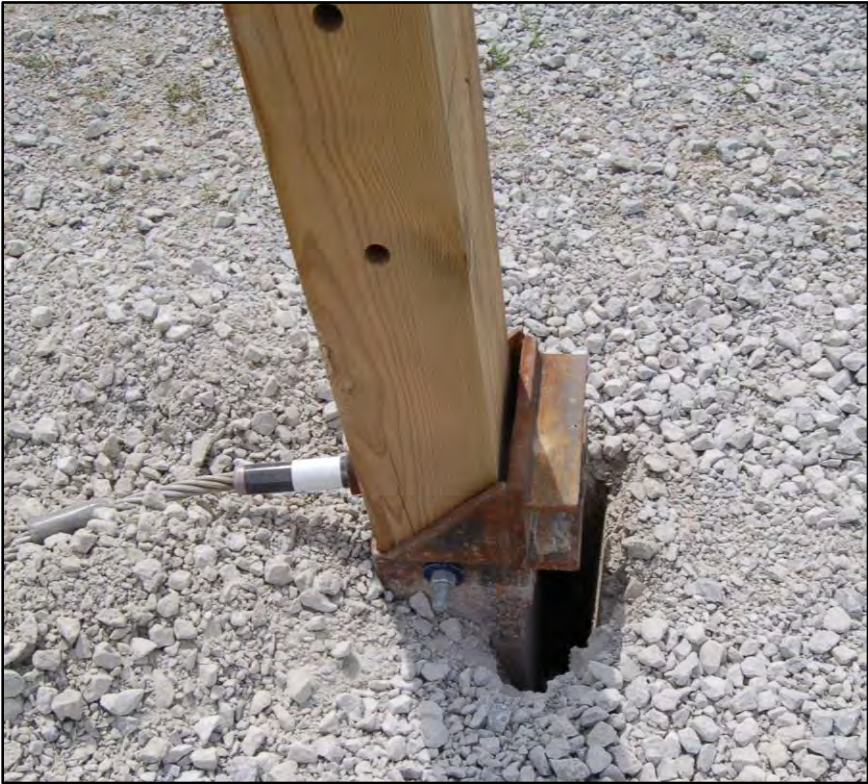
Figure 37. Time-Sequential and Post-Impact Photographs, Test No. MGSEA-1

Time-sequential and post-test photographs of test no. MGSEA-1 are shown in Figure 37. During test no. MGSEA-1, the anchor foundation tube was pulled by the cable attached to the bogie vehicle, which was traveling at an initial speed of 16.1 mph (26.0 km/h) when the cable started to be tensioned. As a consequence of the pull force, the foundation tube rotated through the ground over a maximum dynamic displacement of 6.5 in. (165 mm). The final permanent

set deflection was 4.2 in. (107 mm), as measured using the string potentiometer attached to the back of the tube at ground line. The steel foundation tube bent slightly, thus initiating a plastic hinge at about 8½ in. (216 mm) from its top edge.

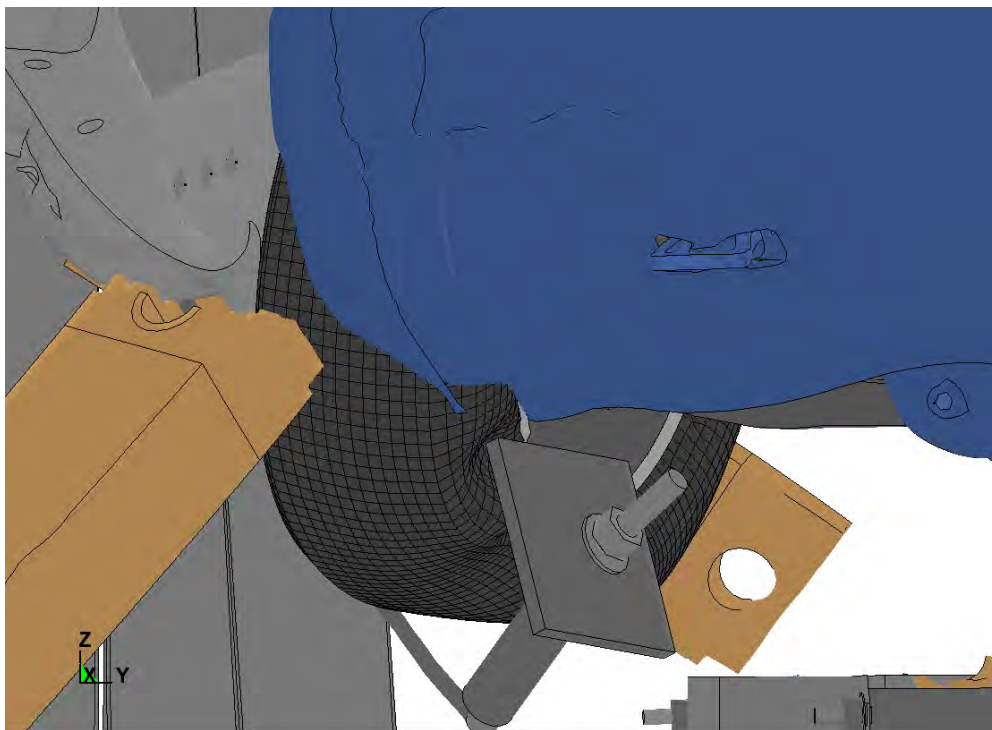
Figure 94. Tire-Bearing Plate Contact for Impact at 2nd Post from Downstream End - 2270P

It should be noted that for an initial impact at the second post from the downstream end, the bearing plate disengaged away from the fractured BCT end post and engaged the vehicle's tire, as shown in Figure 94. Although this interference between the front tire and the bearing plate did not result in any vehicle instability in the simulation, there is still a potential that the vehicle could snag and become unstable if the edge of the bearing plate cuts through the tire.

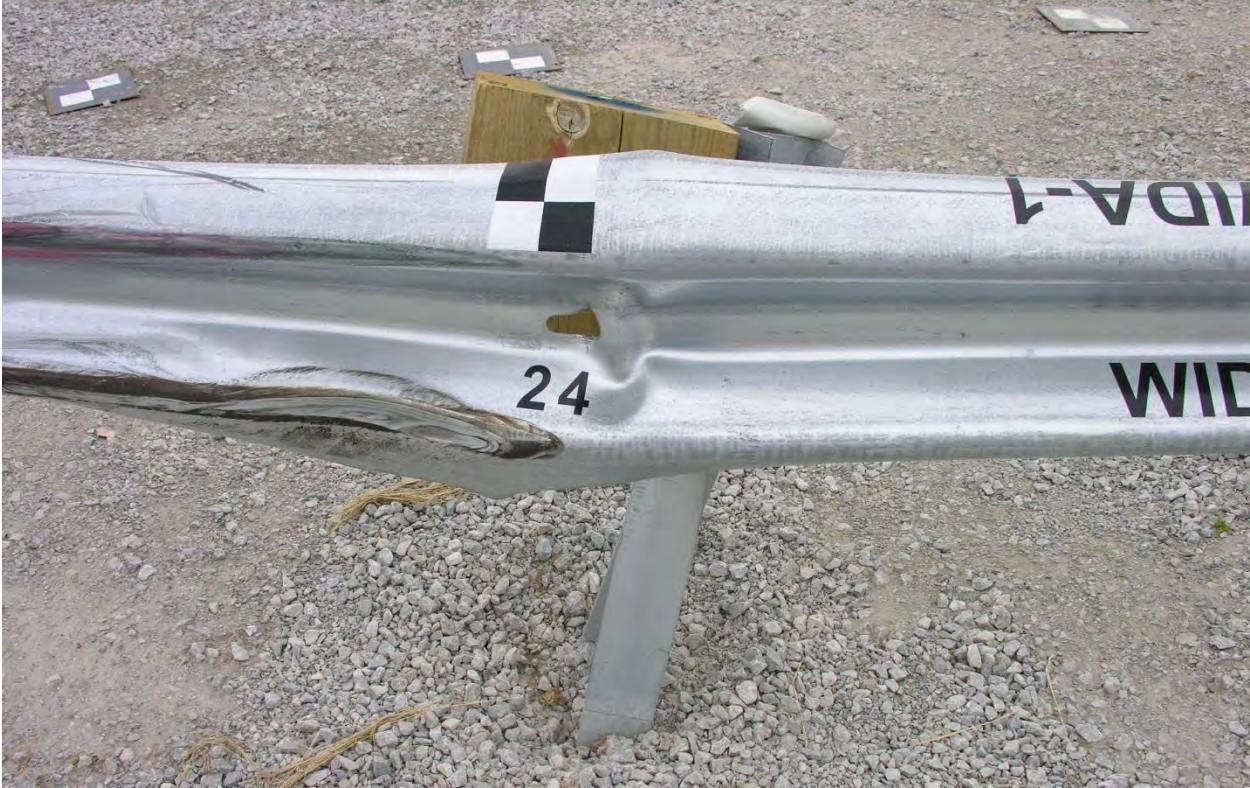
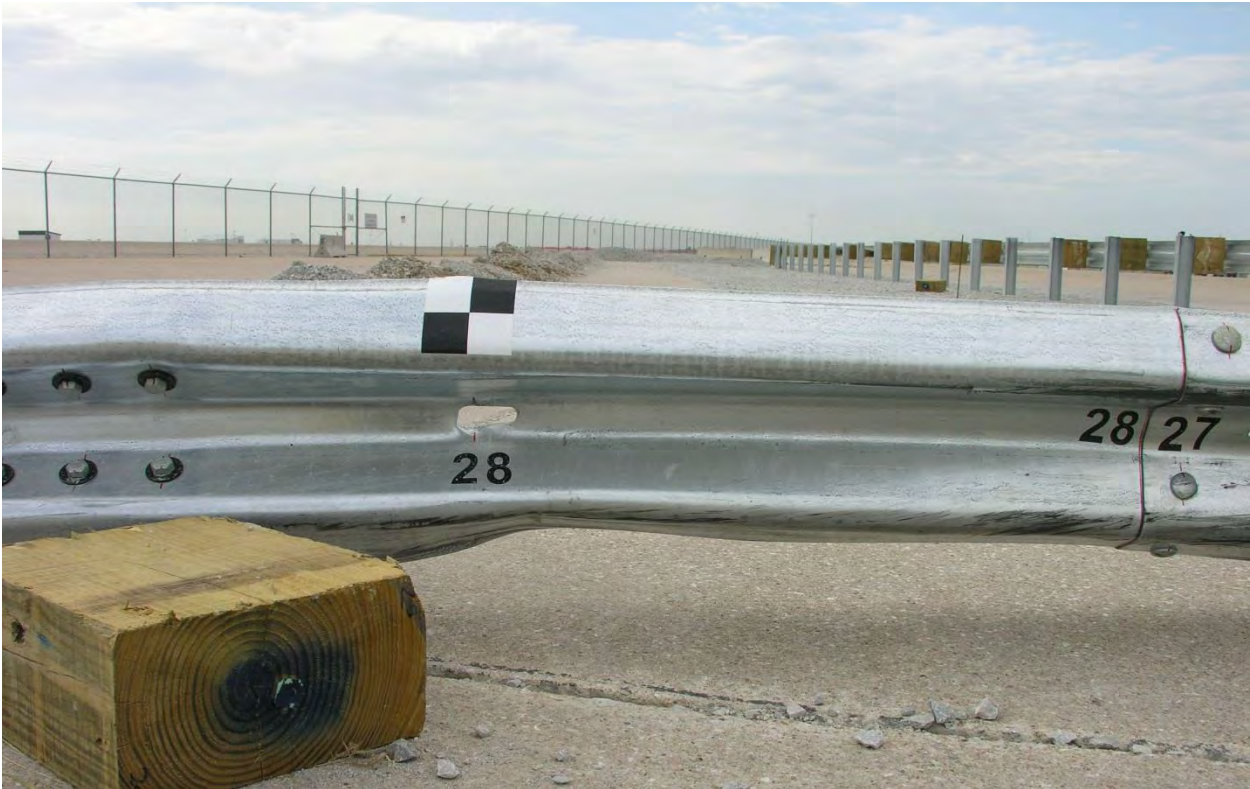
Figure 137. Rail Slot Tearing at Post Nos. 24 and 28, Test No. WIDA-1

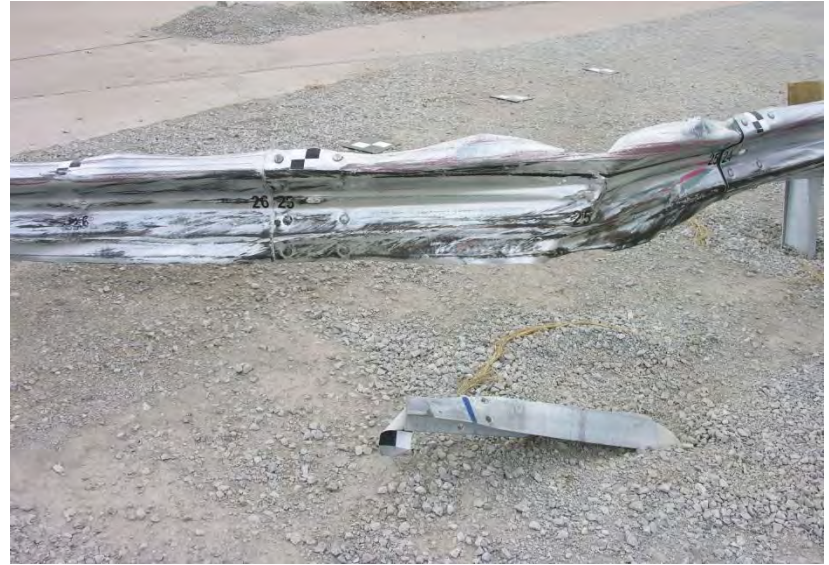
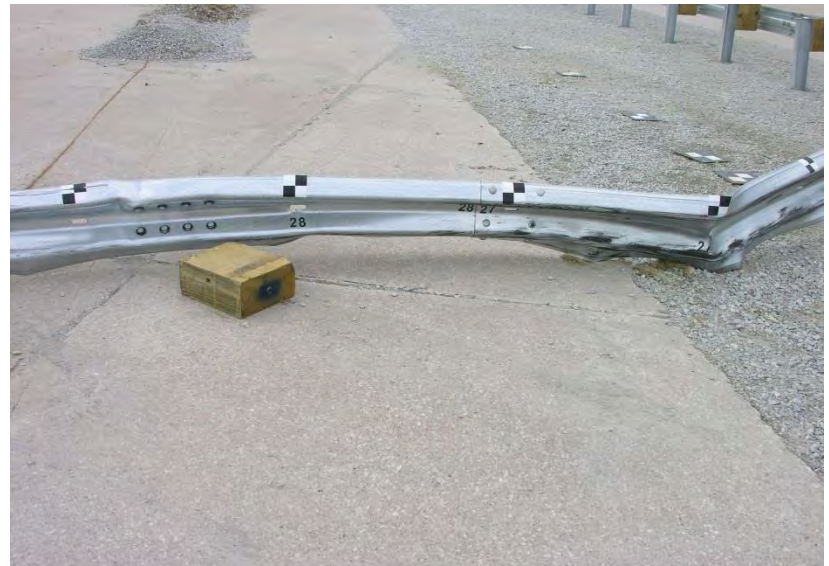
Figure 138. Details of Rail Damage, Test No. WIDA-1

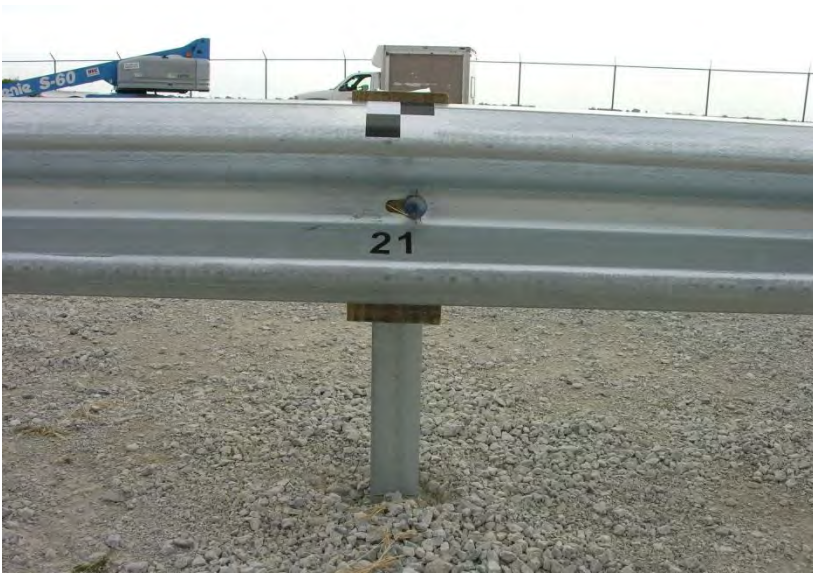
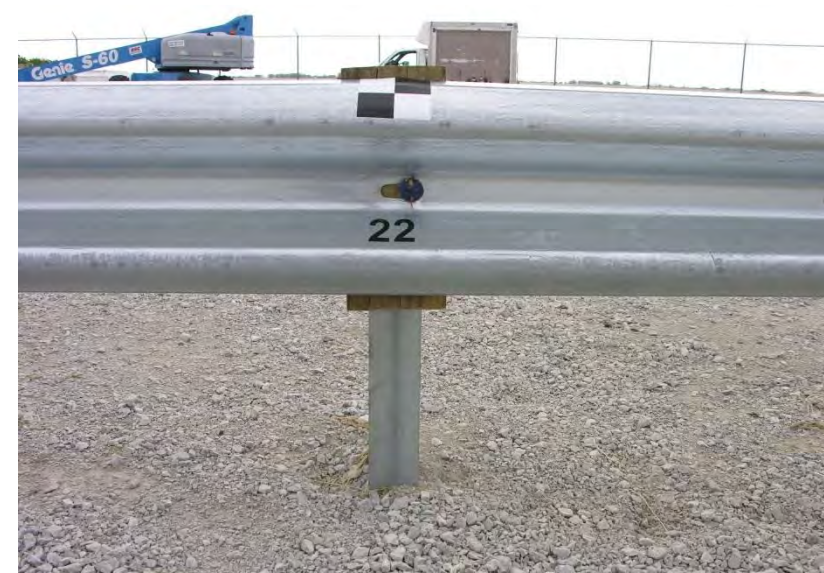
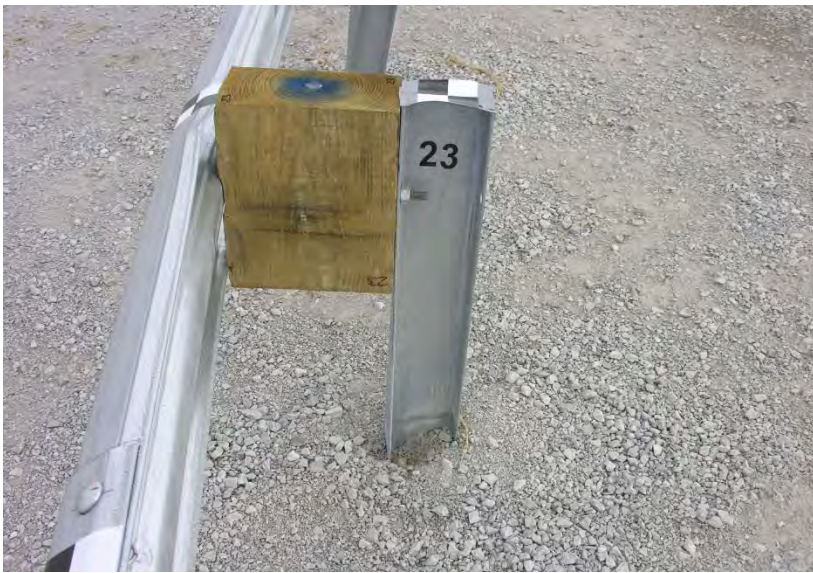
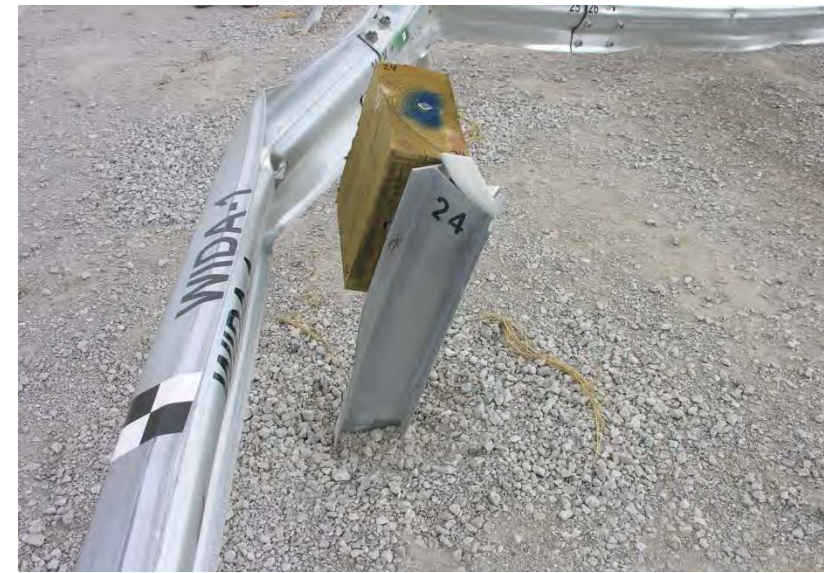
Figure 139. System Damage at Post Nos. 21 through 24, Test No. WIDA-1

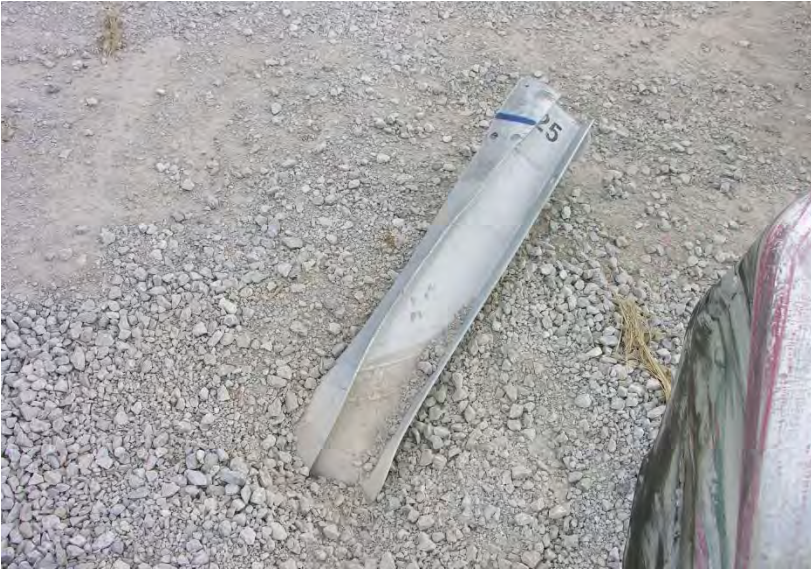
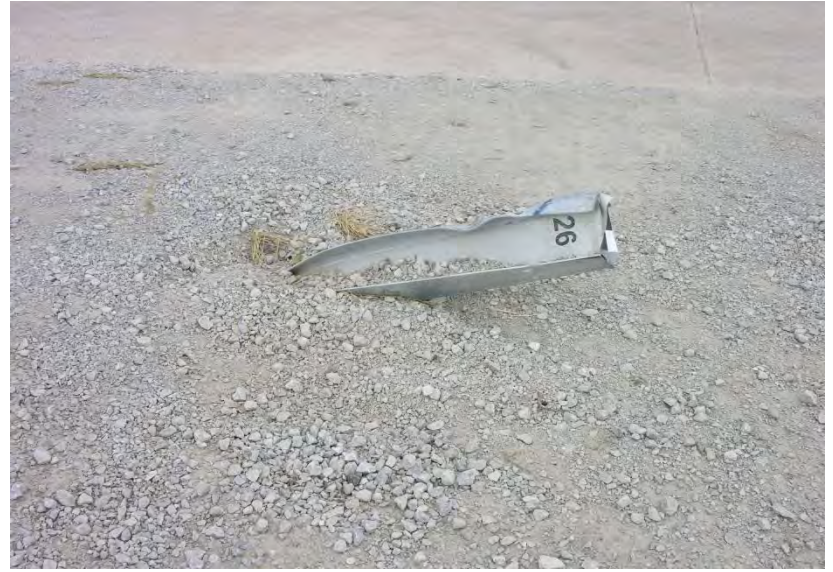
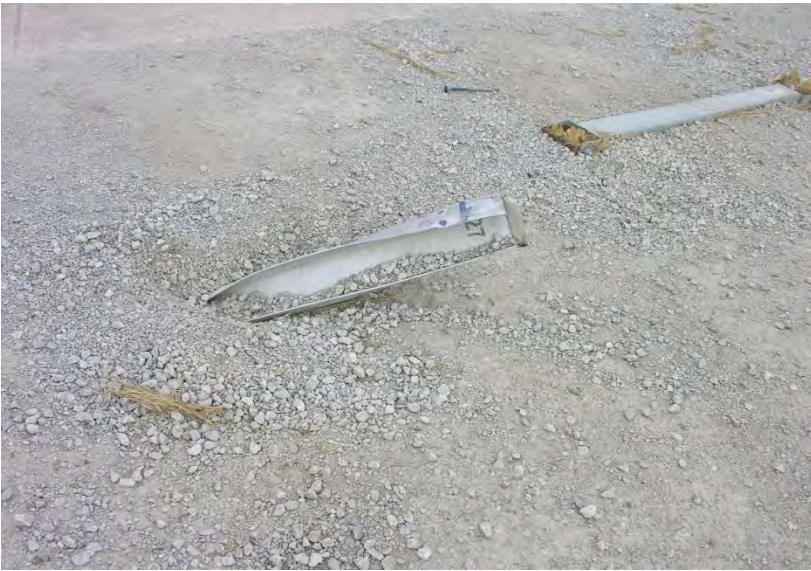
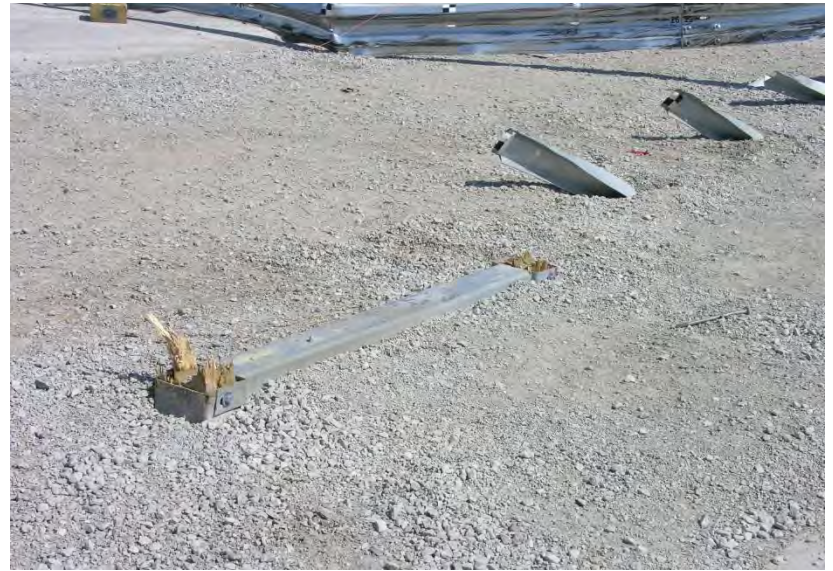
Figure 140. System Damage at Post Nos. 25 through 29, Test No. WIDA-1

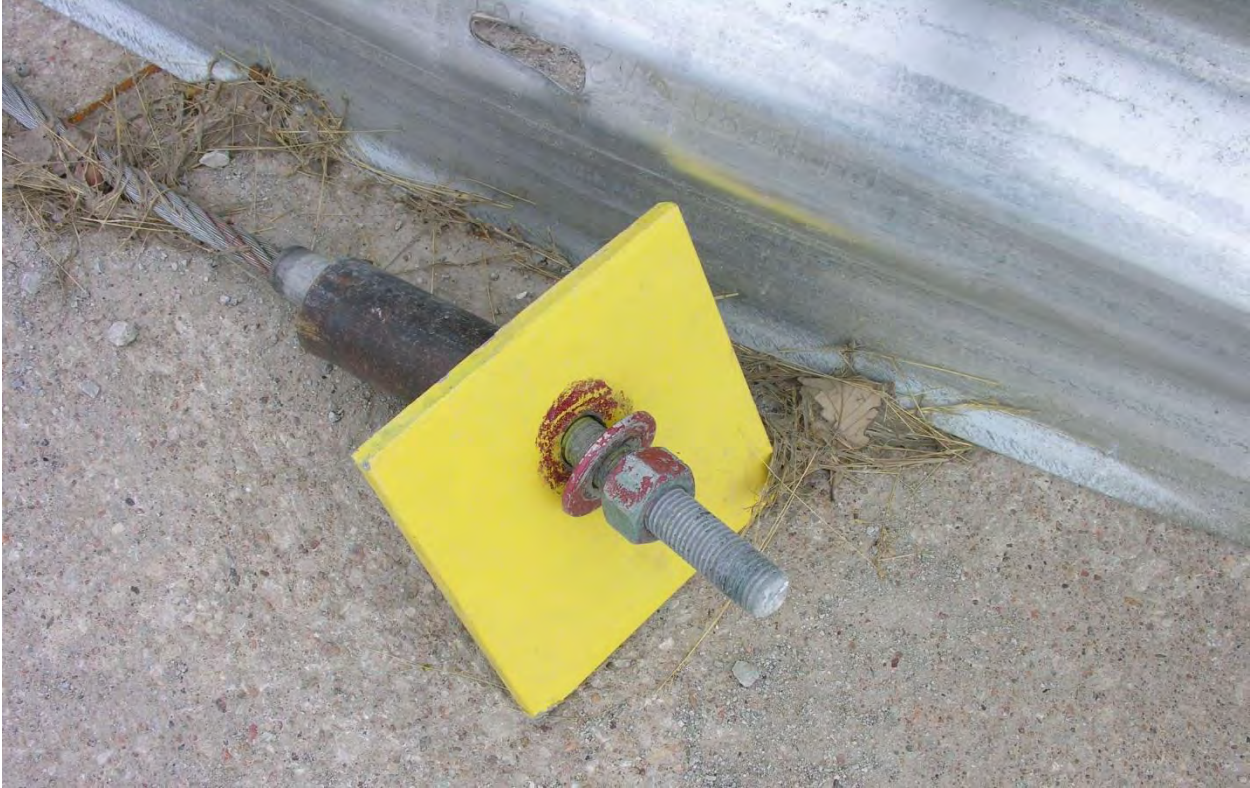
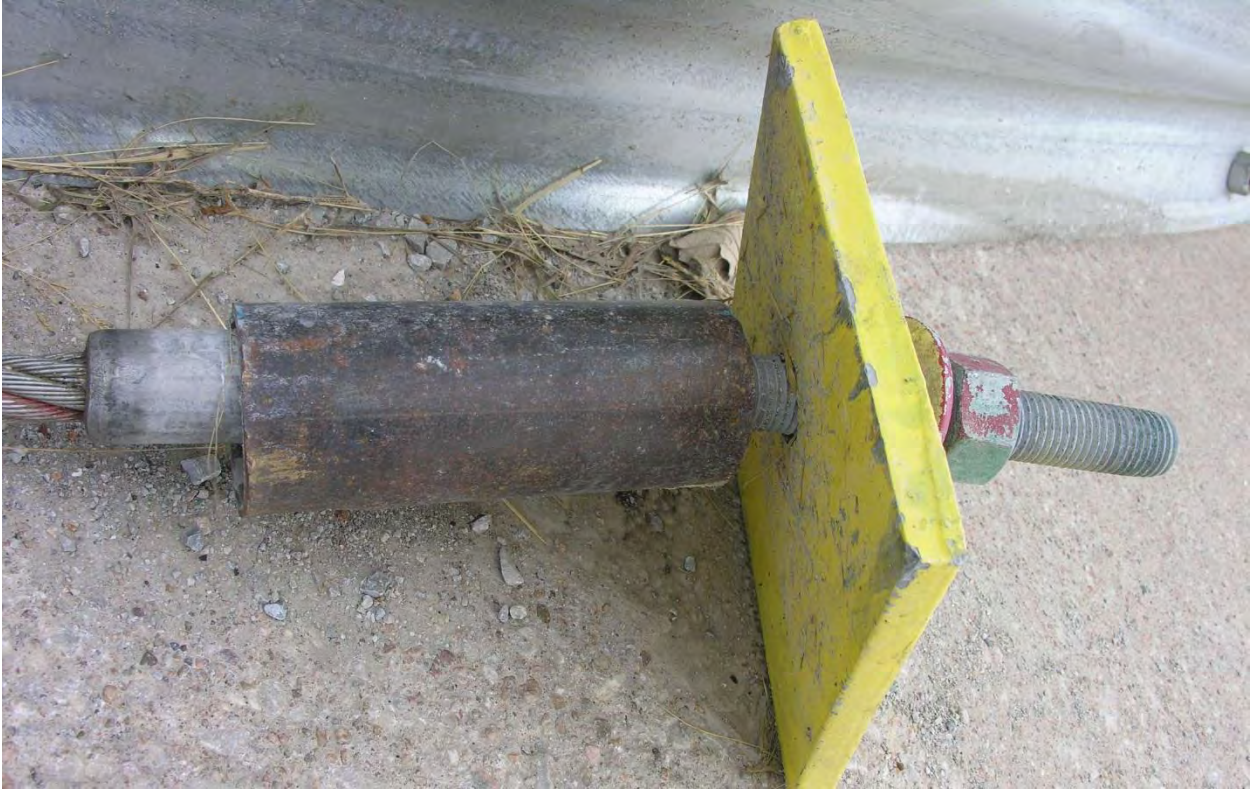
Figure 141. Anchor Cable Damage, Test No. WIDA-1

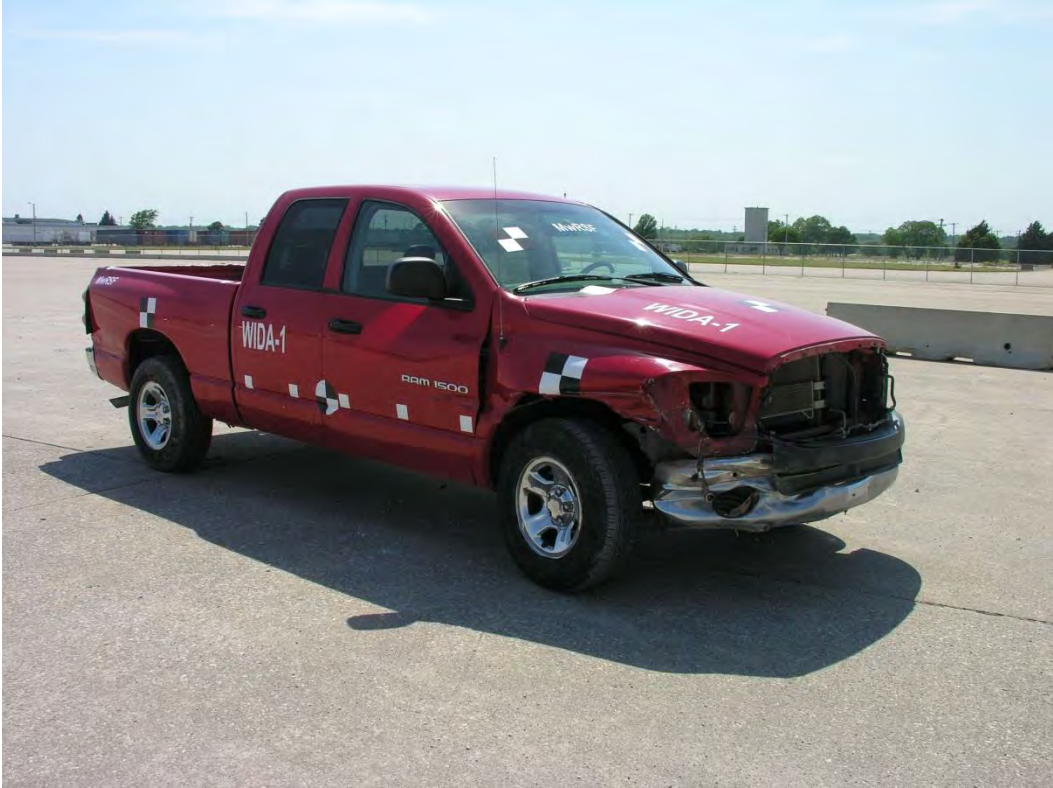
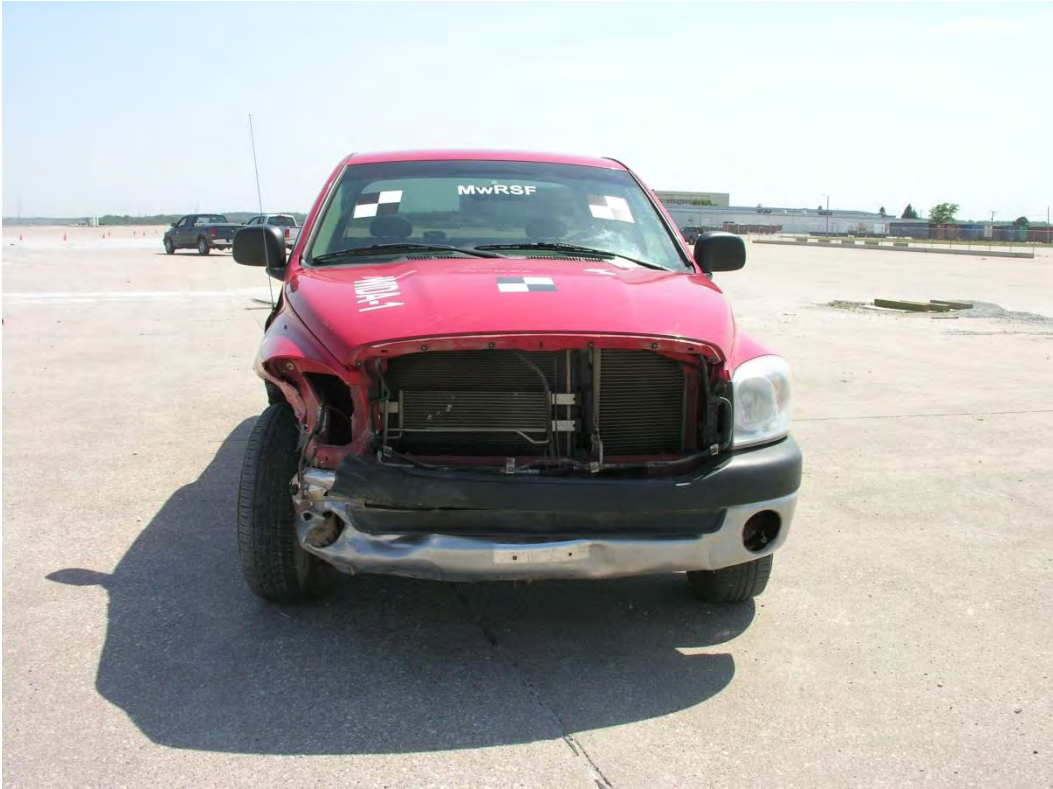
Figure 142. Vehicle Damage, Test No. WIDA-1

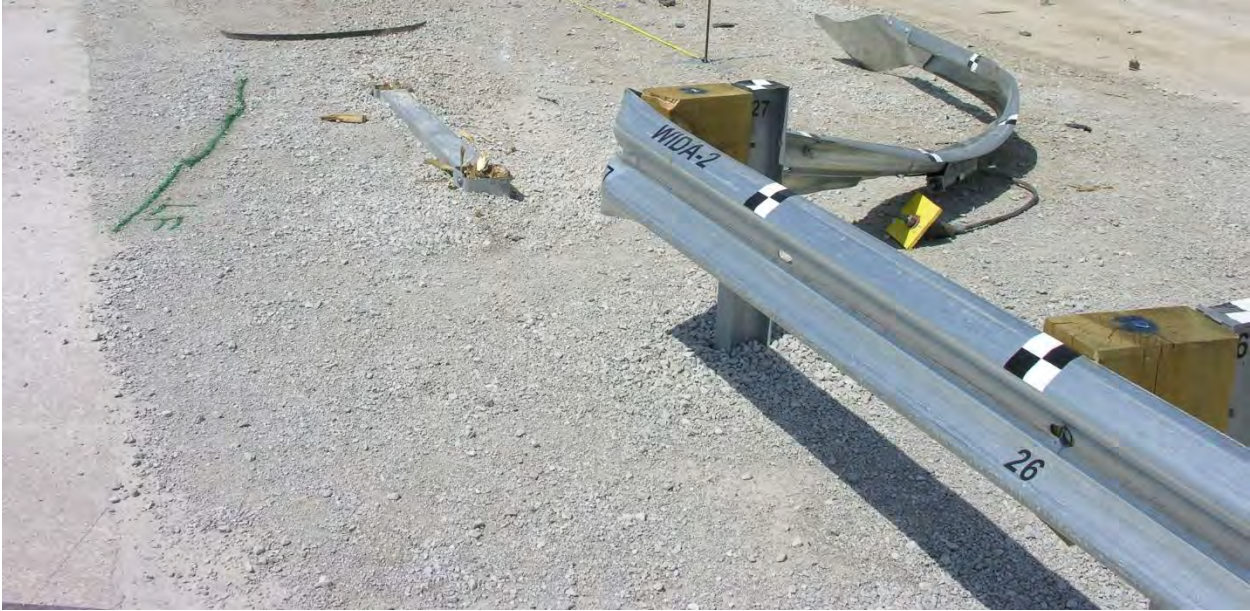
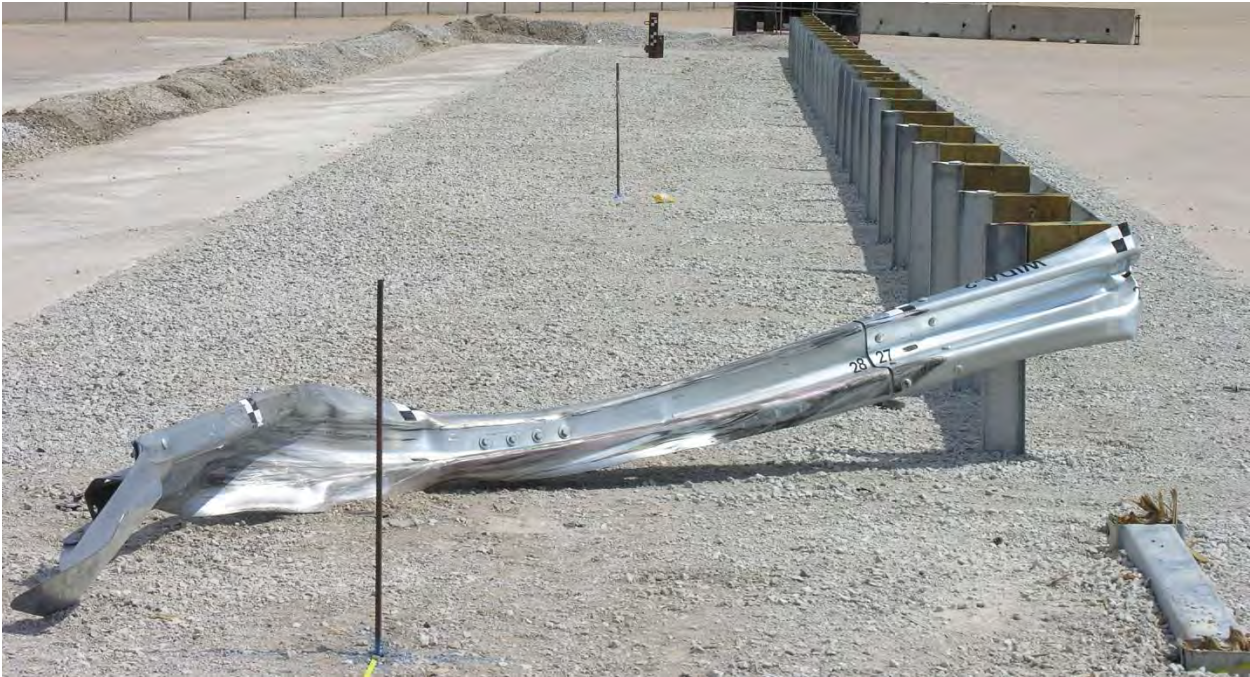
Figure 152. System Damage, Test No. WIDA-2

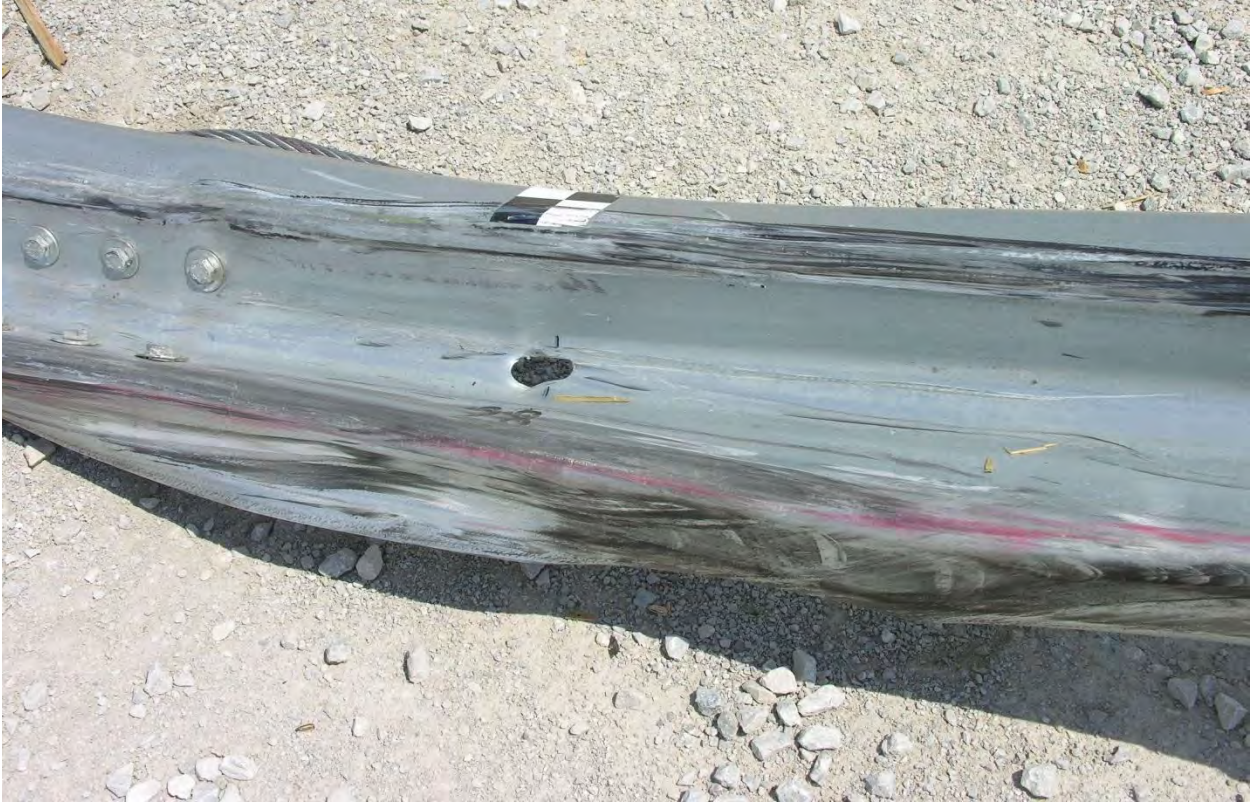
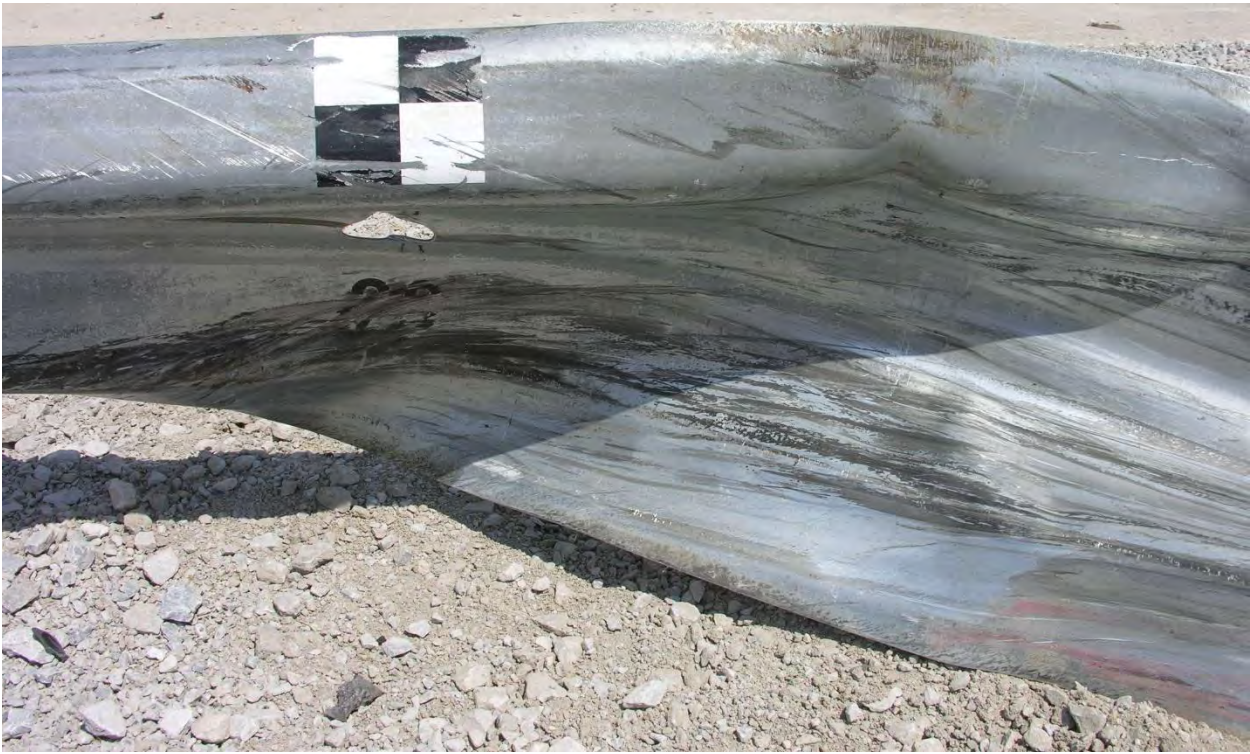
Figure 153. Rail Slot Tearing at Post Nos. 27 and 29, Test No. WIDA-2

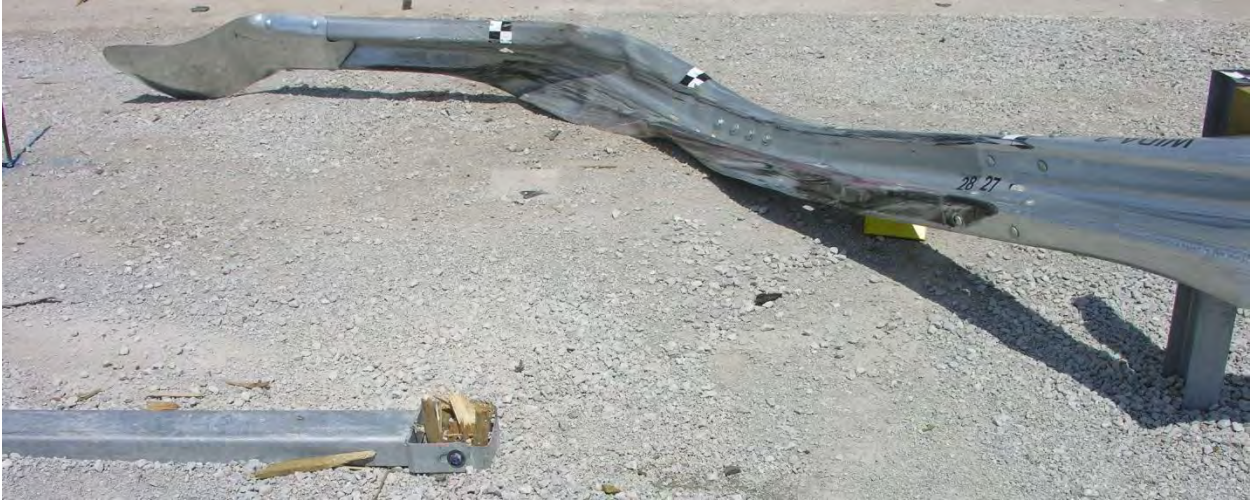
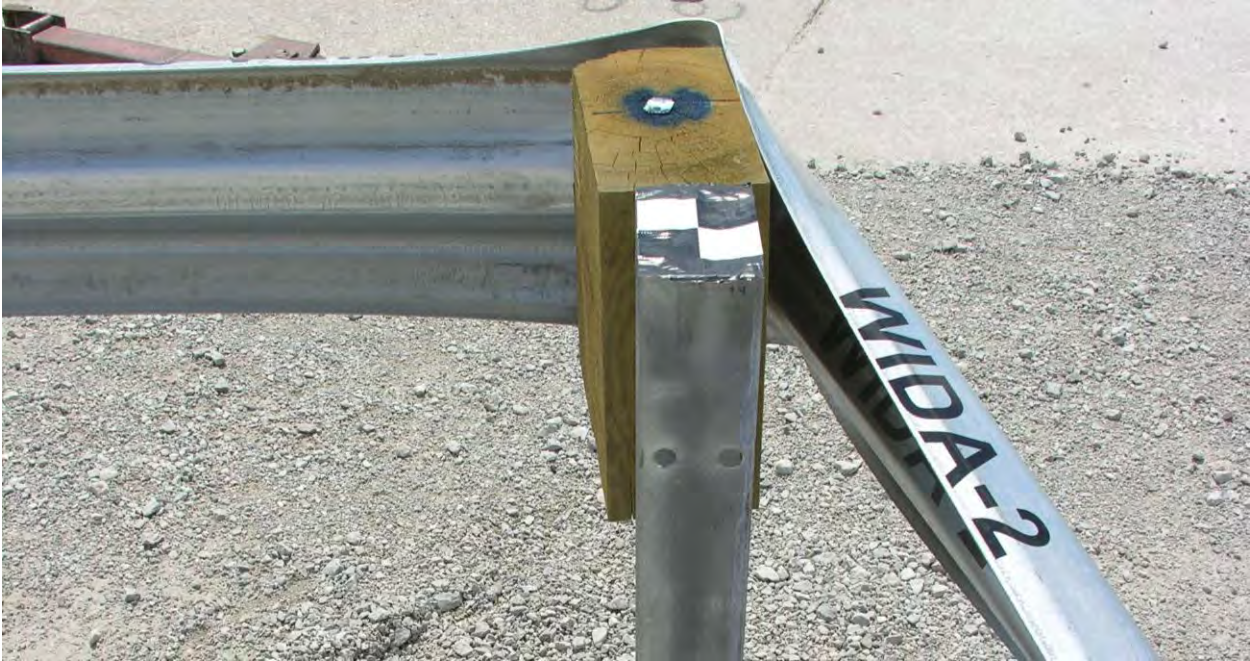
Figure 154. Rail Damage, Test No. WIDA-2
