DOWNSTREAM ANCHORING REQUIREMENTS FOR THE MIDWEST GUARDRAIL SYSTEM

MIDWEST ROADSIDE SAFETY FACILITY

MwRSF Research Report No. TRP-03-279-13

October 28, 2013

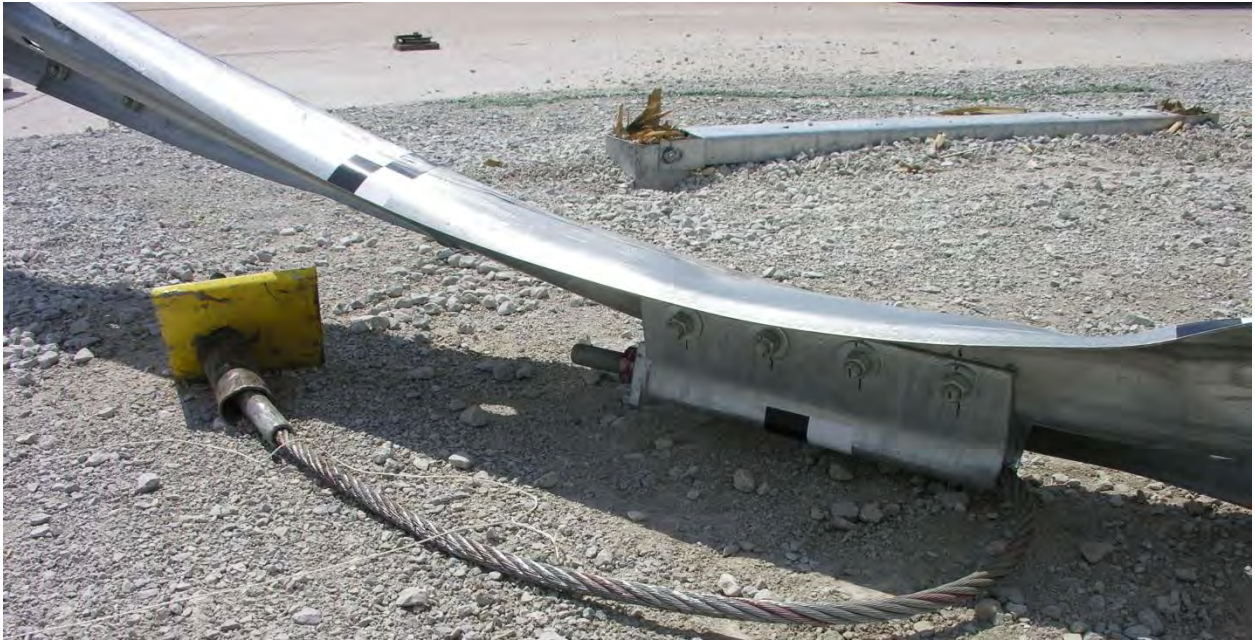
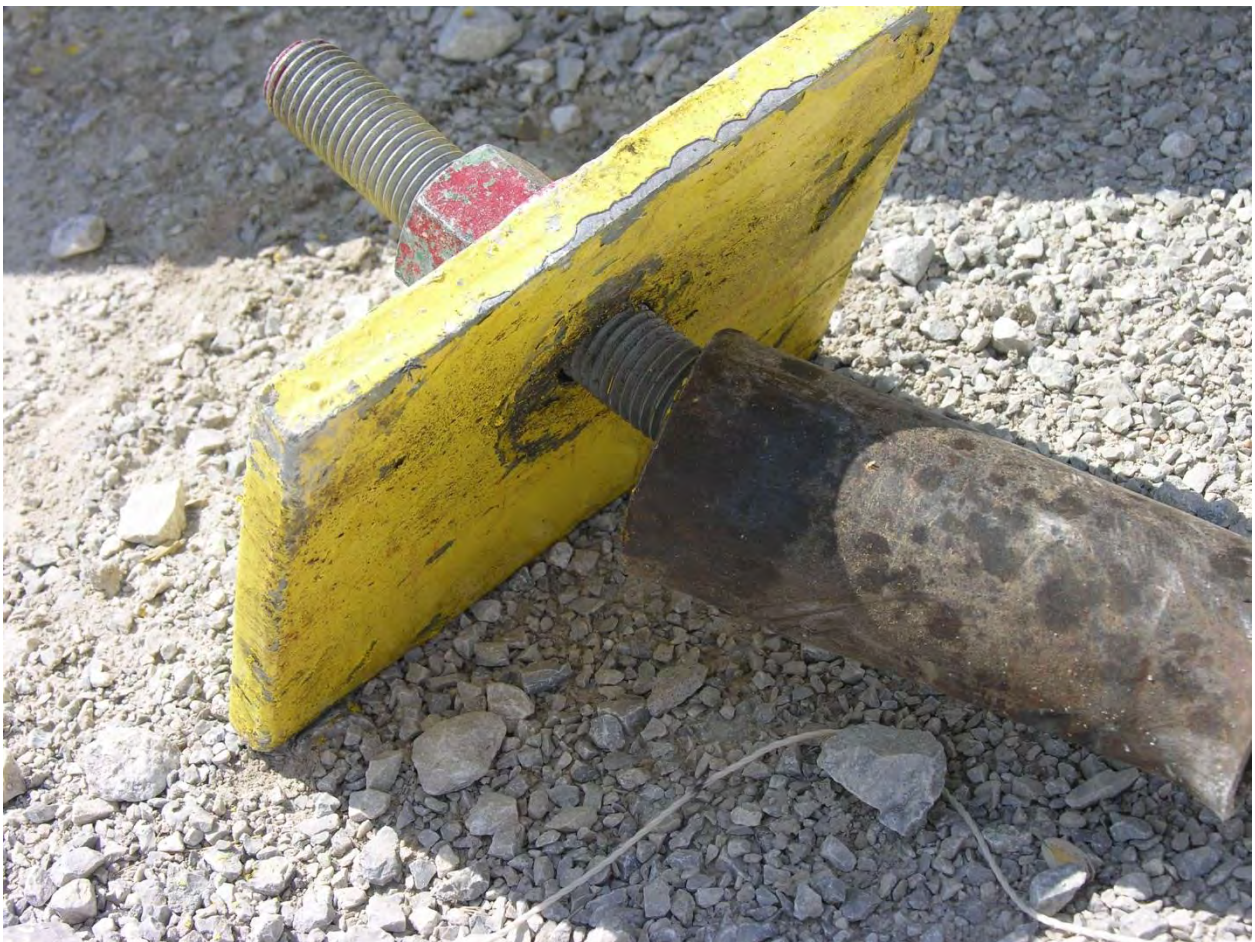
Figure 156. Anchor Cable Damage, Test No. WIDA-2

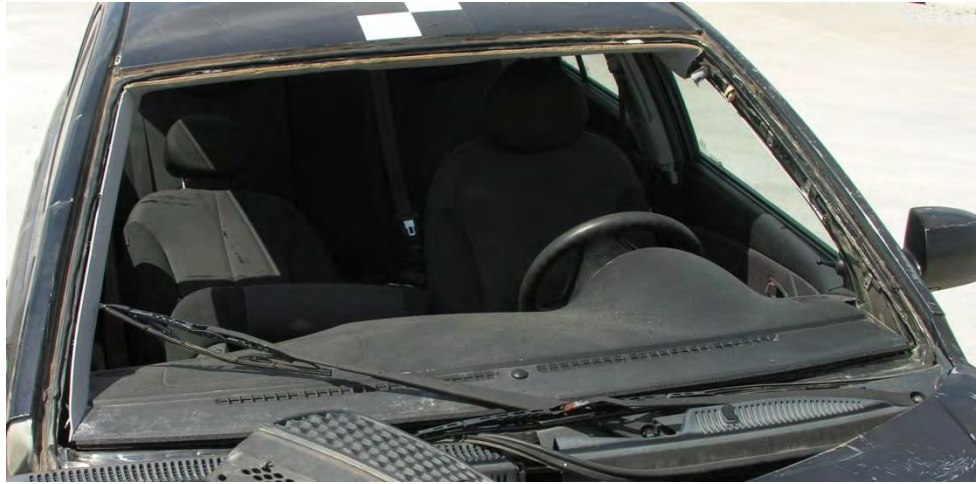
Figure 160. Vehicle Damage - Windshield, Test No. WIDA-2

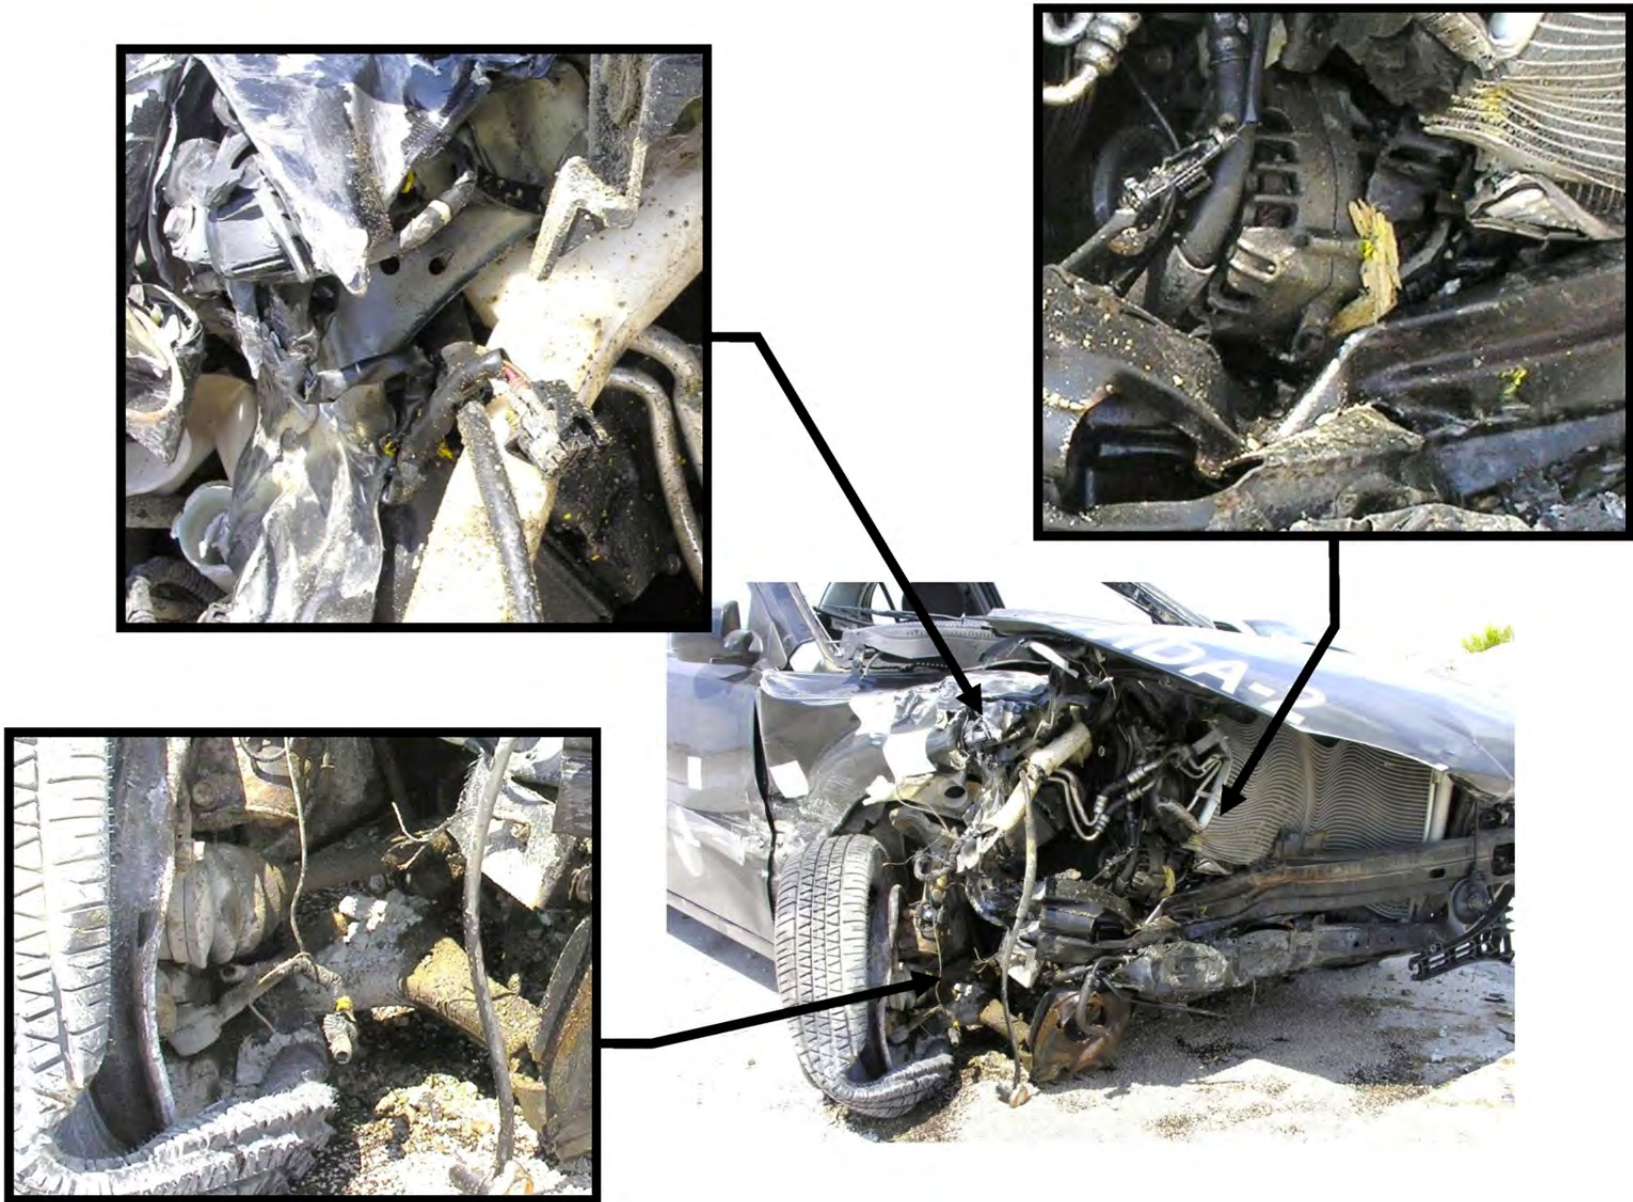
Figure 162. Traces of Bearing Plate Motion Path along Vehicle's Front End, Test No. WIDA-2
