DEVELOPMENT OF A PCB STEEL COVER PLATE FOR LARGE OPEN JOINTS – PHASE II

MIDWEST ROADSIDE SAFETY FACILITY

MwRSF Research Report No. TRP-03-387b-20

December 17, 2020

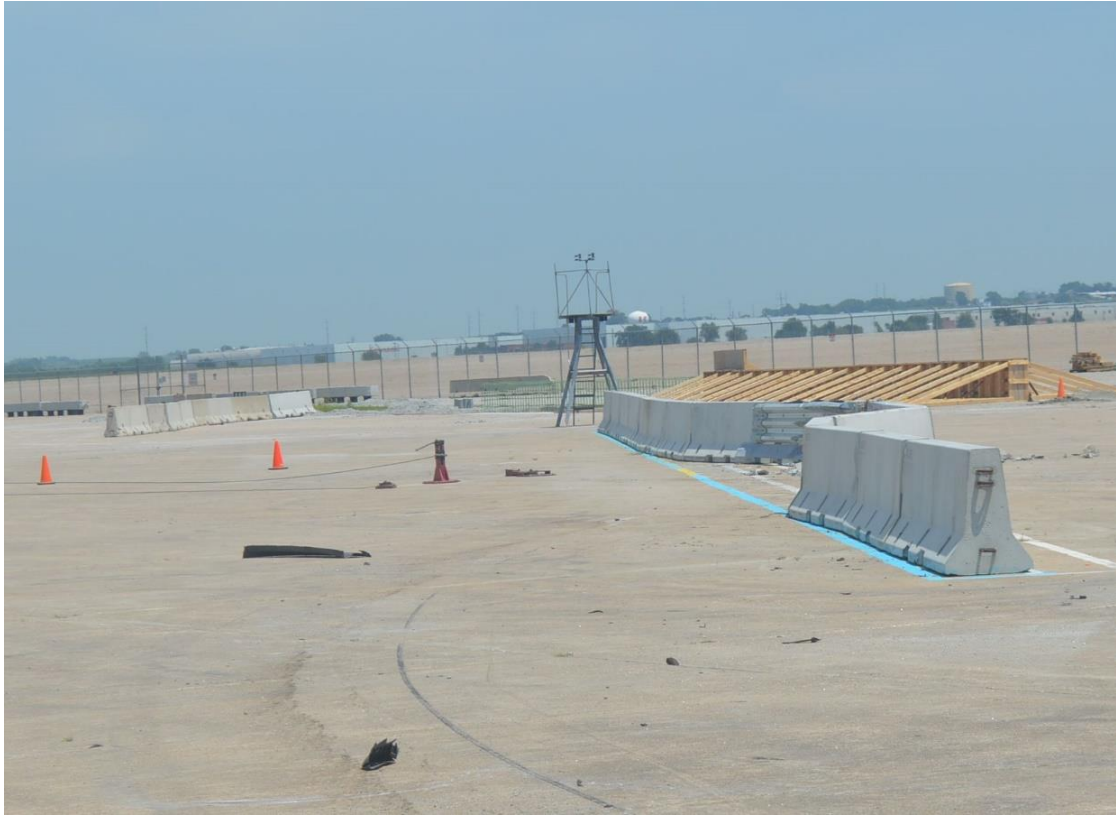
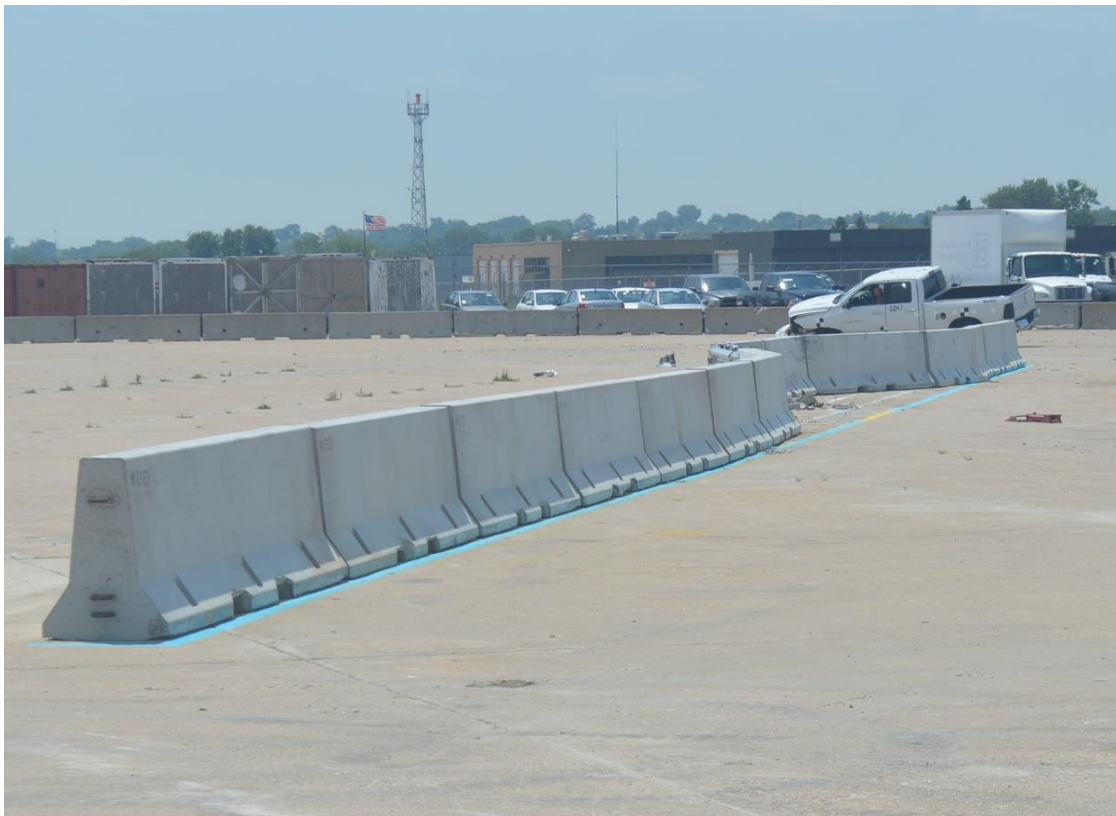
Figure 36. Overall System Damage, Test No. GSH-1

Damage to the barrier was moderate, as shown in Figures 36 through 41. Barrier damage consisted of deformation of the thrie-beam guardrail, contact marks on the front face of the thrie-beam and concrete barriers, spalling of the concrete, and concrete cracking and failure. The length of vehicle contact along the barrier was approximately 34 ft – 5 in. (10.5 m), which spanned from 10 in. (254 mm) upstream from the target impact point to the upstream end of barrier no. 11.

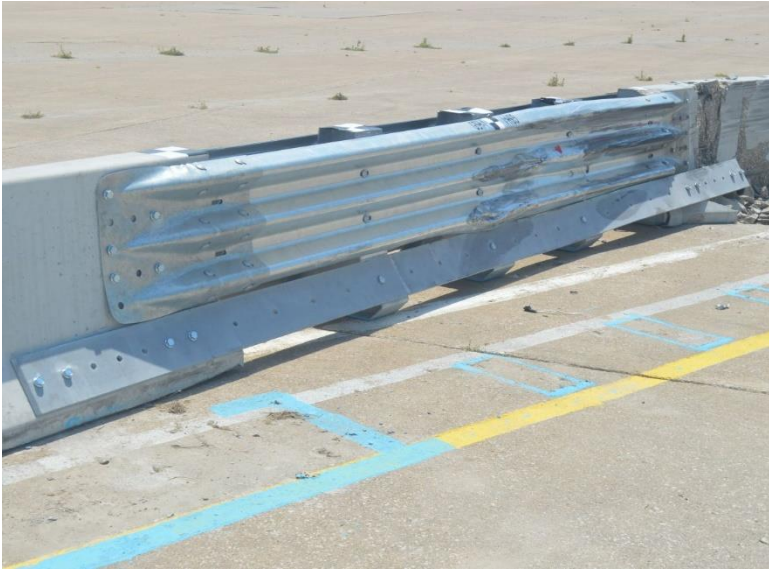
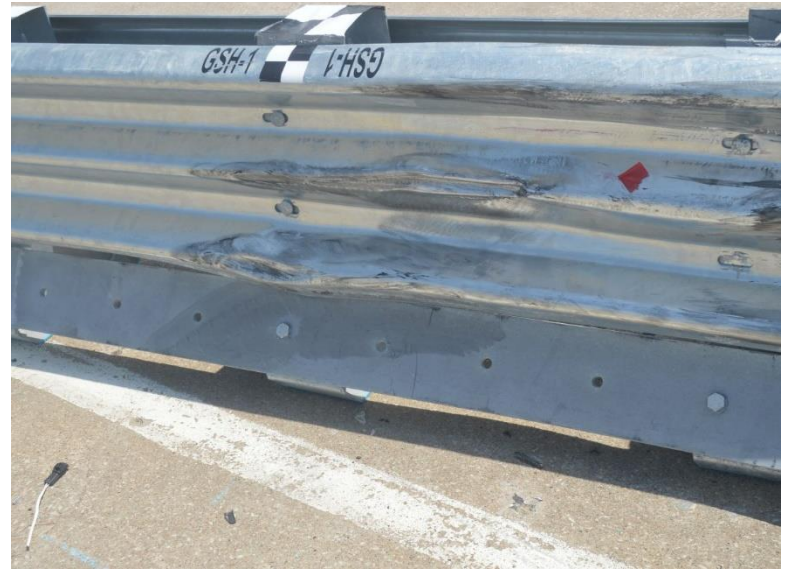
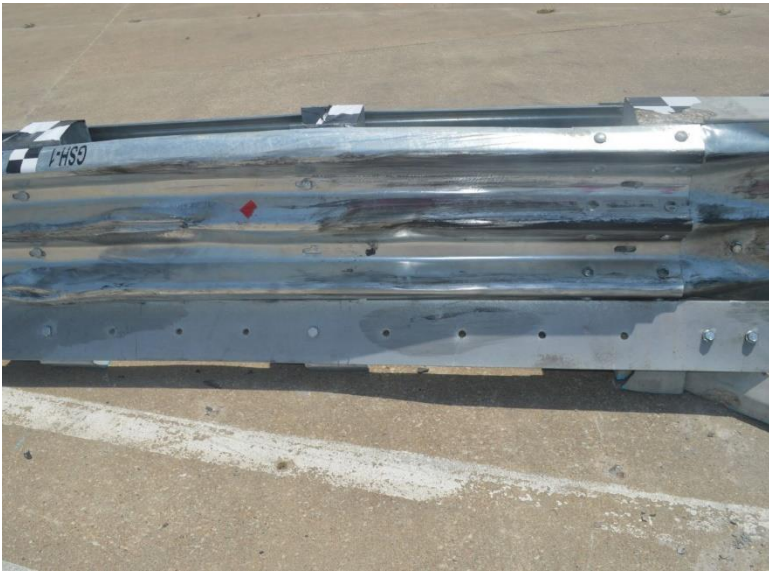
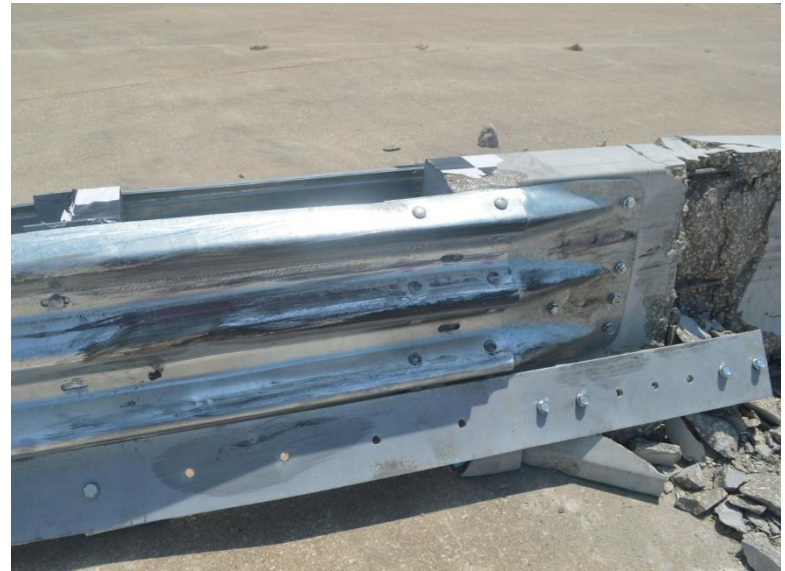
Figure 38. Thrie-Beam Damage, Test No. GSH-1

Additional damage was noted on the gap-spanning hardware. A 10-in. long × 2-in. tall (254-mm × 51-mm) dent occurred 4 in. (102 mm) upstream from the target impact point on the bottom corrugation of the thrie-beam section and at 14 in. (356 mm) downstream from the target impact point on the middle corrugation of the thrie-beam section. At 18 in. (457 mm) downstream from the target impact point, the middle corrugation buckled. The lower valley bolt connecting the thrie-beam section to the internal spacer assembly located directly upstream from barrier no. 9 pulled out during the impact event, as shown in Figure 38. A 2-in. × 2-in. (51-mm × 51-mm) dent occurred on the middle corrugation of the thrie-beam transition 46 in. (1,168 mm) downstream from the target impact point. The front ⅝-in. (16-mm) thick steel toe plate bent approximately 1½ in. (38 mm) toward the center of the system 19 in. (483 mm) downstream from the impact point target. All eight of the ¾-in. (19-mm) diameter wedge bolts that fastened the downstream ends of the front and rear toe plates to barrier no. 9 disengaged due to concrete fracture.

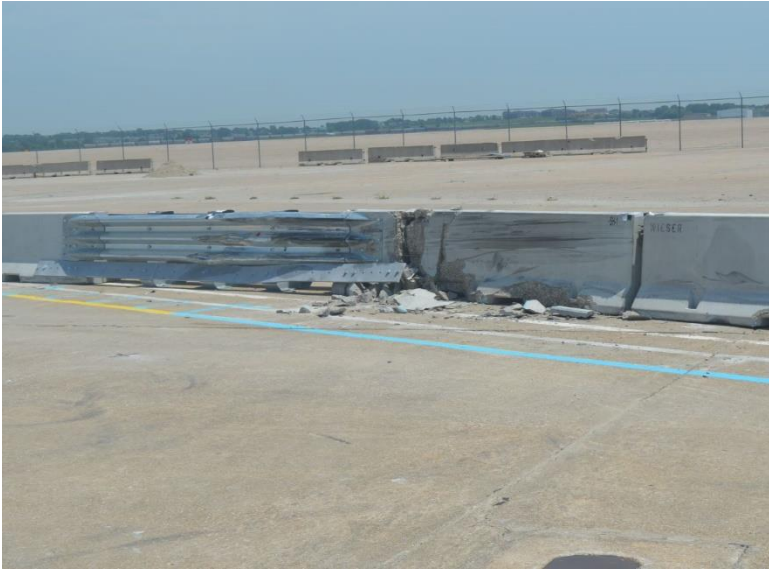
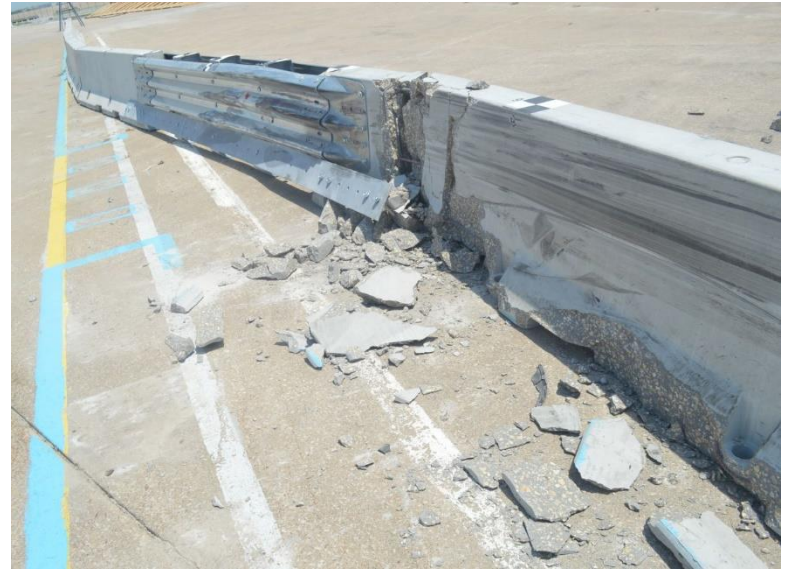
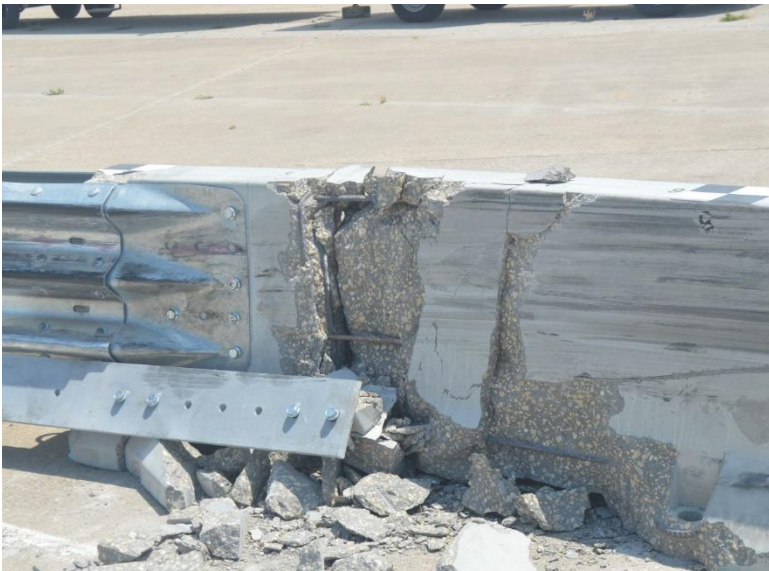
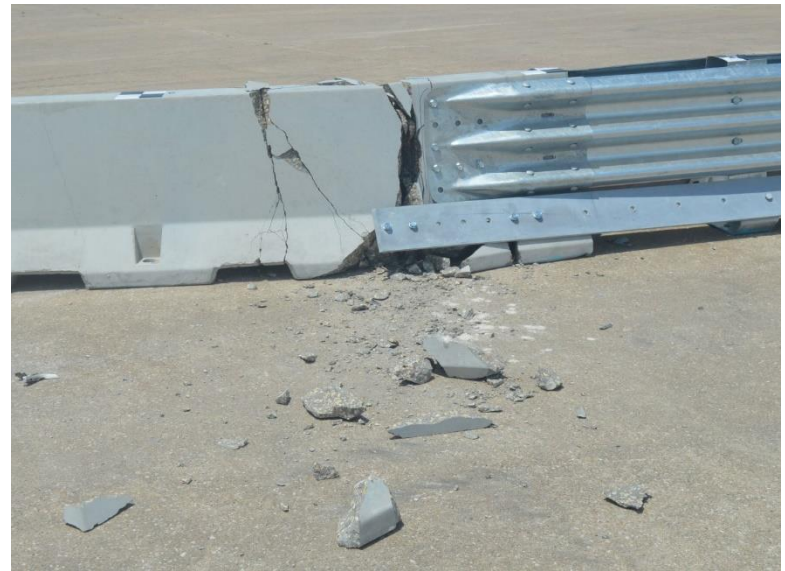
Figure 39. Barrier No. 9 Damage, Test No. GSH-1

Barrier no. 9 damage included significant cracking and spalling. At 4 in. (102 mm) downstream from the upstream edge of barrier no. 9, spalling occurred, and an 8½-in. long × 3-in. wide × ¼-in. thick (216-mm × 76-mm × 6-mm) piece of concrete disengaged from the top front corner of the barrier. A crack occurred across the top of barrier no. 9 at a distance of 25 in. (635 mm) from the upstream end of the segment. Significant cracking occurred 30½ in. (775 mm) downstream from the upstream end of barrier no. 9. The cracking extended through the entire width of the barrier and led to major spalling, measuring 18 in. (457 mm) wide and 3½ in. (89 mm) deep, which caused layers of concrete to disengage from the front and rear faces of the barrier. Additionally, one of the longitudinal rebar on the backside of barrier no. 9 fractured in tension at the location of the concrete fracture, as shown in Figure 40. At 9 in. (229 mm) downstream from the upstream end of barrier no. 9, the front toe of the barrier disengaged, which extended 63 in. (1,600 mm) long and 3½ in. (89 mm) deep. A 30-in. (762-mm) long section of the rear face toe of barrier no. 9 also disengaged 13 in. (330 mm) downstream from the upstream end on the non-traffic side face. Further cracking on barrier no. 9 occurred on the front, top, and rear faces 55 in. (1,397 mm) downstream from the upstream end of the barrier. Further toe disengagement occurred on the front face of barrier no. 9, 83 in. (2,108 mm) downstream from the upstream end. The disengaged toe section was 55 in. long × 9½ in. tall × 3 in. deep (1,397 mm × 241 mm × 76 mm).

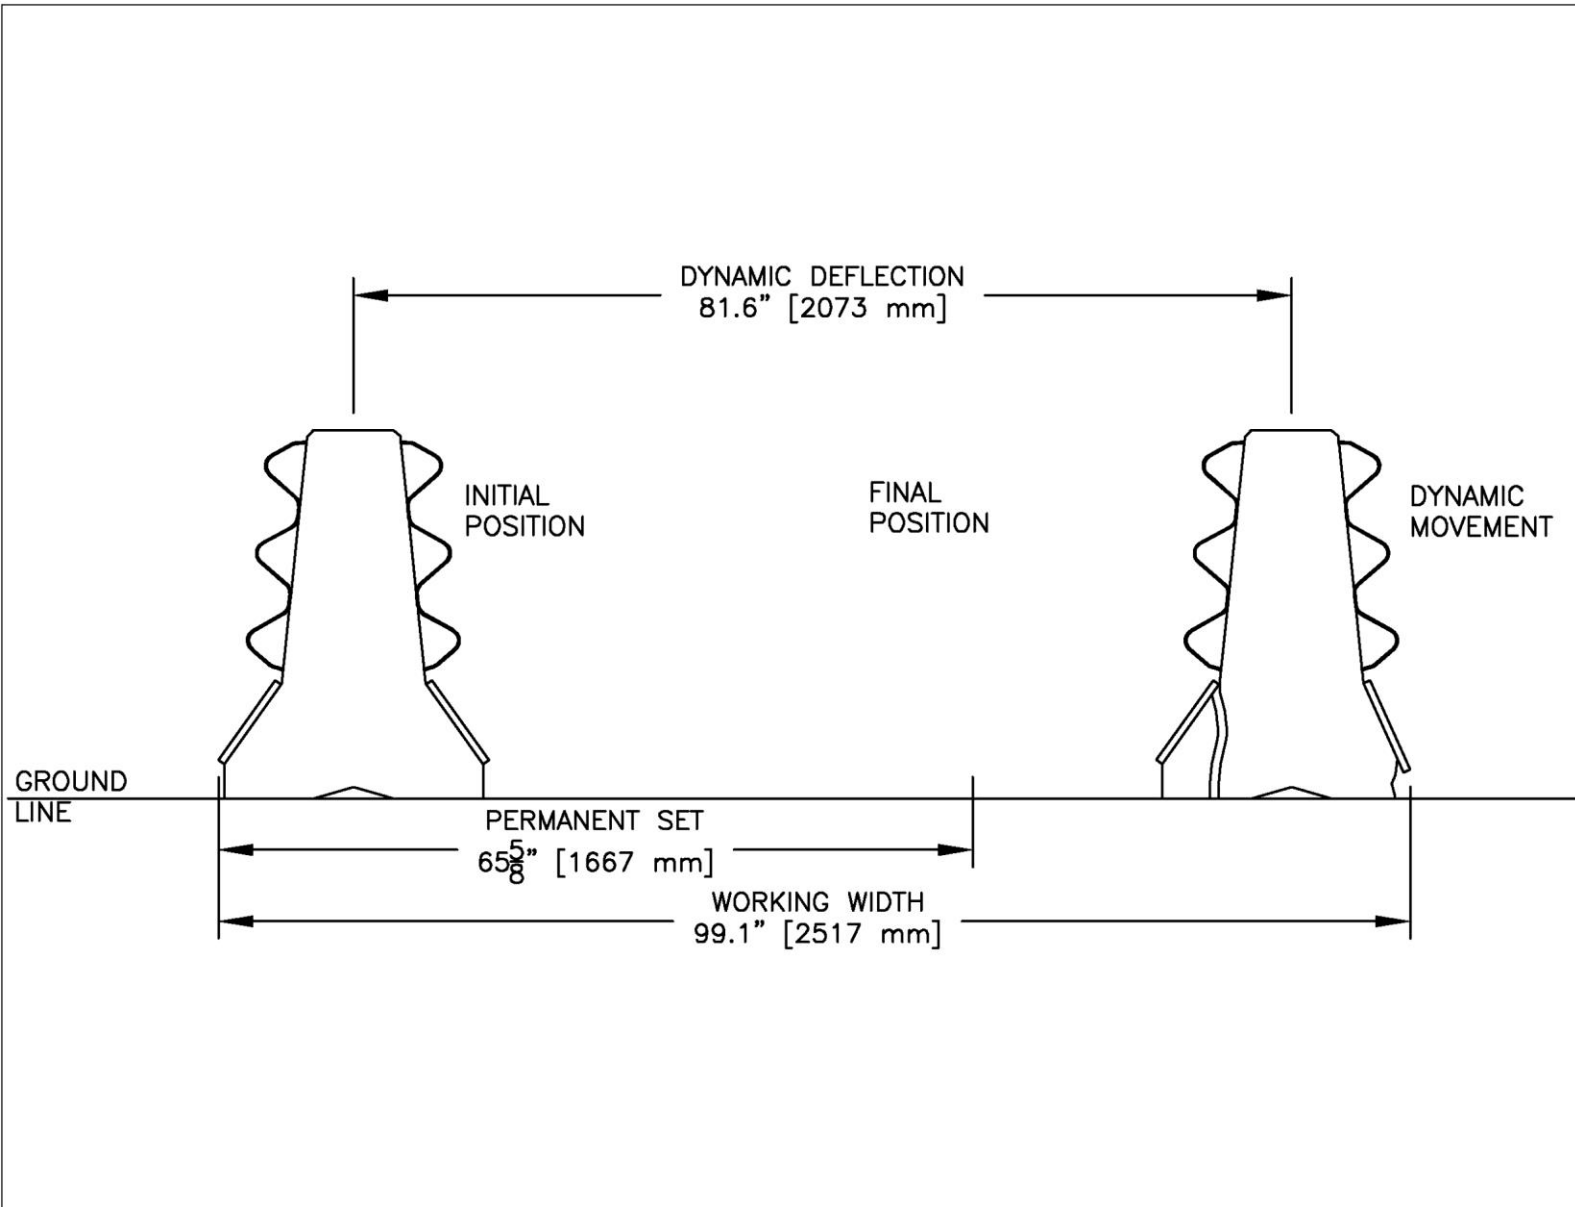
Figure 42. Permanent Set Deflection, Dynamic Deflection, and Working Width, Test No. GSH-1

The maximum lateral permanent set of the barrier system was 81.6 in. (2,073 mm), which occurred at the upstream end of barrier no. 9, as determined from high-speed digital video analysis. The maximum lateral dynamic barrier deflection, including tipping of the barrier along the top surface, was 81.6 in. (2,073 mm) located at the steel toe plate at the upstream end of barrier no. 9, as determined from high-speed digital video analysis. The working width of the system was found to be 99.1 in. (2,517 mm), also determined from high-speed digital video analysis. A schematic of the permanent set deflection, dynamic deflection, and working width is shown in Figure 42.

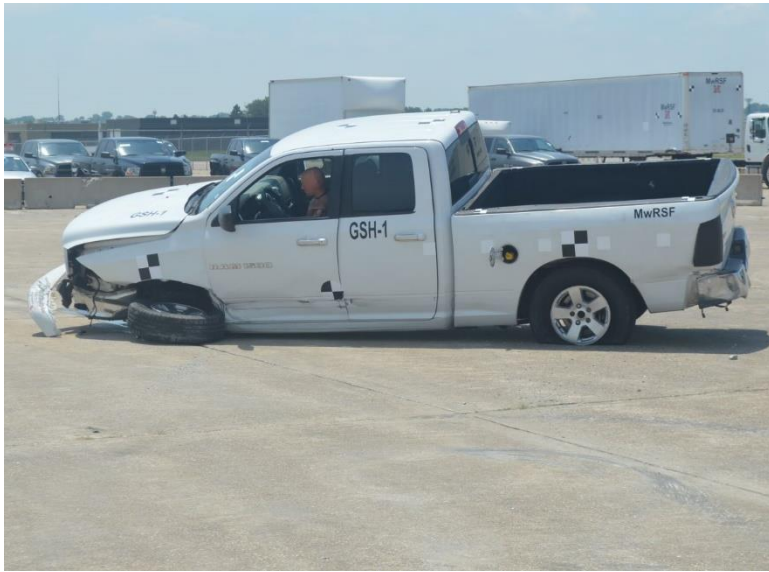
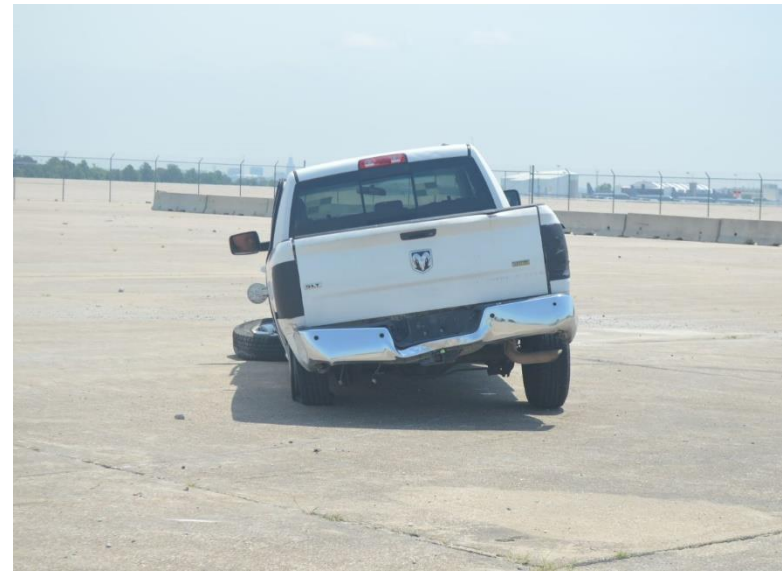
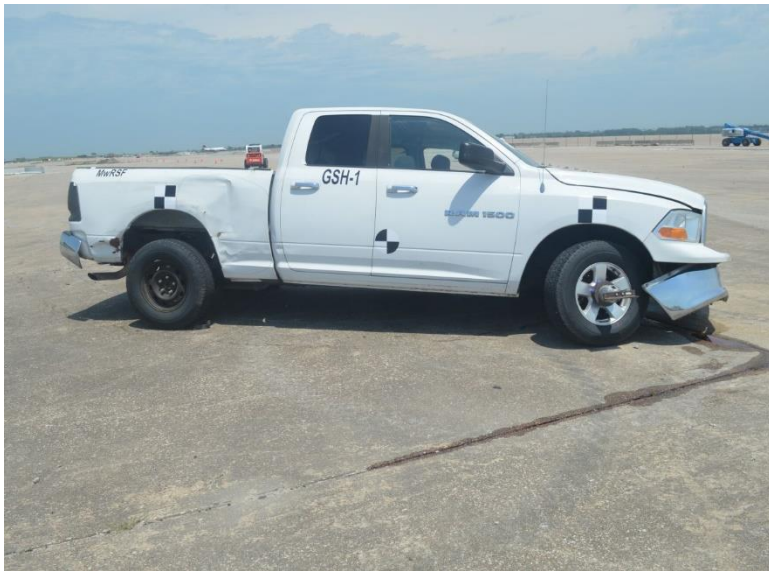
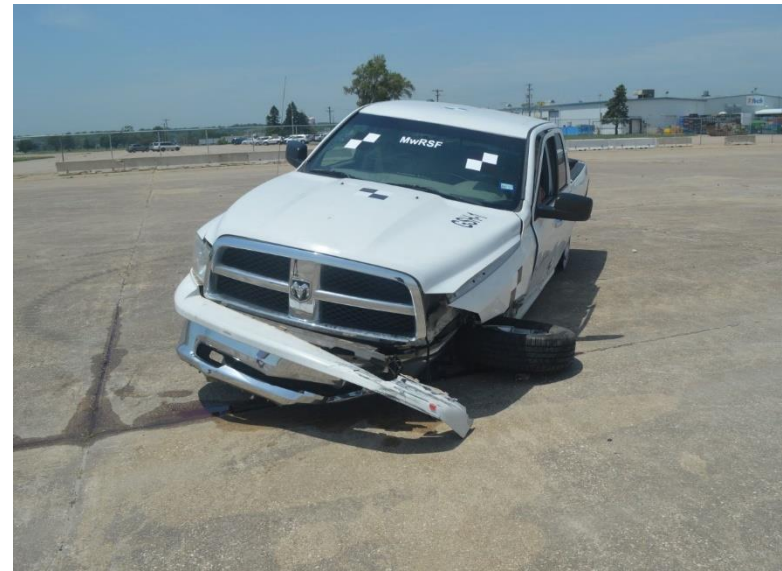
Figure 43. Vehicle Damage, Test No. GSH-1

The damage to the vehicle was moderate, as shown in Figures 43 through 45. The maximum occupant compartment intrusions are listed in Table 6, along with the intrusion limits established in MASH 2016 for various areas of the occupant compartment. Complete occupant compartment and vehicle deformations and the corresponding locations are provided in Appendix C. MASH 2016 defines intrusion or deformation as the occupant compartment being deformed and reduced in size with no observed penetration. There were no penetrations into the occupant compartment and none of the established MASH 2016 deformation limits were violated. Outward deformations, which are denoted as negative numbers in Appendix C, are not considered crush toward the occupant, and are not evaluated by MASH 2016 criteria.

The majority of damage was concentrated on the left-front corner and left side of the vehicle, where the impact had occurred. The left side of the bumper was crushed inward and backward, as shown in Figure 44. The left-front fender was dented and bent behind the left-front wheel and pushed into the left-front door. The left-front steel rim and tire disengaged from the vehicle. The left upper control arm was bent upward and inward into the engine bay and the left-side steering knuckle assembly disengaged from the vehicle. The left side of the frame and the left bumper mounting plate were both bent inward toward the center of the vehicle. The left-rear tire was deflated. The left-side headlight and fog light disengaged from the vehicle during impact. Denting and scraping were observed on the left side of the vehicle, primarily at the left-front door. The left-front and left-rear doors were slightly ajar at the top of the doorframe, and each door had a small puncture located at the base of the door. The rear bumper was twisted, and the left side of the rear bumper was dented and scuffed. A gap occurred between the hood and both the left and right fenders due to the deformation of the hood and fenders. The left-front window shattered during the test due to contact with the test dummy's head at 106 ms after impact, but the roof and remaining window glass remained undamaged.

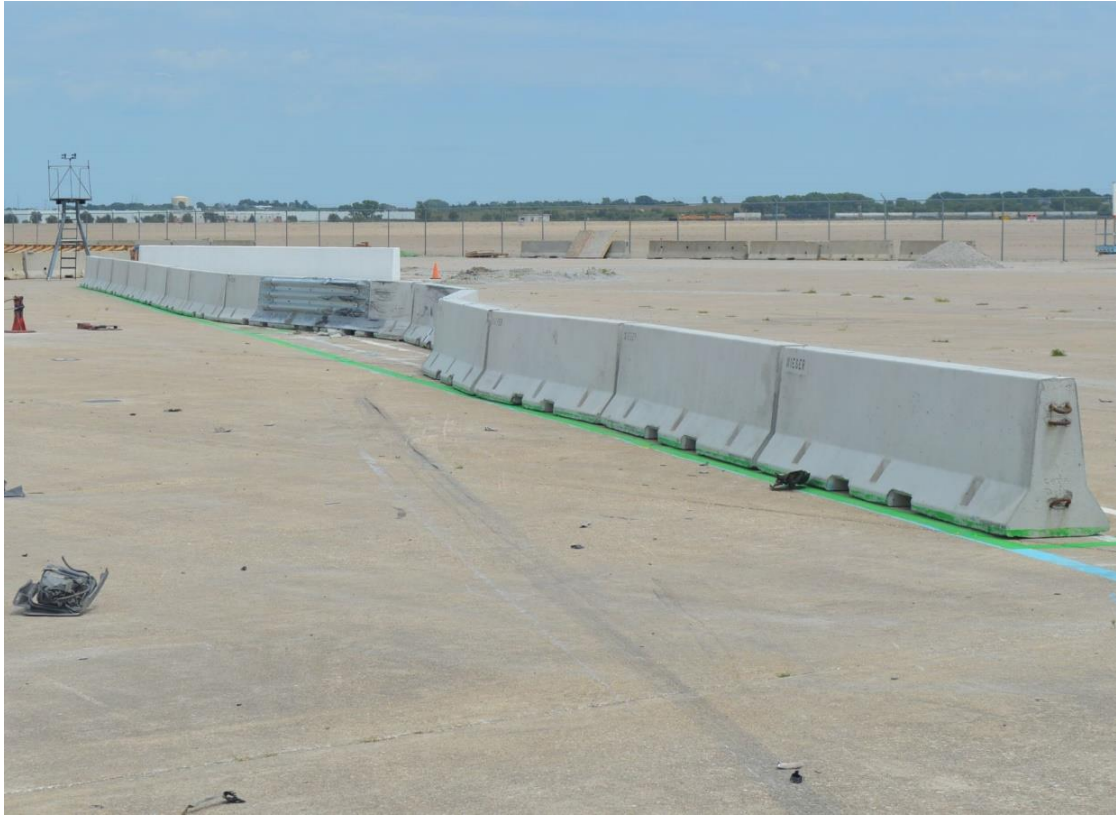
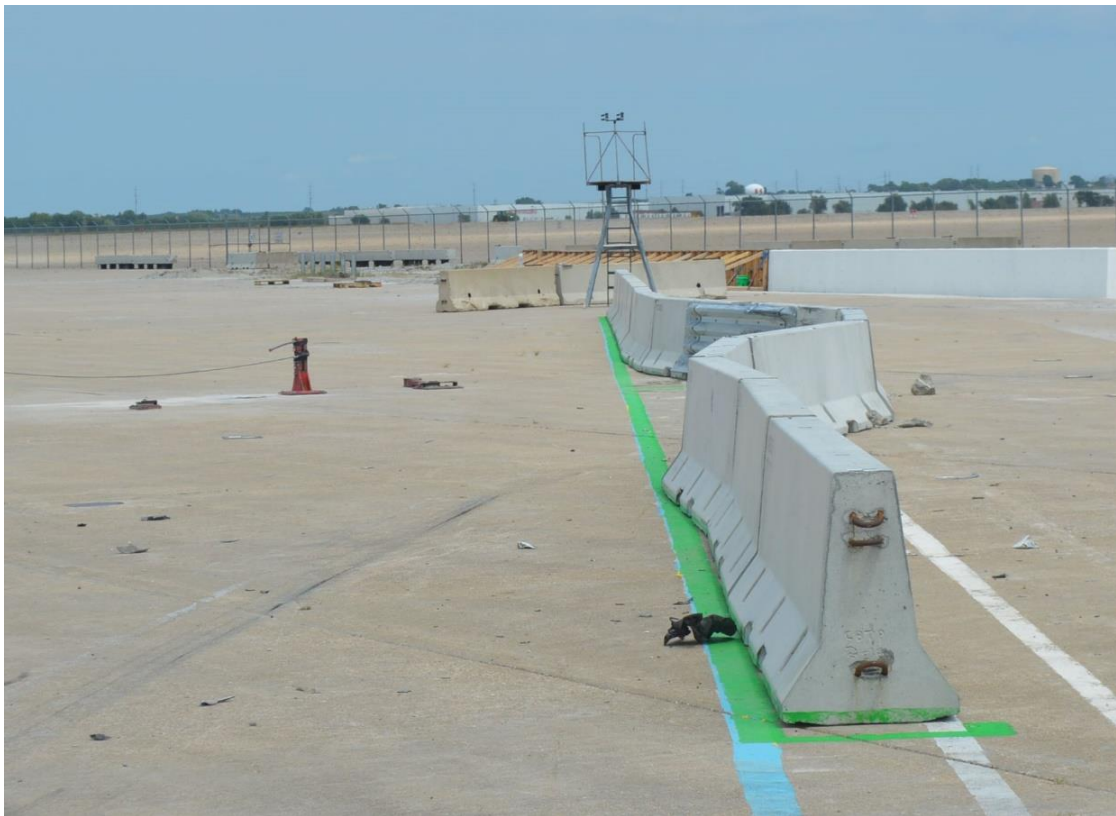
Figure 72. Overall System Damage, Test No. GSH-2

Damage to the barrier was moderate, as shown in Figures 72 through 78. Barrier damage consisted of deformation of the thrie-beam guardrail, contact marks on the front face of the thrie-beam and concrete segments, spalling of the concrete, and concrete cracking and failure. The length of vehicle contact along the barrier was approximately 24 ft – 2 in. (7.4 m), which spanned from 12 in. (305 mm) upstream from the center of the impact point target to 13 in. (330 mm) upstream from the downstream end of barrier no. 10. Secondary contact marks also occurred, which were 6 ft – 4 in. (1.9 m) in length and spanned from 57 in. (1,448 mm) upstream from the downstream end of barrier no. 11 to 19 in. (483 mm) downstream from the upstream end of barrier no. 12.

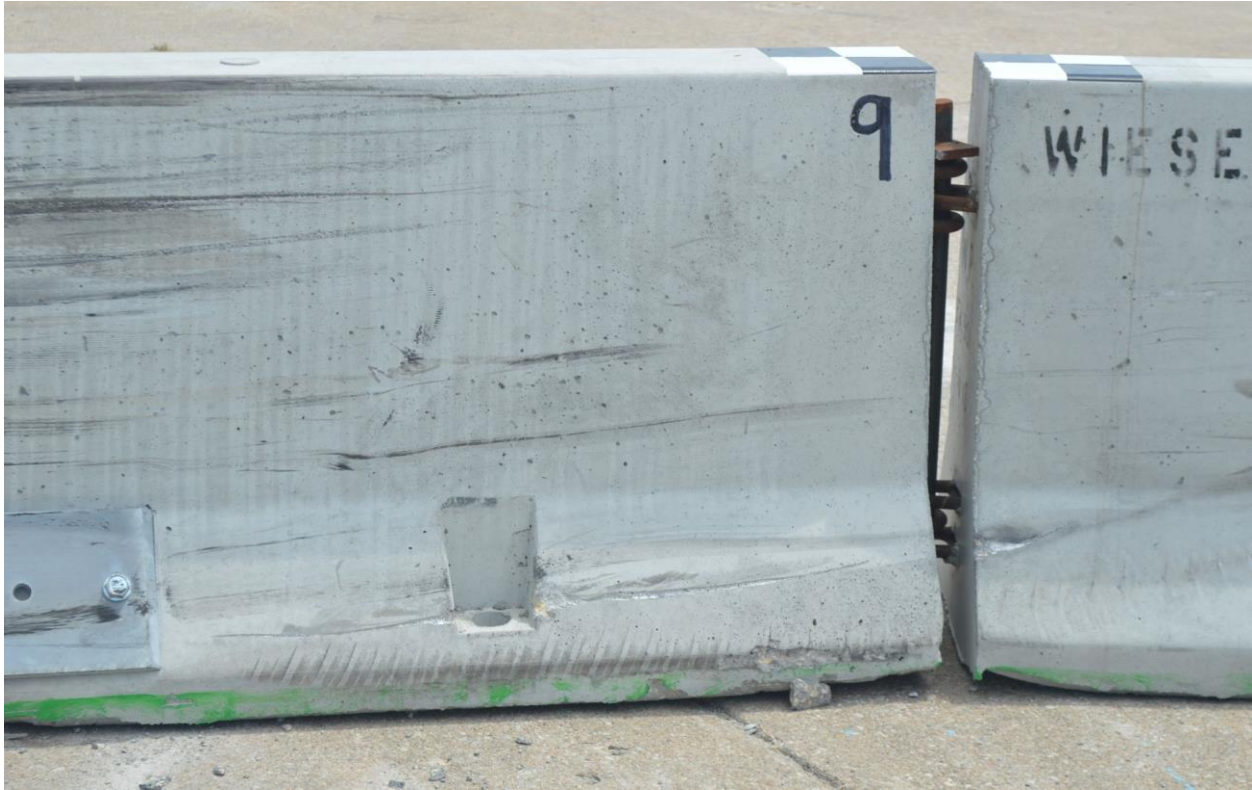
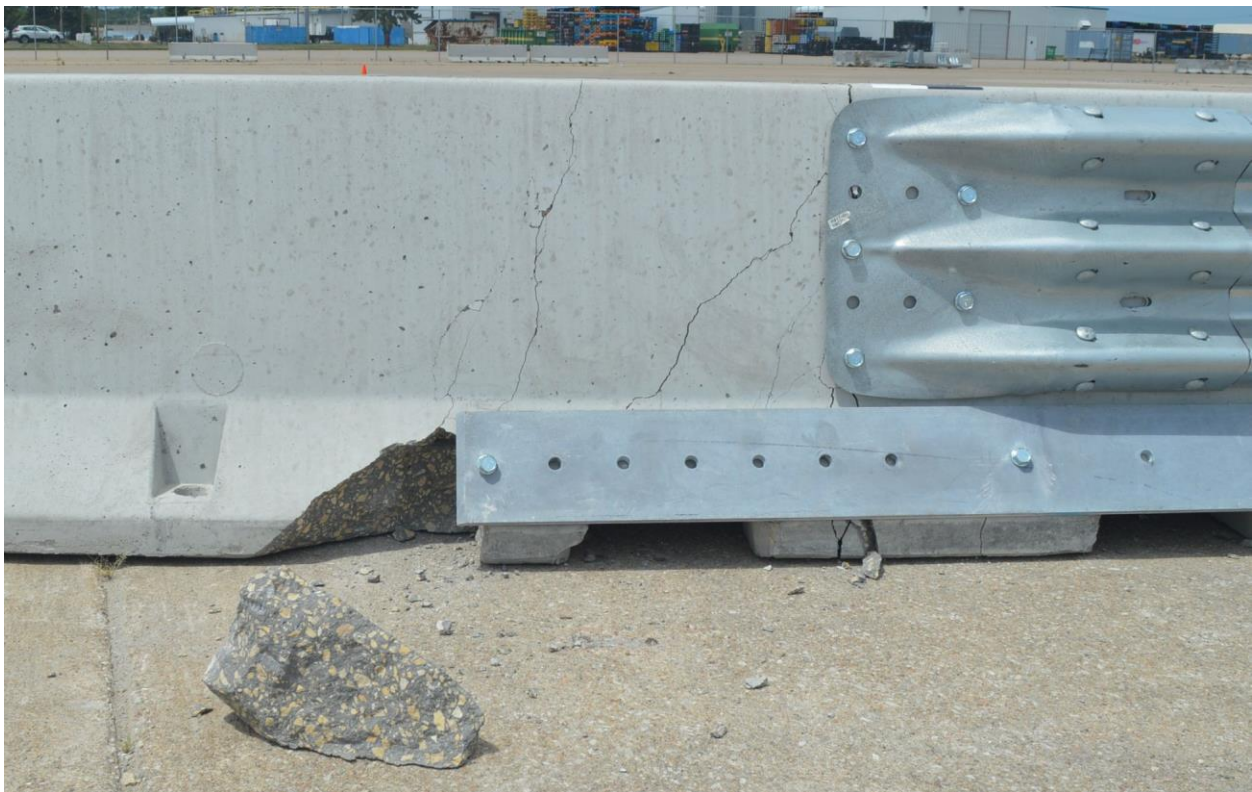
Figure 75. Barrier No. 9 Damage, Test No. GSH-2

Damage to barrier no. 9 primarily consisted of cracking and spalling of the concrete. Cracking, which began at the middle of the barrier's top face and extended vertically down the rear face of the barrier to the ground, was observed 1½ in. (38 mm) downstream from the target impact point. Toe spalling occurred from the upstream end of barrier no. 9 to 110 in. (2,794 mm) downstream. Further cracking occurred 5½ in. (140 mm) downstream from the centerline of barrier no. 9 and extended across the entire height of the rear face, the top face, and 4 in. (102 mm) down the front face below the top edge. Concrete spalling occurred 13 in. (330 mm) downstream from the centerline of barrier no. 9 and 4½ in. (114 mm) from the top edge of the barrier. Additional cracking was found 24 in. (610 mm) downstream from the centerline of barrier no. 9, which started in the center of the top face of the barrier and extended down the entire height of the rear face of the barrier. Concrete spalling occurred 20½ in. (521 mm) below the top edge of the barrier at 25 in. (635 mm) downstream from the centerline of barrier no. 9, and at the anchor pocket located 54 in. (1,372 mm) downstream from the centerline of barrier no. 9. At 46 in. (1,168 mm) downstream from the target impact point, a 6-in. long × 2¼-in. wide × ¼-in. deep (152-mm × 57-mm × 6-mm) piece of concrete disengaged from the top of barrier no. 9. Additional toe spalling occurred 39 in. (991 mm) upstream from the downstream end of barrier no. 9 on the rear face the barrier, which disengaged a 9-in. long × 11-in. wide × 8-in. deep (229-mm × 279-mm × 203-mm) piece of concrete and resulted in the pull out of the farthest downstream toe plate anchor bolt on the rear face of the barrier, as shown in Figure 75.

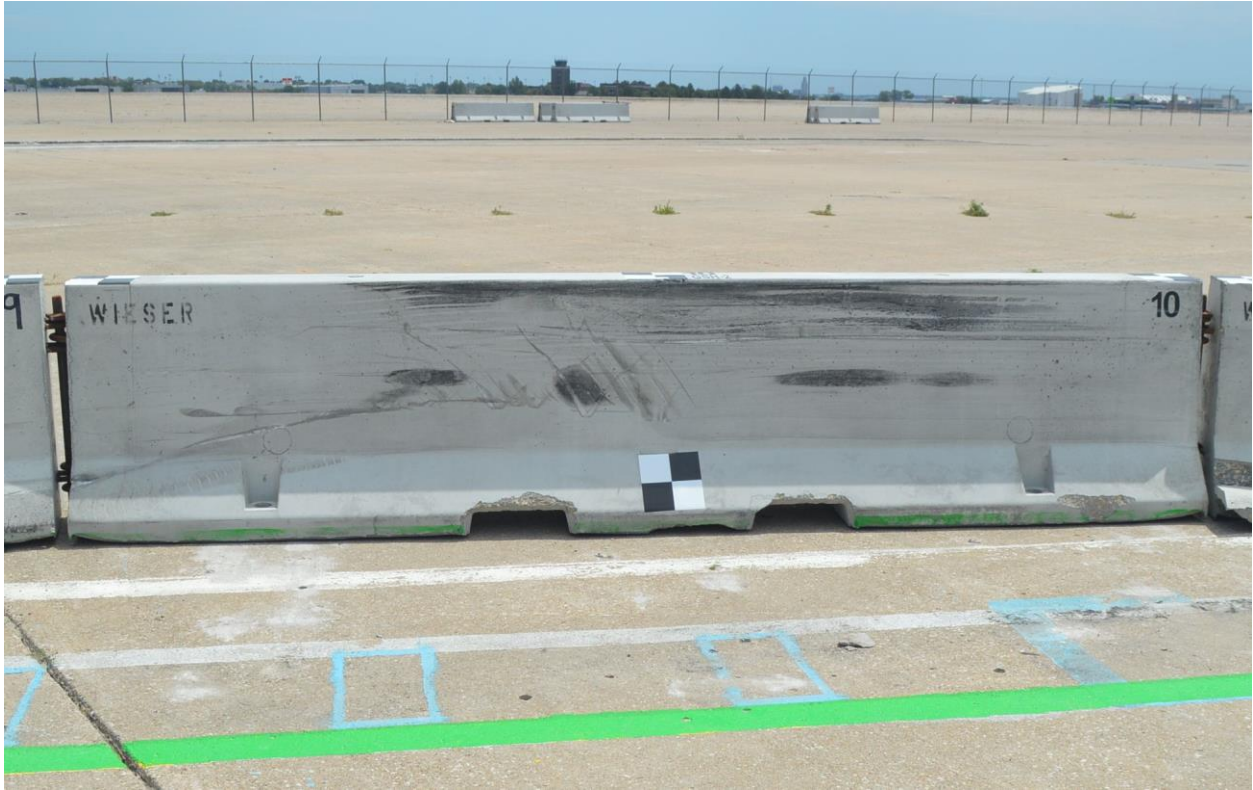
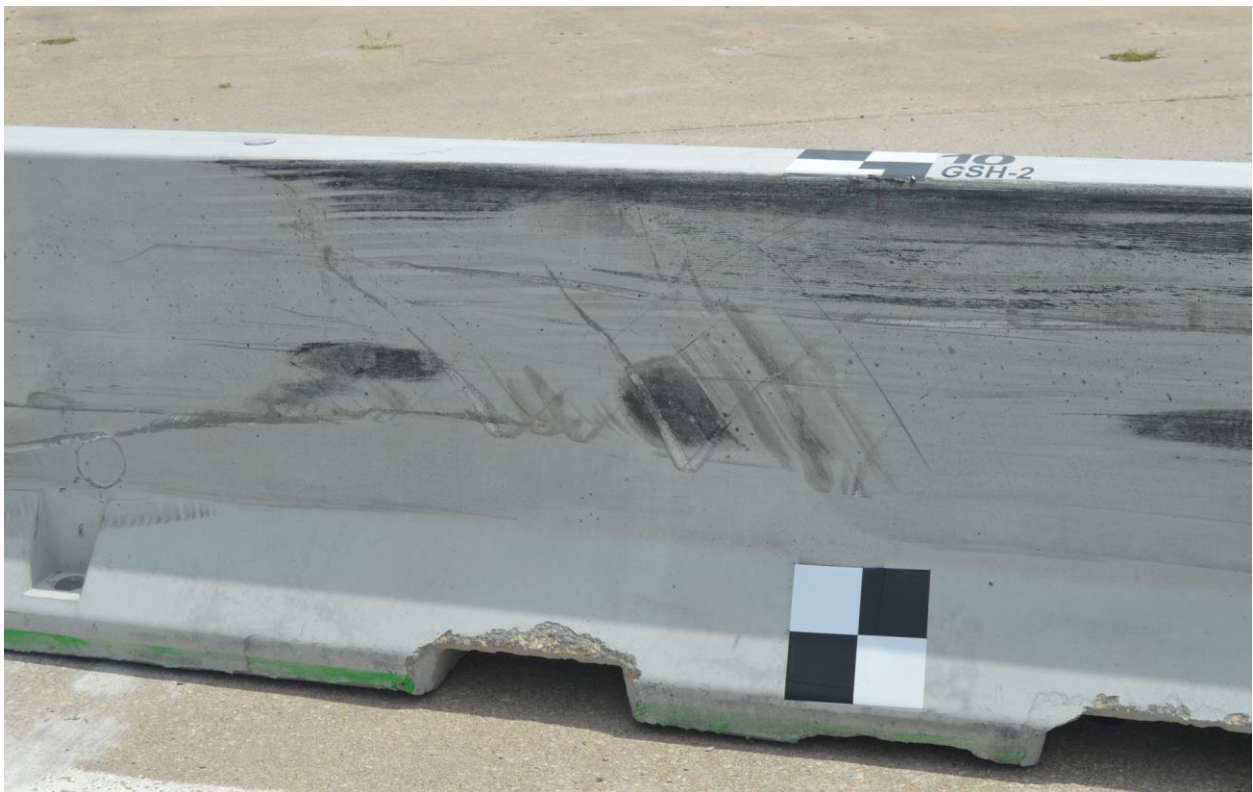
Figure 77. Barrier No. 10 Damage, Test No. GSH-2

Concrete spalling and contact marks were found on barrier no. 10, as shown in Figure 77. Minor concrete spalling occurred 1 in. (25 mm) downstream from the upstream end of the barrier.

Additional spalling occurred near the base of the barrier 20 in. (508 mm) upstream and 58 in. (1,473 mm) downstream from the centerline of barrier no. 10. Concrete cracking occurred 23 in. (584 mm) upstream of the centerline of barrier no. 10 on both the front and rear faces of the barrier. Damage to barrier no. 11 consisted primarily of concrete spalling. A 21½-in. long × 7½-in. wide × 3½-in. tall (546-mm × 191-mm × 89-mm) piece of concrete disengaged from the front toe on the front face of barrier no. 11, 10 in. (254 mm) downstream from the upstream edge of the barrier. On the non-traffic side of barrier no. 11, toe pull out occurred 24 in. (610 mm) downstream from the upstream edge of the barrier at the location of the anchor pocket, as shown in Figure 78. Additional spalling was found along the top face of barrier no. 11. Minor concrete spalling was also found on the front face of the upstream end of barrier no. 12.

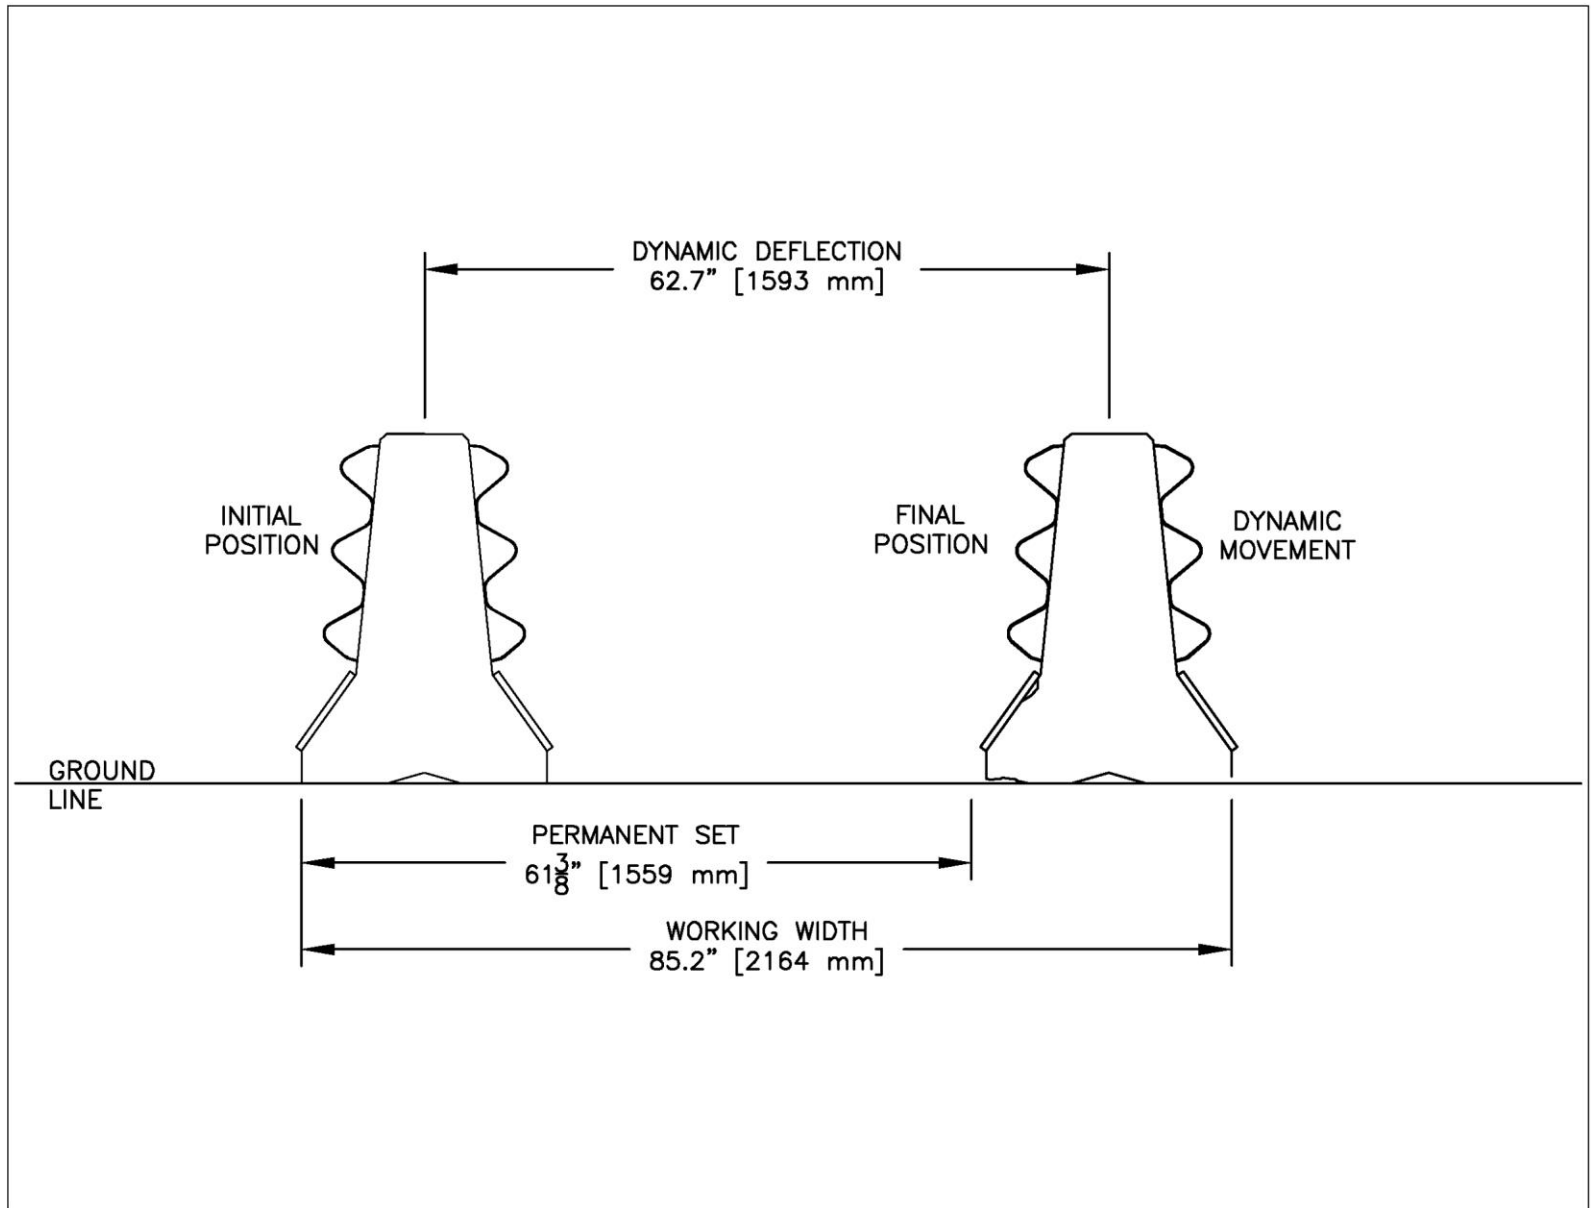
Figure 79. Permanent Set Deflection, Dynamic Deflection, and Working Width, Test No. GSH-2

The maximum lateral permanent set of the barrier system was 61⅜ in. (1,559 mm), which occurred at the upstream end of barrier no. 10, as measured in the field. The maximum lateral dynamic barrier deflection, including tipping of the barrier along the top surface, was 62.7 in. (1,593 mm) at the upstream end of barrier no. 10, as determined from high-speed digital video analysis. The working width of the system was found to be 85.2 in. (2,164 mm), also determined from high-speed digital video analysis. A schematic of the permanent set deflection, dynamic deflection, and working width is shown in Figure 79.

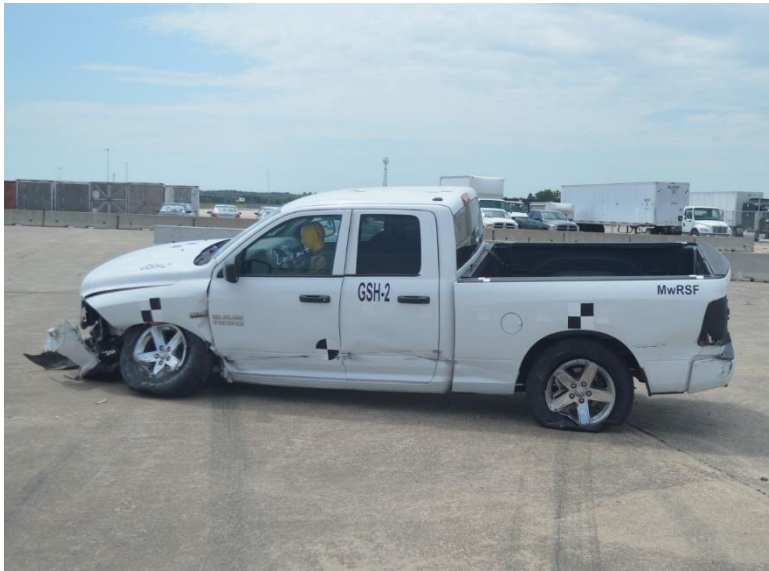
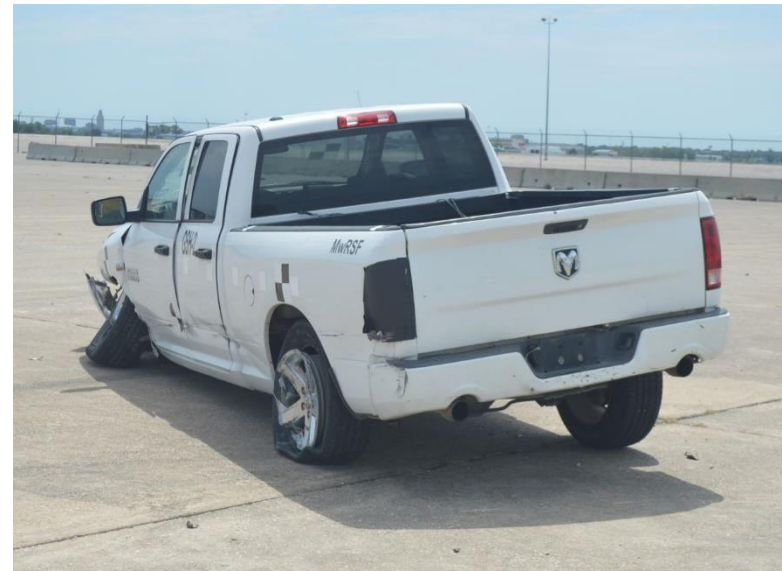
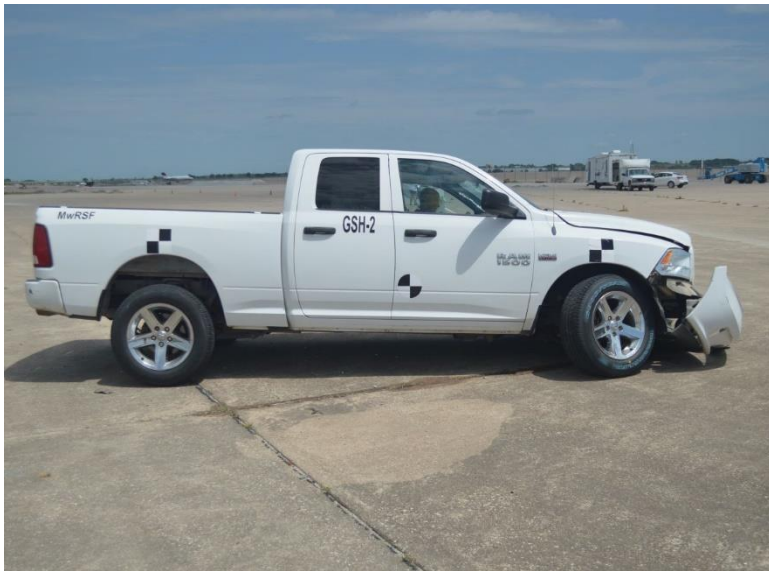
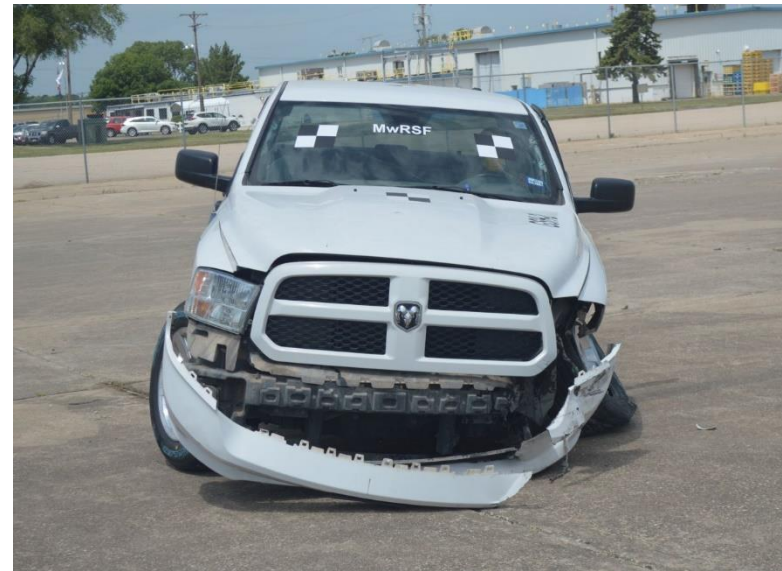
Figure 80. Vehicle Damage, Test No. GSH-2

The damage to the vehicle was moderate, as shown in Figures 80 through 83. The maximum occupant compartment deformations are listed in Table 11 along with the deformation limits established in MASH 2016 for various areas of the occupant compartment. Complete occupant compartment and vehicle deformations and the corresponding locations are provided in Appendix C. MASH 2016 defines intrusion or deformation as the occupant compartment being deformed and reduced in size with no observed penetration. There were no penetrations into the occupant compartment and none of the established MASH 2016 deformation limits were violated. Outward deformations, which are denoted as negative numbers in Appendix C, are not considered crush toward the occupant, and are not evaluated by MASH 2016 criteria.

Majority of damage was concentrated on the left-front corner and left side of the vehicle, where the impact had occurred. The front bumper fractured at the lower-left corner of the grille and the entire front bumper disengaged from the vehicle. The left-front fender was pushed upward near the door panel and was dented and torn behind the left-front wheel. The left-front steel rim was severely deformed with tears and significant crushing, as shown in Figure 82. The sway/anti-roll bar disengaged from the lower control arm on the front left side of the vehicle. The lower-left control arm disengaged and fractured into three pieces. The left-side tie rod fractured at the steering knuckle joint and disengaged. The rear engine cross member buckled downward, and the frame buckled inward in front of the rear transmission mount on the left side of the vehicle. The engine and transmission shifted due to the fracture of two of the four engine mount bolts on the left side of the vehicle. The left-front tire was torn along the tread and deformed.

The left-side headlight and fog light were removed from the vehicle. Denting and scraping were observed on the entire left side of the vehicle with majority of the damage located at the left-front and left-rear doors, as shown in Figure 81. The left-front door was ajar at the top of the door frame, and creases were found in the sheet metal on both the left-front and left-rear doors. The left-rear steel rim was crushed, and a puncture and scuff marks were found on the tire. The left side of the rear bumper was dented and scuffed below the left taillight. A gap occurred between the hood and both the left and right fenders due to deformation from impact. The roof was undamaged following the test, and the side windows remained intact. The windshield was cracked prior to the test, and further cracking was observed on the left side of the windshield following the test.
