**Roadside Safety
Pooled Fund**

**Texas A&M
Transportation
Institute**

Test Report No. 609731-5&6
Test Report Date: August 2021

EVALUATION OF MODIFIED MINNESOTA SWING-AWAY MAILBOX

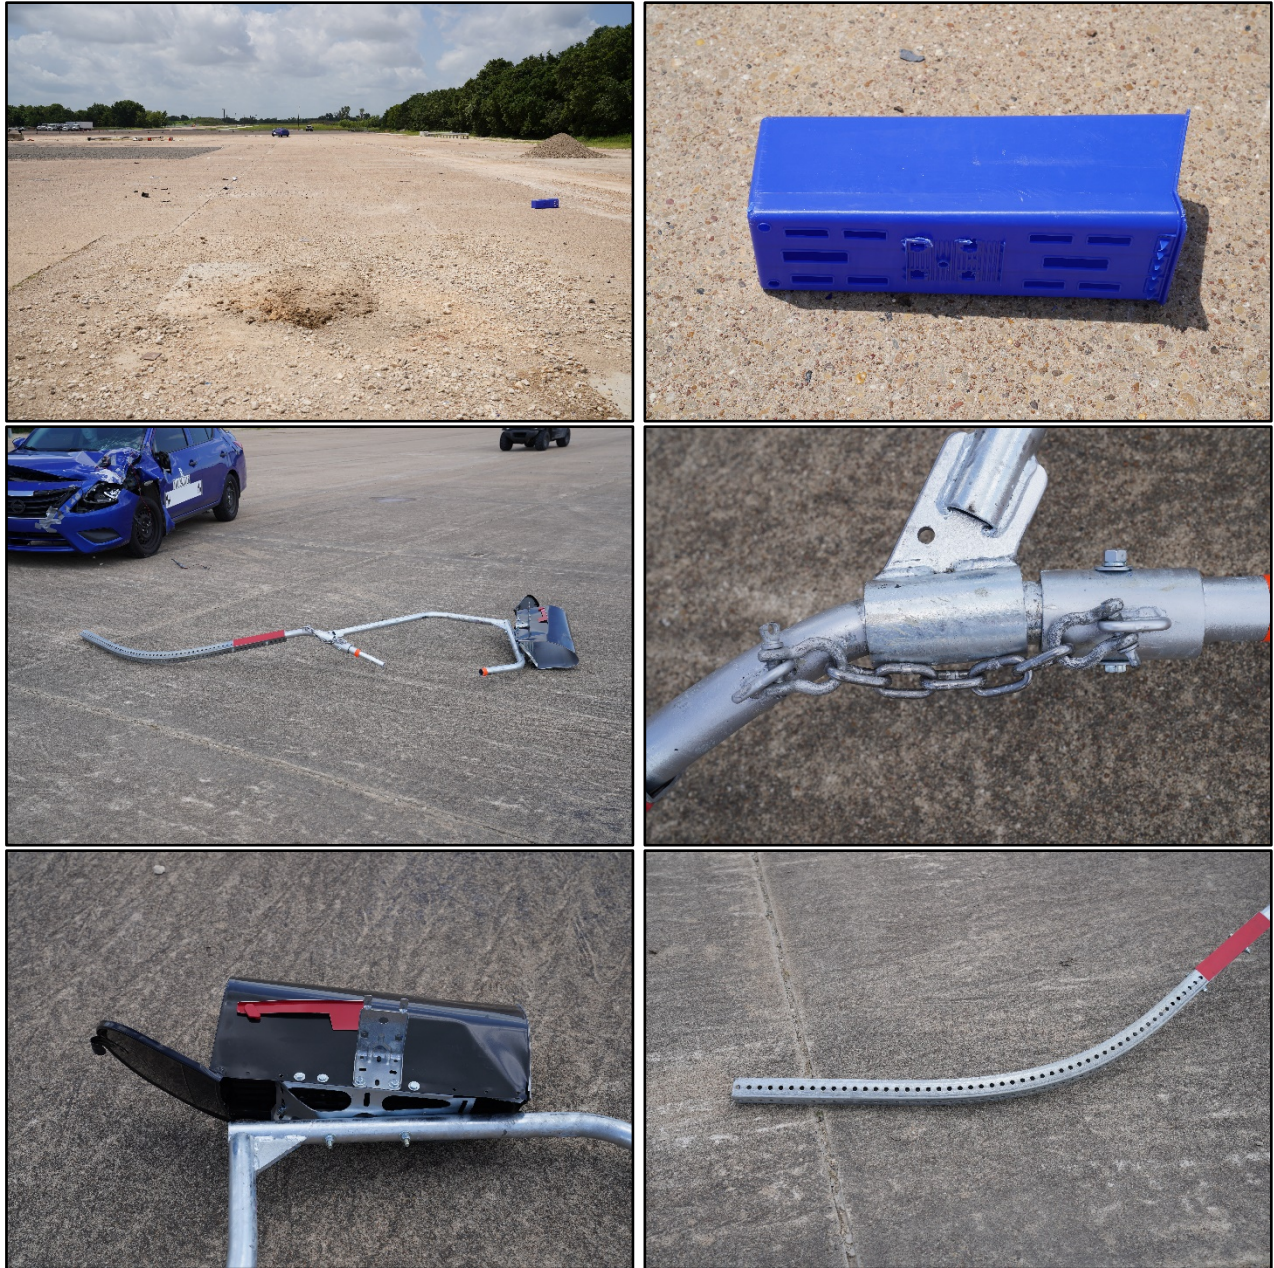
Figure 5.3. Mailbox after Test No. 609731-5.

Figure 5.3 shows the damage to the mailbox. The perforated steel tubing pulled completely out from the ground, and the entire mailbox assembly landed 319 ft downstream and 30 ft to the left of impact, except for the newspaper box, which disconnected from the mailbox at impact. The mailbox was deformed, and the top portion of the mailbox mount opened and separated from the leg.

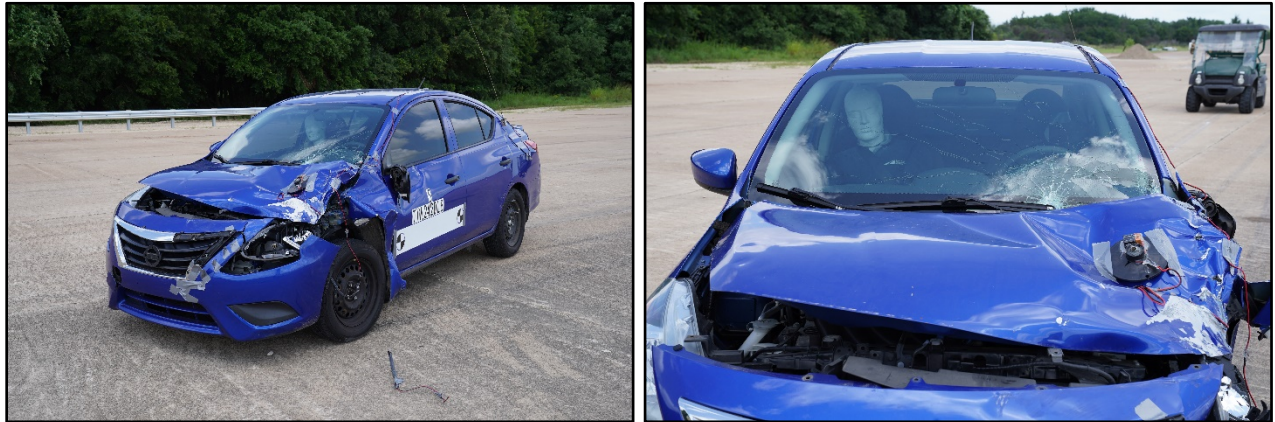
Figure 5.4. Test Vehicle after Test No. 609731-5.

Figure 5.4 shows the damage sustained by the vehicle. The front bumper, hood, grill, radiator and support, left front fender, and left front door were damaged. The windshield was cracked over an area 16 inches \times 11 inches and 0.25 inch deep, however there were no holes, cuts, or tears in the laminate. No fuel tank damage was observed. Maximum exterior crush to the vehicle was 8.0 inches in the front plane at the left front corner at bumper height. Maximum occupant compartment deformation was 0.25 inches in the windshield with no other deformation

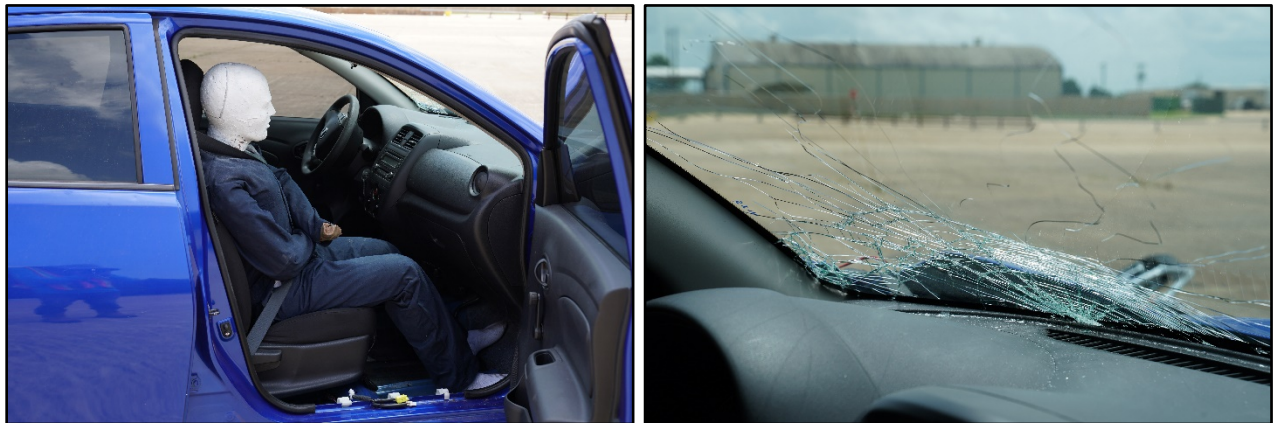
Figure 5.5. Interior of Test Vehicle after Test No. 609731-5.

or intrusion. Figure 5.5 shows the interior of the vehicle. Tables C.2 and C.3 in Appendix C.1 provide exterior crush and occupant compartment measurements.

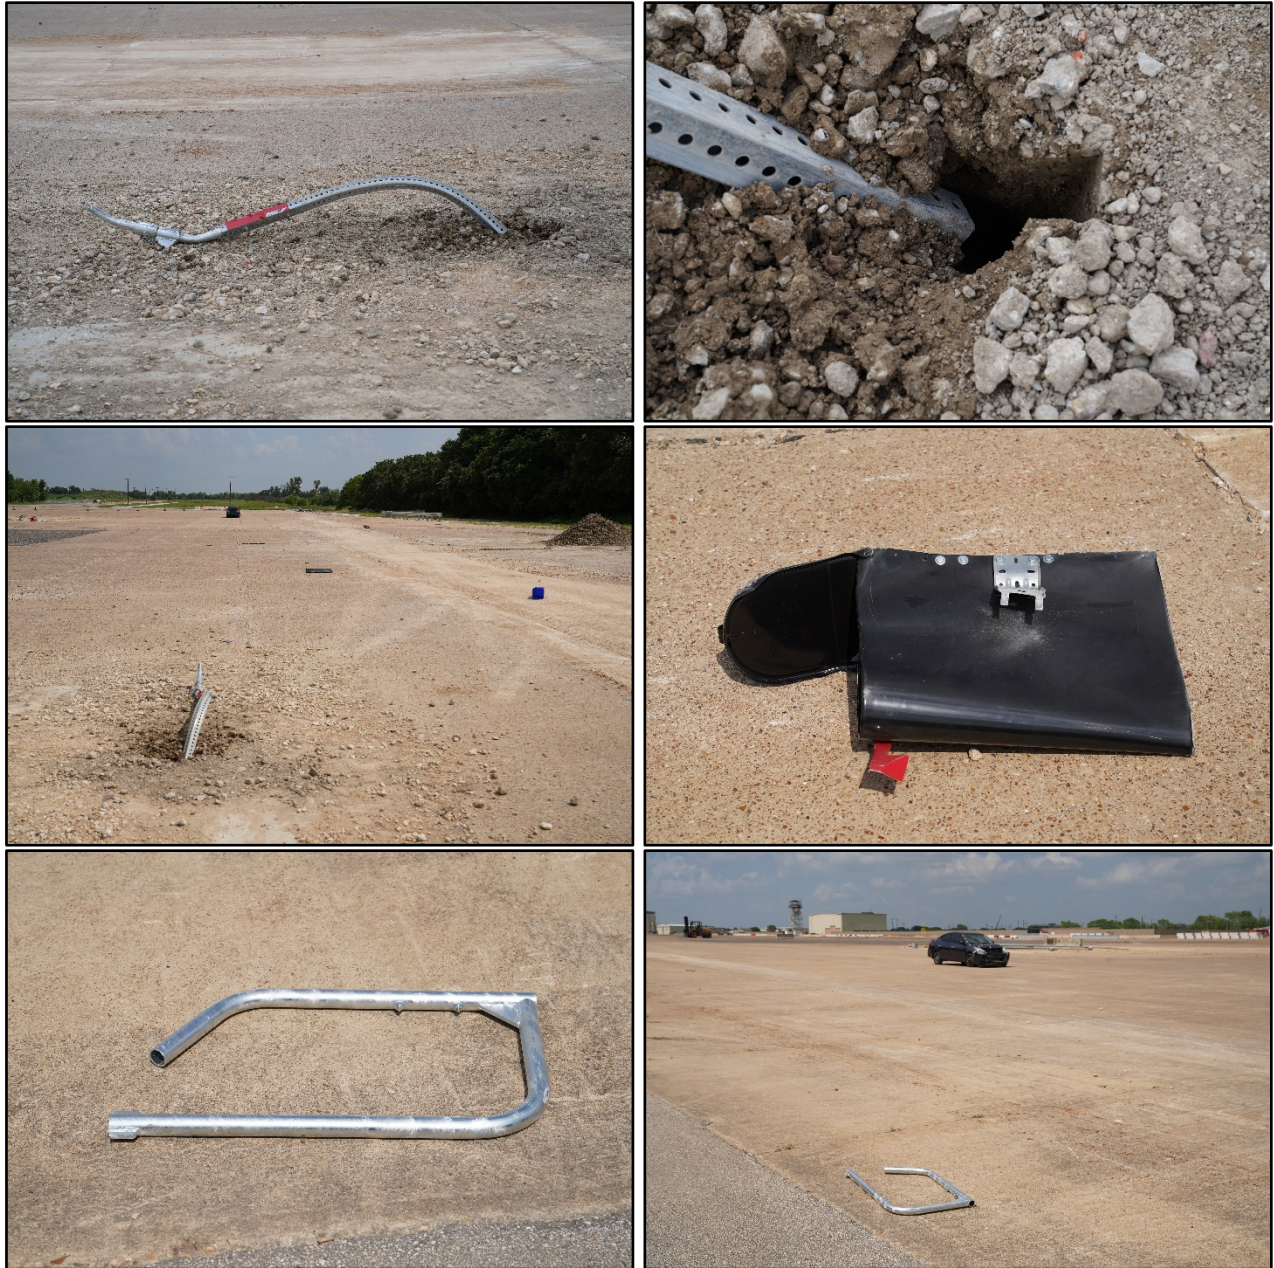
Figure 6.2. Mailbox after Test No. 609731-6.

Figure 6.2 shows the damage to the mailbox. The perforated post pulled out of the ground and laid over at the impact area. The lower gusset plate, connecting the post and the lower horizontal pipe broke. The mailbox landed 155 ft downstream and 29 ft to the right of impact, and the mailbox pipe landed 400 ft downstream and 52 ft to the right.

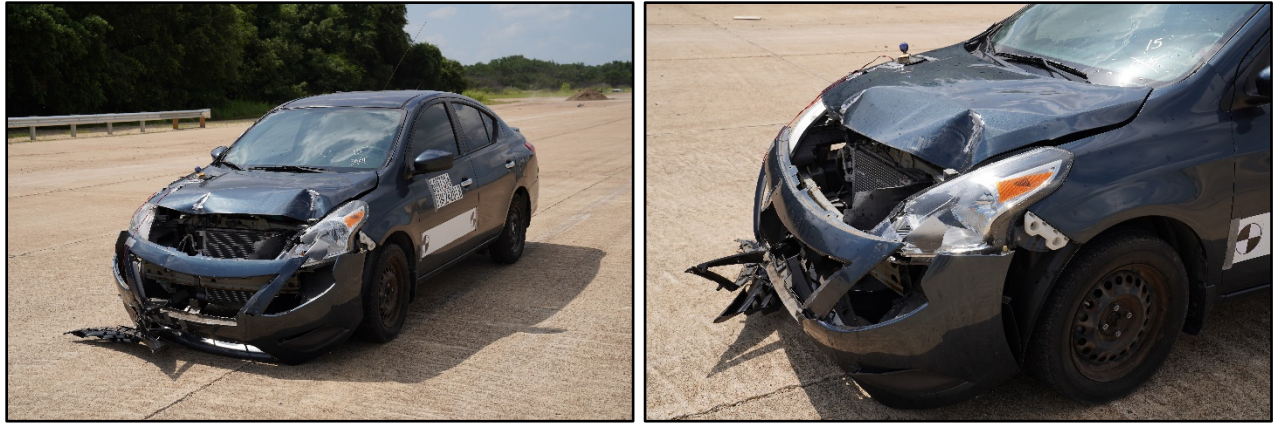
Figure 6.3. Test Vehicle after Test No. 609731-6.

Figure 6.3 shows the damage sustained by the vehicle. The front bumper, hood, and grill were damaged. The hood sustained two deformation areas; one 4 inches \times 6 inches \times 1.25 inches deep to the right of centerline, and another 8 inches \times 8 inches \times 2.5 inches deep 19 inches to the left of centerline. The windshield was not cracked, shattered, or torn. No fuel tank damage was observed. Maximum exterior crush to the vehicle was 4.0 inches in the front plane at the front at bumper height. No occupant compartment deformation or intrusion was observed. Figure 6.4 shows the interior of the vehicle. Tables D.3 and D.4 in Appendix D.1 provide exterior crush and occupant compartment measurements.
