## TECHNICAL MEMORANDUM

**Contract No.:** 1807207  
**Test Report No.:** 610461-2  
**Project Name:** Thrie/W-Beam/Tubular Barrier Gap Rail for MASH TL-3  
**Sponsor:** Roadside Safety Research Pooled Fund

### SUMMARY REPORT

American Association of State Highway and Transportation Officials (AASHTO) *Manual for Assessing Safety Hardware (MASH)* Test 3-10 was performed on the Tubular Barrier Gap Rail as reported herein. (1) The test was not successful with respect to the *MASH* Test 3-10 criteria. Therefore, the design is not acceptable with respect to *MASH* specifications.

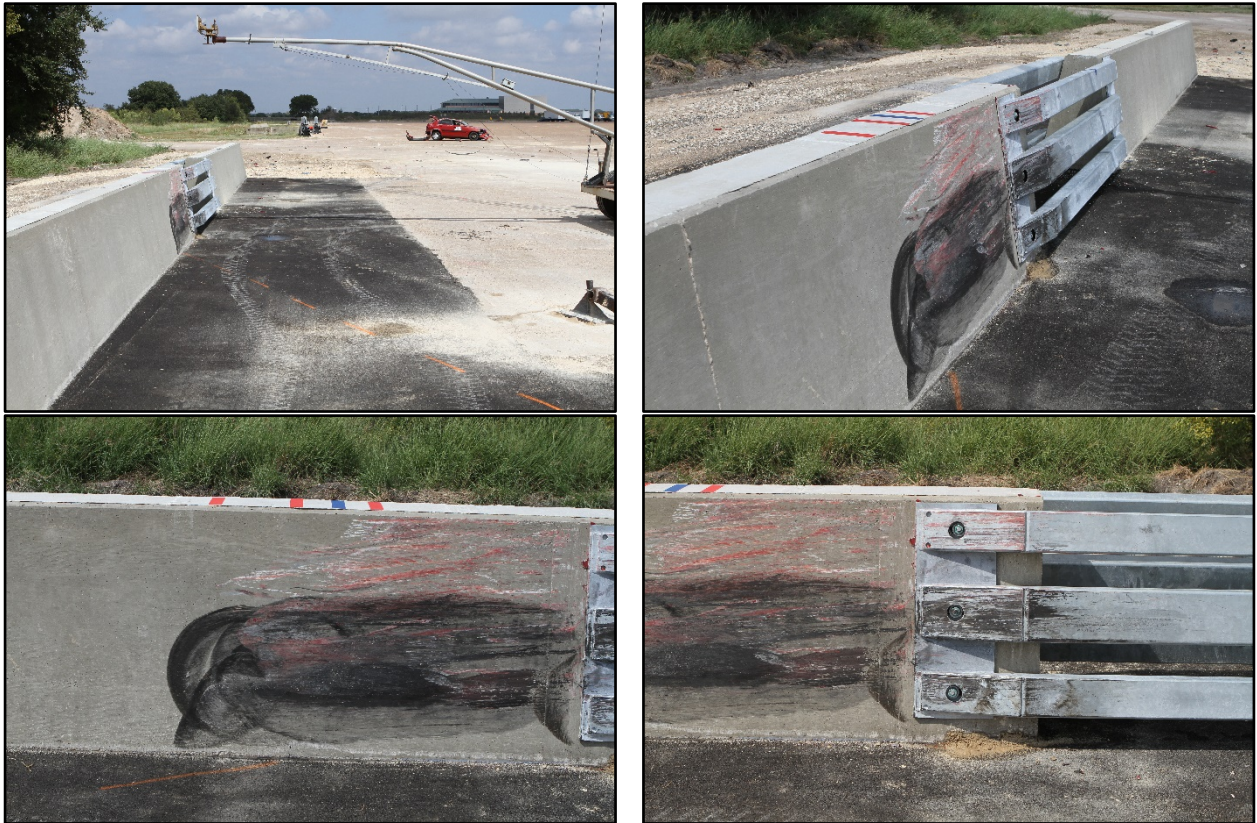
**Figure 2. Barrier Gap Rail after Test No. 610461-2.**

Figure 2 shows damage to the barrier gap design. No damage was observed other than cosmetic damage in the form of vehicle scuffs and scrapes. No dynamic deflection was observed during the test, and there was no measurable permanent deformation after the test. Working width\* was 31.0 inches at a height of 5.5 inches.

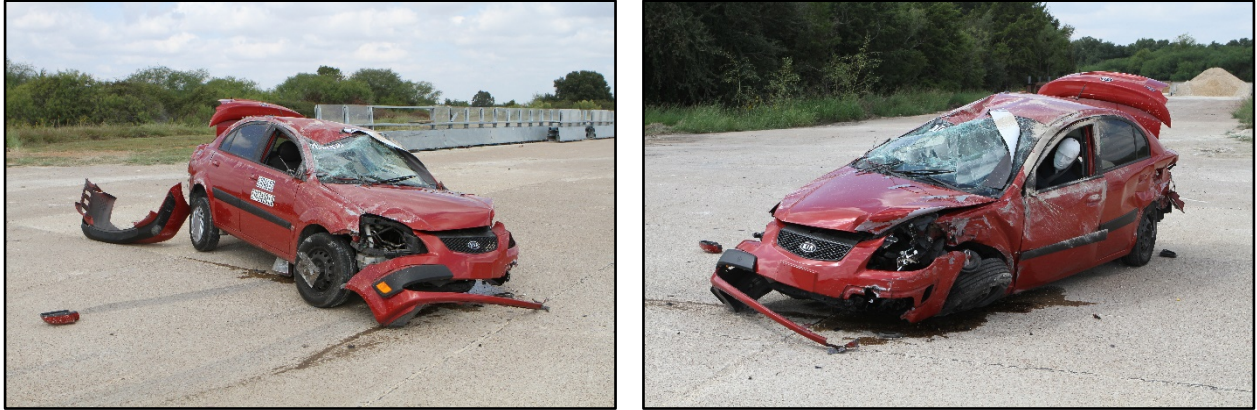
**Figure 3. Vehicle after Test No. 610461-2.**

Figure 3 shows damage to the test vehicle after the test. The 1100C vehicle rolled one revolution and came to rest upright. Maximum occupant compartment deformation was 5.5 inches in the windshield/roof area.

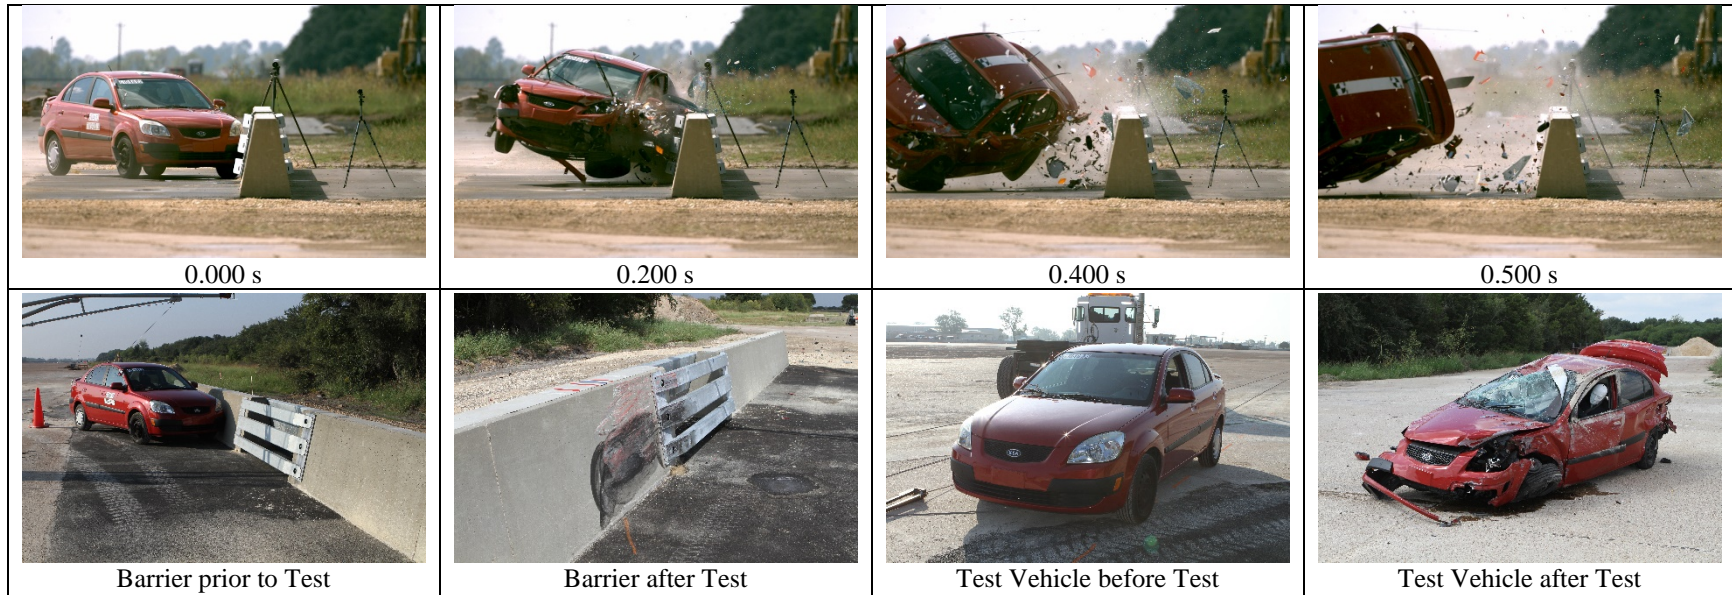
**Figure 4. Summary of Results for MASH Test 3-10 on Barrier Gap Design.**

Due to vehicle rollover, the barrier gap rail did not perform acceptably for *MASH* Test 3-10, as shown in Table 3.
