Test Report No. 619541-01-1 & 2

MASH TL-3 EVALUATION OF SIGN POSTS WITH FLASHING BEACON EQUIPMENT

Sponsored by
Roadside Safety Pooled Fund

November 2024

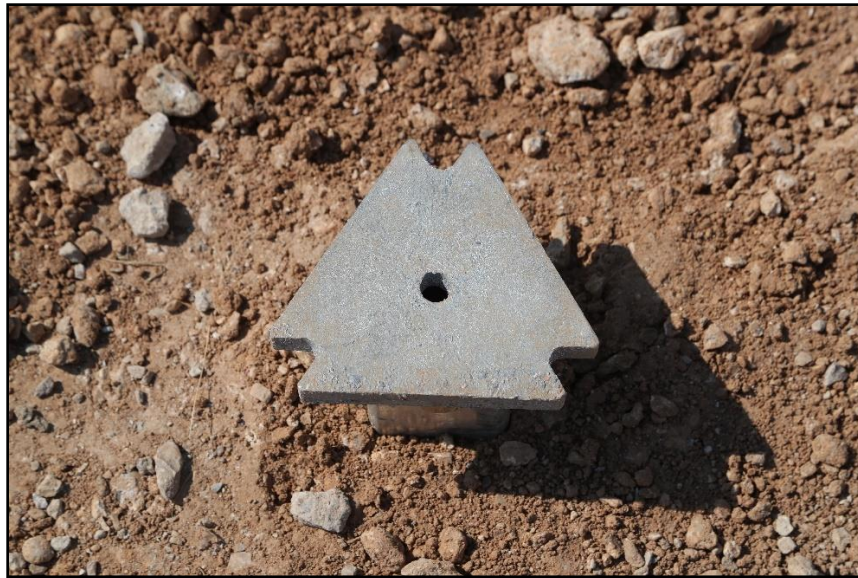
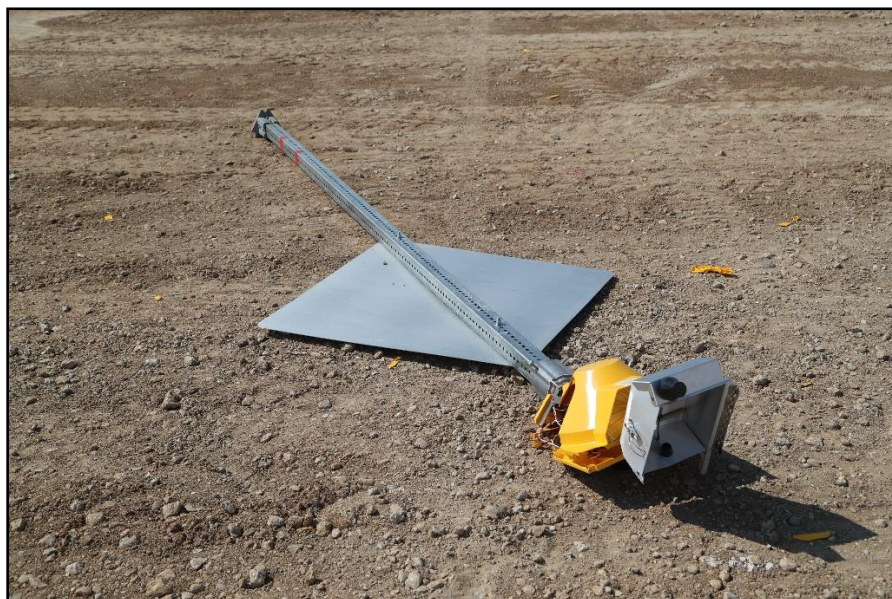
The post landed 32 ft downstream and 6 ft to the left of the impact path. The integrated flashing beacon and solar panel fractured during impact. The batteries in the solar panel separated during impact and landed near the post. There was a 0.3-inch gap on the non-impact side of the anchor. Figure 6.6 and Figure 6.7 show the damage to the breakaway sign support system with flashing equipment.

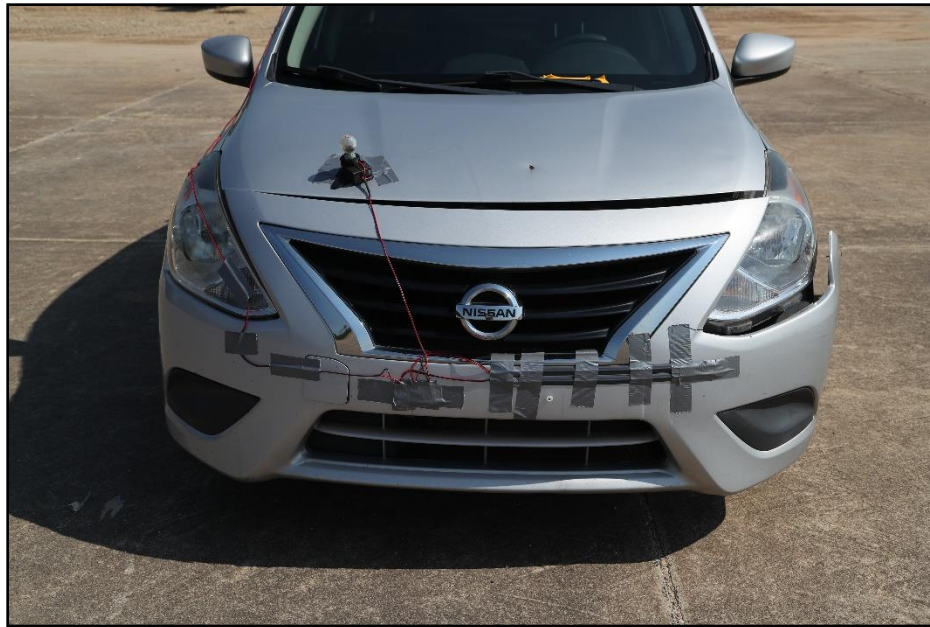
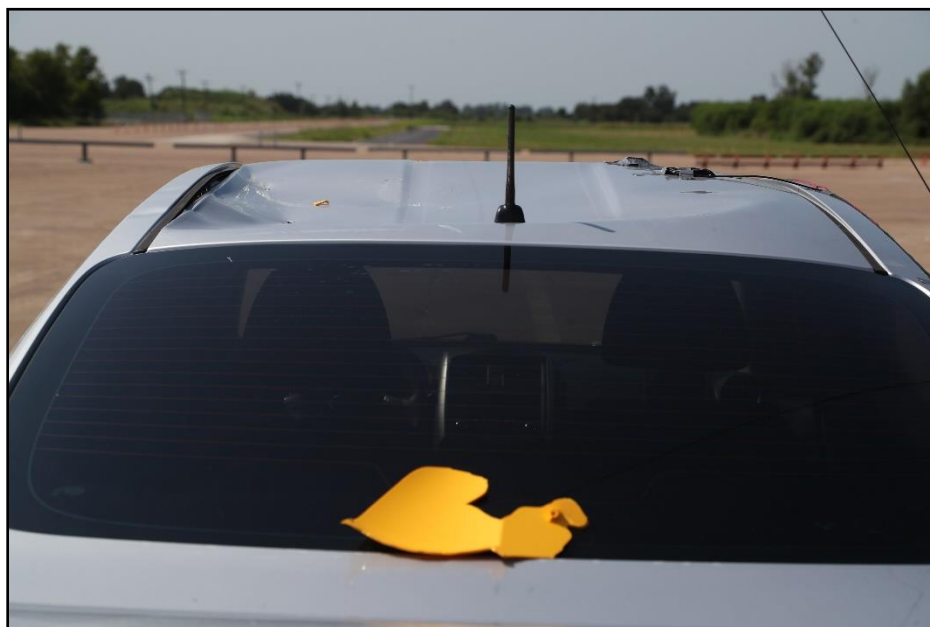
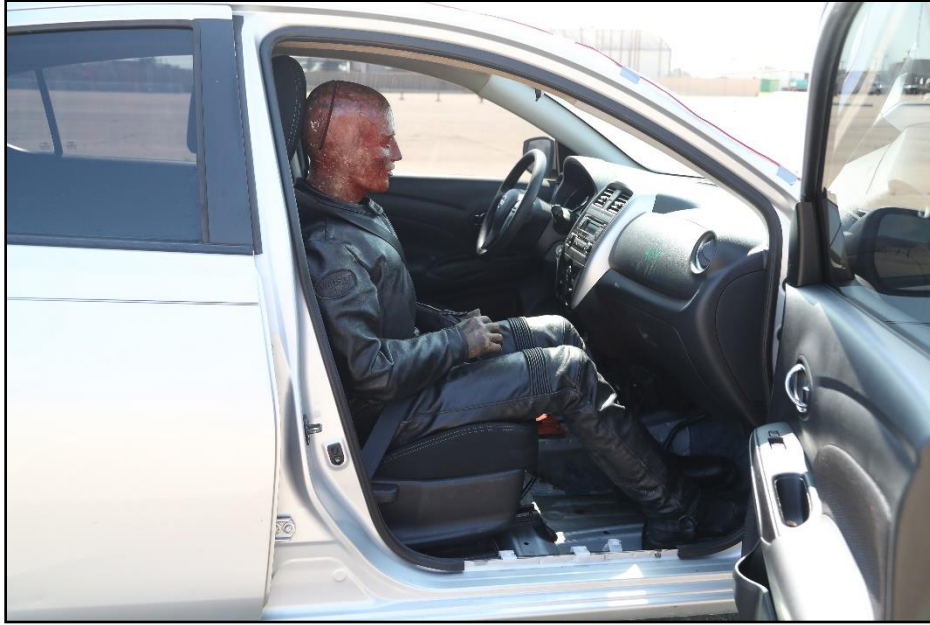
Figure 6.8 and Figure 6.9 show the damage sustained by the vehicle. Figure 6.10 shows the interior of the test vehicle. Table 6.6 and Table 6.7 provide details on the occupant compartment deformation and exterior vehicle damage. Figures C.2 and C.3 in Appendix C.1 provide exterior crush and occupant compartment measurements.

Test Parameter	Details
Side Windows	Side windows remained intact
Maximum Exterior Deformation	3 inches in the top of the roof
VDS	12FC1
CDC	12FCHN1
Fuel Tank Damage	None
Description of Damage to Vehicle:	There was a small fracture on the left side of the bumper cover which had released at the left fender. There was a deformation in the rear roof 32 inches wide by 32 inches long by 3 inches deep. At the passenger side cross member 9 inches away from the passenger door and 17 inches away from back glass was a 0.25 wide by a 0.25 inch long hole in the roof.

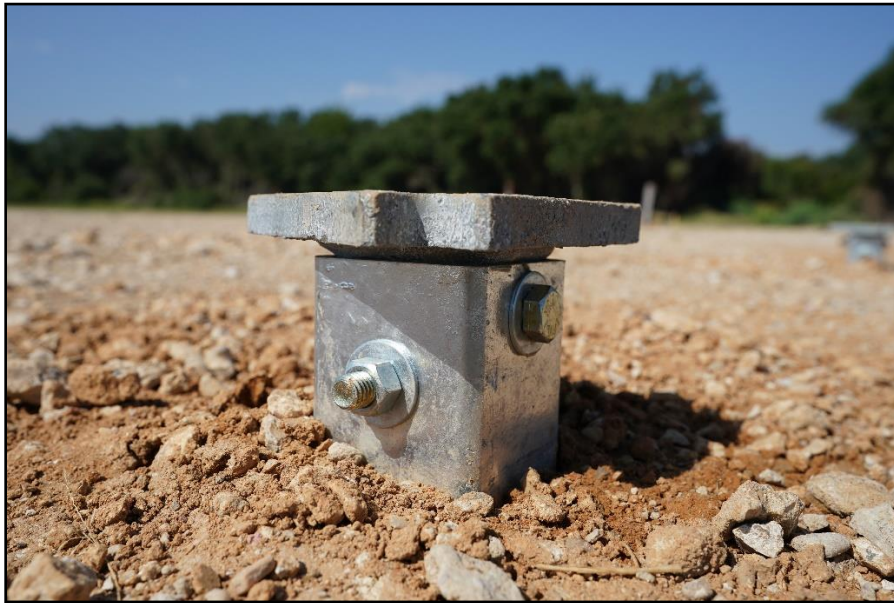
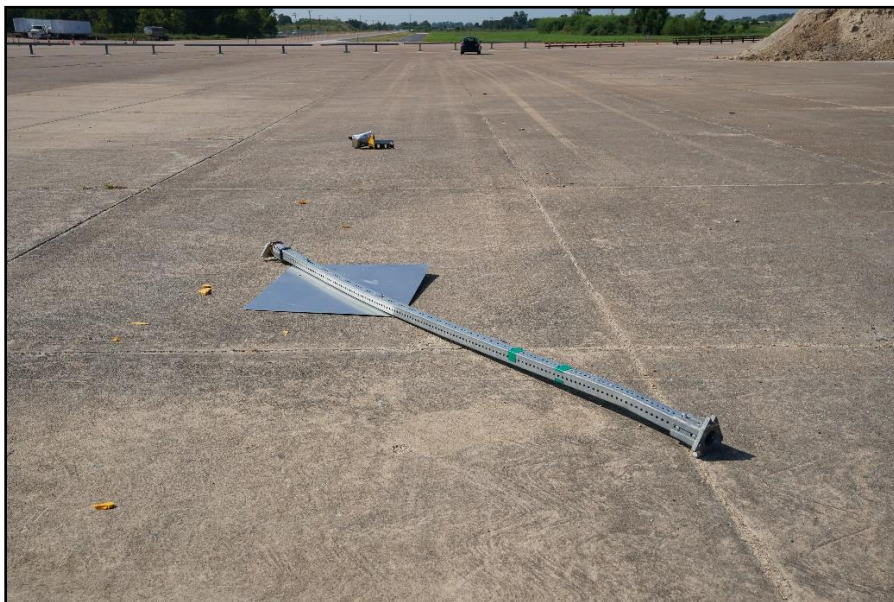
Figure 7.6 and Figure 7.7 show the damage to the Sign Posts with Flashing Beacon.

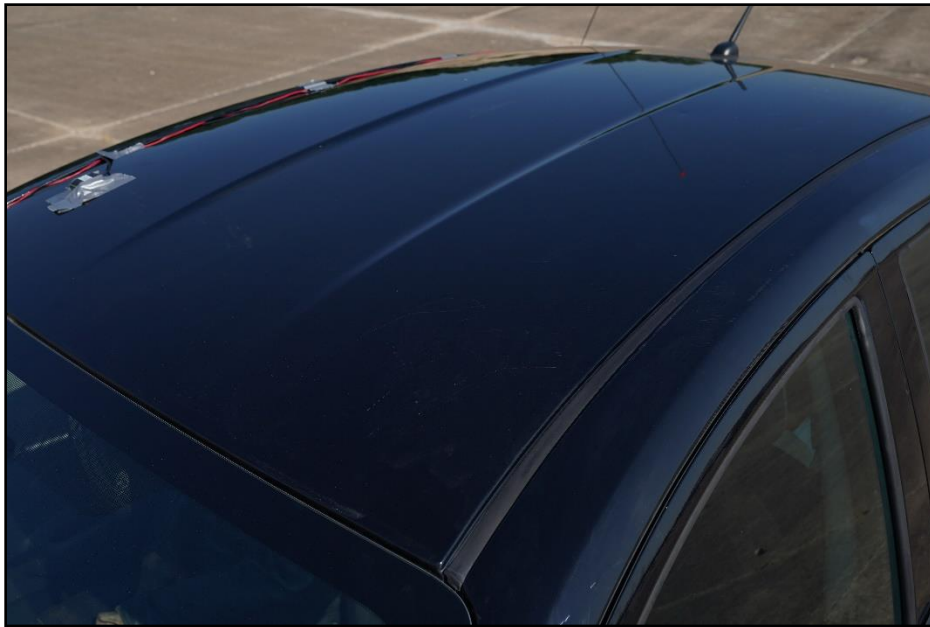
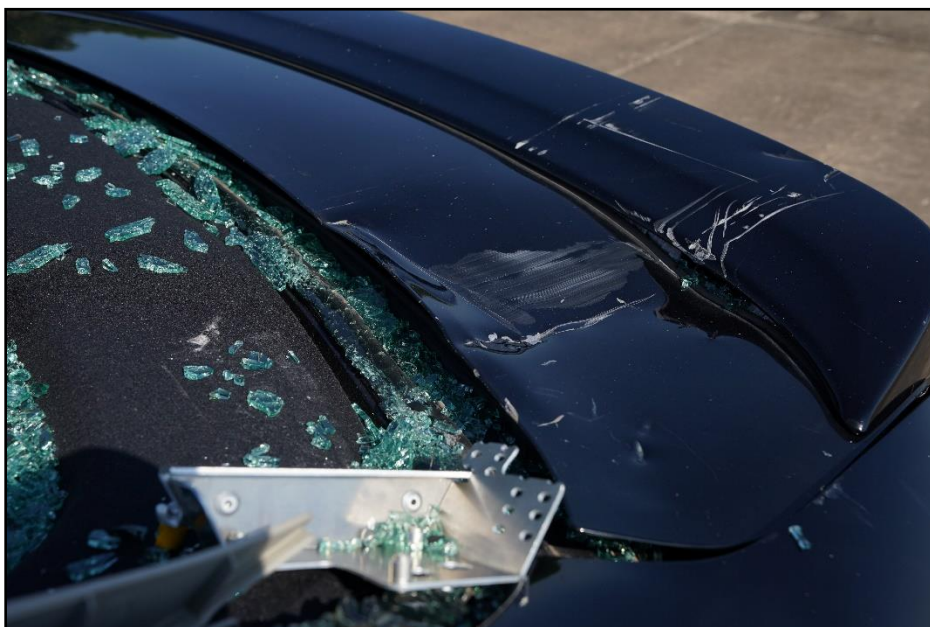
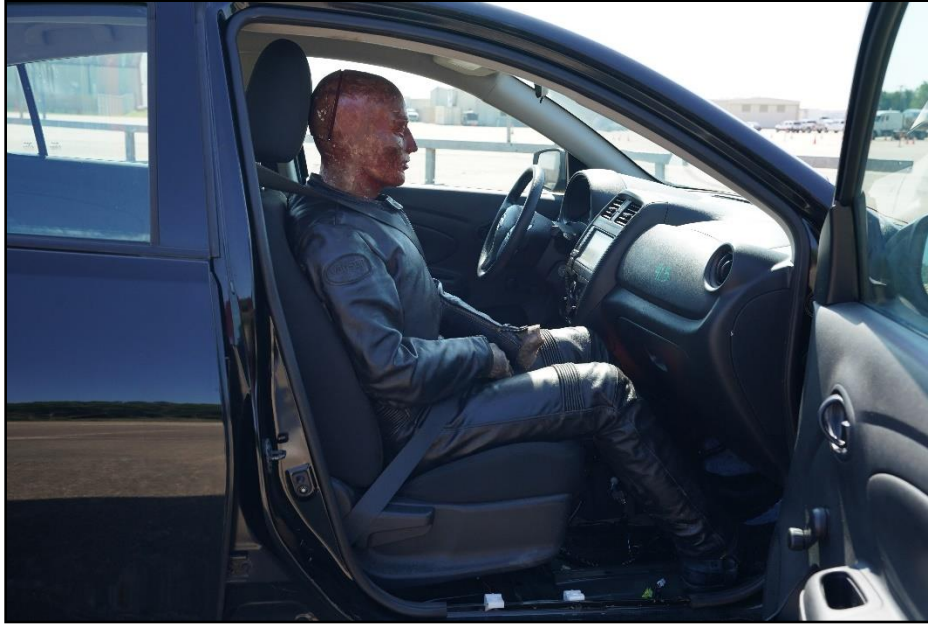
Figure 7.8 and Figure 7.9 show the damage sustained by the vehicle. Figure 7.10 shows the interior of the test vehicle. Table 7.6 and Table 7.7 provide details on the occupant compartment deformation and exterior vehicle damage. Figures D.2 and D.3 in Appendix D.1 provide exterior crush and occupant compartment measurements.

Test Parameter	Details
Side Windows	Side windows remained intact
Maximum Exterior Deformation	0.3 inches at front bumper
VDS	12FC1
CDC	12FCHN1
Fuel Tank Damage	None
Description of Damage to Vehicle:	The bumper cover was dislodged and the grill was fractured. The bumper was deformed in by 0.3 inches with a collapsed rail frame of the bumper on the driver's side. The back glass was shattered due to penetration by the support post. This also caused a 0.8 inch long by 0.8 inch wide laceration in the carpet on the driver's side of the package tray. The trunk lid had a 5 inch wide by 5 inch long by 0.3 inch deep deformation on the driver's side, and there were abrasions on the spoiler.

Table 8.1 shows that the breakaway sign support system with flashing equipment did not meet the performance criteria for *MASH* TL-3 Support Structures. The test installation penetrated the rear window during *MASH* Test 3-61 and did not meet the occupant compartment evaluation criterion D. *MASH* Test 3-62 was not performed after *MASH* Test 3-61 failed to meet all *MASH* performance criteria for support structures.
