Test Report No. 616401-01

MULTI-DIRECTIONAL BASE DESIGN FOR STEEL BEAM NON-PROPRIETARY LARGE SIGN SUPPORTS

Sponsored by Roadside Safety Pooled Fund

TEXAS A&M TRANSPORTATION INSTITUTE PROVING GROUND

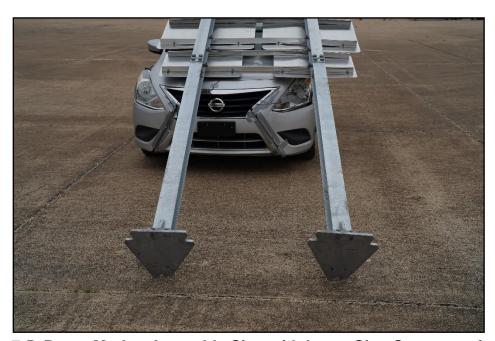
Figure 7-5. Route Marker Assembly Sign with Large Sign Supports after Test 616401-01-1.

The sign released at the slip base and remained on top of the car. The second from the bottom through the fourth from the bottom stiffeners were deformed. Figure 7-5 and Figure 7-6 show the damage to the Route Marker Assembly Sign with Large Sign Supports.

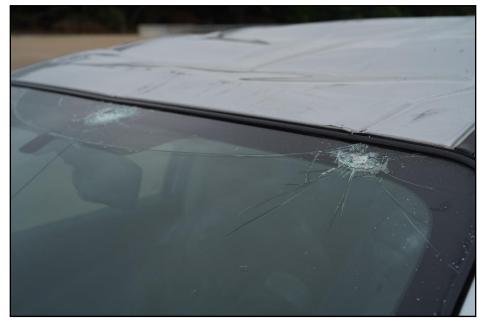
Figure 7-9. Test Vehicle Windshield Damage after Test 616401-01-1.

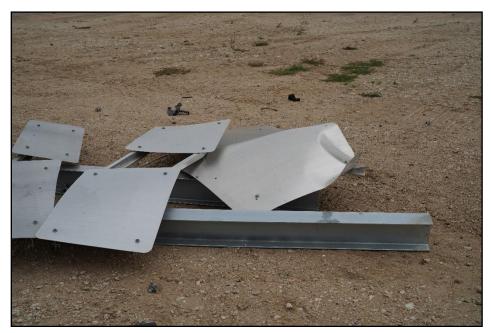
Figure 8-5. Route Marker Assembly Sign with Large Sign Supports after Test 616401-01-2.

The impact sign post came rest at 138 feet downstream, and the downstream post at 8 feet downstream of impact. The two small signs on stiffeners stopped at 25 feet downstream and 9 feet to the right of impact. The rest of the signs came to rest 36 feet downstream. Figure 8-5 and Figure 8-6 show the damage to the Route Marker Assembly Sign with Large Sign Supports.

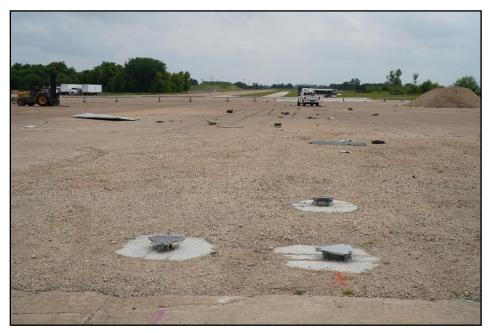
Figure 9-5. Guide Sign with Large Sign Supports at Impact Location after Test 616401-01-3.

The post assemblies released from the sign panel assembly, and the sign panel assembly came to rest 95 feet downstream and 35 feet to the left of impact. The upper support posts released from the lower support posts, with one upper post coming to rest 45 feet downstream and 4 feet to the right of impact. The second upper post stopped at 137 feet downstream and 6 feet to the right. One lower post came to rest 265 feet downstream and 45 feet to the right of impact. The second lower post stopped at 358 feet downstream and 17 feet to the left. The downstream slip base bent downstream and was raised 1.5 inches above the installed height on impact side. Figure 9-5 and Figure 9-6 show the damage to the Guide Sign with Large Sign Supports.

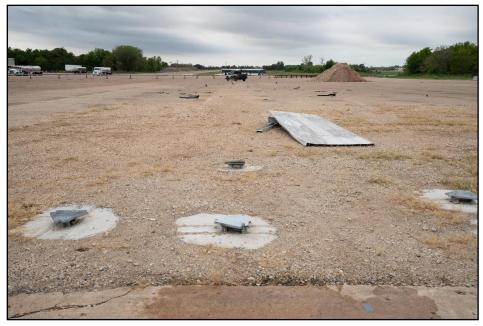
Figure 10-5. Guide Sign with Large Sign Supports at Impact Location after Test 616401-01-9.

The downstream footer was cracked, and the soil around it was disturbed. The upstream anchor bolt and the fuse plate did not release from the impact footer, and the downstream footer was bent downstream. The sign panel assembly and downstream upper support posts came to rest 32 feet downstream and 8 feet to the right. The lower downstream support post stopped at 188 feet downstream and 3 feet to the left. The lower impact support post came to rest 376 feet downstream. This post was deformed in the middle with tearing and scuffing. Figure 10-5 and Figure 10-6 show the damage to the Guide Sign with Large Sign Supports.

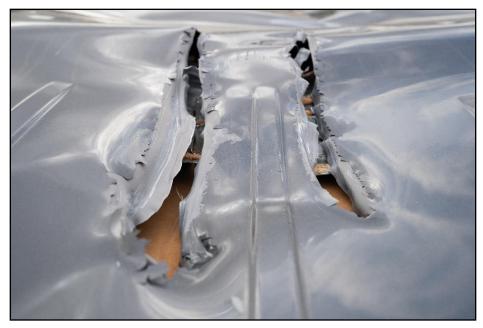
Figure 10-9. Detail of Roof Damage on the Test Vehicle after Test 616401-01-9.

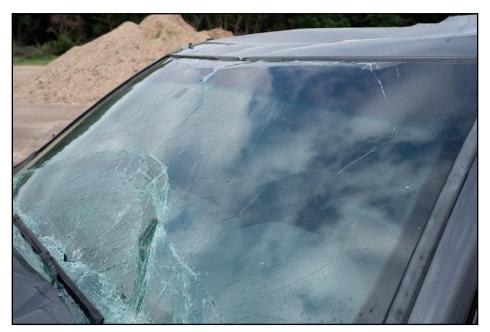
Figure 10-10. Test Vehicle Windshield Damage after Test 616401-01-9.

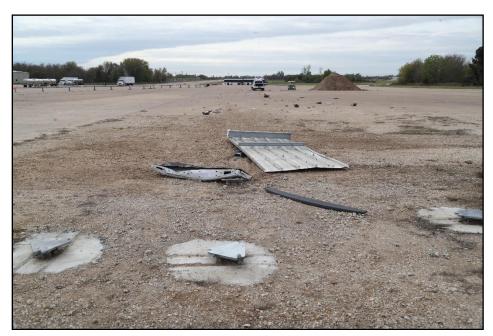
Figure 11-5. Guide Sign with Large Sign Supports at Impact Location after Test 616401-01-4.

downstream. Figure 11-5 and Figure 11-6 show the damage to the Guide Sign with Large Sign Supports.

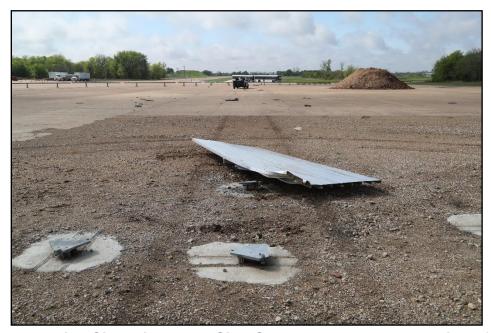
Figure 12-5. Guide Sign with Large Sign Supports at Impact Location after Test 616401-01-8.

Both support posts released from the footers and the sign panel assembly, with one landing 435 feet downstream from impact and the other landing 390 feet downstream of impact. The sign landed at the downstream footer, which was leaning downstream, with the impact side 3 inches above the installed height. Figure 12-5 and Figure 12-6 show the damage to the Guide Sign with Large Sign Supports.

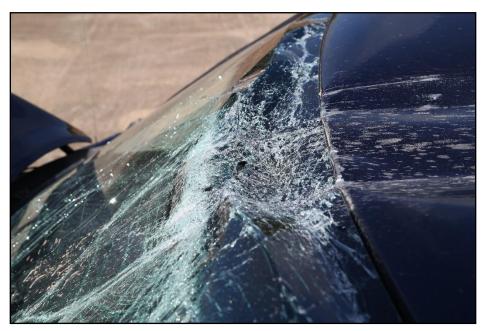
Figure 12-9. Test Vehicle Windshield Damage after Test 616401-01-8.

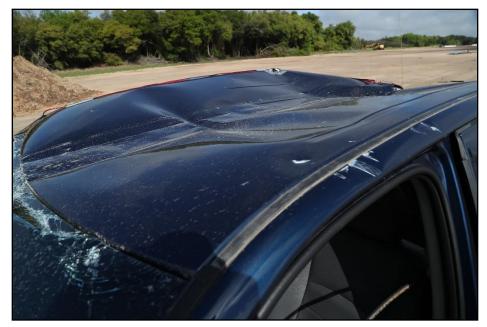
Figure 12-10. Roof of the Test Vehicle after Test 616401-01-8.
