Test Report No. 618901-01-2-1:7

**PORTABLE SIGN SUPPORTS FOR ALUMINUM SIGNS WITH  
VARIATIONS ON MOUNTING HEIGHT**

Sponsored by  
**The Roadside Safety Pooled Fund**

**TEXAS A&M TRANSPORTATION INSTITUTE PROVING GROUND**

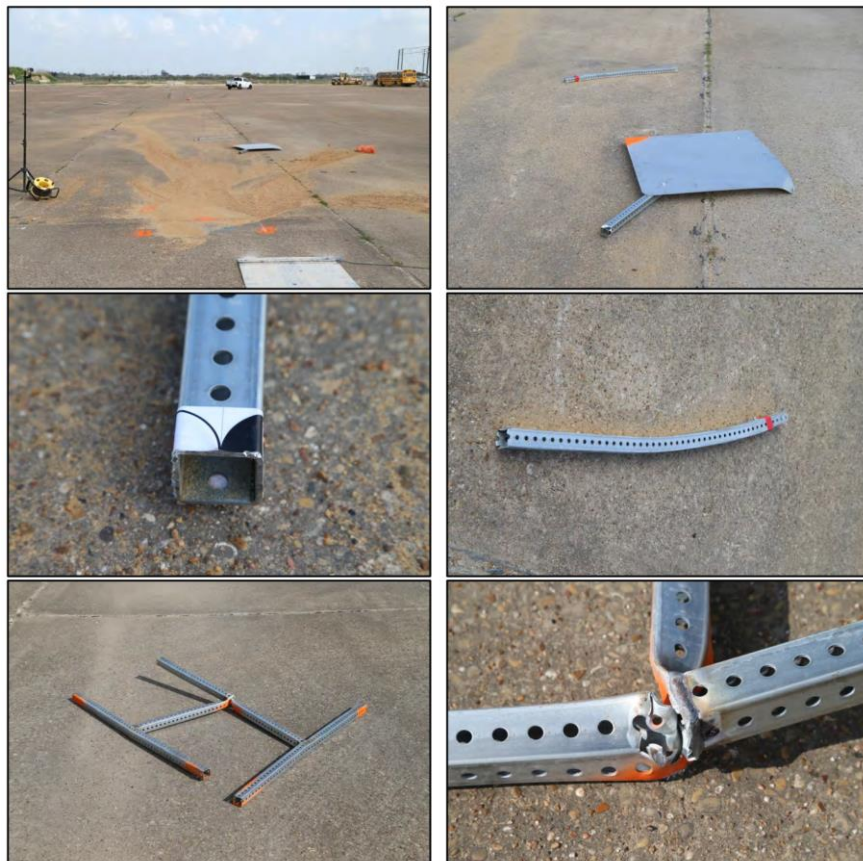
**Figure 2.6. Temporary High-Mounting Sign Support, Option A Test 3-72, 90-degree Impact System Damage (2)**

In *MASH* test 3-72 (test 490026-2-1), the 2270P pickup truck contacted the Option A temporary work zone sign support 10 inches to the right of centerline of the vehicle at an impact angle of 90 degrees while traveling at an impact speed of 62.9 mi/h. Figure 2.4 and Figure 2.5 present sequential photographs of the test. Figure 2.6 shows the damage to the Option A temporary work zone sign support.

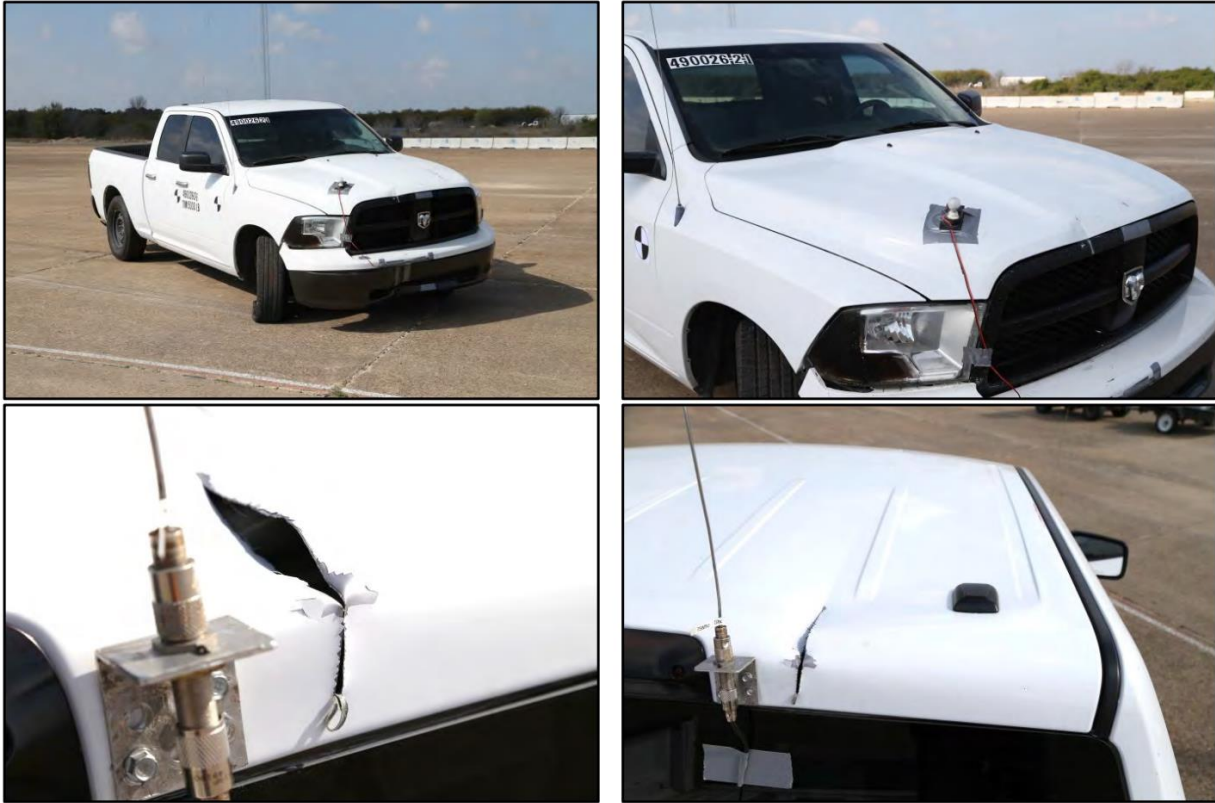
**Figure 2.7. Temporary High-Mounting Sign Support, Option A Test 3-72, 90-degree Impact Vehicle Damage (2)**

Figure 2.7 shows the damage sustained by the vehicle. On the rear of the roof, there was a 16-inch scratch that ended in a 5-inch tear on the outer surface. The cut did not extend into the passenger compartment. The interior roof around the cut was dented approximately one inch, as shown in Figure 2.8. No other occupant compartment deformation or intrusion was noted.

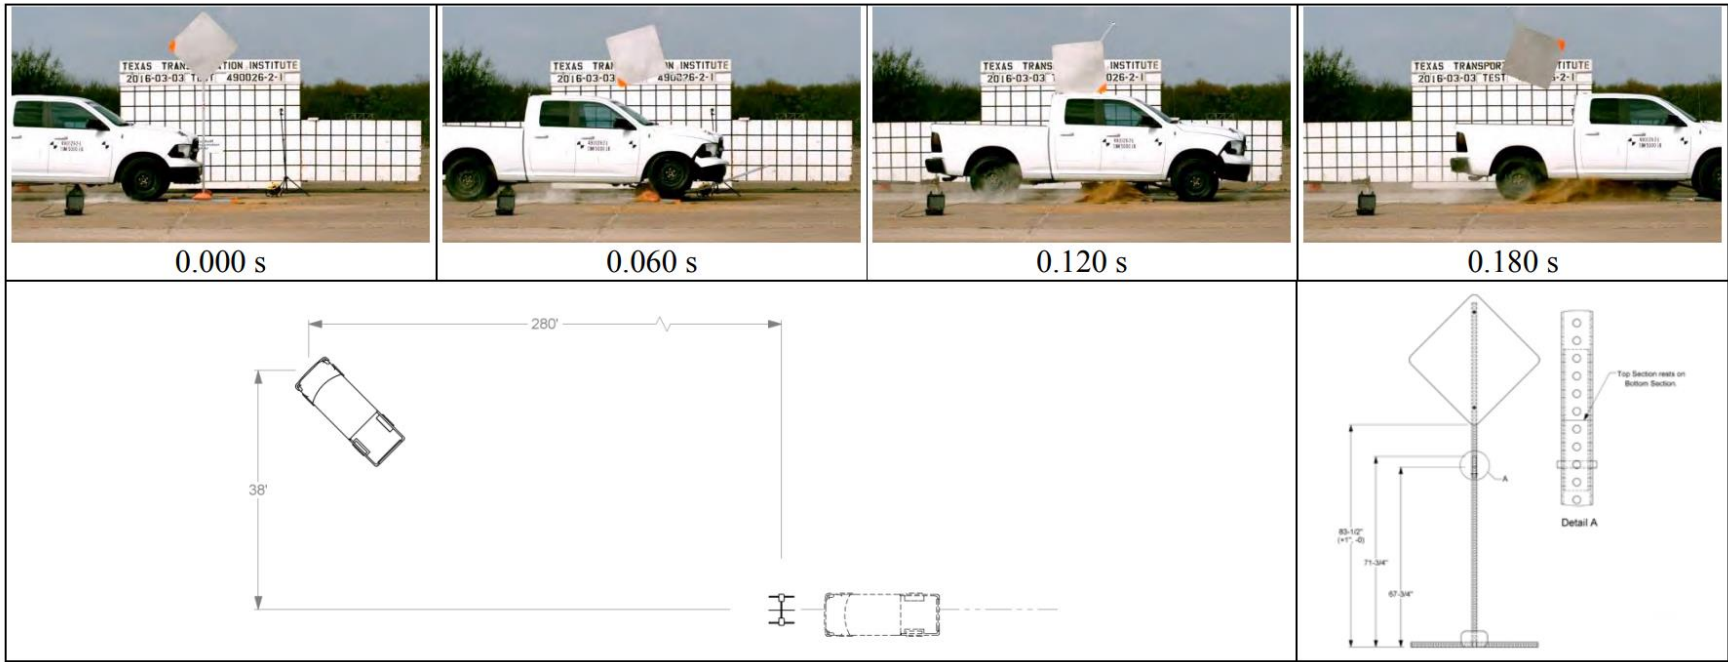
Figure 2.9 provides a summary of the test results. The slip connection incorporated into the vertical support post of the Option A temporary work zone sign support allowed the top of the system to release from the lower section of the vertical support post and base as intended. The corner of the sign panel impacted the vehicle roof, and no tear occurred with this first impact. However, as the vehicle continued forward, the sign panel continued to rotate and impacted the rear of the roof causing a 5-inch tear in the exterior of the roof. The tear did not extend into the occupant compartment but did cause a 1-inch dent in the interior roof panel at this location of the right rear passenger compartment. Consequently, the test article failed to meet *MASH* evaluation criteria.

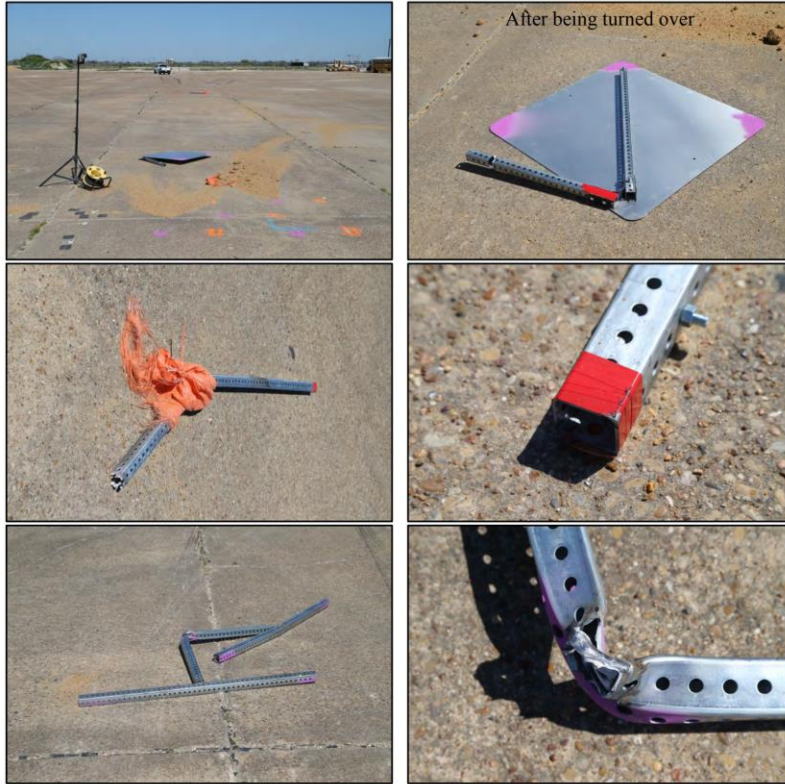
**Figure 2.15. Temporary High-Mounting Sign Support, Option B Test 3-72, 90-degree Impact System Damage (2)**

In *MASH* test 3-72 (test 4900026-2-2), the 2270P pickup truck contacted the Option B temporary work zone sign support 10 inches to the left of centerline of the vehicle at an impact angle of 90 degrees while traveling at an impact speed of 62.6 mi/h. The fuse plates connecting the middle and upper sections of the vertical support successfully activated. Figure 2.13 and Figure 2.14 present sequential photographs of the test. Figure 2.15 shows the damage to the Option B temporary work zone sign support.

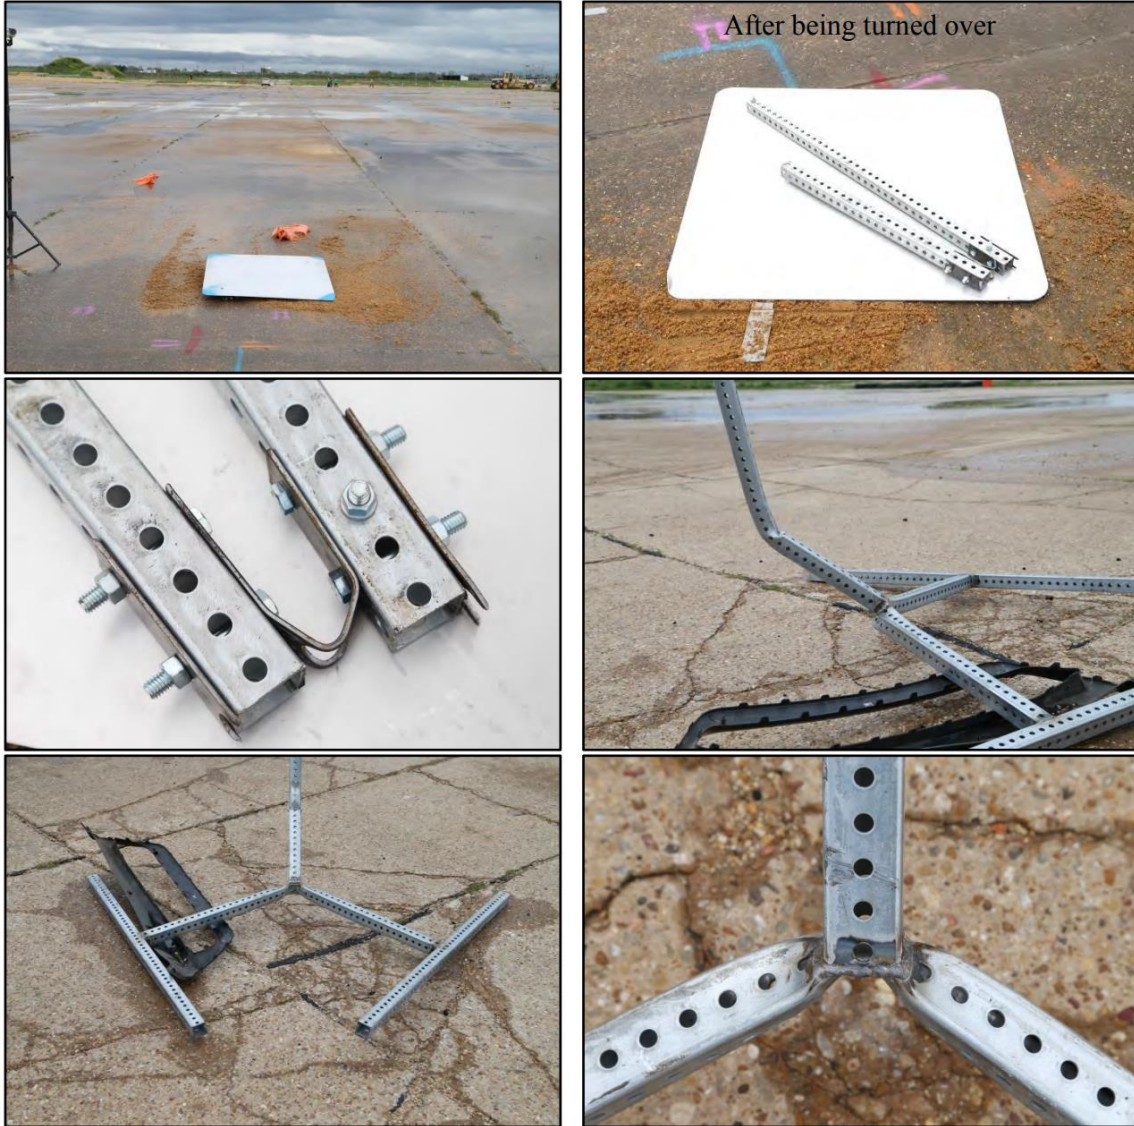
**Figure 2.19. Temporary High-Mounting Sign Support, Option B Test 3-71, 90-degree Impact System Damage (2)**

In *MASH* test 3-71 (test 4900026-2-4), the 1100C small car, traveling at an impact speed of 60.9 mi/h, contacted the Option B temporary work zone sign support 10 inches to the right of centerline of the vehicle at an impact angle of 90 degrees. The fuse plates connecting the middle and upper section of the support successfully activated. Figure 2.17 and Figure 2.18 present sequential photographs of the test. Figure 2.19 shows the damage to the Option B temporary work zone sign support. Figure 2.20 shows the damage sustained by the vehicle. No occupant compartment deformation or intrusion was noted.

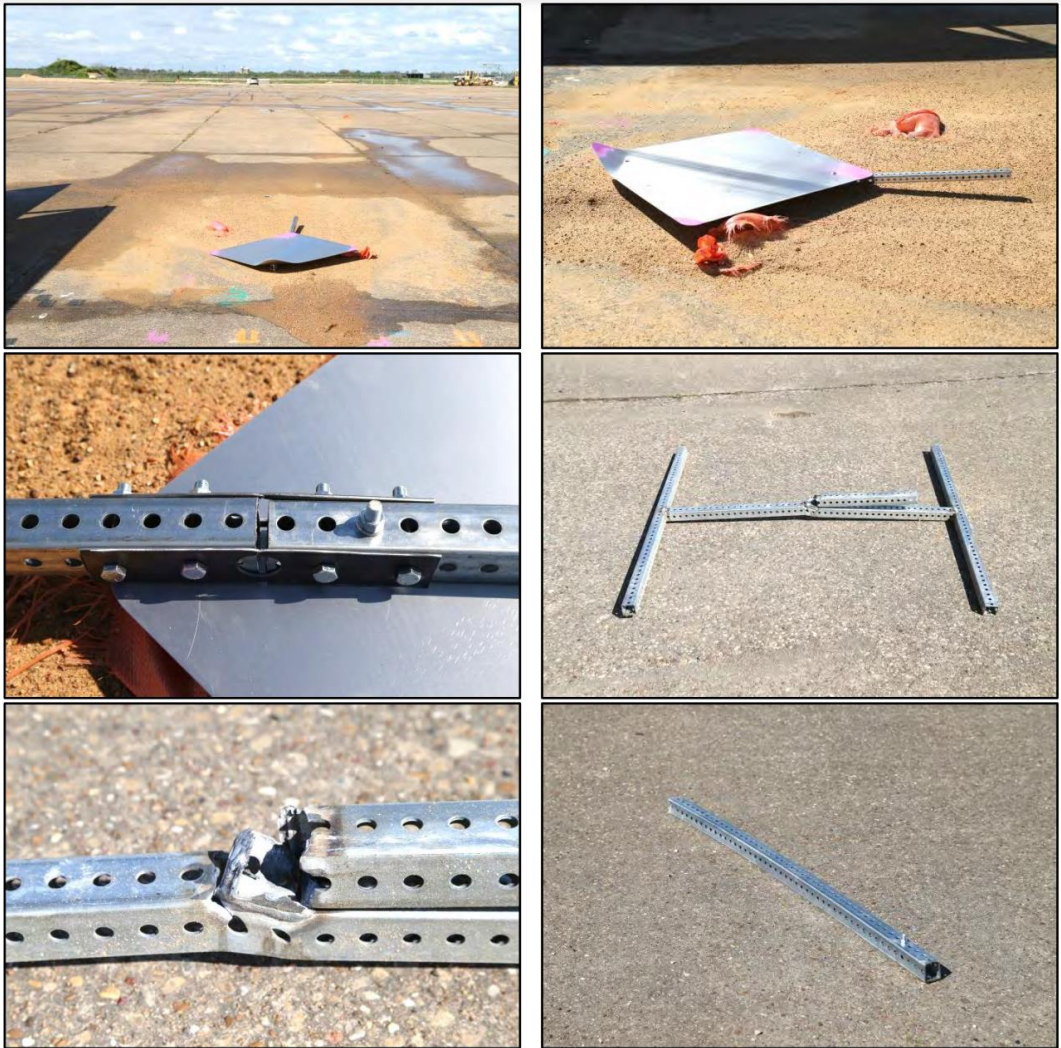
**Figure 2.23. Temporary High-Mounting Sign Support, Option B Test 3-71, 0-degree Impact System Damage (2)**

In *MASH* test 3-71 (test 4900026-2-6), the 1100C contacted the Option B temporary work zone sign support 10 inches to the right of centerline of the vehicle at an impact angle of 0 degrees while traveling at an impact speed of 61.7 mi/h. Figure 2.21 and Figure 2.22 present sequential photographs during the test. Figure 2.23 shows the damage to the Option B temporary work zone sign support. Figure 2.24 shows the damage sustained by the vehicle. No occupant compartment penetration, deformation, or intrusion was noted.

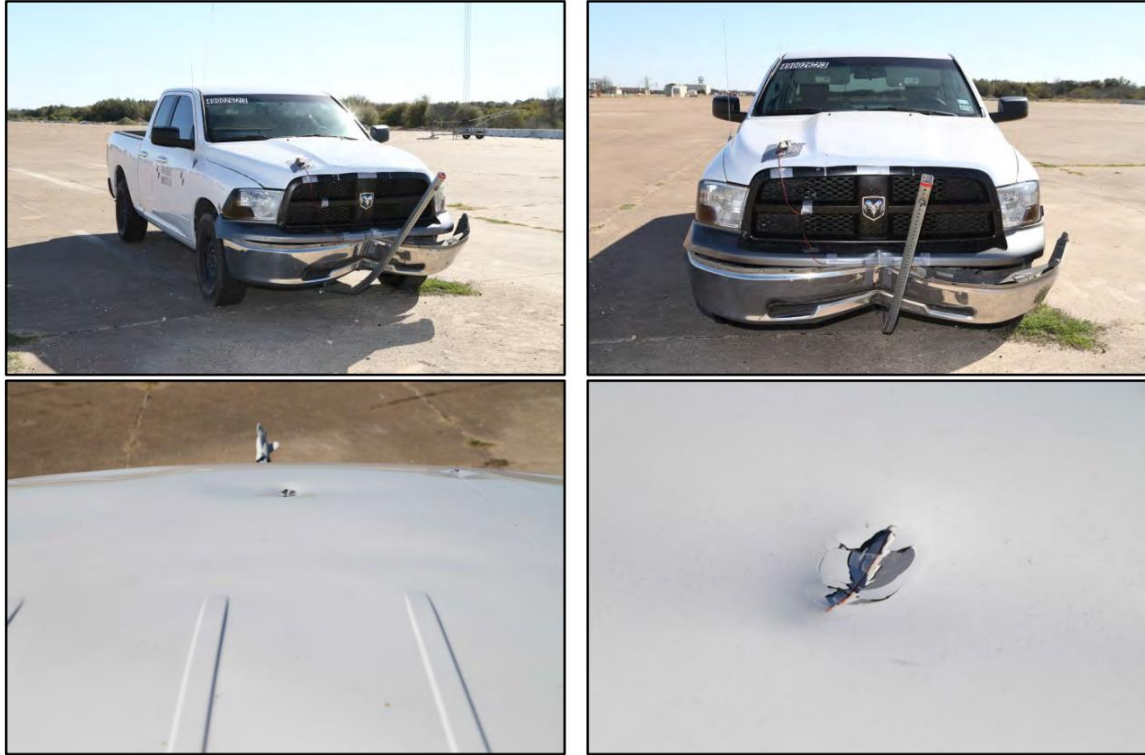
**Figure 2.39. Temporary High-Mounting Sign Support, Option C Test 3-72, 90-degree Impact Vehicle Damage (2)**

damage sustained by the vehicle. There was a 3-inch-long dent on the outer surface of the front of the roof of the cab, but no occupant compartment deformation or intrusion was noted.

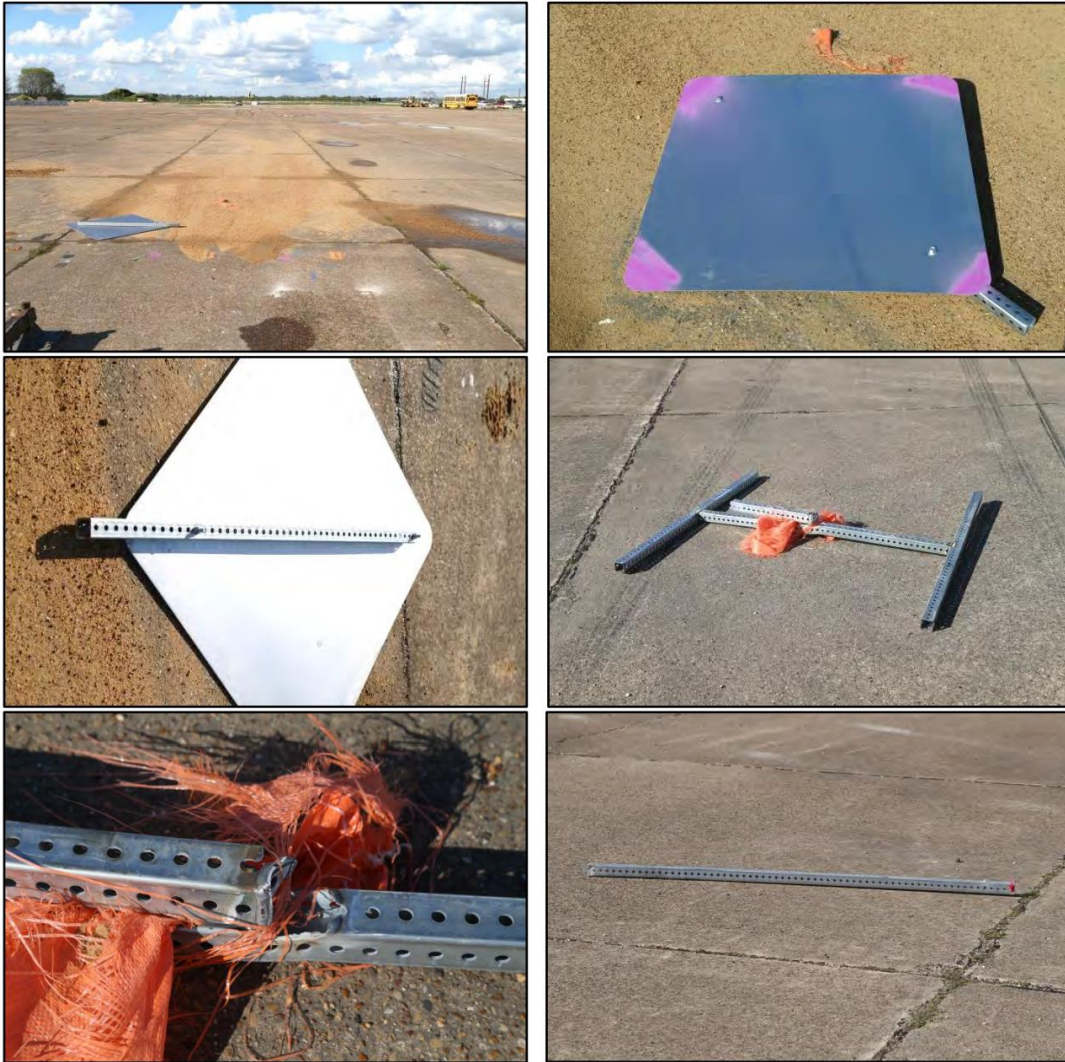
**Figure 2.46. Temporary High-Mounting Sign Support, Option C Test 3-71, 0-degree Impact System Damage (2)**

In *MASH* test 3-71 (test 4900026-2-7), the 1100C small car, traveling at an impact speed of 61.9 mi/h, contacted the Option C temporary work zone sign support 10 inches to the left of centerline of the vehicle at an impact angle of 0 degrees. Figure 2.44 and Figure 2.45 present sequential photographs during the test. Figure 2.46 shows the damage to the Option C temporary work zone sign support. Figure 2.47 shows the damage sustained by the vehicle. The 1100C vehicle sustained only scrapes to the bumper and hood with no measurable exterior vehicle deformation. No occupant compartment deformation or intrusion was noted.

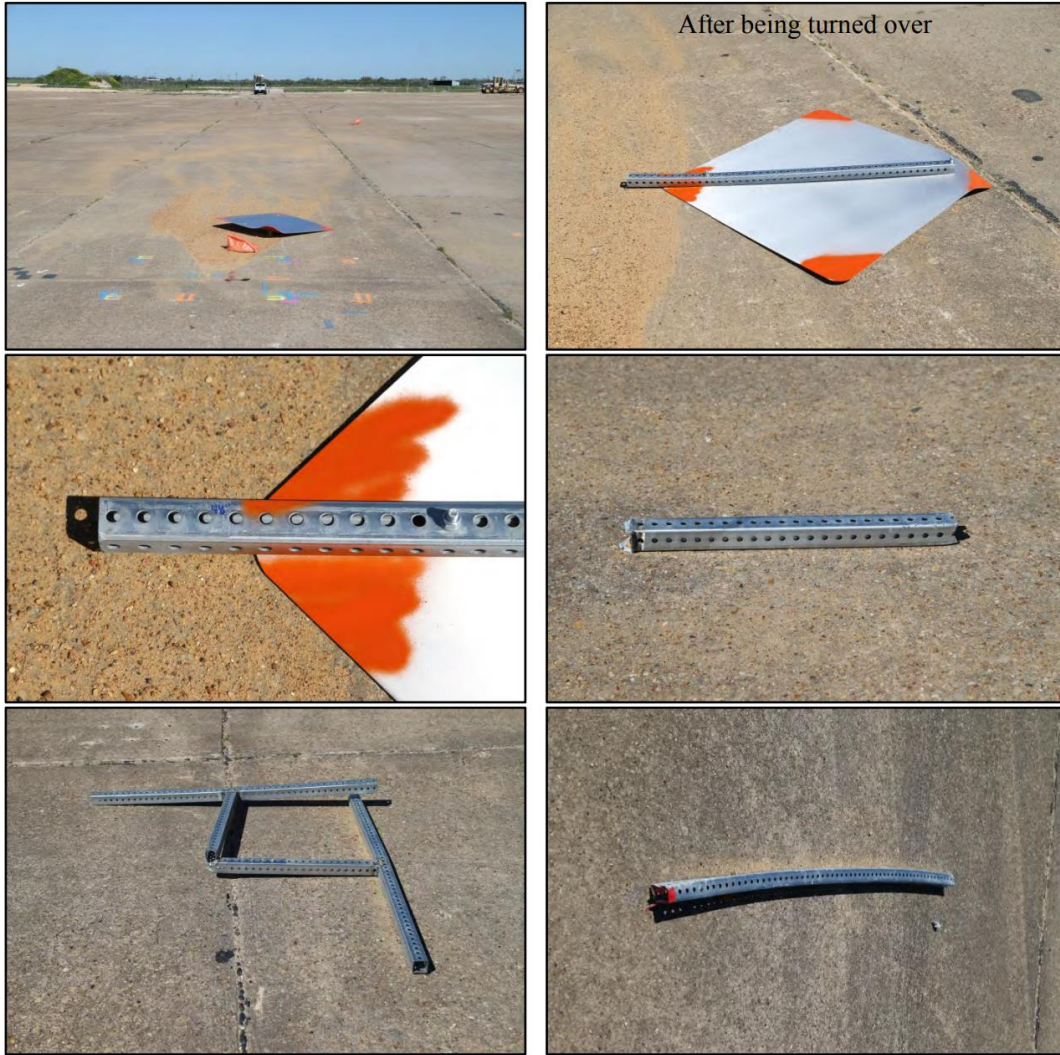
**Figure 2.50. Temporary High-Mounting Sign Support, Option C Test 3-72, 0-degree Impact System Damage (2)**

In *MASH* test 3-72 (test 4900026-2-9), the 2270P pickup truck, traveling at an impact speed of 62.9 mi/h, contacted the Option C temporary work zone sign support 10 inches to the left of centerline of the vehicle at an impact angle of 0 degrees. Figure 2.48 and Figure 2.49 present sequential photographs of the test. Figure 2.50 shows the damage to the Option C temporary work zone sign support. Figure 2.51 shows the damage sustained by the vehicle. No occupant compartment deformation or intrusion was noted.

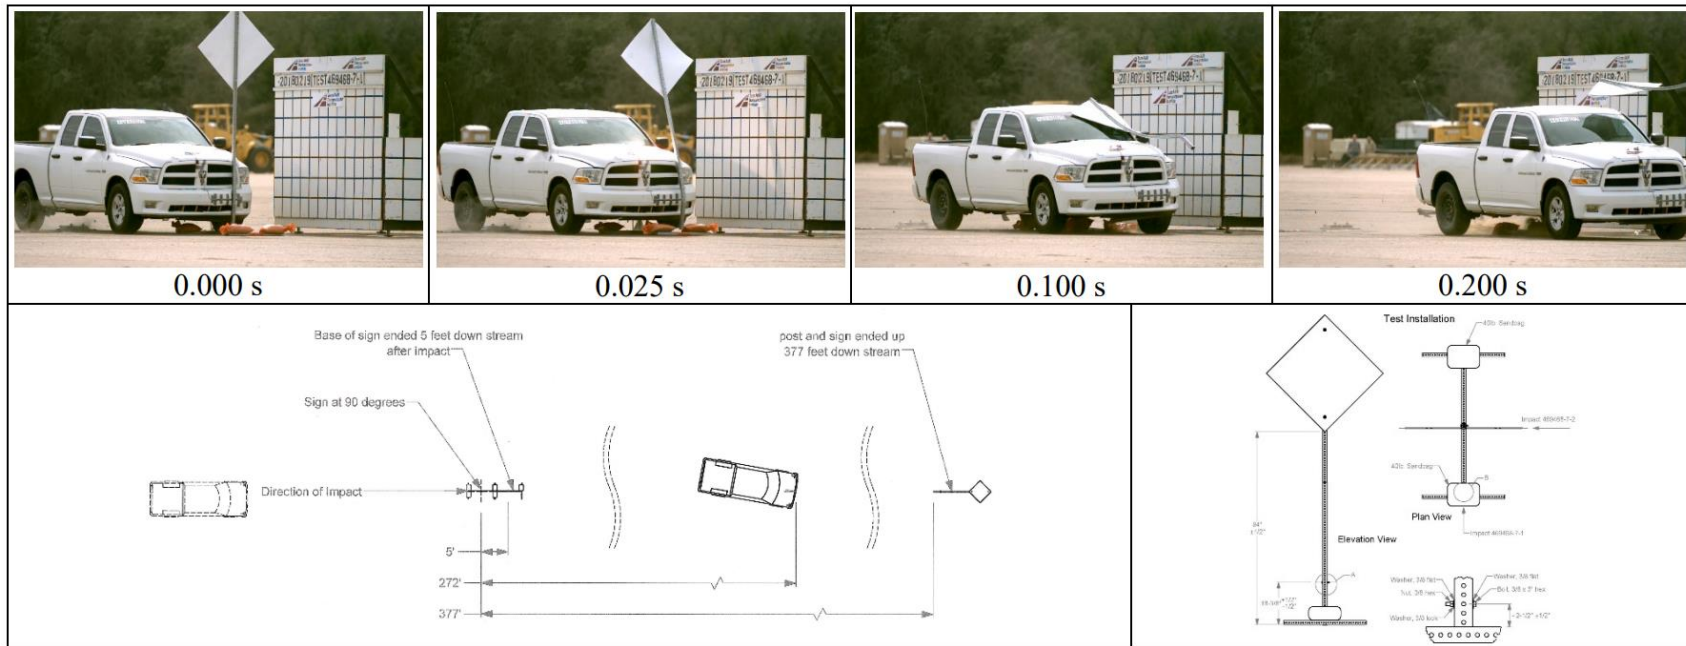
Figure 2.91 provides an assessment of the test based on the applicable safety evaluation criteria for MASH Test 3-72. The skid-mounted single perforated steel tube temporary sign support system met all applicable criteria for *MASH* Test 3-72 at 0°.
