Test Report No. TRNo. 618911-01-1 - 3

EVALUATION OF A FOUR BOLT SLIP BASE FOR BREAKAWAY LUMINAIRE SUPPORTS WITH VARIOUS POLE CONFIGURATIONS

Sponsored by The Roadside Safety Pooled Fund

TEXAS A&M TRANSPORTATION INSTITUTE PROVING GROUND

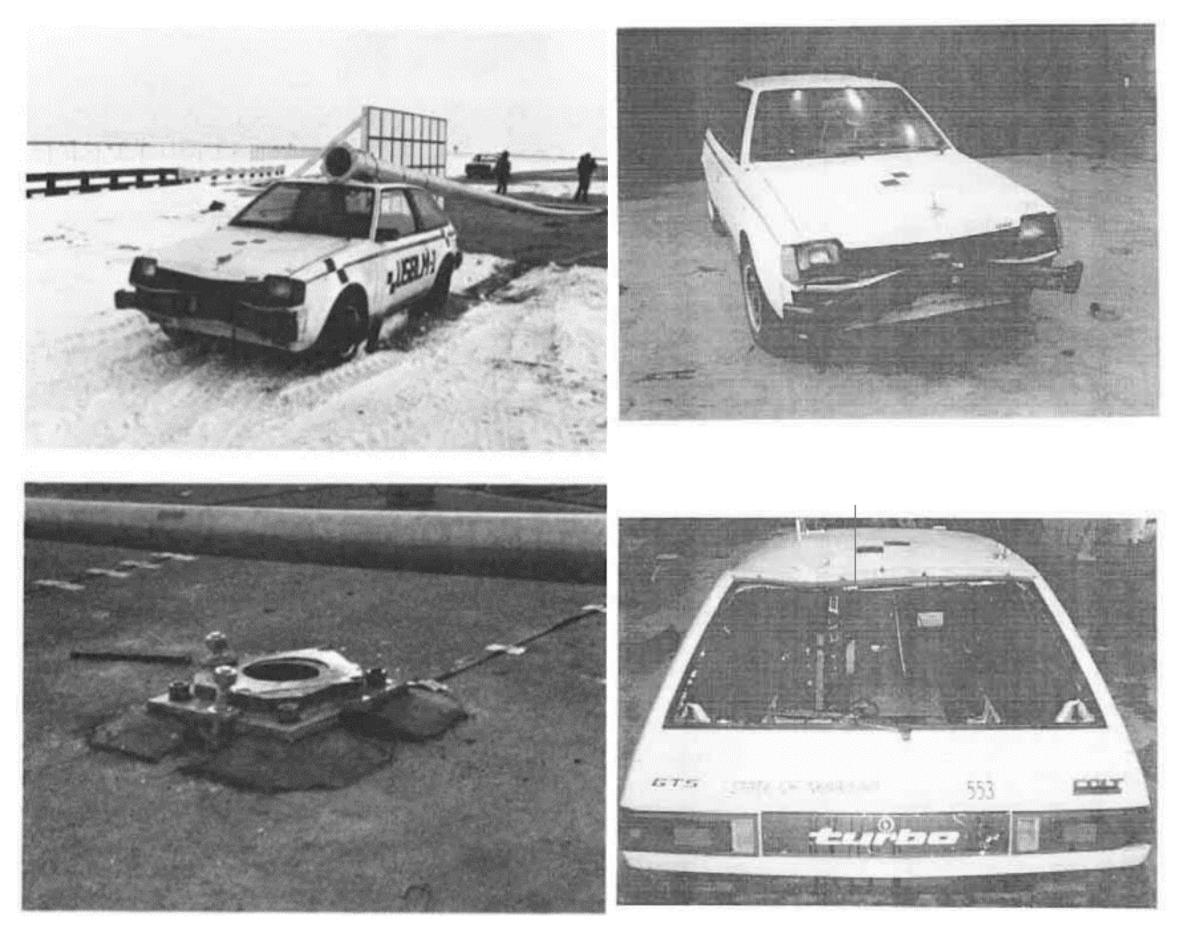
Figure 2.3. Post-Test images of Vehicle, Luminaire, and Slip base (3)

The first crash test involved a 1,750 lb 1984 Dodge Colt, impacting the luminaire support at the center point of the bumper at a speed of 15-mi/h. The front bumper of the vehicle crushed inward upon impact, as the base started to slip. The support hit the roof of the car 2.33 seconds after impact. The vehicle change in speed was calculated using a combination of film and accelerometer data. The occupant impact velocity was determined to be 7.6 ft/s, the maximum ridedown deceleration of 3.5 g's, and the vehicle change in speed was 6.1 ft/s. All were well below the requirements set forth by the guidelines listed in the previous paragraph. The damage to the vehicle was minimal, with only a 9 in. crushing distance in the bumper and slight damage to the roof. The vehicle and assembly damage are shown below in Figure 2.3.

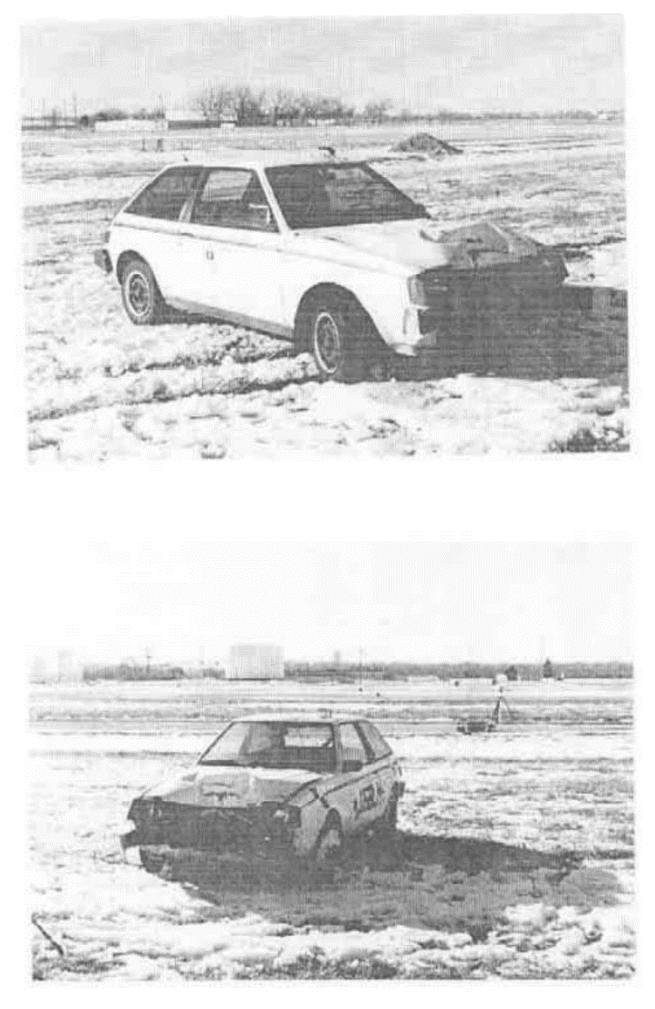
Figure 2.4. Post-Test Images of Vehicle

The second test was conducted using a repaired vehicle from the previous test. The center of the bumper impacted the luminaire support at a speed of 57.5 mi/h. The front of the bumper crushed upon impact as the base began to slip. The front of the vehicle began to lift up and continued on its rear wheels for 1 second after impact. The occupant impact velocity was determined to be 14.2 ft/s, the ridedown deceleration was 1.0 g's, and the change in speed was 13.5 ft/s. All were well below the requirements set forth by the guidelines listed previously. The only damage done to the vehicle was a maximum crushing distance of 12 in. on the bumper. The vehicle damage is shown below in Figure 2.4.

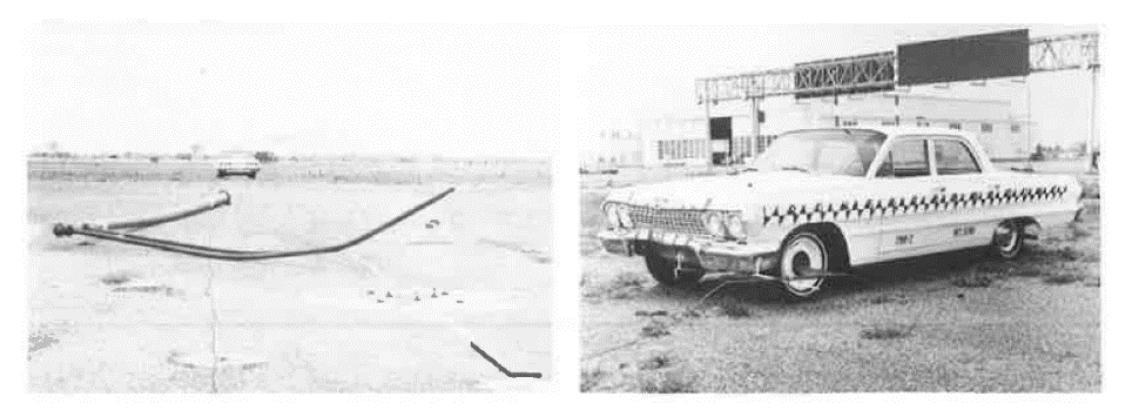
Figure 2.5. Post-Impact Images of the Vehicle and Assembly (Ninth Test) (4)

This effort involved a large series of crash tests evaluating a number of luminaire support configurations. In the ninth test, a 1963 Chevrolet impacted the luminaire support at a speed of 40.2 mi/h. The slip base on this pole became disengaged quickly, and the pole rotated upward. This allowed the vehicle to pass under it with relatively small change in speed. The change in momentum was determined to be 405 lb-sec from the high-speed film, and 425 lb-sec from the accelerometer. The assembly and vehicle damage are shown below in Figure 2.5.

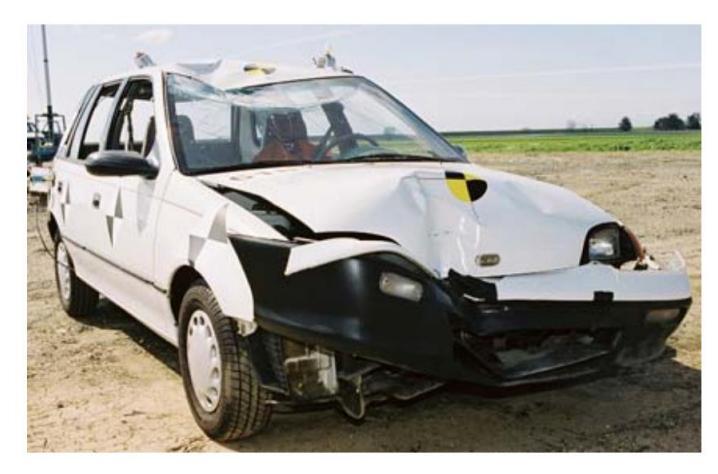
Figure 2.7. Post-Test Image of Vehicle Damage (First Test) (5)

The first test conducted on the assembly had an impact angle and speed of 0 degrees and 23.7 mi/h. The impact point was 5.0 in. to the right of the pole's center. Upon impact, the vehicle began to deform as it came in contact with the assembly, and the slip base engaged as anticipated. The sign assembly rotated throughout the course of the impact until the top impacted the ground behind the vehicle. The entire front of the vehicle was moderately damaged from the initial impact. The front windshield was damaged along the roofline but was not penetrated. The roof had the largest deformation centered at the top of the windshield, approximately 3.5 in. It was determined that no significant occupant risk would have occurred. The occupant impact velocity was determined to be 16.4 ft/s and the maximum ridedown acceleration was determined to be 2.04 g's.

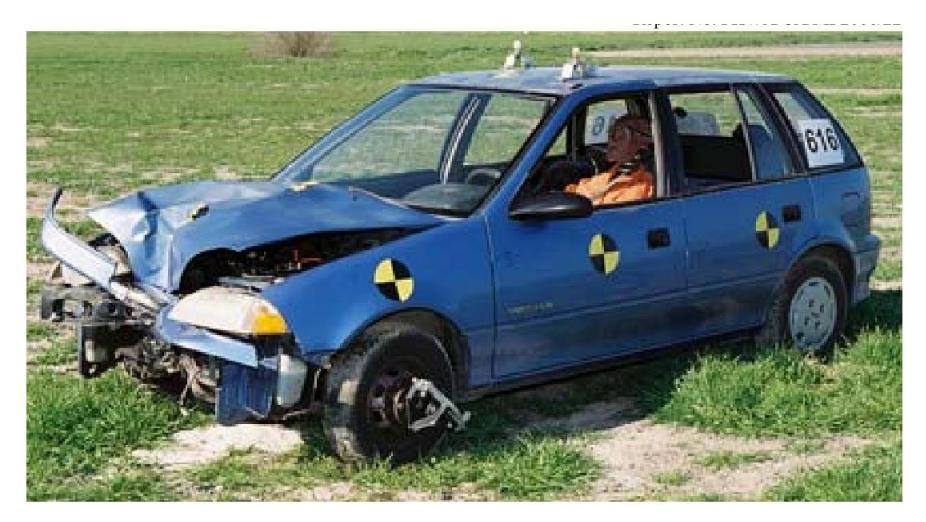
Figure 2.8. Post-Test Image of Vehicle Damage (Second Test) (5)

The second test conducted on the assembly had an impact angle of 0 degrees and location of 4.3 in. to the right of center of the pole at a speed of 63.8 mi/h. Upon impact, the vehicle began to deform as it came in contact with the assembly, and the slip base activated. The sign rotated and cleared the rest of the vehicle. The hood, bumper, headlamp area, grille, front fenders, and suspension components were damaged in the impact. The occupant impact velocity was determined to be 11.4 ft/s and the maximum ridedown acceleration was 4.40 g's.

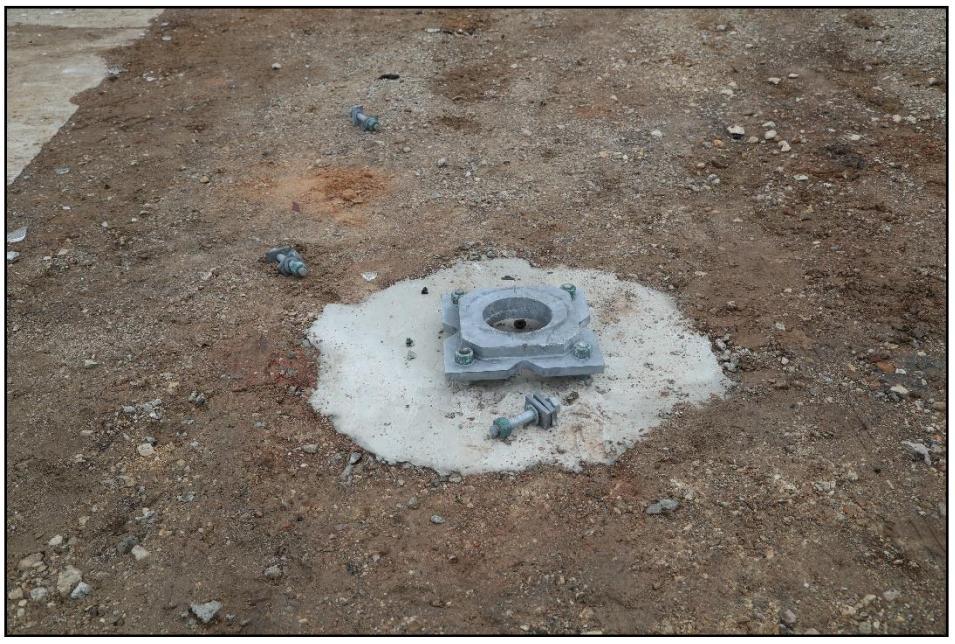
Figure 7.5. Four Bolt Slip Base Support for Luminaire Poles at Impact Location after Test 618911-01-1.

The lights released from the support arms, and the base of the pole came to rest on the trunk of the vehicle. Figure 7.5 and Figure 7.6 show the test article post impact.

Due to the 6.3 inch dent in the roof and the penetration of the base of the luminaire pole through the back glass, this test failed to meet evaluation criteria D of *MASH* for support structures. Figure 7.11 summarizes the results of *MASH* Test 618911-01-1.

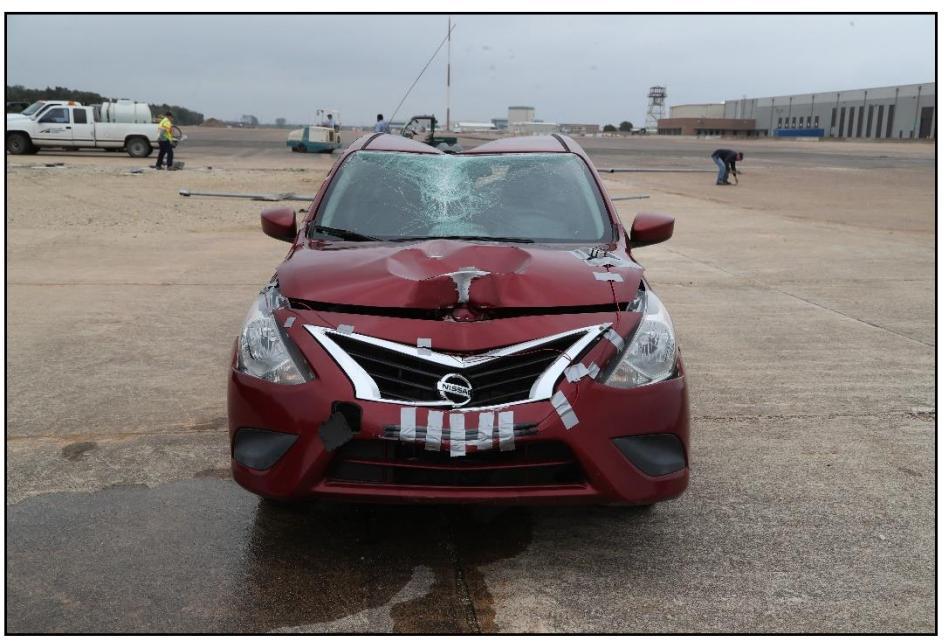
Figure 7.7. Impact Side of Test Vehicle after Test 618911-01-1.

Side Windows	Side windows remained intact		
Maximum Exterior Deformation	12 inches at the front bumper		
VDS	12FC5		
CDC	12FCAW6		
Fuel Tank Damage	None		
Description of Damage to Vehicle:	The bumper, grill, hood, radiator, and roof were crushed. The front windshield was fractured, and the rear window glass was shattered. A section of the carpet inside the occupant compartment was ripped near the rear window. There was a small dent in the sheet metal under the rear windshield. There was a dent on the trunk lid and a cracked rear spoiler.

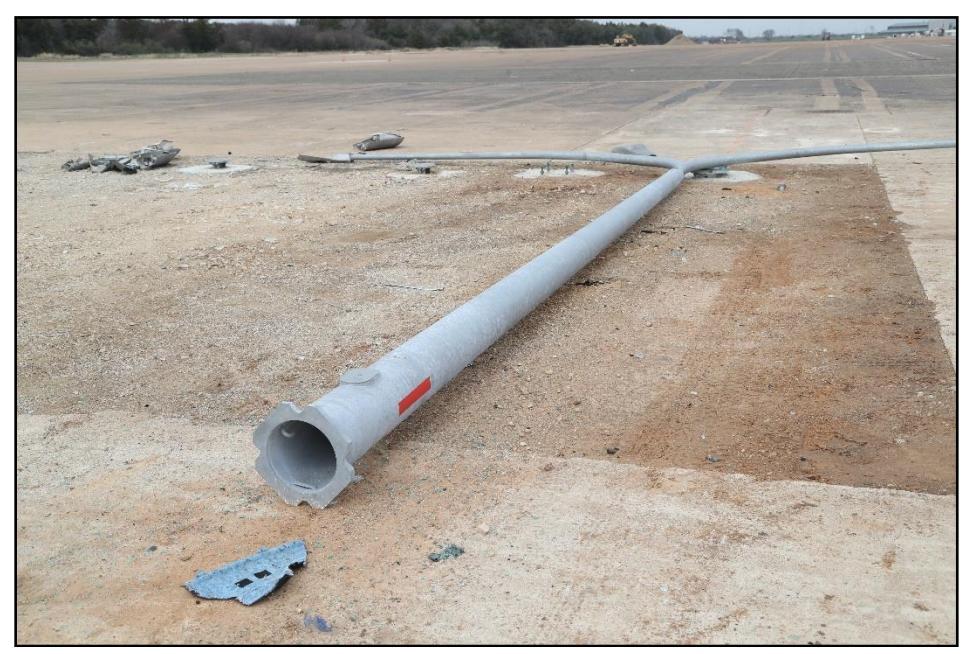
Figure 8.5. Test Article at Impact Location after Test 618911-01-2.

The luminaires released from the arms and the base of the luminaire pole came to rest 31 feet downstream. Figure 8.5 and Figure 8.6 show the damage to the Four Bolt Slip Base Support for Luminaire Poles.

Due to occupant compartment penetration in the back window from the test article, this test failed to meet evaluation criteria D of *MASH*. Figure 8.10 summarizes the results of *MASH* Test 618911-01-2.

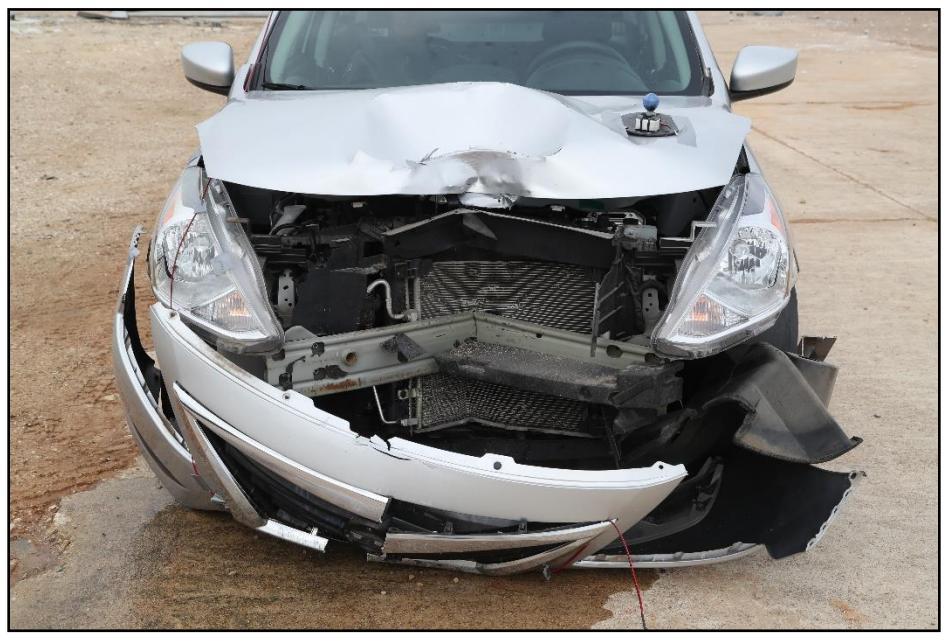
Figure 8.7. Front of Test Vehicle after Test 618911-01-2.

Side Windows	Side windows remained intact
Maximum Exterior Deformation	13 inches at the front bumper
VDS	12FC5
CDC	12FCHW6
Fuel Tank Damage	None
Description of Damage to Vehicle:	The hood, bumper, grill, radiator, and cross bar support were bent. There were two cracks at the top of the windshield, with a 33-inch-wide x 5-inch-long x 1.8-inch-deep dent in the roof. There was carpet ripped and two small dents inside the vehicle occupant compartment near where the rear window was shattered. There was a small dent on the trunk lid, and the rear spoiler was cracked.

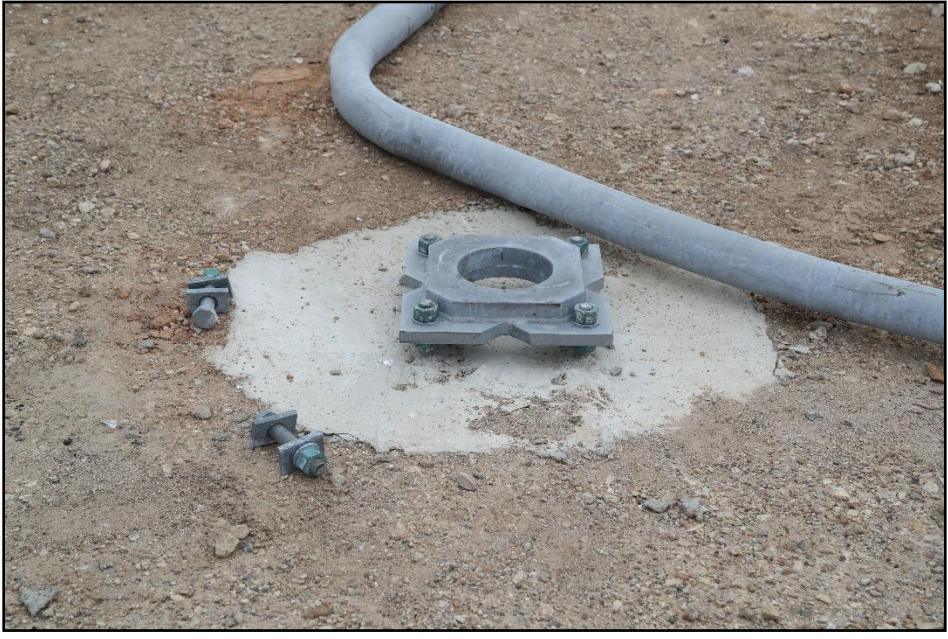
Figure 9.5. Four Bolt Slip Base Support for Luminaire Poles at Impact Location after Test 618911-01-3.

The final resting location of the base of the luminaire pole landed 40 feet downstream and 9 feet right from the impact with the top landing upstream. The luminaire pole released from the base and was dented at the impact point. The luminaire also released from the arm and shattered. Figure 9.5 and Figure 9.6 show the damage to the Four Bolt Slip Base Support for Luminaire Poles.

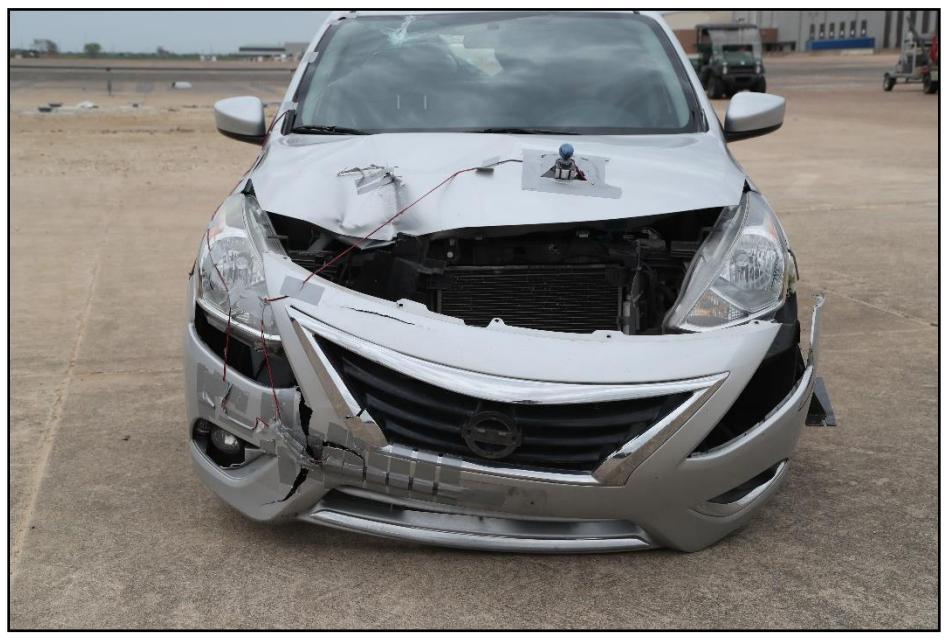
Figure 9.7. Front of Test Vehicle after Test 618911-01-3.

Side Windows	Side windows remained intact		
Maximum Exterior Deformation	9 inches at the front bumper		
VDS	12FC4		
CDC	12FCHW4		
Fuel Tank Damage	None		
Description of Damage to Vehicle:	The roof was damaged with a max depth of 2.8 inches. The front windshield was cracked but no holes were present. The back windshield was shattered but there was no indication of occupant compartment penetration. The bumper, grill, and hood were damaged.
