Test Report No. 616151-01
Test Report Date: August 2022

DESIGN AND EVALUATION OF A *MASH*TL-2 PERMANENT LOW-PROFILE BARRIER

1. Report No.	2. Government Accession No.	3. Recipient's Catalog No.	
4. Title and Subtitle DESIGN AND EVALUATION OF A MASH TEST LEVEL 2 COMPLIANT PERMANENT CONCRETE LOW-PROFILE BARRIER		5. Report Date August 2022

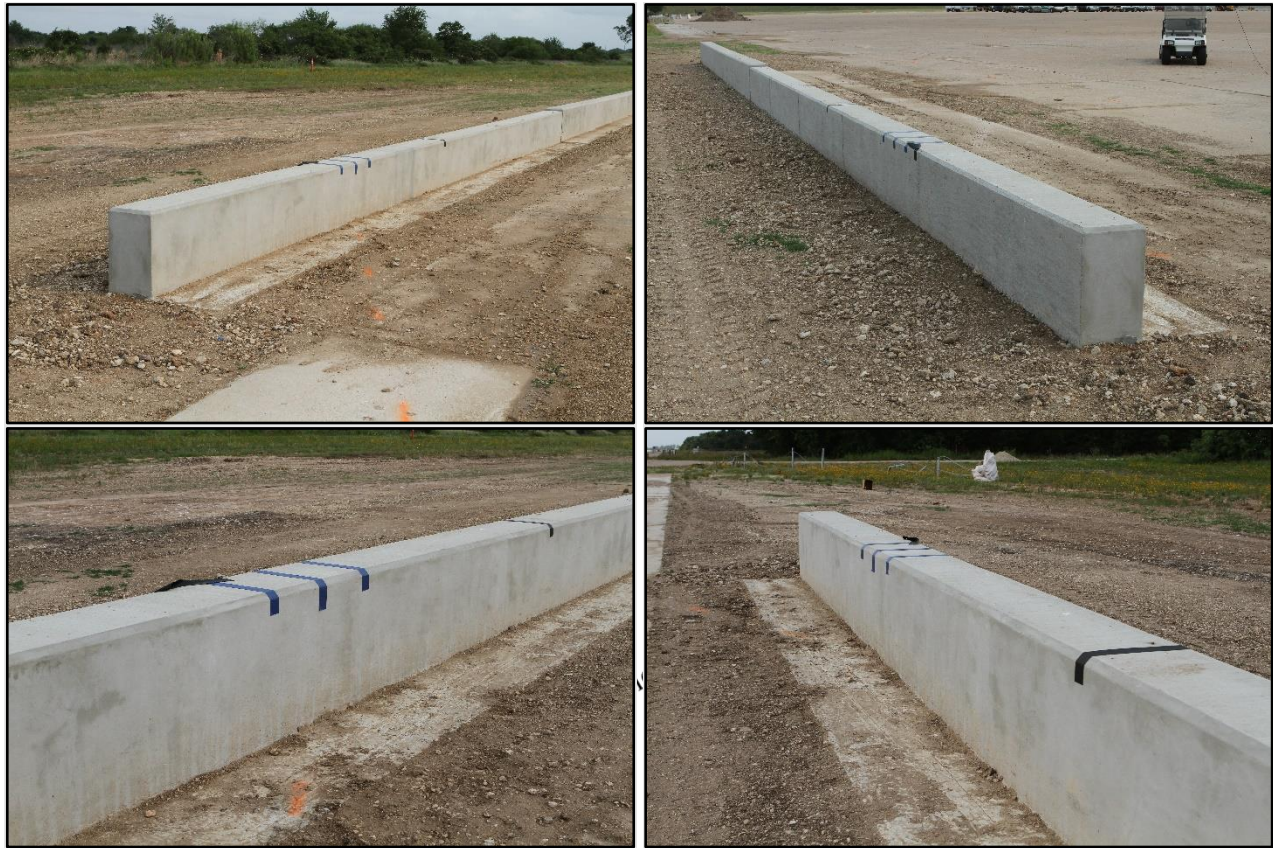
Figure 3.2 Permanent Low-Profile Barrier prior to Testing.

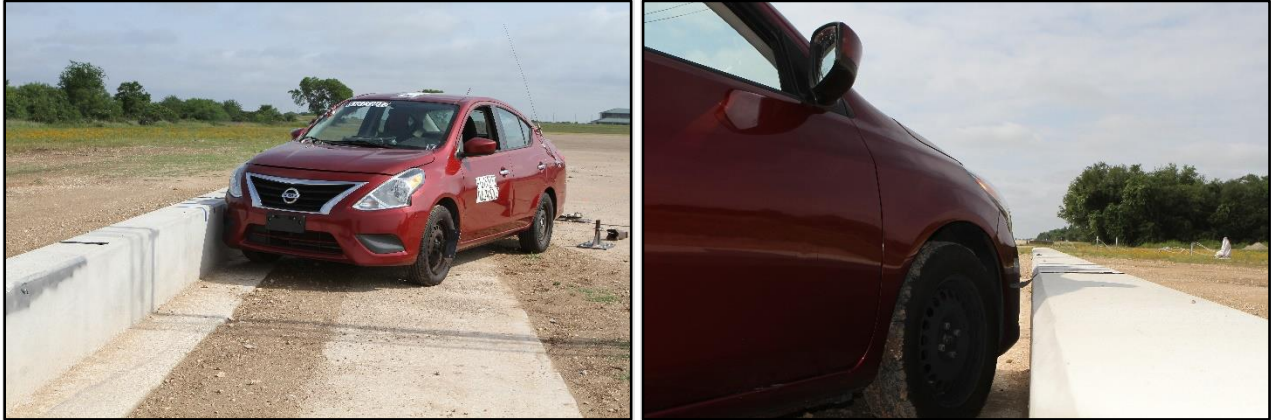
See Table 6.1 for details on *MASH* impact conditions for this test. Figure 6.1 depicts the target impact setup.

Figure 6.1 Permanent Low-Profile Barrier/Test Vehicle Geometrics for Test 616151-01-2.

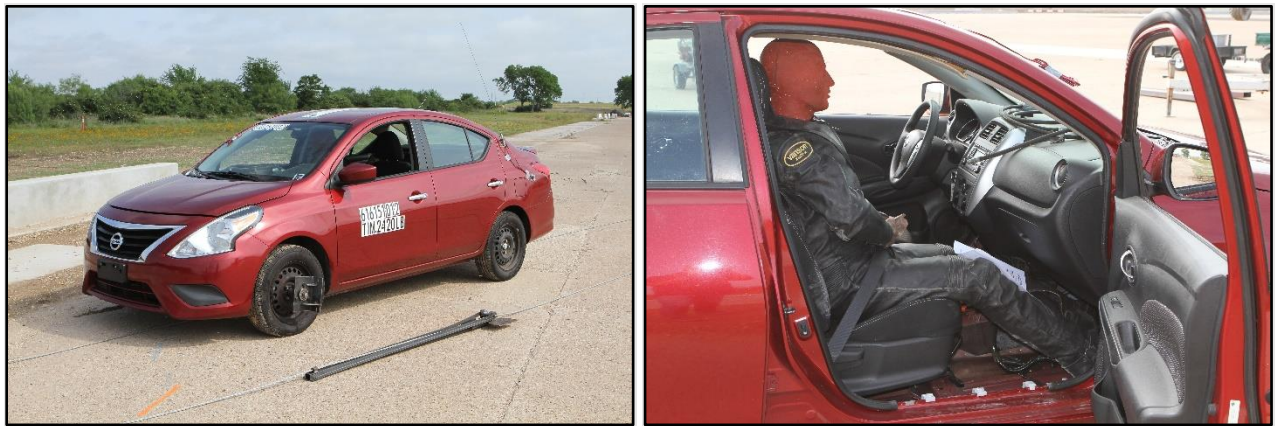
Figure 6.2 shows the 2017 Nissan Versa used for the crash test. Table 6.3 shows the vehicle measurements. Table C.1 in Appendix C.1 gives additional dimensions and information on the vehicle.

Figure 6.2 Test Vehicle before Test 616151-01-2.

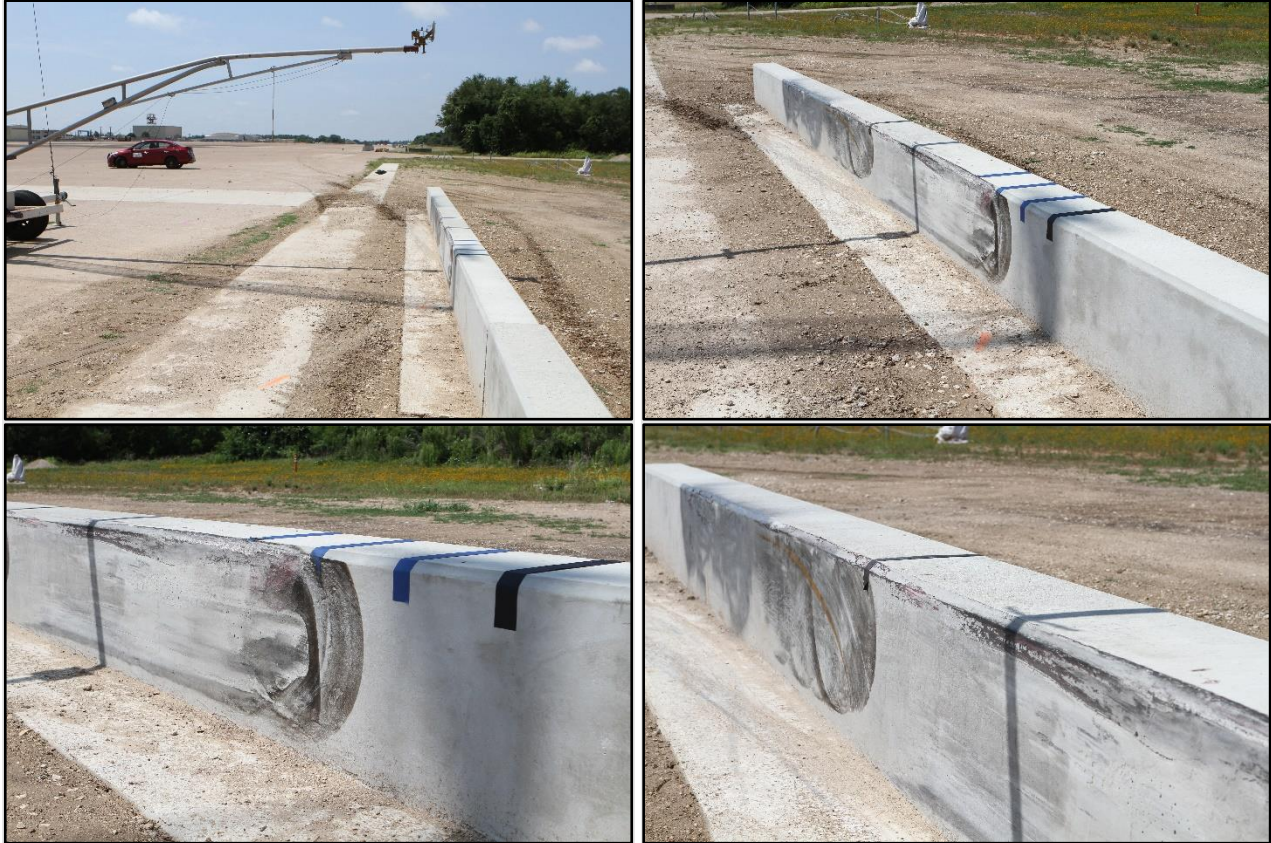
There was some scuffing and gouging at impact, and the soil was disturbed at the traffic side edge of the deck. No cracking or other damage to the installation was observed. Figure 6.3 shows the damage to the Permanent Low-Profile Barrier. Table 6.5 describes the damage to the Permanent Low-Profile Barrier.

Figure 6.3 Permanent Low-Profile Barrier after Test 616151-01-2.

Test Parameter	Measured
Permanent Deflection/Location	There was no permanent deflection
Dynamic Deflection	0.6 inches toward field side
Working Width* and Height	23.4 inches, at a height of 16.9 inches Front Passenger Side Headlight Unit

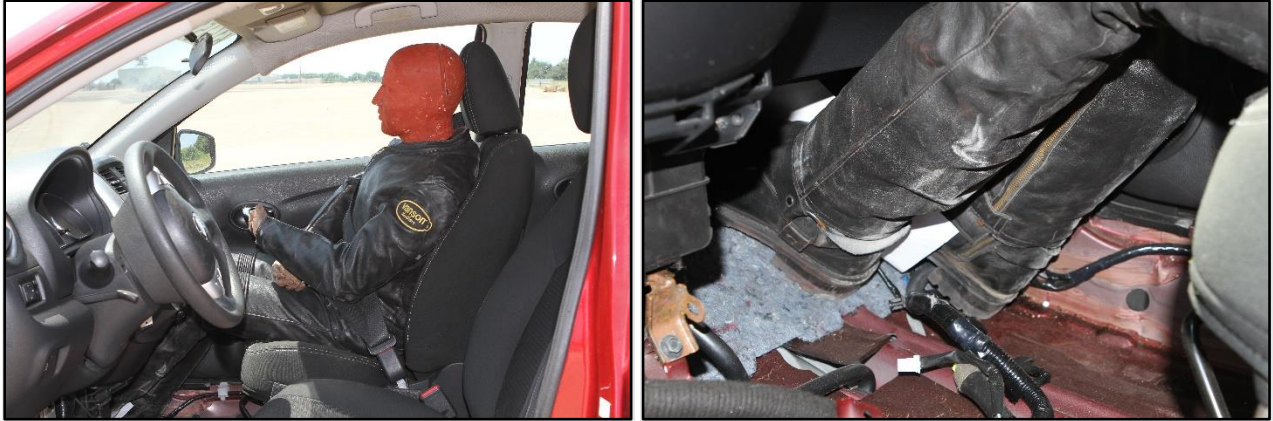
Figure 6.5 Interior of Test Vehicle after Test 616151-01-2.

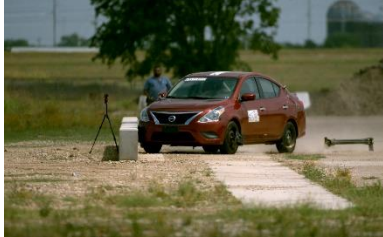
<p>0.000 s</p>	Test Agency		Texas A&M Transportation Institute (TTI)					
	Test Standard/Test No.		MASH 2016, Test 2-10					
	TTI Project No.		616151-01-2					
	Test Date		2022-05-23

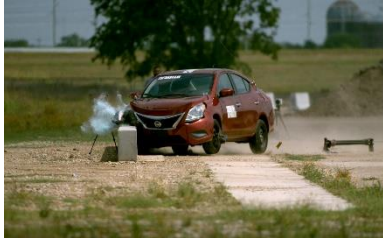
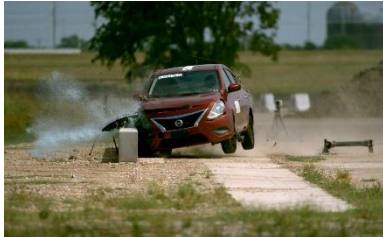
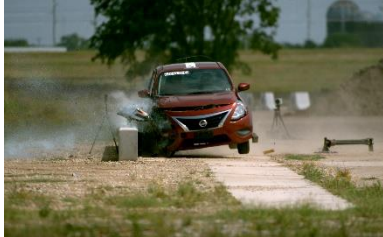
EXIT CONDITIONS								
Exit Speed (mi/h)		30.8						
Trajectory/Heading Angle (deg)		7.2 / 11.0						
Exit Box Criteria		Crossed						
Stopping Distance		92 feet downstream 52 feet to the traffic side						
TEST ARTICLE DEFLECTIONS								
Dynamic (inches)		0.6						
Permanent (inches)		None						
Working Width / Height (inches)		23.4 / 16.9						
VEHICLE DAMAGE								
VDS		11FRQ3						
CDC		11FREW3						
Max. Ext. Deformation		3 inches						
Max Occupant Compartment Deformation		1 inch in the right kick panel and above the seat.						
OCCUPANT RISK VALUES								
Long.OIV (ft/s)	20.4	Long. Ridedown (g)	1.9	Max 50ms Long. (g)	-10.6	Max Roll (deg)	29	
Lat. OIV (ft/s)	23.2	Lat. Ridedown (g)	3.8	Max 50ms Lat. (g)	-13.3	Max Pitch (deg)	5	
THIV (m/s)	9.4	ASI	1.9	Max 50ms Vert (g)	-2.7	Max Yaw (deg)	92

Figure 6.6 Summary of Results for MASH Test 2-10 on Permanent Low-Profile Barrier.

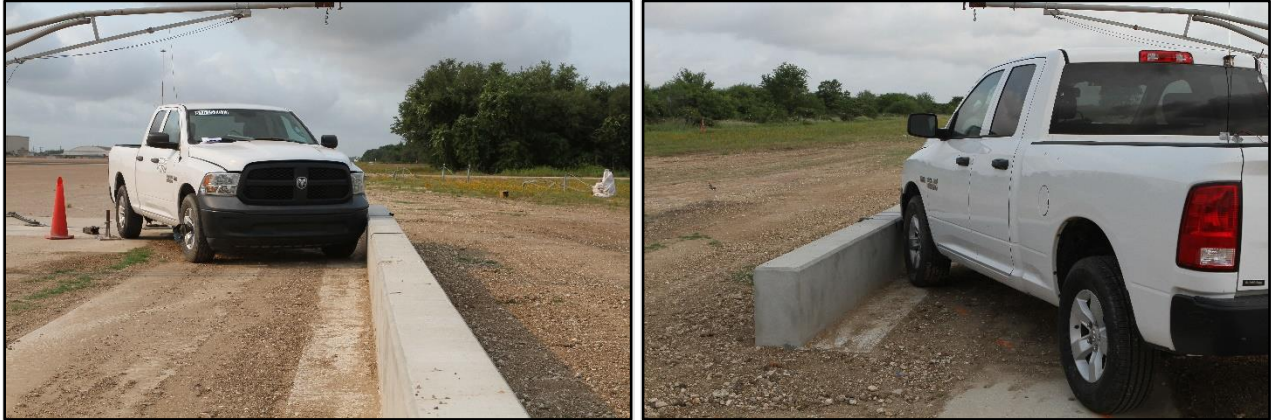
See Table 7.1 for details on *MASH* impact conditions for this test. Figure 7.1 depicts the target impact setup.

Figure 7.1 Permanent Low-Profile Barrier/Test Vehicle Geometrics for Test 616151-01-1.

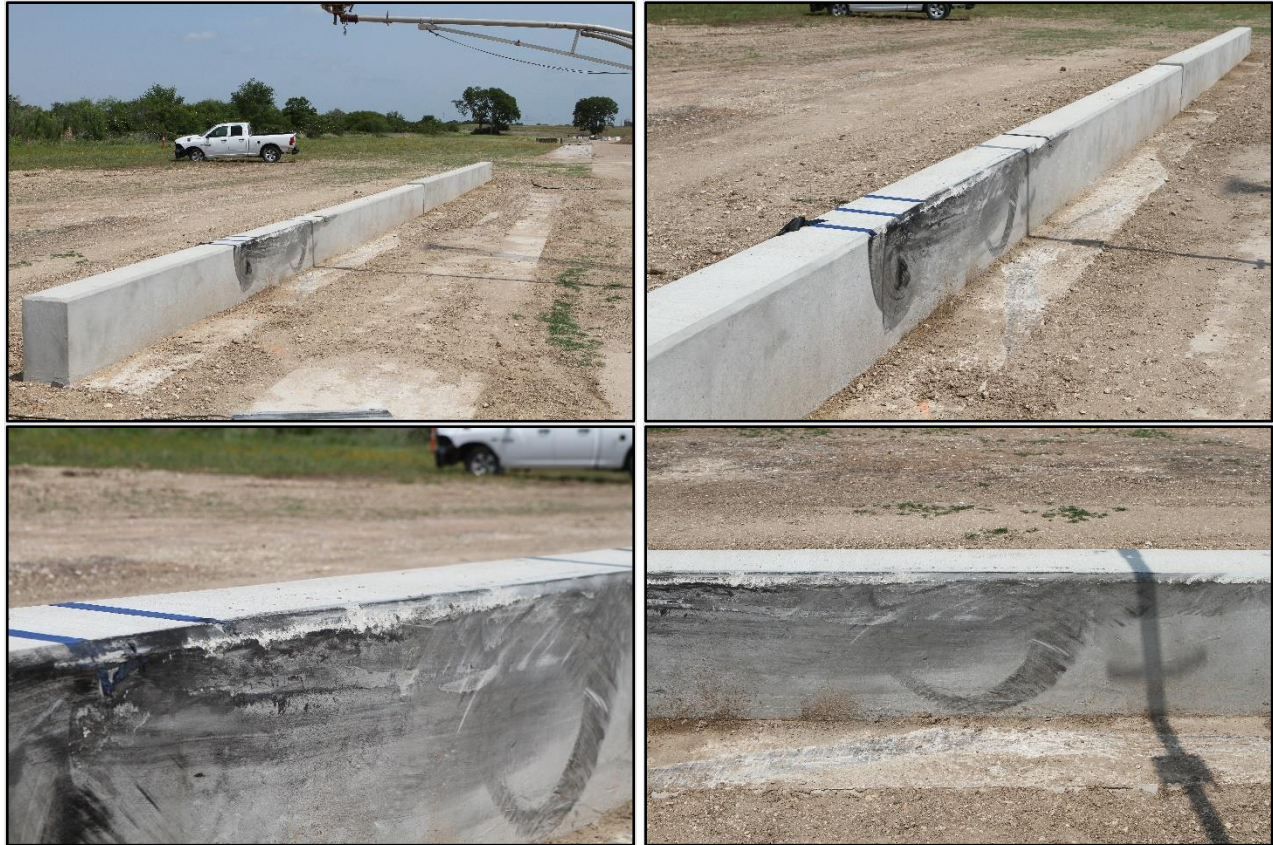
There was some scuffing and gouging at impact, and the soil was disturbed at the traffic side edge of the deck. No cracking or other damage to the installation was observed. Figure 7.3 shows the damage to the Permanent Low-Profile Barrier. Table 7.5 describes the damage to the Permanent Low-Profile Barrier.

Figure 7.3 Permanent Low-Profile Barrier after Test 616151-01-1.

Test Parameter	Measured
Permanent Deflection/Location	There was no permanent deflection
Dynamic Deflection	1.6 inches toward field side
Working Width* and Height	19.1 inches, at a height of 55.2 inches. Right front corner of truck.

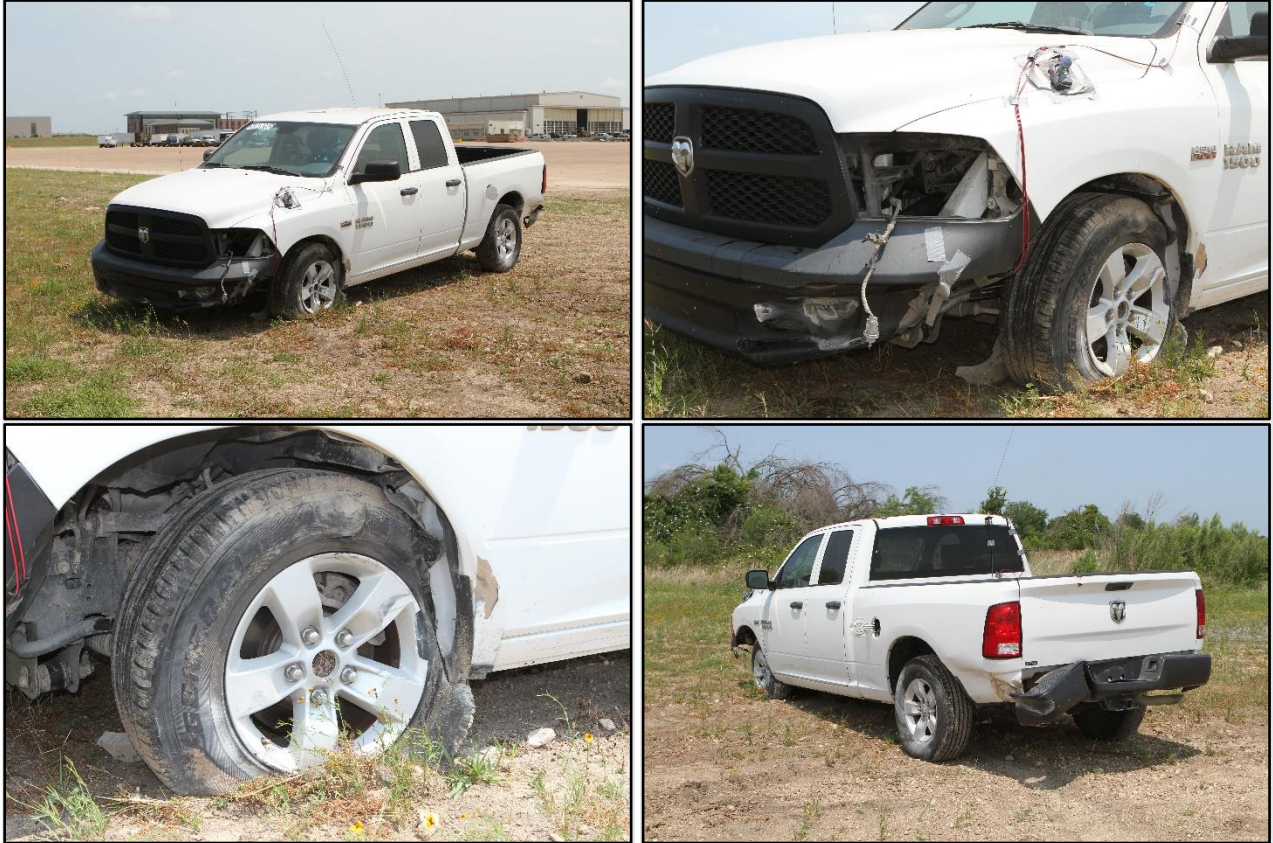
Figure 7.4 shows the damage sustained by the vehicle. Table 7.6 provides details on the interior and exterior damage to the vehicle. Tables C.2 and C.3 in Appendix C.1 provide exterior crush and occupant compartment measurements.

Figure 7.4 Test Vehicle after Test 616151-01-1.

Test Parameter		Specification	Measured
Roof		≤ 4.0 inches	0 inches
Windshield		≤ 3.0 inches	0 inches
A and B Pillars		≤ 5.0 overall / ≤ 3.0 inches lateral	0 inches
Foot Well/Toe Pan		≤ 9.0 inches	0 inches
Floor Pan/Transmission Tunnel		≤ 12.0 inches	0 inches
Side Front Panel		≤ 12.0 inches	0 inches
Front Door (above Seat)		≤ 9.0 inches	0 inches
Front Door (below Seat)		≤ 12.0 inches	0 inches
Side Windows		The side windows remained intact	
Maximum Exterior Deformation		14 inches in the front plane at the left front corner at bumper height	
VDS	11FLQ2	CDC	11FLEW2
Fuel Tank Damage		None	
Description of Damage to Vehicle:			
The front bumper, left headlight, left front tire and rim, left front quarter fender, left rear quarter fender and rear bumper were damaged.

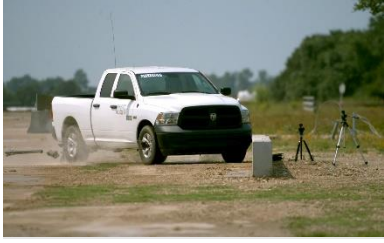
<p style="text-align: center;">0.000 s</p>	Test Agency	Texas A&M Transportation Institute (TTI)							
	Test Standard/Test No.	MASH 2016, Test 2-11							
	TTI Project No.	616151-01-1							
	Test Date	2022-05-19							
TEST ARTICLE									
		Type	Longitudinal Barrier						
		Name	TL-2 Permanent Low-Profile Concrete Barrier						
		Length	80 feet 2 inches						
		Key Materials	3400 PSI Concrete

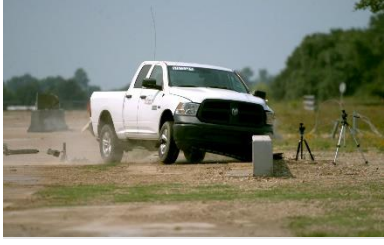
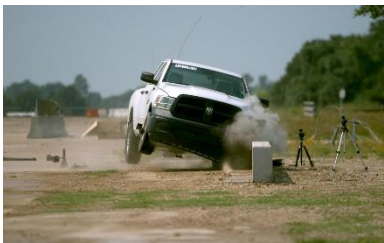
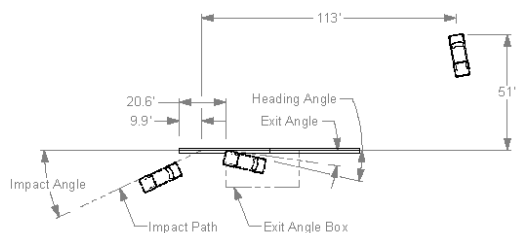
<p style="text-align: center;">0.200 s</p>	EXIT CONDITIONS								
			Exit Speed (mi/h)	38.8					
			Trajectory/Heading Angle (deg)	7.8 / 12.6					
			Exit Box Criteria	Did Not Cross Box					
		Stopping Distance	113 feet downstream 51 feet to the field side						
TEST ARTICLE DEFLECTIONS									
		Dynamic (inches)	1.6						
		Permanent (inches)	None						
		Working Width / Height (inches)	19.1 / 55.2						
VEHICLE DAMAGE									
		VDS	11FLQ2						
		CDC	11FLEW2						
		Max. Ext. Deformation	14 inches						
		Max Occupant Compartment Deformation	None						
OCCUPANT RISK VALUES									
Long. OIV (ft/s)	14.4	Long. Ridedown (g)	2.4	Max 50ms Long. (g)	-6.5	Max Roll (deg)	30		
Lat. OIV (ft/s)	20.6	Lat. Ridedown (g)	5.9	Max 50ms Lat. (g)	10.2	Max Pitch (deg)	20		
THIV (m/s)	7.7	ASI	1.3	Max 50ms Vert (g)	-2.0	Max Yaw (deg)	40

Figure 7.4 Summary of Results for MASH Test 2-11 on Permanent Low-Profile Barrier.

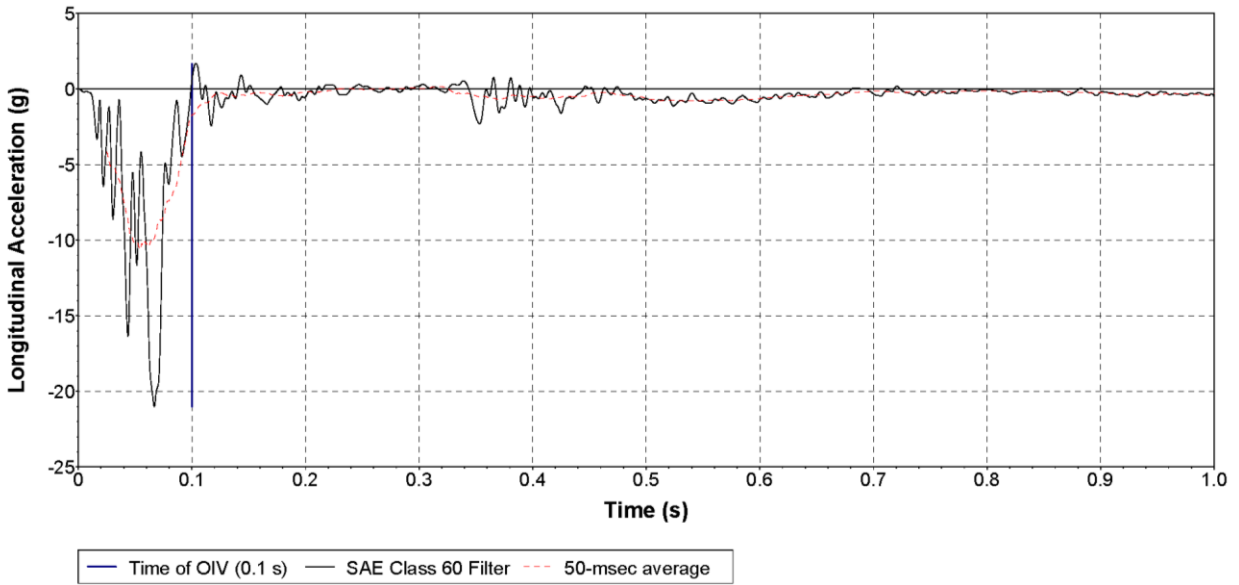
Figure C.4. Vehicle Longitudinal Accelerometer Trace for Test No. 616151-01-2 (Accelerometer Located at Center of Gravity).

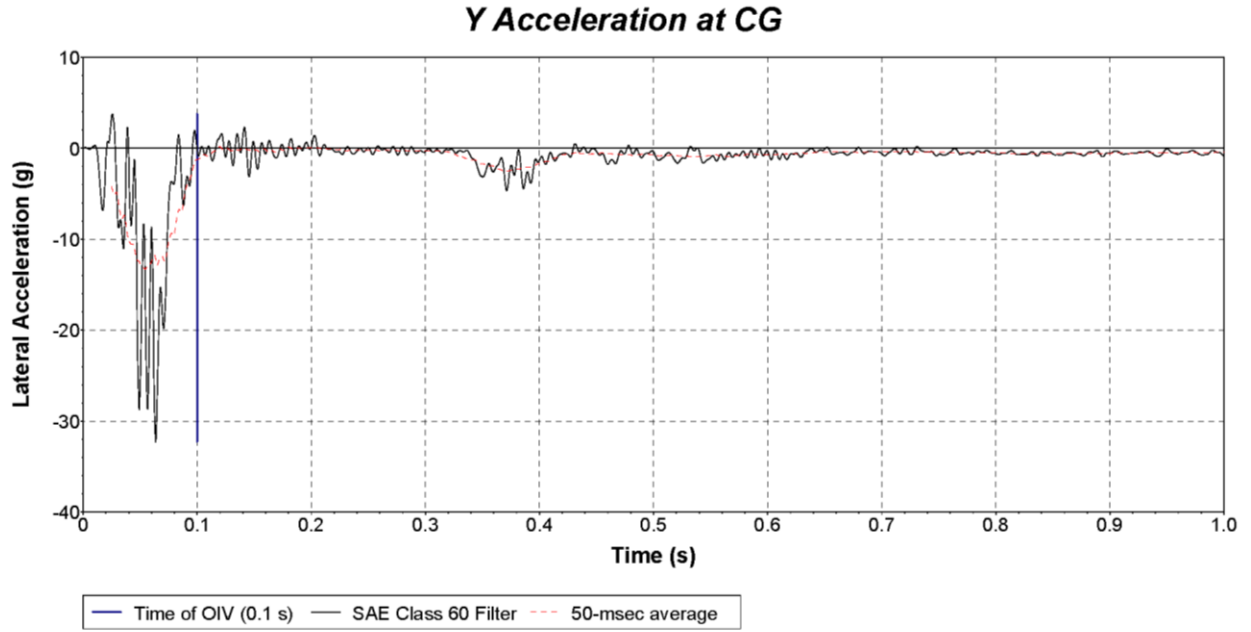
Figure C.5. Vehicle Lateral Accelerometer Trace for Test No. 616151-01-2 (Accelerometer Located at Center of Gravity).

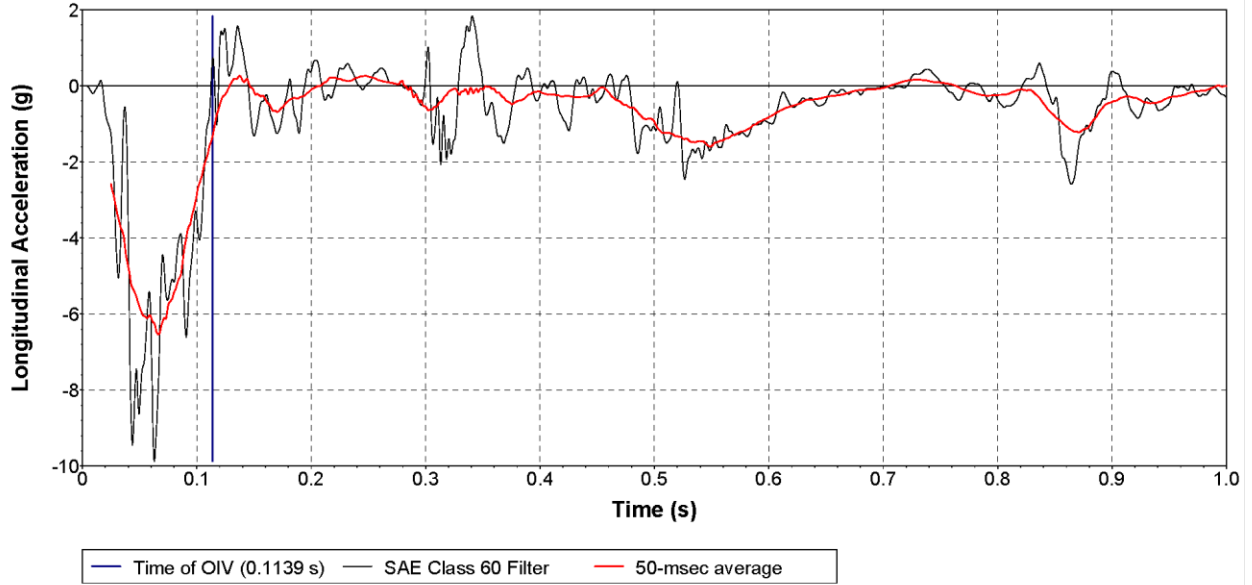
Figure D.4. Vehicle Longitudinal Accelerometer Trace for Test No. 616151-01-1 (Accelerometer Located at Center of Gravity).
