Test Report No. 610461-01-3&4
Test Report Date: April 2021

MASH TL-3 EVALUATION OF REDESIGNED BARRIER GAP RAIL

Contract No.: T-4541 CZ
Test Nos.: 610461-01-3 and 610461-01-4
Test Dates: 2021-04-07 and 2021-04-09

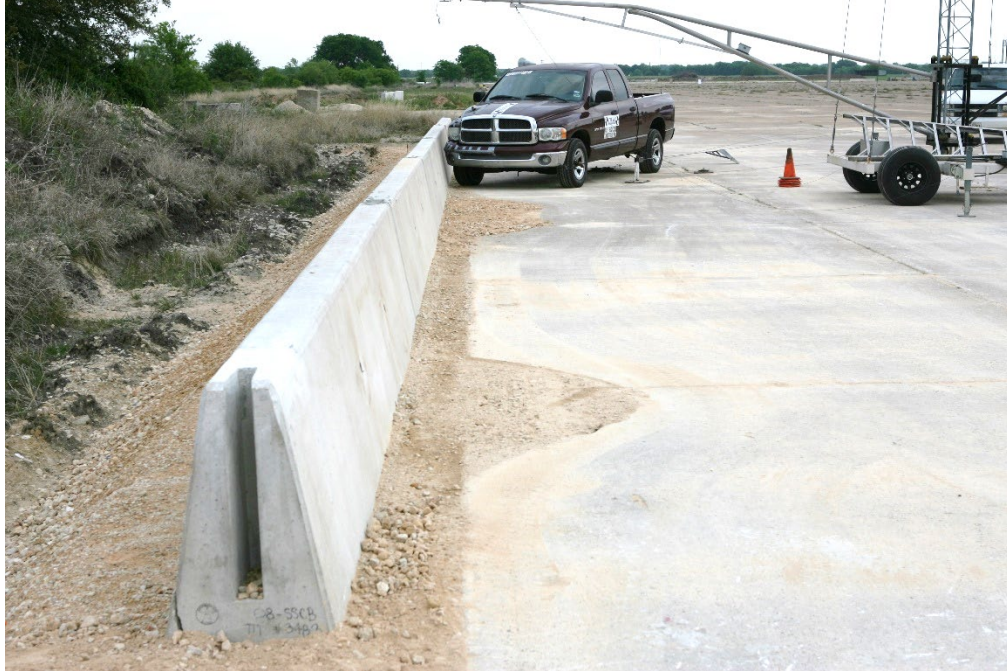
Figure 1.1. 32-inch Barrier with Steel Grid Slot Connection Embedded 10 inches.

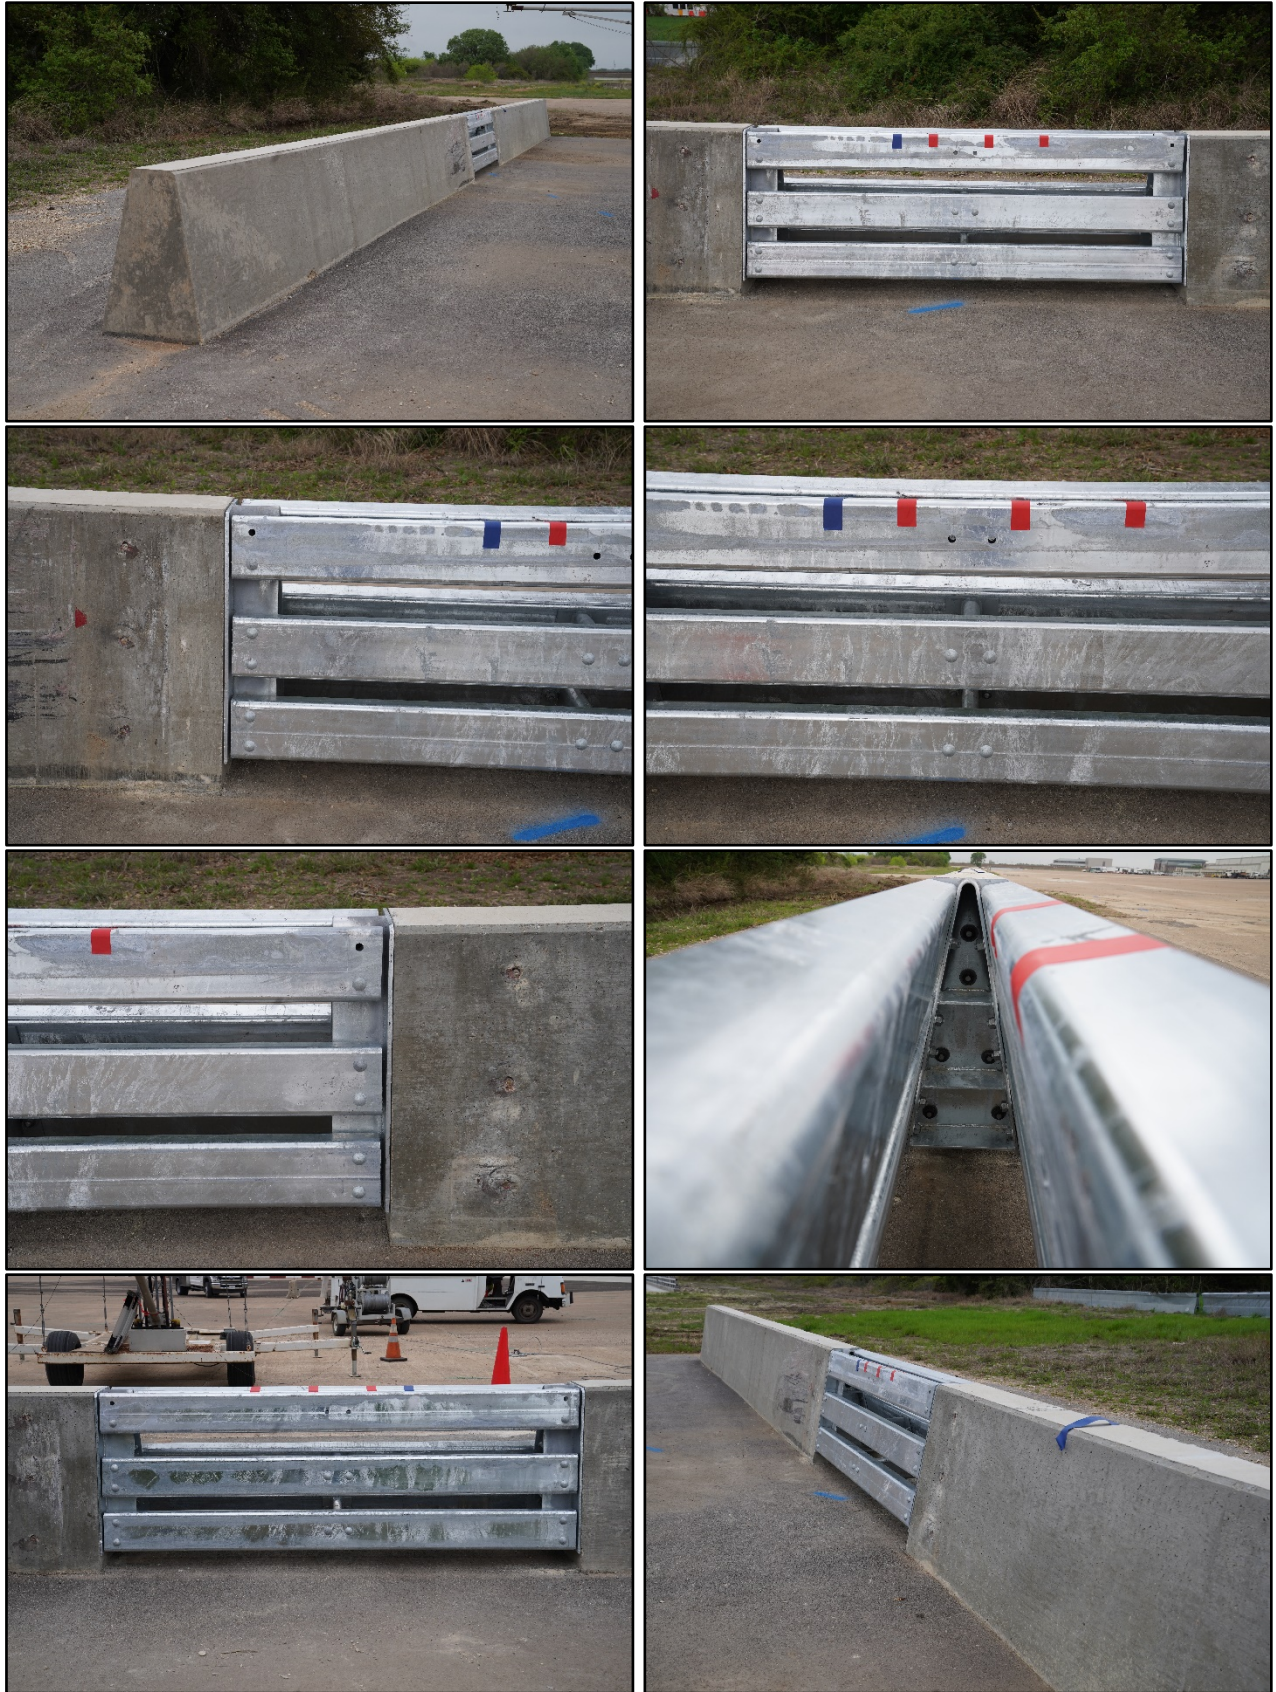
Figure 2.2. Redesigned Barrier Gap Rail prior to Testing.

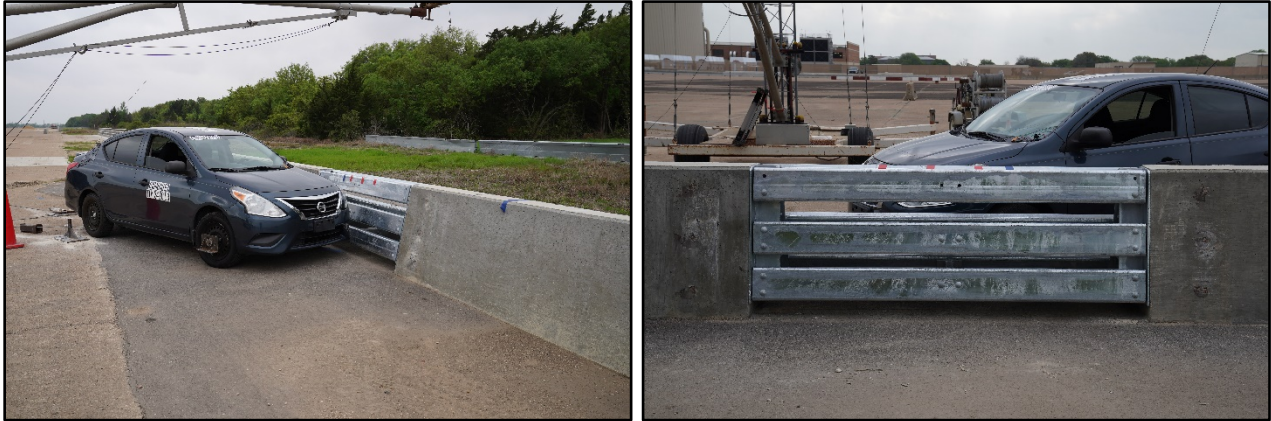
Figure 5.1. Redesigned Barrier Gap Rail/Test Vehicle Geometrics for Test No. 610461-01-3.

MASH Test 3-10 involves a 1100C vehicle weighing $2420 \text{ lb} \pm 55 \text{ lb}$ impacting the CIP of the longitudinal barrier at an impact speed of $62 \text{ mi/h} \pm 2.5 \text{ mi/h}$ and an angle of $25 \text{ degrees} \pm 1.5 \text{ degrees}$. The CIP for MASH Test 3-10 on the redesigned barrier gap rail was $3.6 \text{ ft} \pm 1 \text{ ft}$ upstream of the downstream barrier end. Figure 3.1 and Figure 5.1 depict the target impact setup.

The 1100C vehicle weighed 2425 lb, and the actual impact speed and angle were 62.5 mi/h and 24.5 degrees . The actual impact point was 3.0 ft upstream of the downstream barrier end. Minimum target impact severity (IS) was 51 kip-ft, and actual IS was 55 kip-ft.

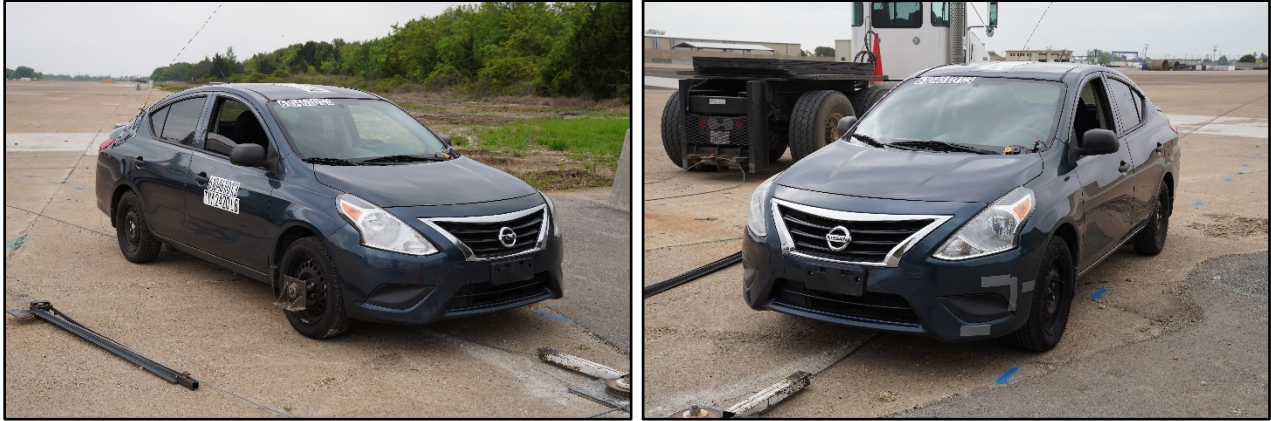
Figure 5.2. Test Vehicle before Test No. 610461-01-3.

Figure 5.2 shows the 2015 Nissan Versa used for the crash test. The vehicle's test inertia weight was 2425 lb, and its gross static weight was 2590 lb. The height to the lower edge of the vehicle bumper was 7.0 inches, and the height to the upper edge of the bumper was 22.25 inches. Table C.1 in Appendix C.1 gives additional dimensions and information on the vehicle. The vehicle was directed into the installation using a cable reverse tow and guidance system, and was released to be freewheeling and unrestrained just prior to impact.

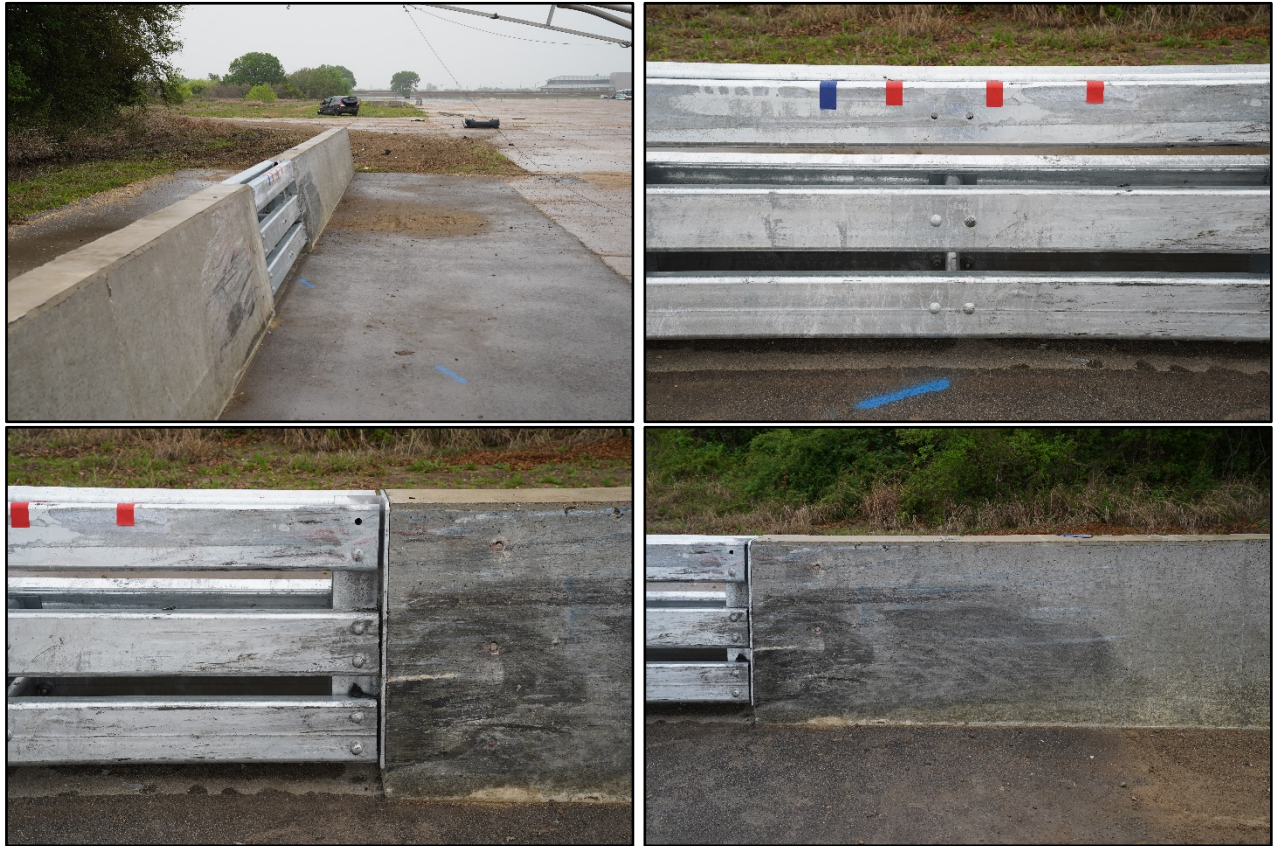
Figure 5.3. Redesigned Barrier Gap Rail after Test No. 610461-01-3.

Figure 5.3 shows the damage to the redesigned barrier gap rail. There was some scuffing downstream of the rails on the concrete barrier, and some small gouging on the downstream barrier at the middle rail connection. Working width* was 24.0 inches, and height of working

width was at the toe of the barrier. No dynamic deflection during the test or permanent deformation after the test was observed.

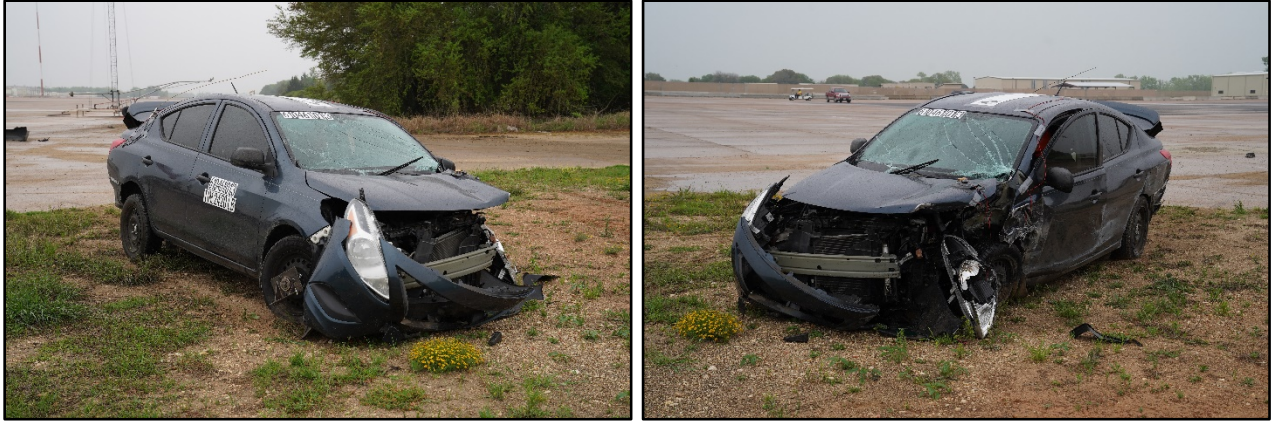
Figure 5.4. Test Vehicle after Test No. 610461-01-3.

Figure 5.4 shows the damage sustained by the vehicle. The front bumper, hood, grill, radiator and support, left front fender, left front strut and tower, left front tire and rim, left front A-pillar, left front corner of floor pan, left front and rear doors, left rear quarter panel, and rear bumper were damaged. The windshield sustained stress cracks radiating upward and inward from the left lower corner. No fuel tank damage was observed. Maximum exterior crush to the vehicle was 10.0 inches in the side plane at the left front corner at bumper height. Maximum occupant compartment deformation was 3.0 inches in the left front firewall area. Figure 5.5 shows the interior of the vehicle. Tables C.2 and C.3 in Appendix C.1 provide exterior crush and occupant compartment measurements.

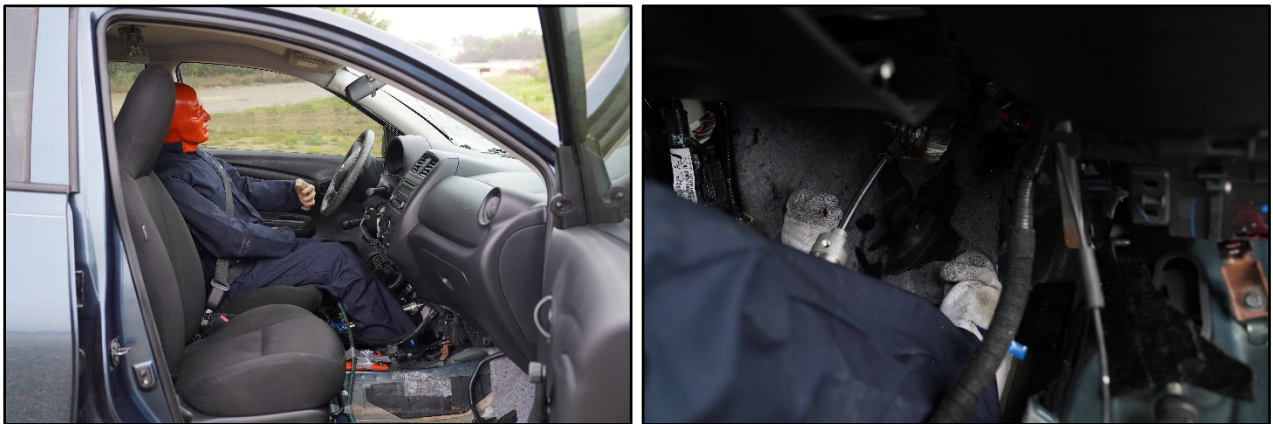
Figure 5.5. Interior of Test Vehicle after Test No. 610461-01-3.

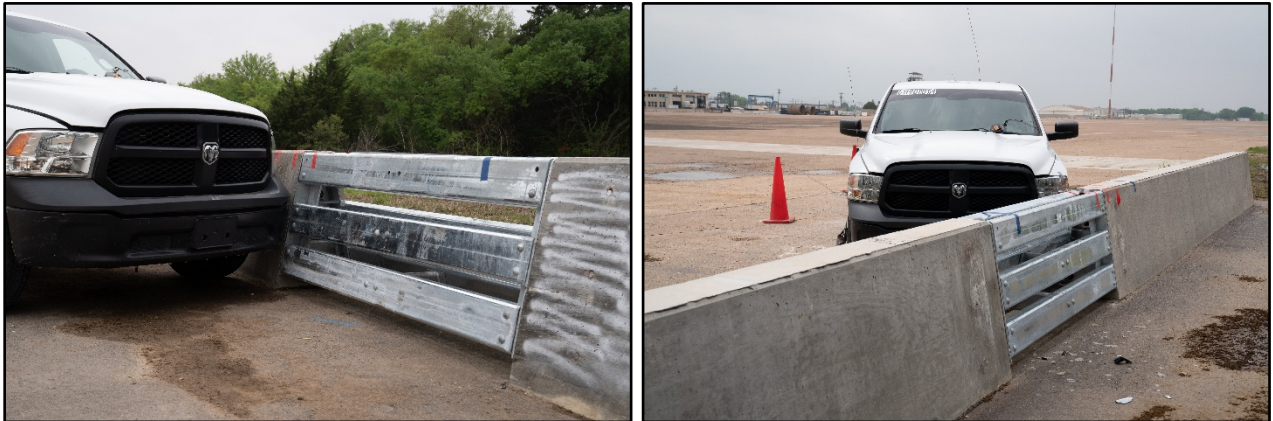
Figure 6.1. Redesigned Barrier Gap Rail/Test Vehicle Geometrics for Test No. 610461-01-4.

MASH Test 3-11 involves a 2270P vehicle weighing 5000 lb \pm 110 lb impacting the CIP of the longitudinal barrier at an impact speed of 62 mi/h \pm 2.5 mi/h and an angle of 25 degrees \pm 1.5 degrees. The CIP for MASH Test 3-11 on the redesigned barrier gap rail was 4.3 ft \pm 1 ft upstream of the centerline of the metal rail. Figure 3.1 and Figure 6.1 depict the target impact setup.

The 2270P vehicle weighed 5071 lb, and the actual impact speed and angle were 62.5 mi/h and 25.3 degrees. The actual impact point was 4.1 ft upstream of the centerline of the metal rail. Minimum target IS was 106 kip-ft, and actual IS was 121 kip-ft.

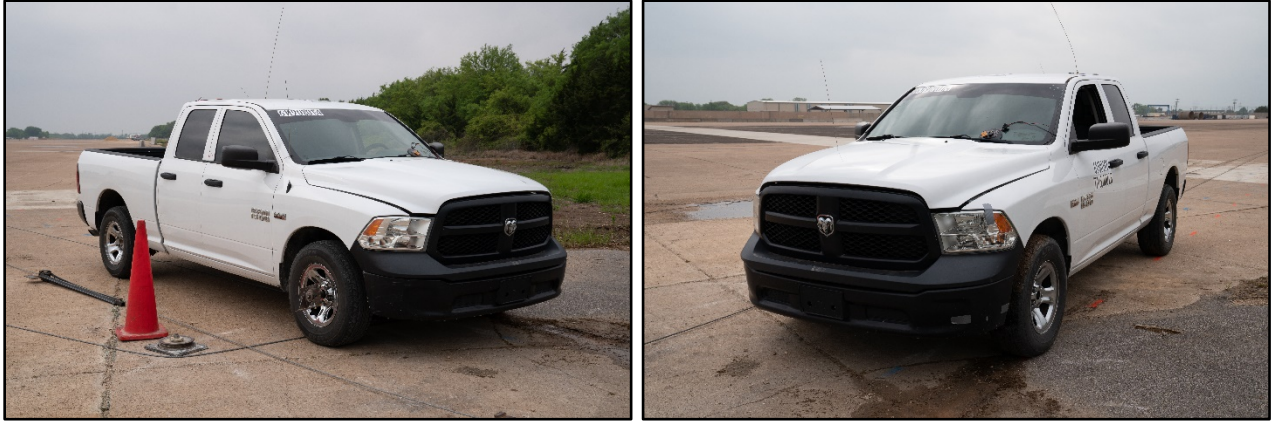
Figure 6.2. Test Vehicle before Test No. 610461-01-4.

Figure 6.2 shows the 2016 RAM 1500 pickup truck used for the crash test. The vehicle's test inertia weight was 5071 lb, and its gross static weight was 5236 lb. The height to the lower edge of the vehicle bumper was 11.75 inches, and height to the upper edge of the bumper was 27.0 inches. The height to the vehicle's center of gravity was 28.25 inches. Tables D.1 and D.2 in Appendix D.1 give additional dimensions and information on the vehicle. The vehicle was directed into the installation using a cable reverse tow and guidance system and was released to be freewheeling and unrestrained just prior to impact.

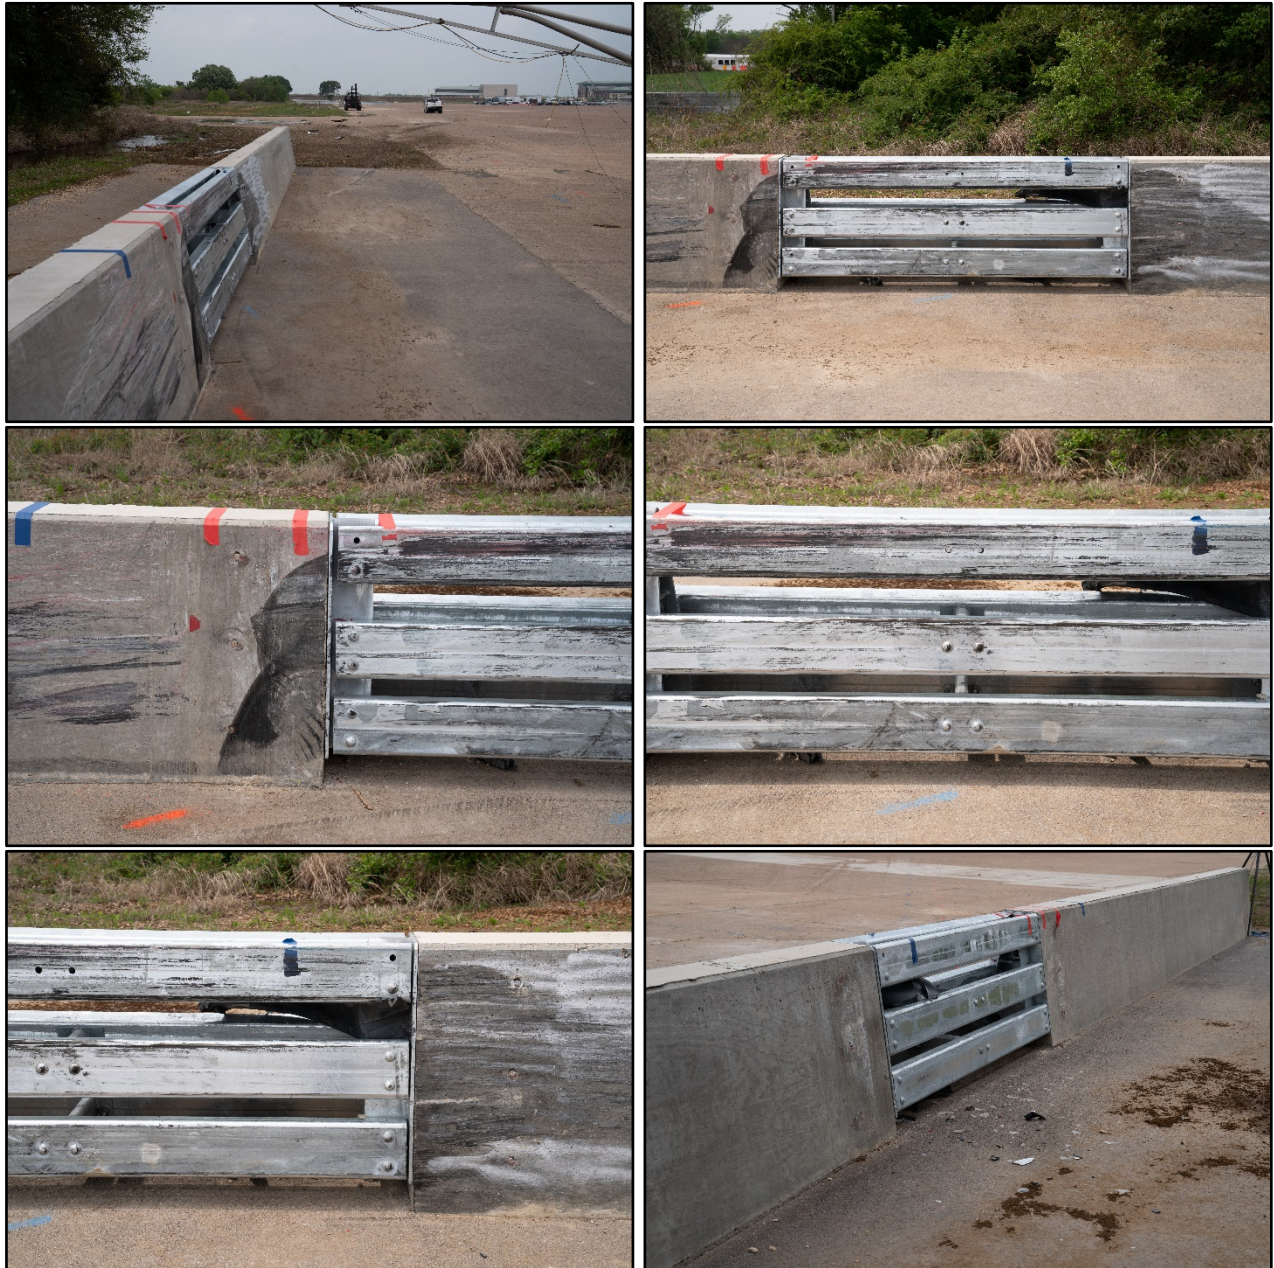
Figure 6.3. Redesigned Barrier Gap Rail after Test No. 610461-01-4.

Figure 6.3 shows the damage to the redesigned barrier gap rail. There was some scuffing of the barrier at impact, and along the rails until loss of contact at the second barrier. Working width* was 24.0 inches, and height of working width was at the toe of the barrier. Maximum

dynamic deflection during the test was 1.0 inches in the metal rail, and no permanent deformation was after the test was observed.

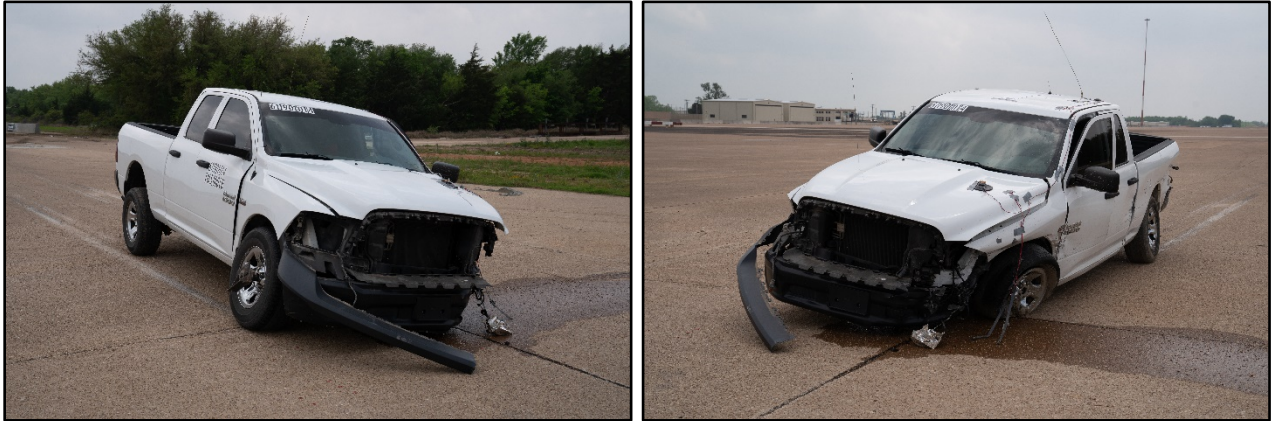
Figure 6.4. Test Vehicle after Test No. 610461-01-4.

Figure 6.4 shows the damage sustained by the vehicle. The front bumper, hood, grill, left front fender, left front tire and rim, left front and rear doors, left front floor pan, left rear cab corner, left rear exterior bed, and left rim were damaged. The windshield sustained stress cracks radiating upward and inward from the left lower corner. No fuel tank damage was observed.

Maximum exterior crush to the vehicle was 10.0 inches in the front plane at the left front corner at bumper height. Maximum occupant compartment deformation was 3.5 inches in the left front firewall area. Figure 6.5 shows the interior of the vehicle. Tables D.3 and D.4 in Appendix D.1 provide exterior crush and occupant compartment measurements.

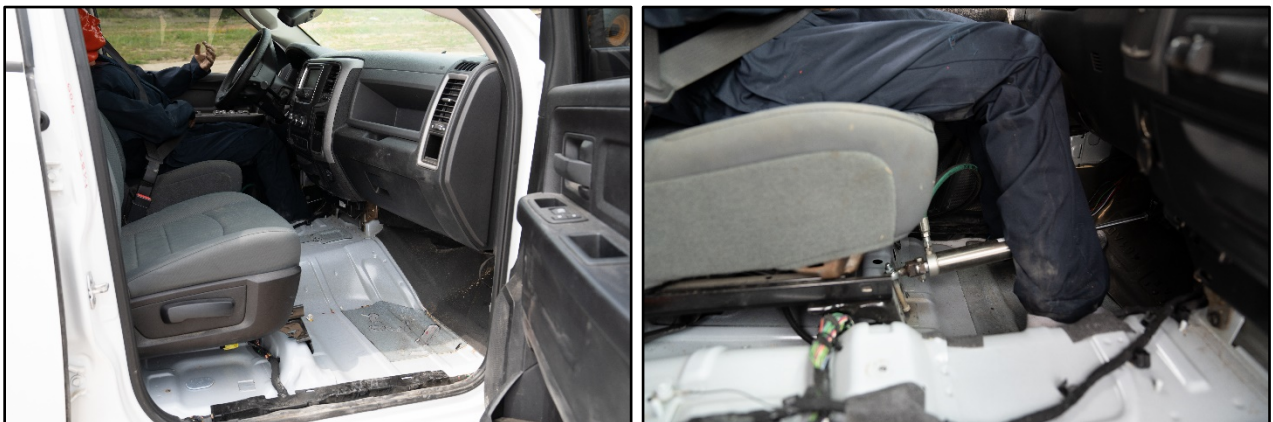
Figure 6.5. Interior of Test Vehicle after Test No. 610461-01-4.

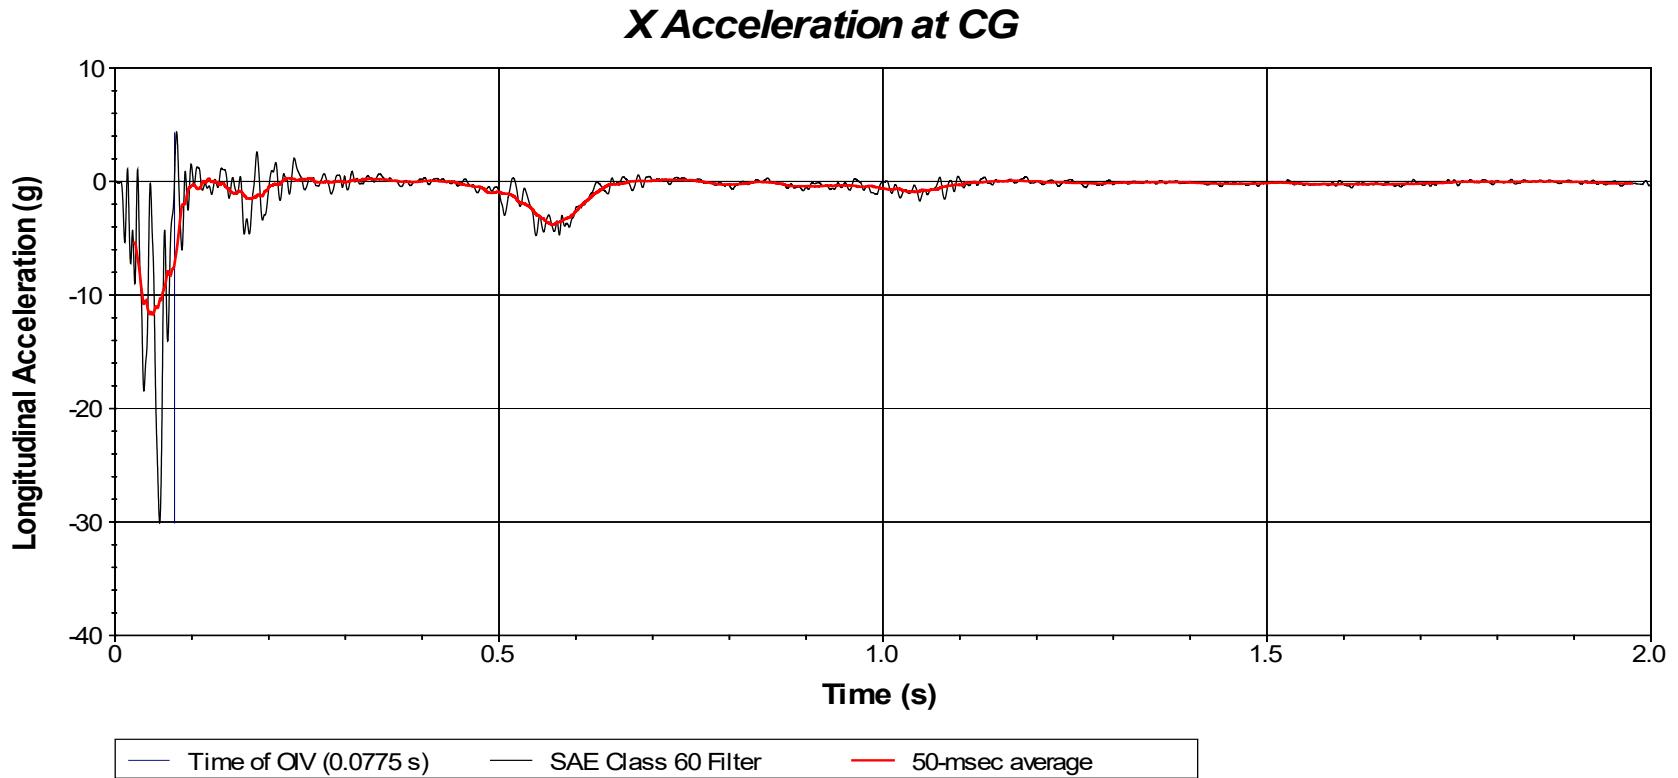
Test Number: 610461-01-3
 Test Standard Test Number: *MASH* Test 3-10
 Test Article: Redesigned Barrier Gap Rail
 Test Vehicle: 2015 Nissan Versa
 Inertial Mass: 2425 lb
 Gross Mass: 2590 lb
 Impact Speed: 62.5 mi/h
 Impact Angle: 24.5 degrees

**Figure C.4. Vehicle Longitudinal Accelerometer Trace for Test No. 610461-01-3
(Accelerometer Located at Center of Gravity).**

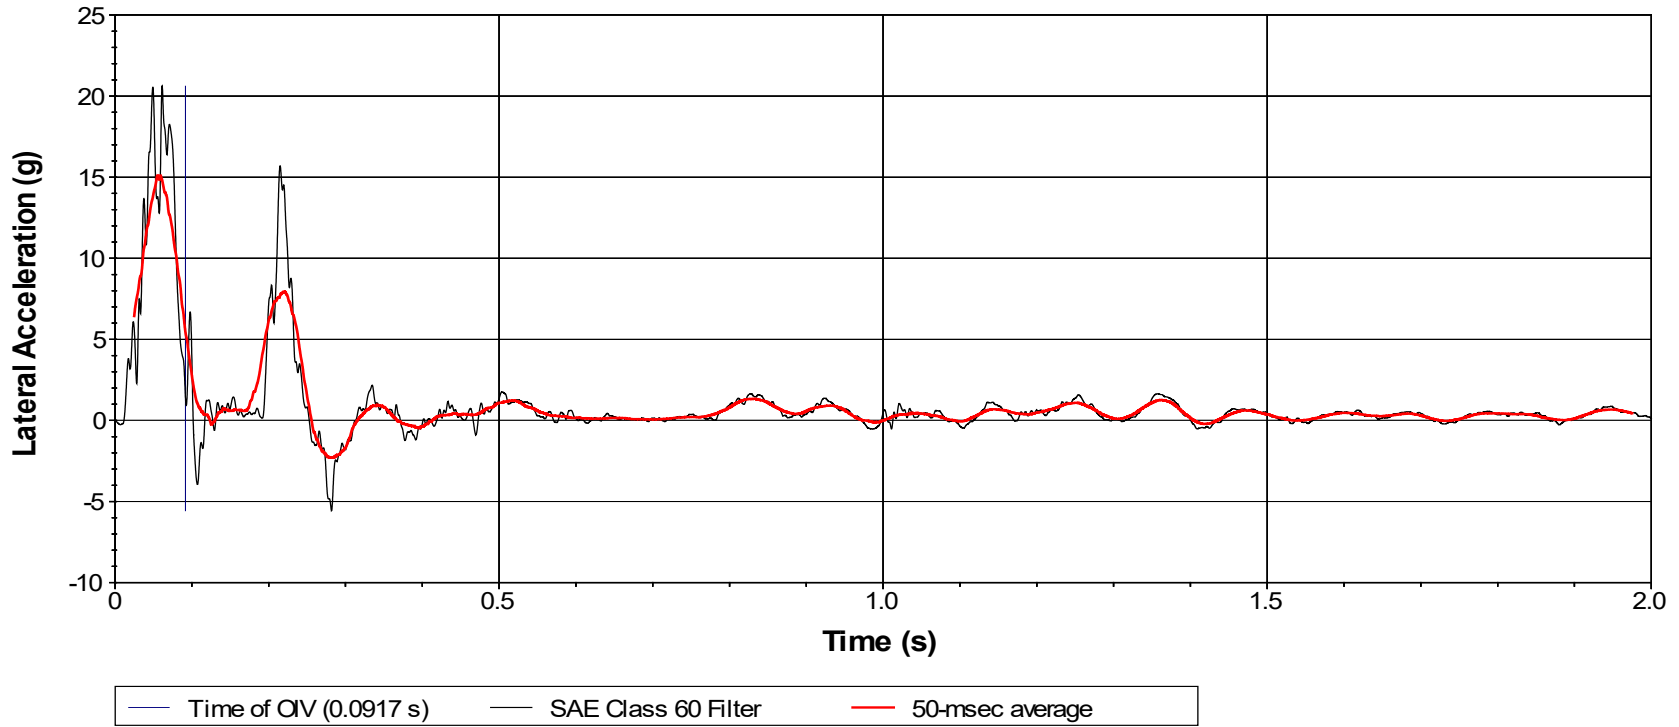
Test Number: 610461-01-4
 Test Standard Test Number: MASH Test 3-11
 Test Article: Redesigned Barrier Gap Rail
 Test Vehicle: 2016 RAM 1500 Pickup
 Inertial Mass: 5071 lb
 Gross Mass: 5236 lb
 Impact Speed: 62.5 mi/h
 Impact Angle: 25.3 degrees

Figure D.5. Vehicle Lateral Accelerometer Trace for Test No. 610461-01-4 (Accelerometer Located at Center of Gravity).
