Midwest Guardrail System for Long-Span Culvert Applications

MIDWEST ROADSIDE SAFETY FACILITY

MwRSF Research Report No. TRP-03-187-07

November 16, 2007

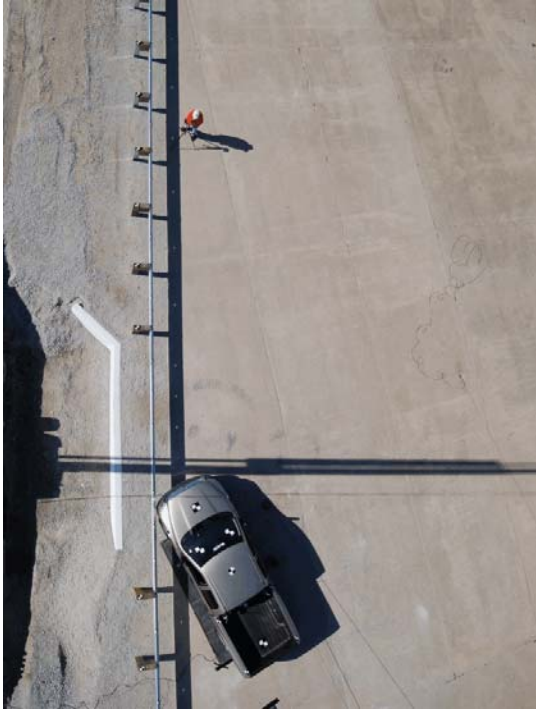
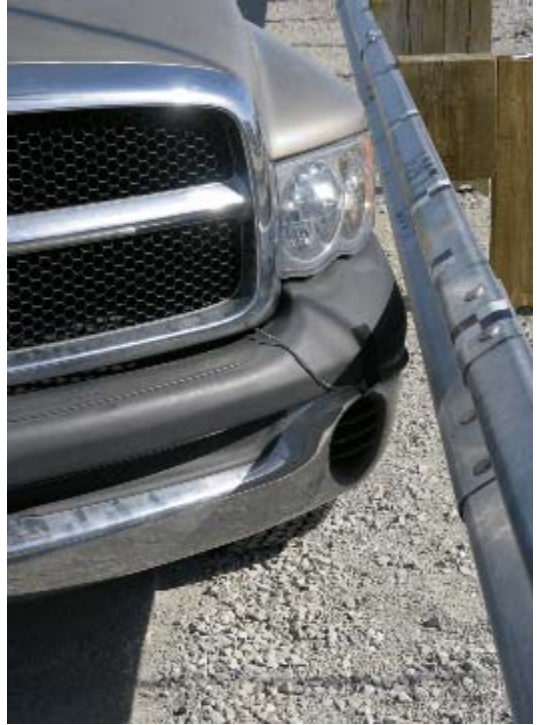
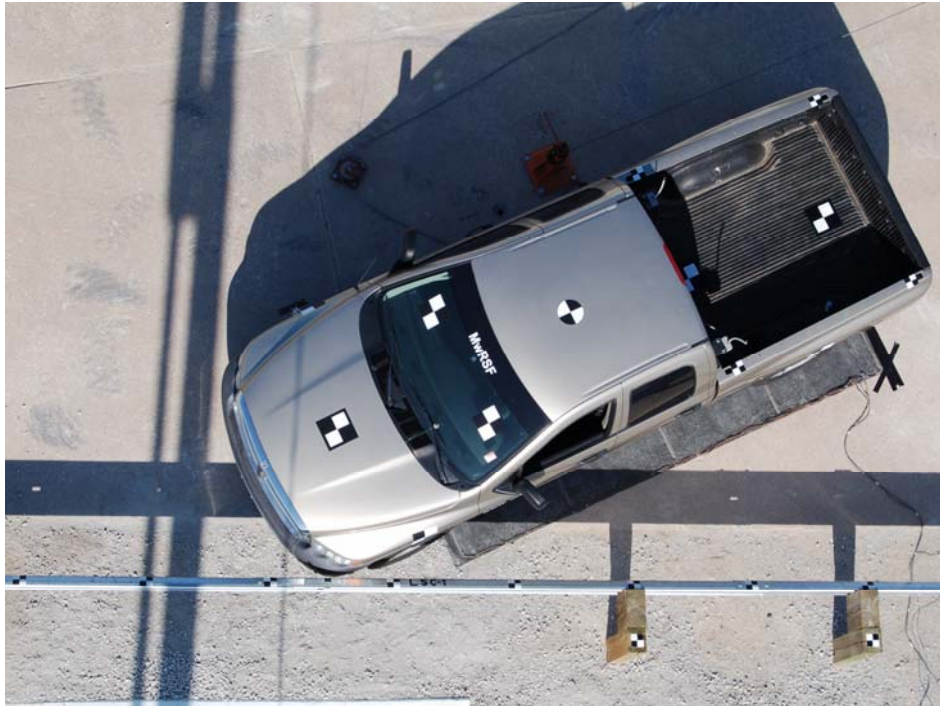
Figure 29. Impact Location, Test No. LSC-1

Initial vehicle impact was to occur between post nos. 13 and 14, or 2.44 m (8 ft) downstream from post no. 13, as shown in Figure 29. Actual vehicle impact occurred 2.44 m (8.0 ft) downstream from the centerline of post no. 13. By 0.054 sec, the left-front corner of the pickup truck had reached the center of the unsupported rail section and deflected the guardrail backward. At 0.108 sec, the first CRT post downstream of the unsupported rail fractured before the truck reached it, thereby reducing snag. At 0.156 sec, the left-front tire had rolled off of the culvert headwall, and post no. 14 had fractured at its base as the pickup truck continued to redirect. At 0.212 sec, the left-front tire contacted the top of the culvert wingwall. At 0.364 sec after impact, the vehicle became parallel to the guardrail with a speed of 73.4 km/h (45.6 mph), and post nos. 15 and 16 had fractured at the base. The vehicle continued to redirect until it exited the system at 1.334 sec with a speed of 56.7 km/hr (35.2 mph) and at an angle of 1 degree. The pickup exited the guardrail in a stable manner and came to rest 31.14-m (102.17-ft) downstream

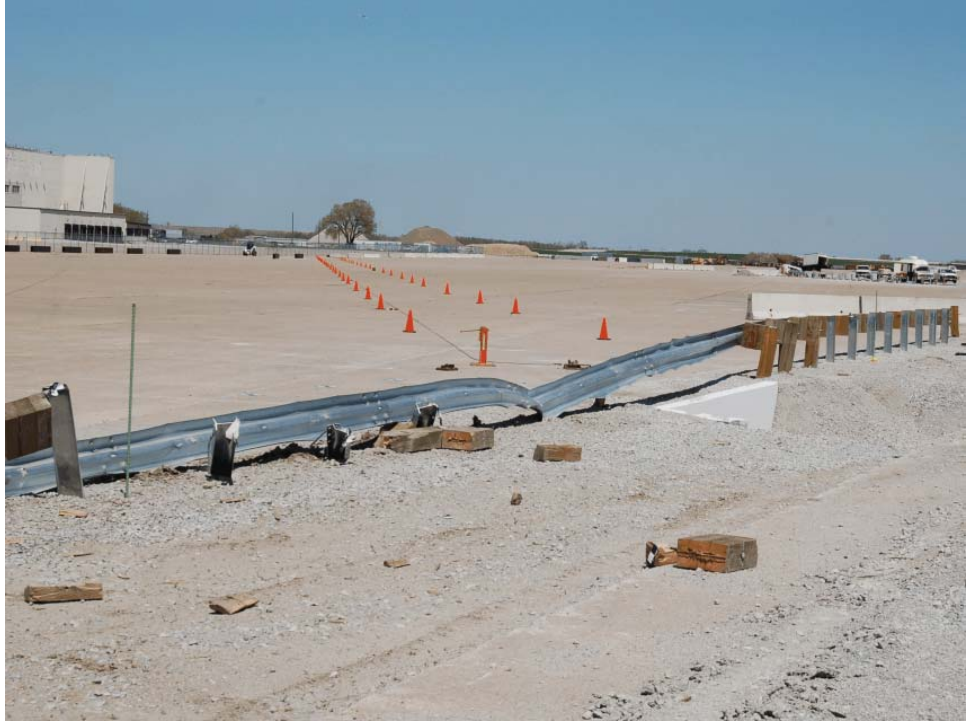
Figure 32. System Overall Damage, Test No. LSC-1

As shown in Figures 32 through 36, damage to the barrier was moderate, consisting mostly of deformed W-beam, contact marks on a guardrail section, and deformed and fractured guardrail posts. The W-beam damage consisted of contact marks and deformation and flattening of the impacted section between post nos. 13 and 20. No indications of rail rupture or tearing were visible on the W-beam. The W-beam rail was pulled off of post nos. 2 through 9. Three CRT posts, post nos. 14 through 16, were completely fractured, while CRT post nos. 12 and 13 were rotated backward. Steel post nos. 17 through 20 were bent and deformed backward and downstream. Neither significant post damage nor deformations occurred to the remaining posts in the system. The maximum lateral permanent set rail deflection was approximately 724 mm (28.5 in.), 1,905 mm (75 in.) upstream of post no. 14, as measured in the field. The maximum lateral dynamic post and rail deflections were 1,205 mm (47.4 in.) at post no. 16 and 2,343 mm (92.24 in) at the centerline of post no. 15, respectively, as determined from the high-speed video analysis. The working width of the system was 2,373 mm (93.43 in.), as determined from the high-speed film analysis.

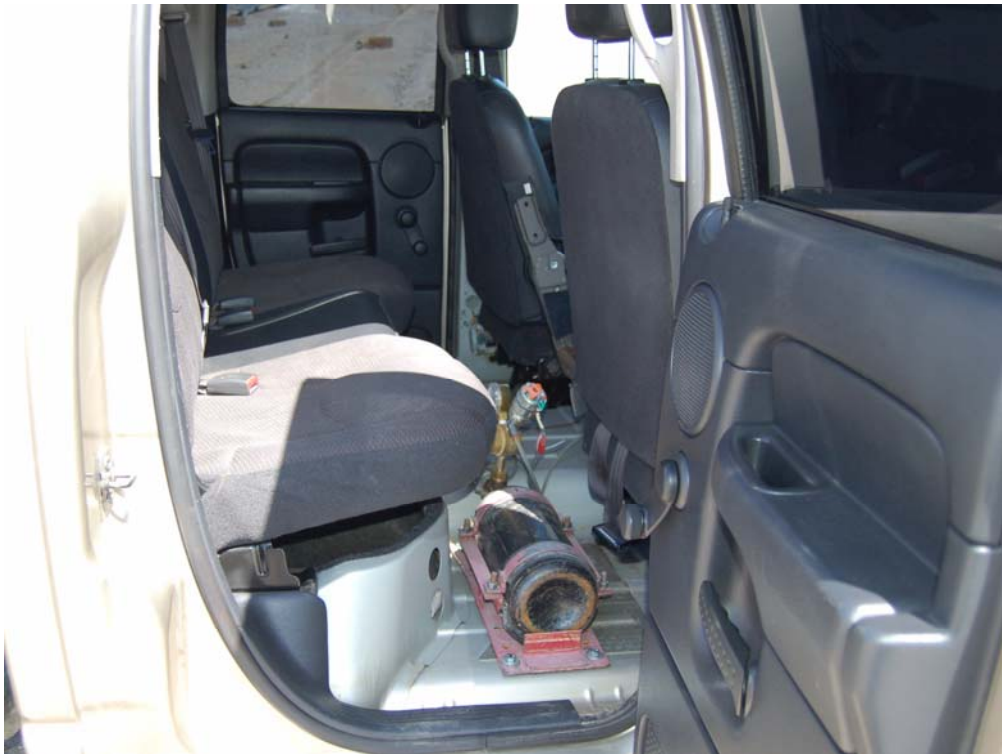
Figure 39. Occupant Compartment Deformation, Test No. LSC-1

inflated. Some deformation and damage were noted on the left-front suspension components. Contact marks and minor deformation were found along most of the lower-left side of the pickup truck. The left-rear quarter panel and the left corner of the rear bumper were dented as well. The left-rear taillight was disengaged from its housing. Interior occupant compartment damage was minimal, as shown in Figure 39 with a maximum vertical deformation of 19 mm (0.75 in.) measured near the right side of the driver-side footwell on the floorpan.

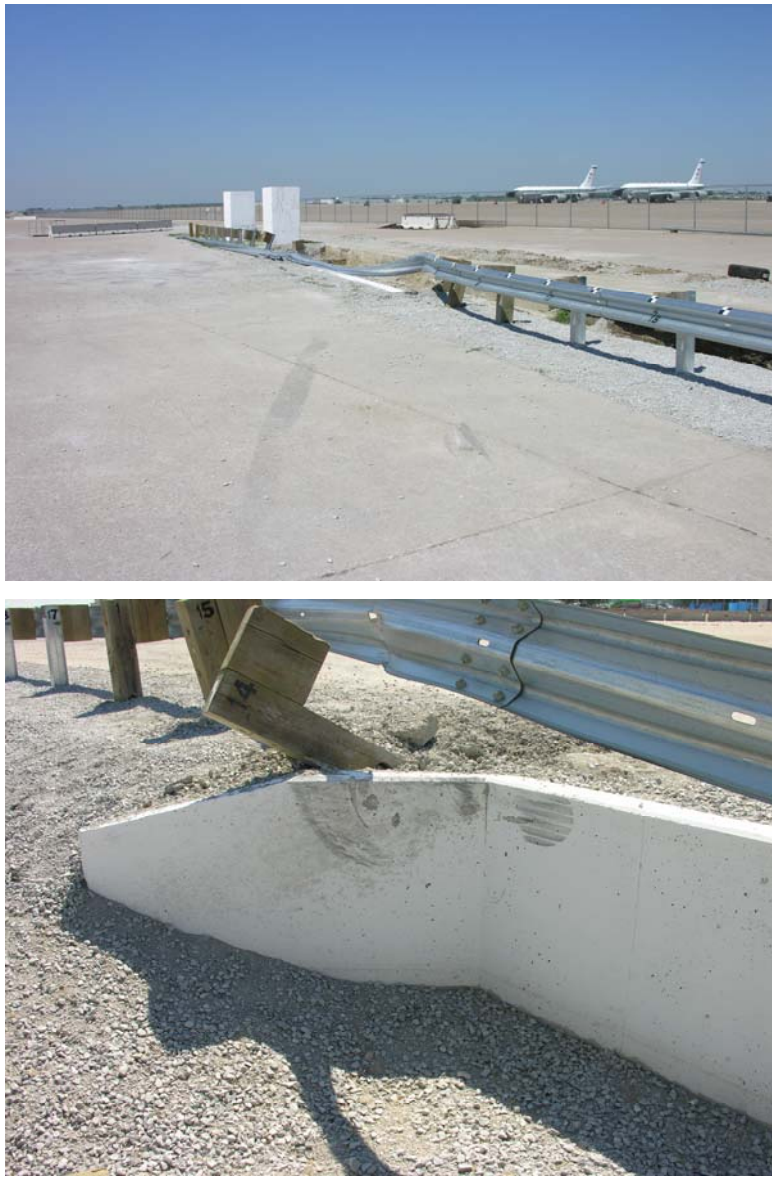
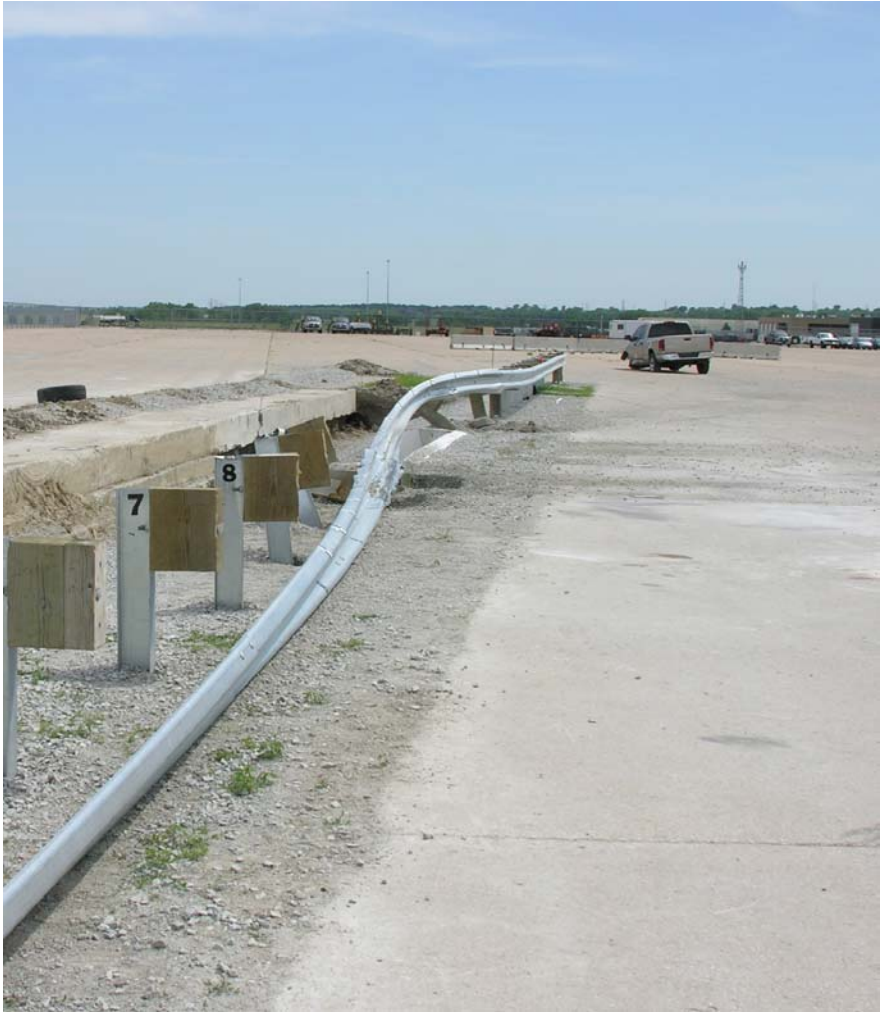
Figure 57. Trajectory and Final Position, Test No. LSC-2

Initial vehicle impact was to occur between post nos. 10 and 11, or 12.67 m (41.6 ft) upstream from the centerline of post no. 14, as shown in Figure 56. Actual vehicle impact occurred 12.57 m (41.24 ft) upstream from the centerline of post no. 14. By 0.170 sec, the pickup truck had moved downstream and began redirecting which caused post nos. 11 through 13 to deflect backward and post no. 13 to fracture at its base. At 0.252 sec, the left-front tire rolled off of the culvert wingwall, and the pickup truck continued to redirect. At 0.368 sec after impact, the vehicle became parallel to the guardrail with a speed of 77.6 km/h (48.2 mph), and the left-front quarter panel and left-front wheel of the vehicle continued to drop vertically into the area behind the culvert. The pickup continued to redirect with both the left-front and left-rear tires extended over the edge of the culvert. At 0.470 sec, the left-front tire contacted the side of the downstream culvert wingwall, causing the left-front wheel to completely disengage from the vehicle suspension and steering. The vehicle continued to redirect in a stable manner after the disengagement of the left-front wheel until it exited the system at 0.992 sec with a speed of 54.3

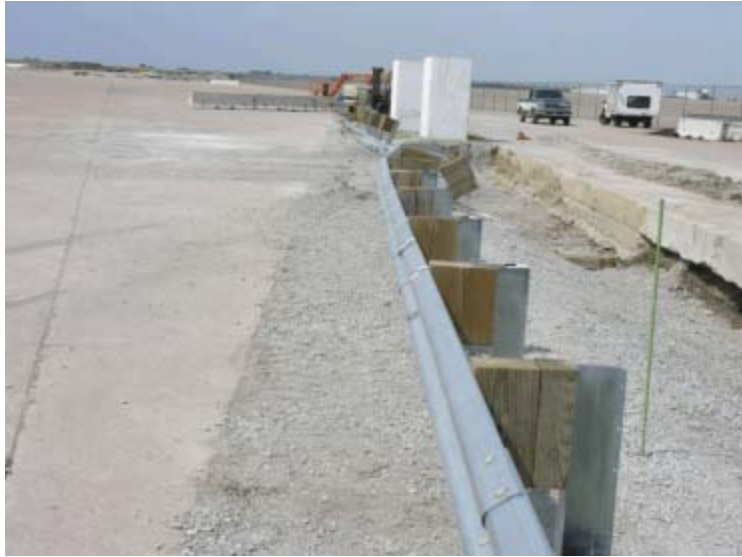
Figure 59. System Overall Damage, Test No. LSC-2

As shown in Figures 59 through 63, damage to the barrier was moderate, consisting mostly of deformed W-beam, contact marks on a guardrail section, and deformed and fractured guardrail posts. The W-beam damage consisted of contact marks and deformation and flattening of the impacted section between post nos. 10 and 16. No indications of rail rupture or tearing were visible on the W-beam. The W-beam rail was pulled off of post nos. 1 through 14. Two CRT posts, post nos. 11 and 13, were completely fractured, while CRT post nos. 12, 14, and 15 were rotated backward in the soil. Steel post nos. 9 and 10 were bent and deformed back and downstream. No significant post damage or deformations occurred to the remaining posts in the system. Contact marks and concrete spalling were visible on the top of the culvert headwall as well as on the downstream wingwall, as shown in Figure 60. The maximum lateral permanent set rail deflection was approximately 1,372 mm (54.0 in.) at 3,810 mm (150 in.) downstream from the centerline of post no. 13, as measured in the field. The maximum lateral dynamic post and rail deflections were 1,186 mm (46.7 in.) at post no. 12 and 1,968 mm (77.5 in.) at 1,905 mm (75 in.) downstream of post no. 13, respectively, as determined from the high-speed video analysis. The working width of the system was 2,133 mm (84.0-in), as determined from the high-speed video analysis.

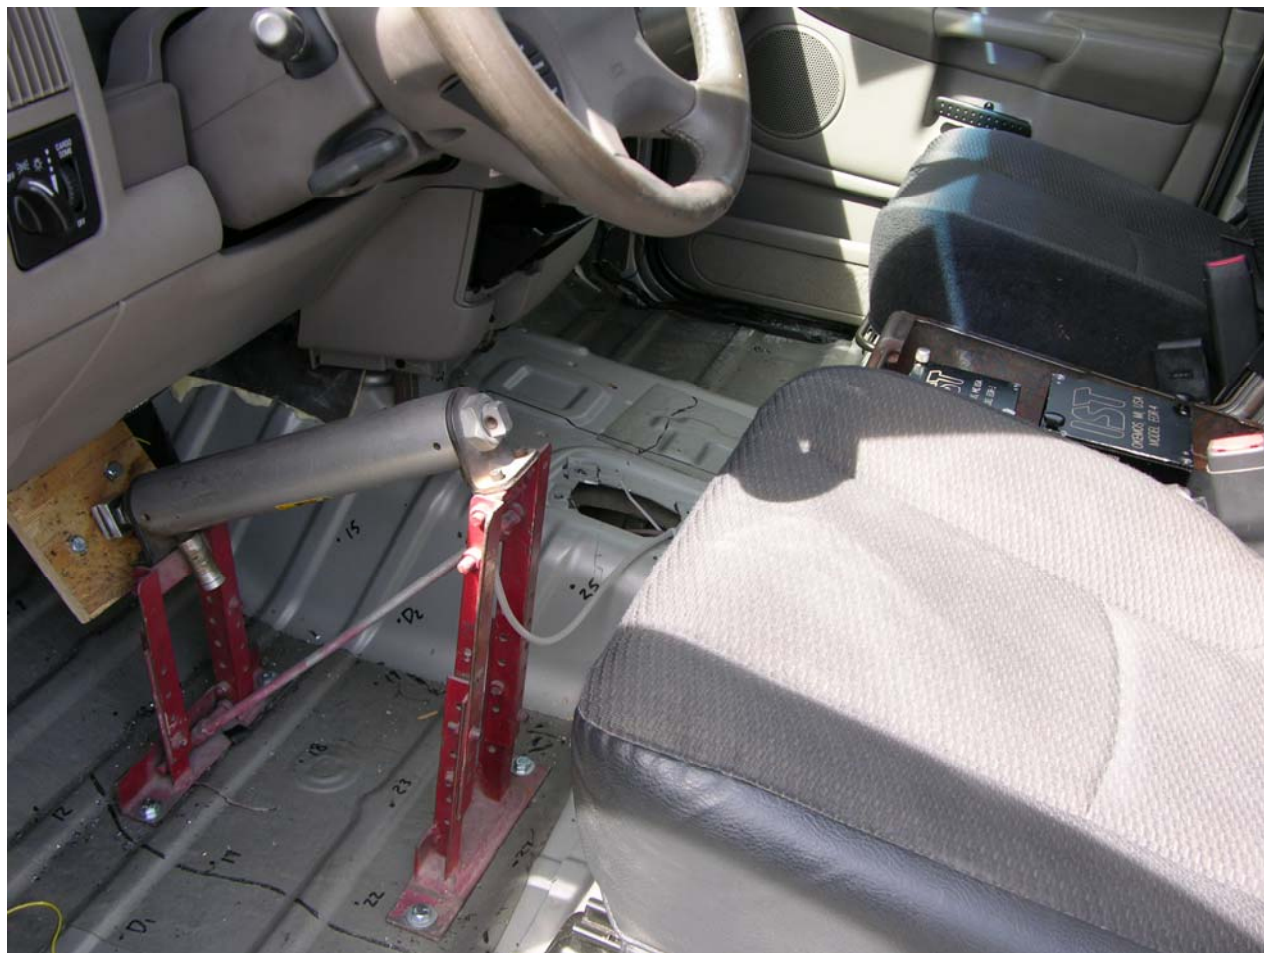
Figure 67. Occupant Compartment Deformation, Test No. LSC-2

Exterior vehicle damage was moderate, as shown in Figures 64 through 66. The left-front quarter panel was crushed inward, and the left side of the front bumper was also bent back toward the engine compartment. The left-front wheel assembly was completely disengaged from the axle, suspension, and steering systems. Some deformation and damage were noted on the left-front suspension components, including the upper and lower control arms, the stabilizer bar, and the joints connecting the suspension components. Contact marks and minor deformation were found along most of the lower-left side of the pickup truck. The left-rear quarter panel and the left corner of the rear bumper were dented as well. The left-rear tire was deflated, and the right-front tire de-beaded from the rim. Interior occupant compartment damage was minimal, as shown in Figure 67, with maximum lateral deformations of 19 mm (0.75 in.) measured near both the right and left sides of the driver-side footwell on the floorpan.
