MASH EVALUATION OF TxDOT HIGH-MOUNTING-HEIGHT TEMPORARY WORK ZONE SIGN SUPPORT SYSTEM

Test Report 9-1002-15-8

**TEXAS A&M TRANSPORTATION INSTITUTE
COLLEGE STATION, TEXAS**

TEXAS DEPARTMENT OF TRANSPORTATION

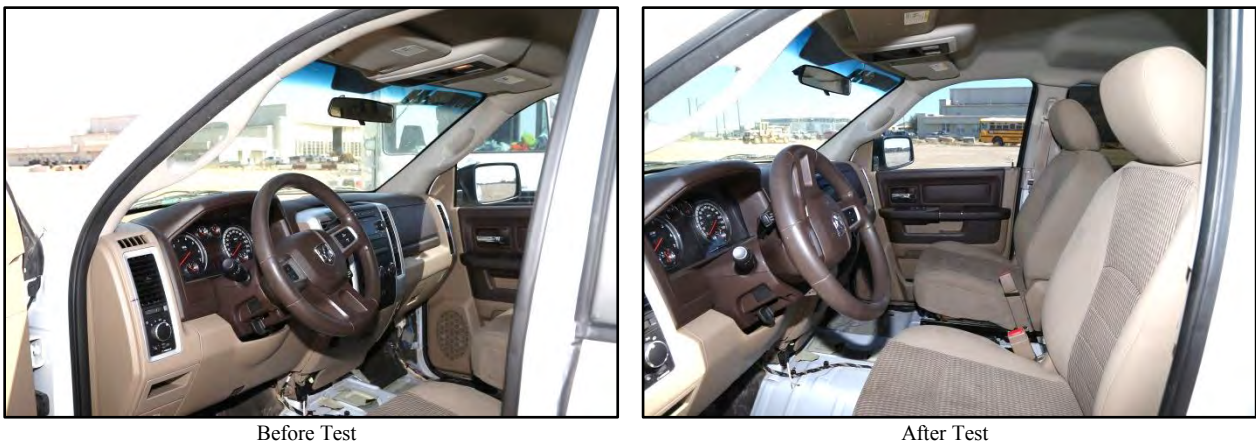
Figure 6.6. Interior of Test Vehicle for Test No. 490026-2-2.

at the left quarter point at bumper height. On the left side of the roof of the cab, there was a 10-inch long dent on the outer surface, but no penetration into the passenger compartment. Figure 6.6 shows the interior of the vehicle. No occupant compartment deformation or intrusion was noted. Tables B.3 and B.4 in Appendix B1 provide exterior crush and occupant compartment measurements.

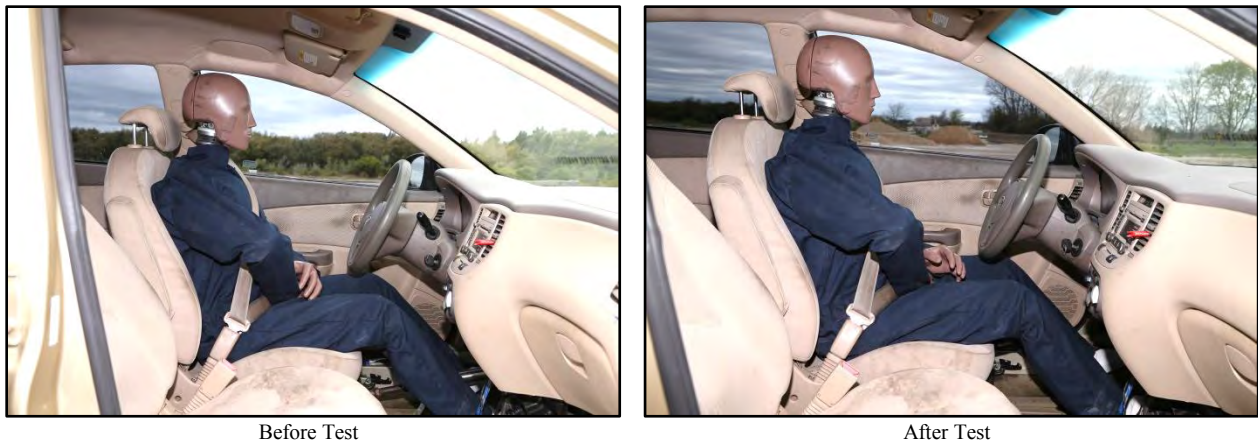
Figure 6.12. Interior of Test Vehicle for Test No. 490026-2-4.

Figure 6.11 shows the damage sustained by the vehicle. The 1100C vehicle sustained only scrapes to the bumper and hood with no measureable exterior vehicle deformation. Figure 6.12 shows the interior of the vehicle. No occupant compartment deformation or intrusion was noted. Tables C.2 and C.3 in Appendix C1 provide exterior crush and occupant compartment measurements.

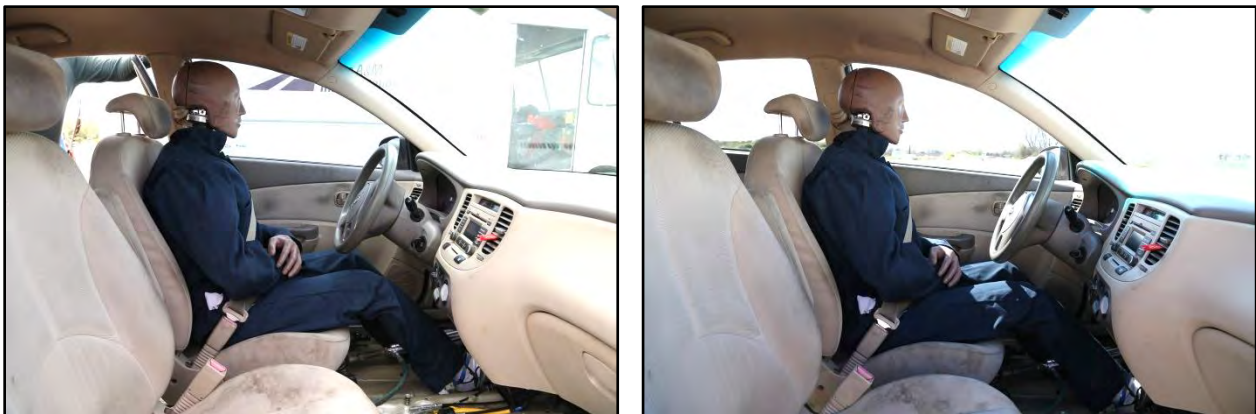
Figure 6.18. Interior of Test Vehicle for Test No. 490026-2-6.

Figure 6.17 shows the damage sustained by the vehicle. The 1100C vehicle sustained only scrapes to the bumper and hood with no measureable exterior vehicle deformation. Figure 6.18 shows the interior of the vehicle. No occupant compartment penetration, deformation, or intrusion was noted. Tables D.2 and D.3 in Appendix D1 provide exterior crush and occupant compartment measurements.

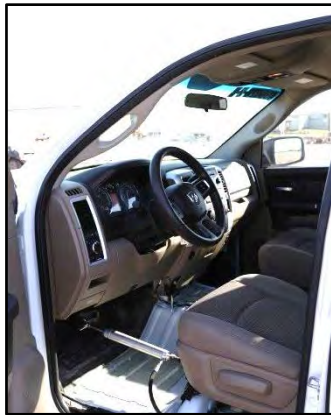
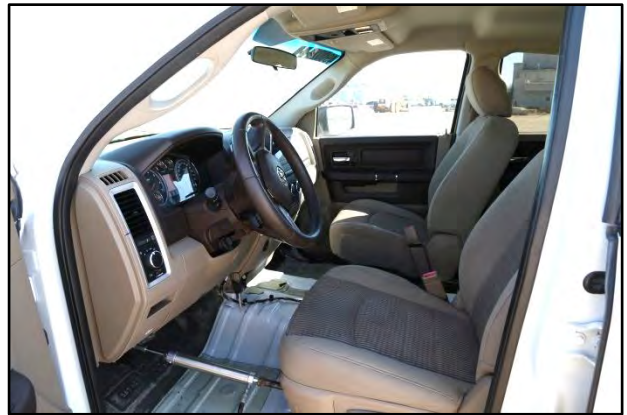
Figure 6.24. Interior of Test Vehicle after Test No. 490026-2-8.

Figure 6.23 shows the damage sustained by the vehicle. The bumper and hood were damaged. Maximum exterior crush to the vehicle was 4.0 inches in the front plane at the left quarter point at bumper height. Figure 6.24 shows the interior of the vehicle. No occupant compartment deformation or intrusion was noted. Tables E.3 and E.4 in Appendix E1 provide exterior crush and occupant compartment measurements.

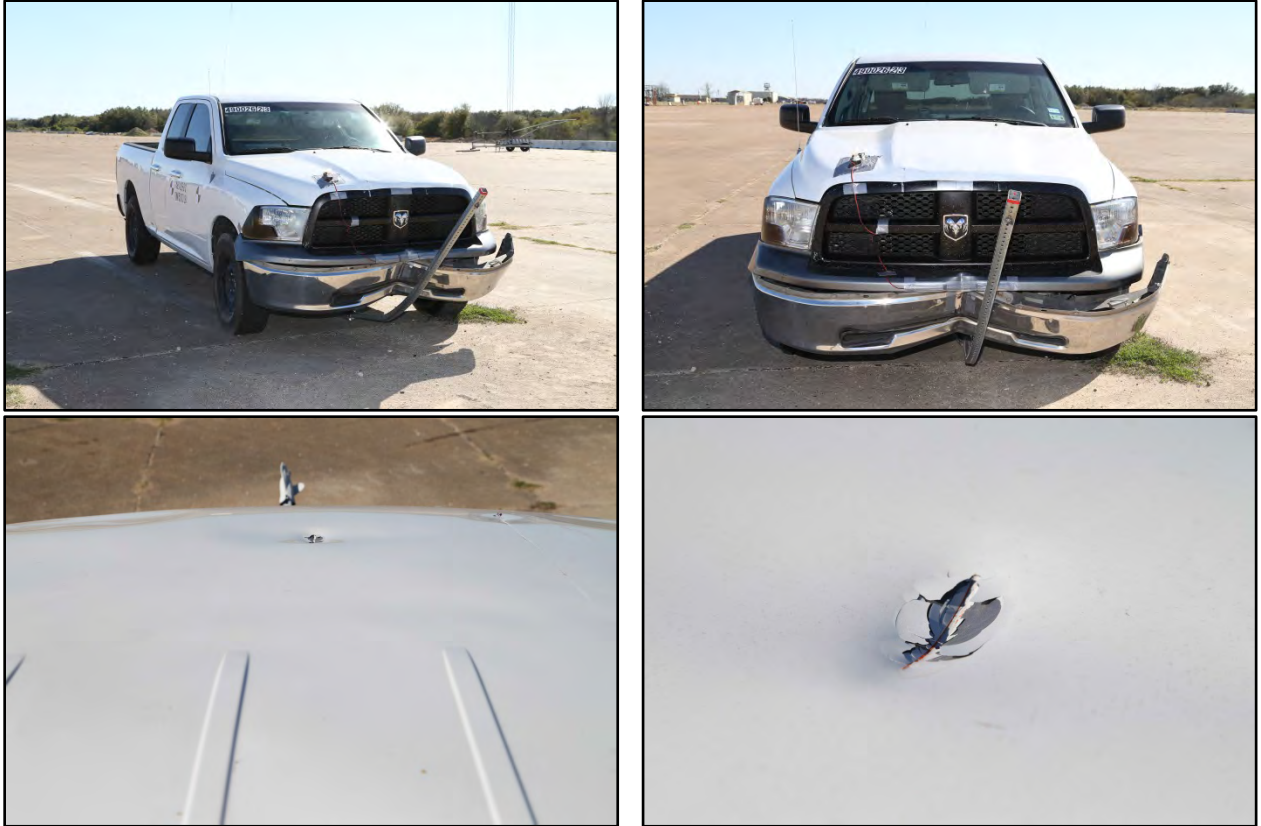
Figure 7.5. Test Vehicle after Test No. 490026-2-3.

Figure 7.5 shows the damage sustained by the vehicle. The bumper, hood, and roof were scraped. Maximum exterior crush to the vehicle was 6 inches in the front plane at the centerline at bumper height. There was a 3-inch long dent on the outer surface of the front of the roof of the cab, but it did not extend into the passenger compartment. Figure 7.6 shows the interior of the vehicle. No occupant compartment deformation or intrusion was noted. Tables F.3 and F.4 in Appendix F1 provide exterior crush and occupant compartment measurements.

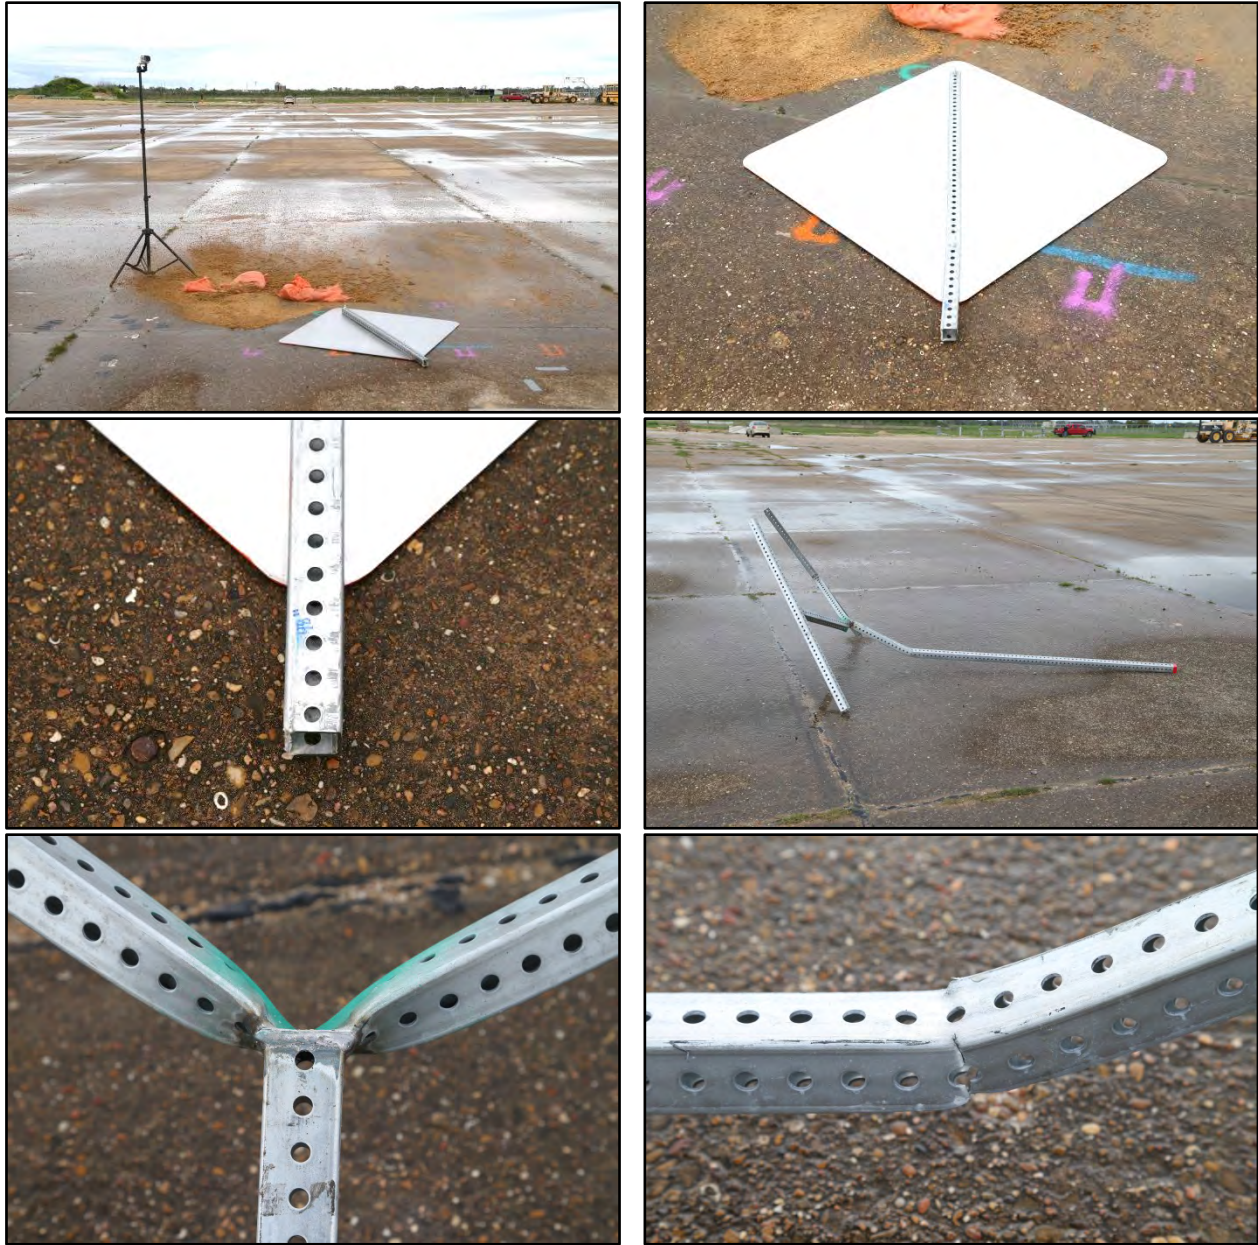
Figure 7.10. Option C Temporary Work Zone Sign Support after Test No. 490026-2-5.

Figure 7.10 shows the damage to the Option C temporary work zone sign support. The sign panel and attached upper section of the vertical support came to rest at the point of impact. The remainder of the temporary work zone sign support rode along with the 1100C vehicle for a distance and then came to rest 230 ft downstream of impact and 25 ft to the left of centerline of the impact path.

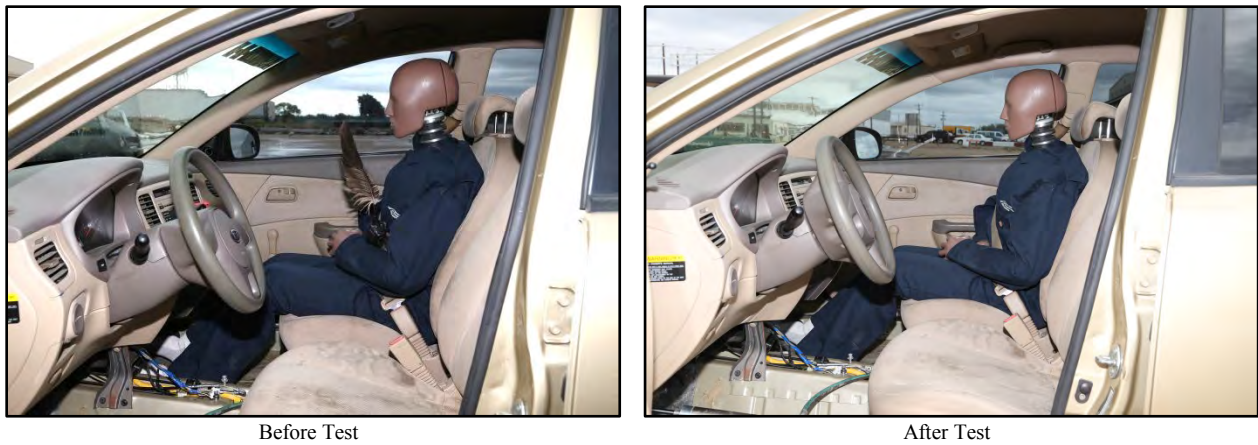
Figure 7.12. Interior of Test Vehicle for Test No. 490026-2-5.

Figure 7.11 shows the damage sustained by the vehicle. The 1100C vehicle sustained only scrapes to the bumper and hood with no measureable exterior vehicle deformation. Figure 7.12 shows the interior of the vehicle. No occupant compartment deformation or intrusion was noted. Tables G.2 and G.3 in Appendix G1 provides exterior crush and occupant compartment measurements.

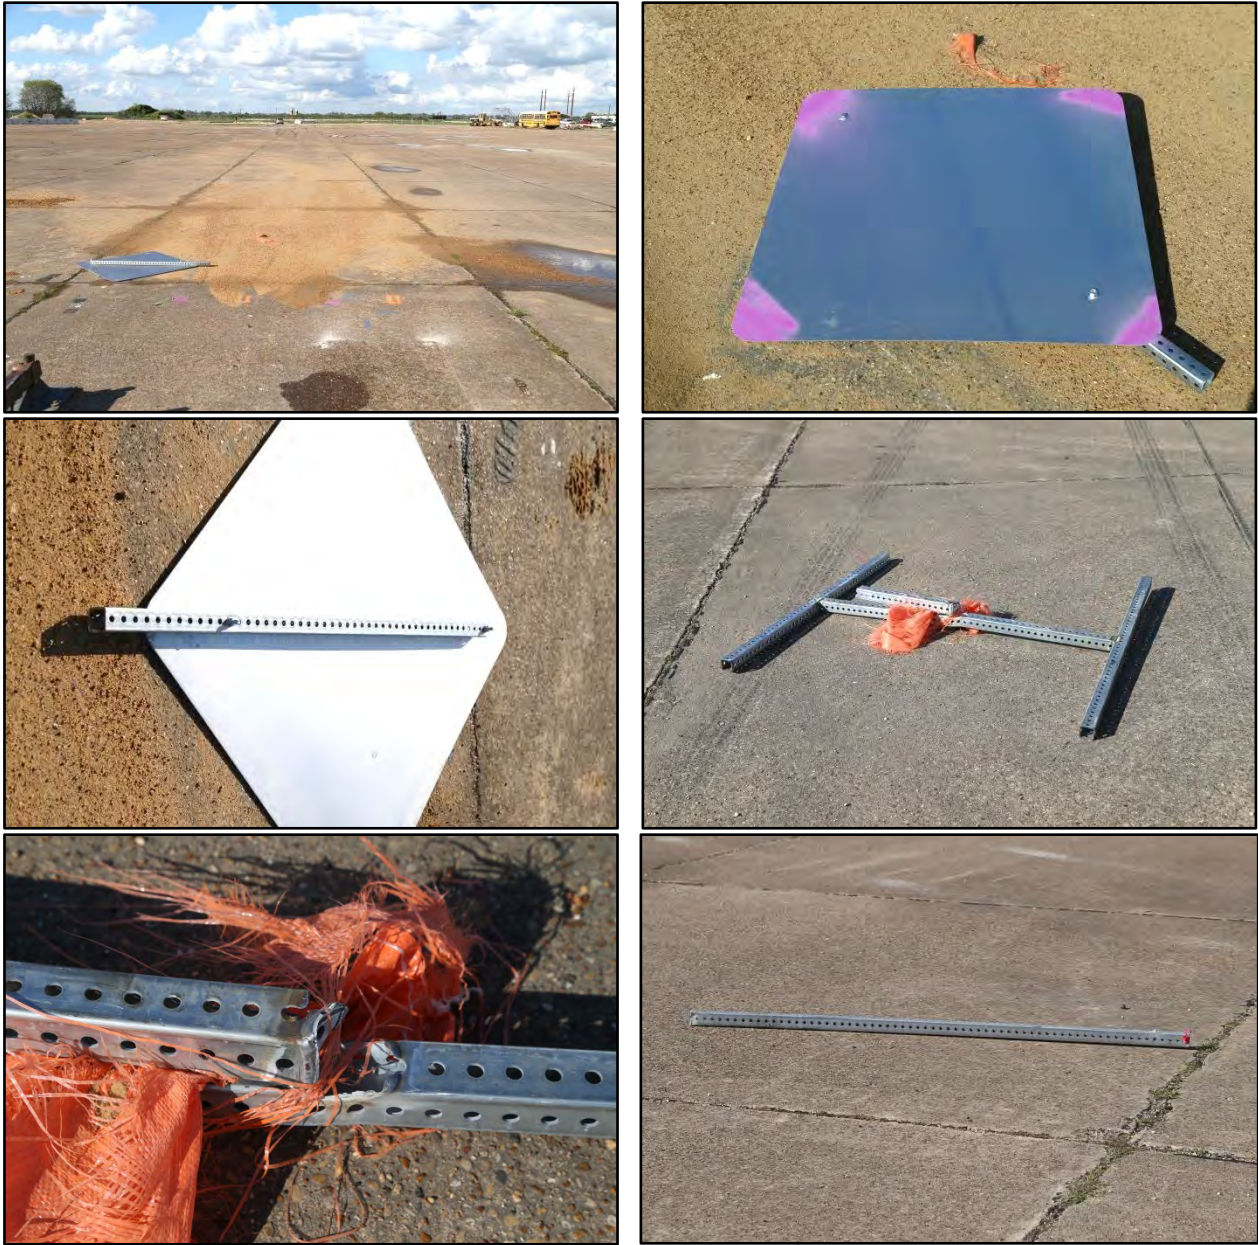
Figure 7.16. Option C Temporary Work Zone Sign Support after Test No. 490026-2-7.

Figure 7.16 shows the damage to the Option C temporary work zone sign support. The sign panel and attached upper section of the vertical support came to rest 2 ft downstream of impact and 2 ft to the left of centerline of the vehicle path. The lower portion of the temporary work zone sign support came to rest 143 ft downstream of impact and 9 ft to the right of centerline of the impact path, and was deformed 85 degrees. A piece of the vertical section fractured away from the lower support 18 inches above ground level, and came to rest 275 ft downstream of impact and 18 ft to the right of centerline of the vehicle path.

Results: The Option C temporary work zone sign support released and fractured into three pieces; however, there was no concern for penetration or intrusion into the vehicle. The lower portion of the sign support rode along with the 1100C vehicle for a distance and came to rest 275 ft downstream of impact and 18 ft to the right of centerline of the vehicle path. (PASS)

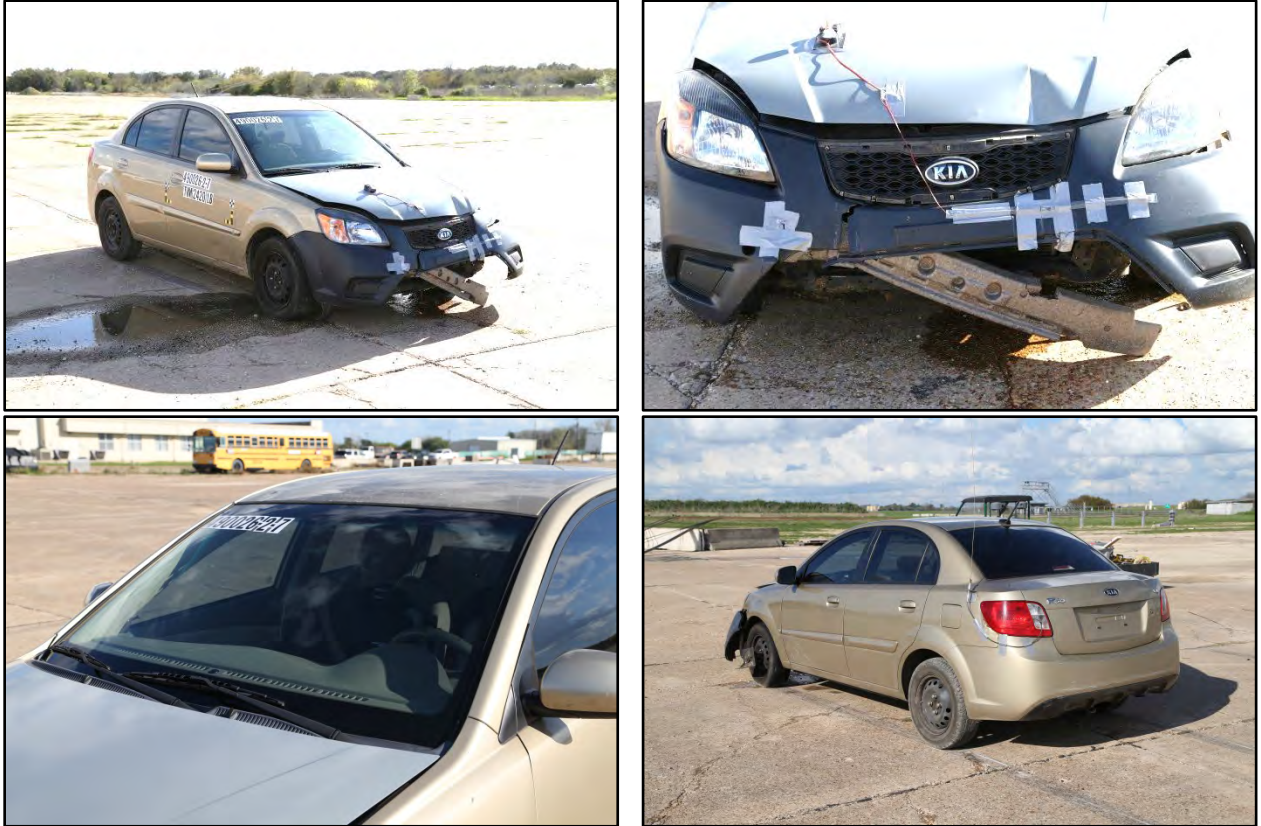
Figure 7.17. Test Vehicle after Test No. 490026-2-7.

Figure 7.17 shows the damage sustained by the vehicle. The 1100C vehicle sustained only scrapes to the bumper and hood with no measureable exterior vehicle deformation. Figure 7.18 shows the interior of the vehicle. No occupant compartment deformation or intrusion was noted. Tables H.2 and H.3 in Appendix H1 provides exterior crush and occupant compartment measurements.

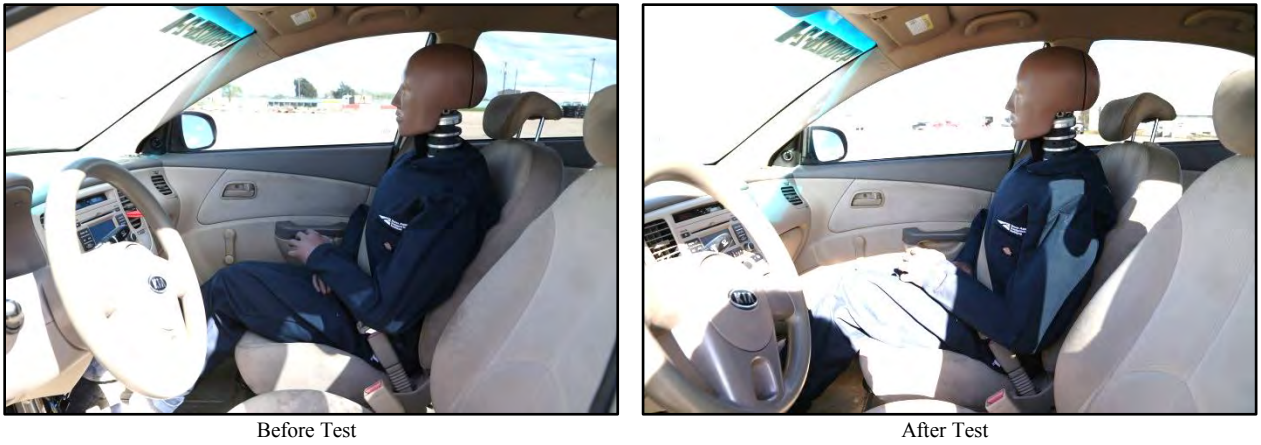
Figure 7.18. Interior of Test Vehicle for Test No. 490026-2-7.

No occupant compartment deformation or intrusion was noted. (PASS)

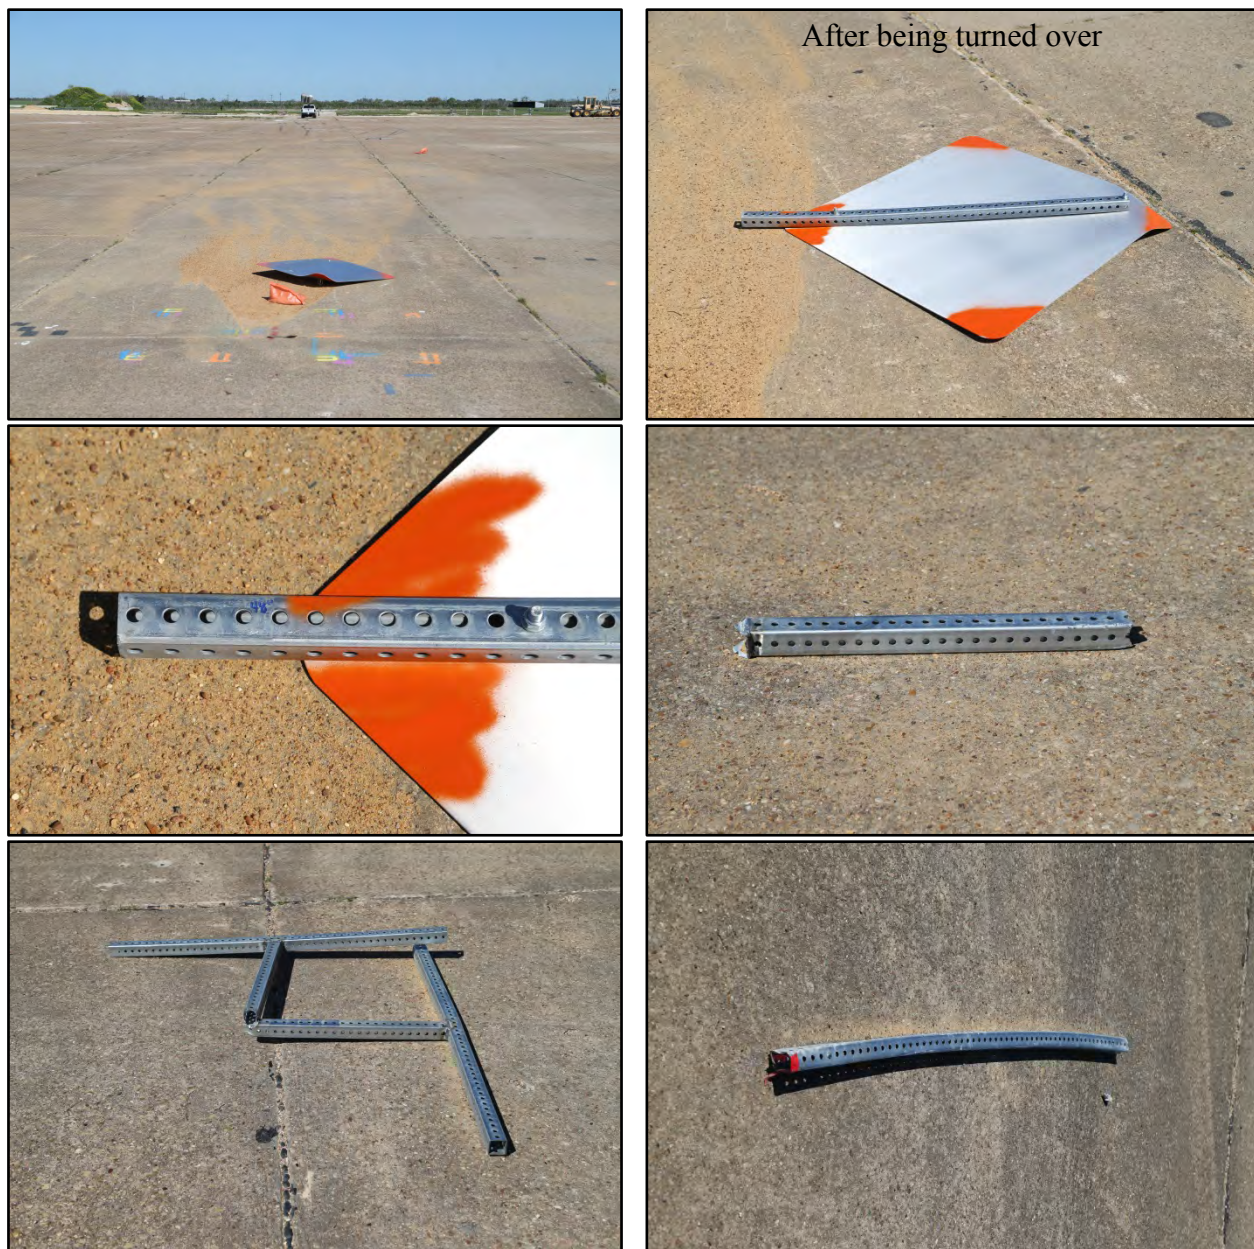
Figure 7.22. Option C Temporary Work Zone Sign Support after Test No. 490026-2-9.

Figure 7.22 shows the damage to the Option C temporary work zone sign support. The sign panel and the attached upper section of the vertical support came to rest 7 ft downstream of impact. A vertical piece fractured from the lower section of the support at 24 inches above ground and came to rest 125 ft downstream of impact. The remainder of the temporary work zone sign support came to rest 120 ft downstream of impact and 10 ft to the right of centerline of the impact path.

Results: The Option C temporary work zone sign support released and fractured into three pieces; however, there was no concern for penetration or intrusion into the vehicle. The lower portion of the sign support lodged under the truck and traveled with the vehicle. (PASS)

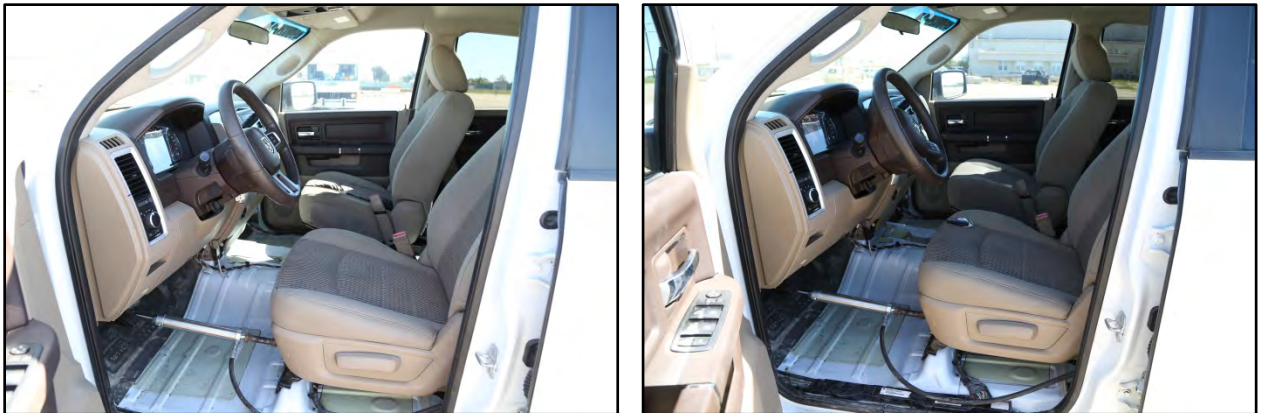
Figure 7.23 shows the damage sustained by the vehicle. The bumper and hood were scraped. Maximum exterior crush to the vehicle was 3.5 inches in the front plane at the left quarter point at bumper height. Figure 7.24 shows the interior of the vehicle. No occupant compartment deformation or intrusion was noted. Tables I.3 and I.4 in Appendix I1 provides exterior crush and occupant compartment measurements.

No occupant compartment deformation or intrusion was noted. (PASS)
