DOWNSTREAM ANCHORING REQUIREMENTS FOR THE MIDWEST GUARDRAIL SYSTEM

MIDWEST ROADSIDE SAFETY FACILITY

MwRSF Research Report No. TRP-03-279-13

October 28, 2013

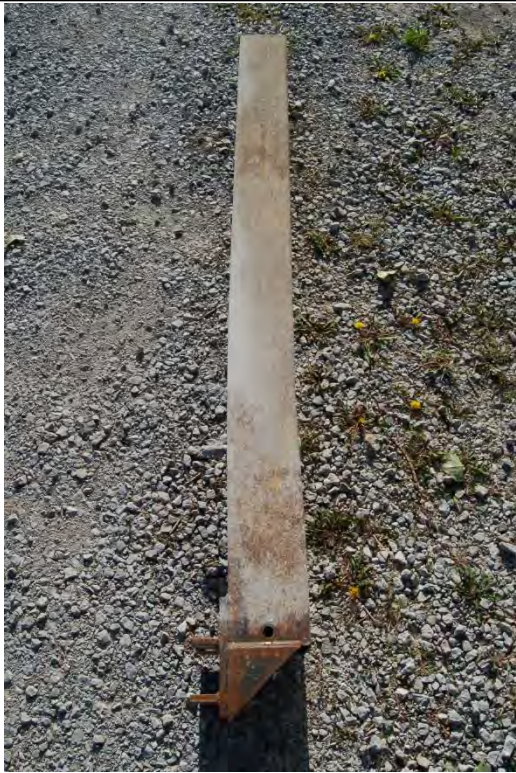
Figure 37. Time-Sequential and Post-Impact Photographs, Test No. MGSEA-1

Time-sequential and post-test photographs of test no. MGSEA-1 are shown in Figure 37. During test no. MGSEA-1, the anchor foundation tube was pulled by the cable attached to the bogie vehicle, which was traveling at an initial speed of 16.1 mph (26.0 km/h) when the cable started to be tensioned. As a consequence of the pull force, the foundation tube rotated through the ground over a maximum dynamic displacement of 6.5 in. (165 mm). The final permanent

set deflection was 4.2 in. (107 mm), as measured using the string potentiometer attached to the back of the tube at ground line. The steel foundation tube bent slightly, thus initiating a plastic hinge at about 8½ in. (216 mm) from its top edge.

The load cell cable connector became disconnected almost immediately after the pull cable was tensioned. Thus, the force was obtained using acceleration data from the bogie vehicle. Although the acceleration measured at the bogie center of mass may include damping effects due to the extension of the pull cable and a time shift, it still provides useful information related to load resistance of the foundation tube embedded into the soil. The maximum peak load was 43.4 kips (193 kN), as obtained from DTS-SLICE accelerometer data.

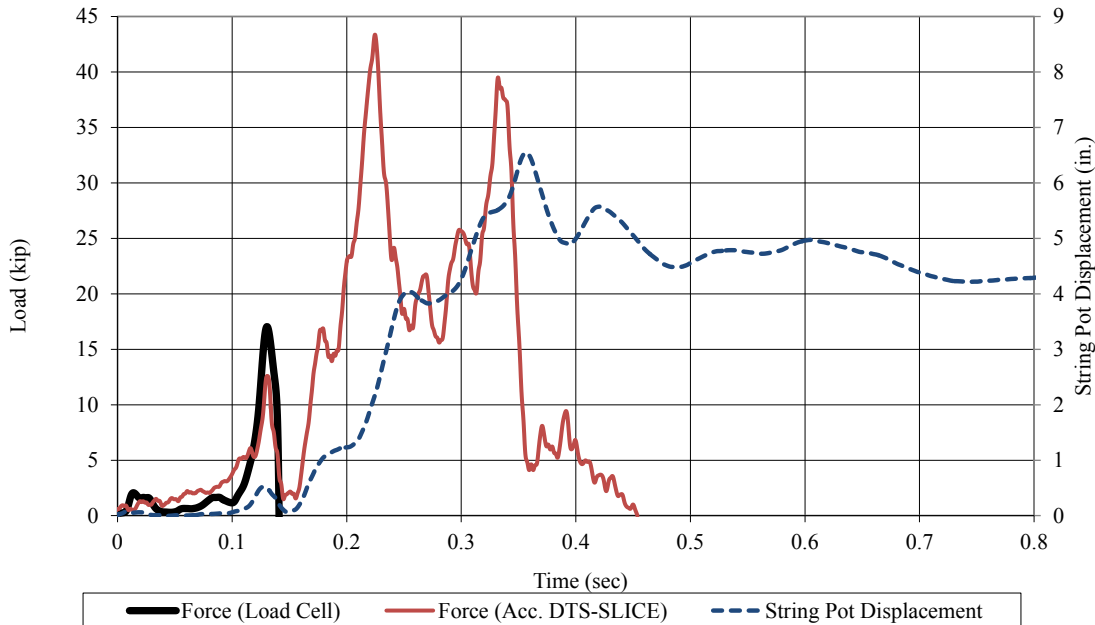
Figure 38. Forces vs. Time and Displacement vs. Time, Test No. MGSEA-1

Force versus time and deflection versus time curves were plotted and are shown in Figure 38. The results from all transducers used in the test are provided in Appendix C. An intensive investigation into event timing was conducted to determine the approximate start times for string pot, accelerometer, and load cell curves. Although visual clues to indicate times of low and high tension were available, the most convenient reference was derived from the instrumentation cable which disconnected from the tension load cell at approximately 0.131 sec after the pull cable began to stretch. It was clearly identifiable in the high-speed video when the data cable disconnected. As a result, high-speed video of the post deflection was used to relate the time of maximum foundation tube deflection to the load cell data. Accelerometer data was also matched to similar load events in the load cell data. Therefore, researchers believe that the load and soil tube displacement curves plotted against time in Figure 38 are representative of the events that occurred in the test.

The force measured by the accelerometer mounted on the bogie, DTS-SLICE, indicated that the maximum force encountered by the BCT anchor cable was approximately 43.4 kip (193

kN), leading to a maximum displacement of the soil tube of approximately 6.5 in. (165 mm) as measured by the string pot. However, real-world soil strengths may be lower than provided by the coarse, compacted crushed limestone recommended by MASH and used for this bogie testing effort. Larger deflections of soil tubes may occur when anchor loads approach the failure limits of a guardrail system’s end anchorage.

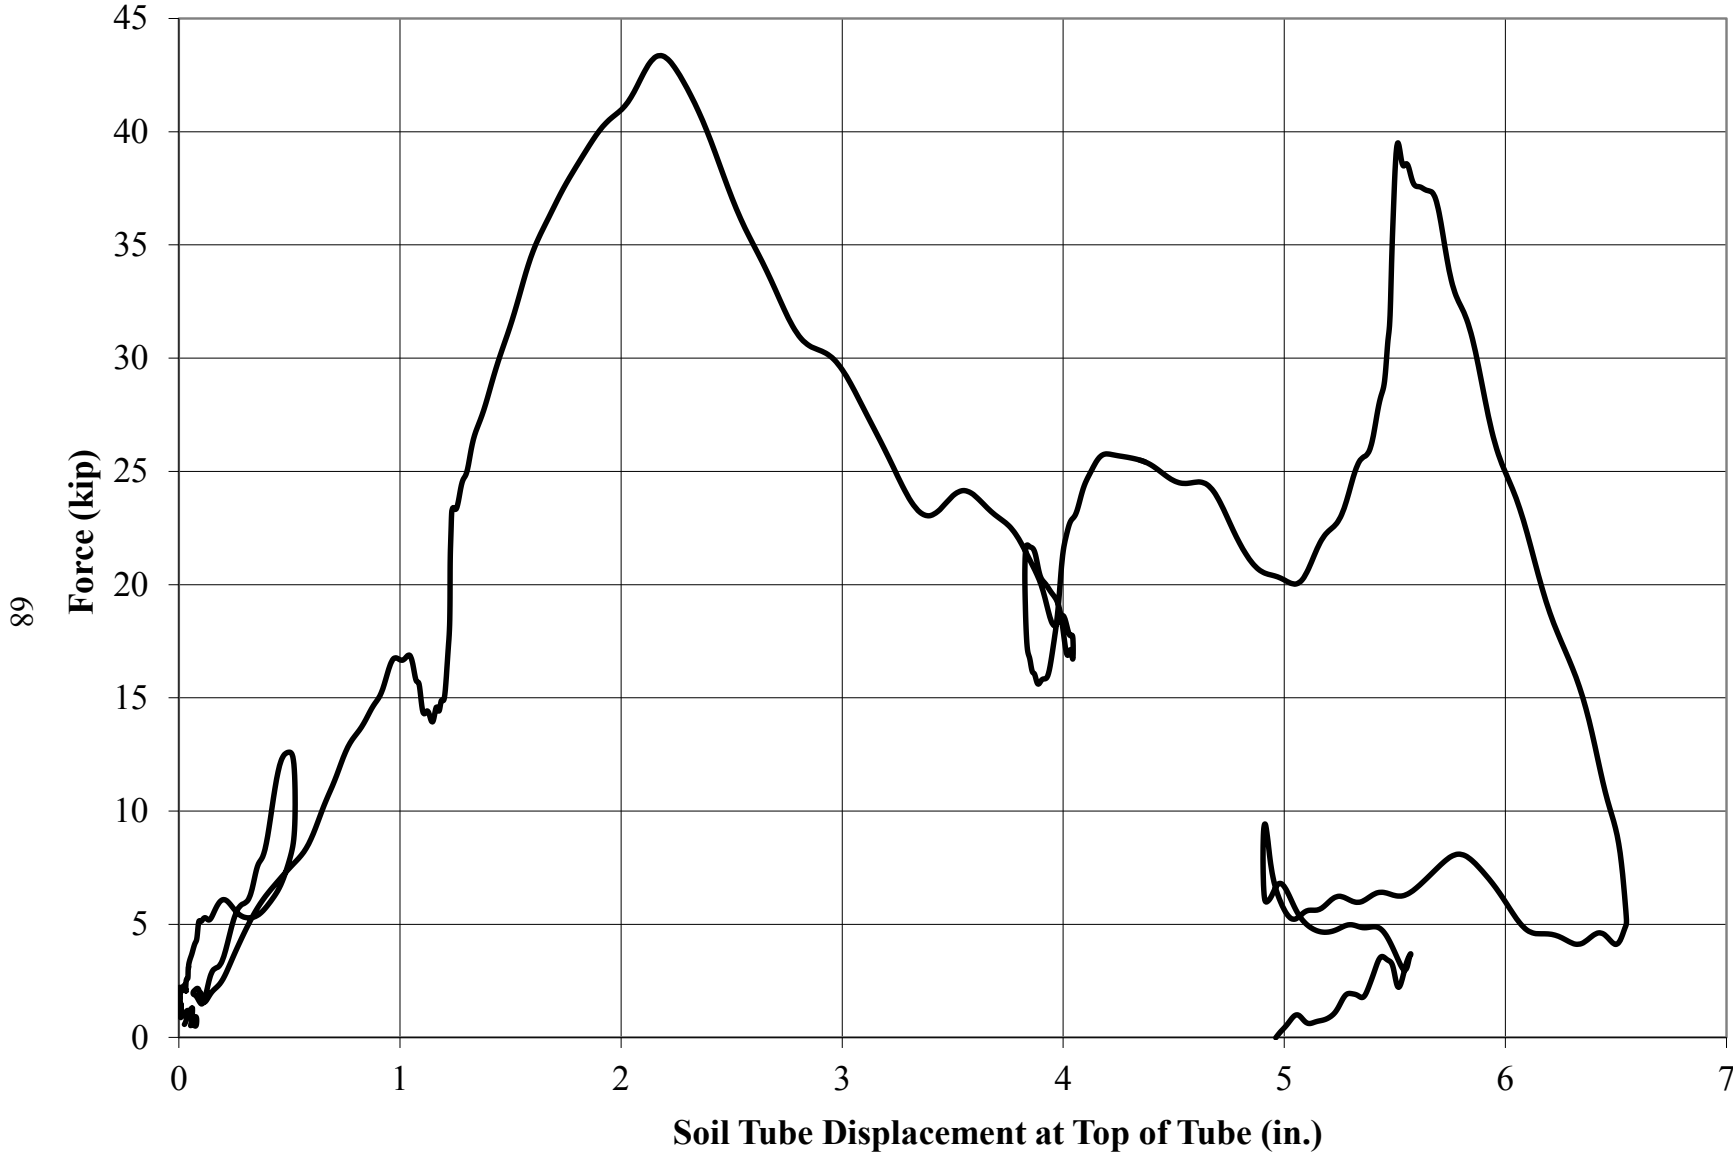
Figure 39. Bogie Force vs. Soil Tube Displacement Measured by String Pot, Test No. MGSEA-1

The force versus deflection curve of the soil foundation tube in test nos. MGSEA-1 is shown in Figure 39. An initial tension pulse caused the force on the foundation tube to ramp up to 13 kip (58 kN), and the deflection increased approximately proportional to the load to a maximum of 0.5 in. (13 mm), after which point the force and deflection dropped to nearly zero. This indicated the foundation tube and soil interaction was initially linearly elastic. The largest force impulse, experienced at approximately 2 in. (51 mm) of deflection, was required to overcome inertia and move the soil and foundation tube. A relatively steady force was recorded between 3 and 5 in. (76 and 127 mm) of displacement before the final force spike and maximum deflection were reached.

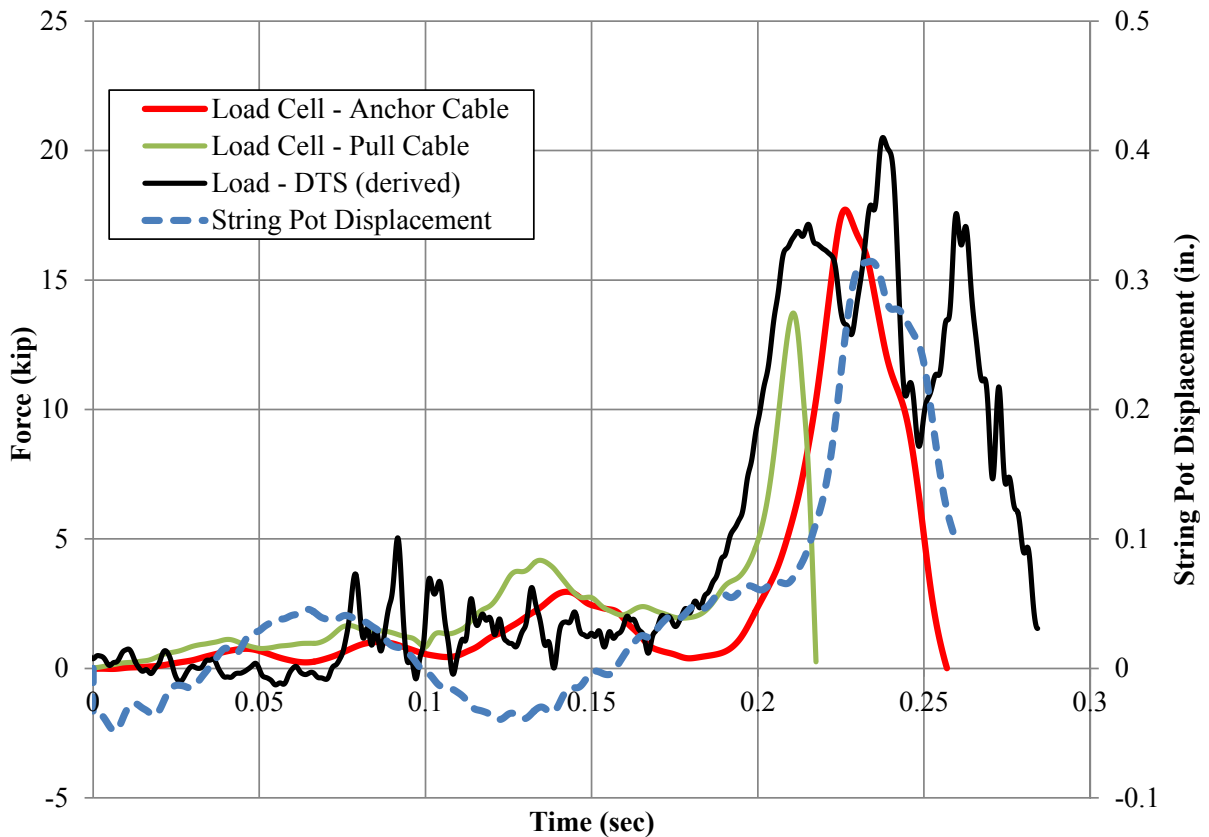
Figure 53. Forces vs. Time and Displacement vs. Time, Test No. DSAP-1

The force versus time curve and deflection versus time curve for test no. DSAP-1 are shown in Figure 53. The load measured by the two compressive load cells in test no. DSAP-1 were discarded, because it was determined that the washer-type load cell is extremely sensitive to small misalignments. The results from all transducers used during the test are provided in Appendix C. The maximum force measured by the tension load cell attached to the anchor cable was approximately 18 kip (80 kN) at approximately 0.13 sec after the start of the pull event. The maximum displacement, as measured by the string potentiometer connected to the top of the foundation tube of the end post, was approximately 0.31 in. (8 mm) and occurred in concomitance to the peak force in the anchor cable. Time-sequential and post-impact photographs are shown in Figures 54 and 55, respectively. Due to the uncertainty associated with the start time in the string pot and load cells, the start time used for the load cell, anchor cable, and string pot data should be considered approximate. Therefore, force versus displacement and energy versus displacement curves were not plotted.

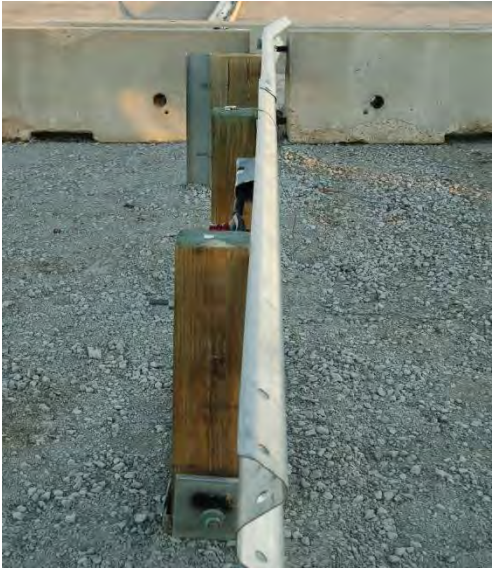
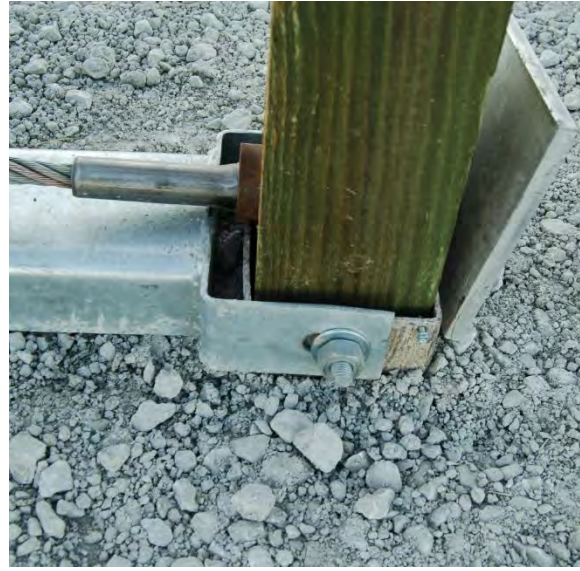
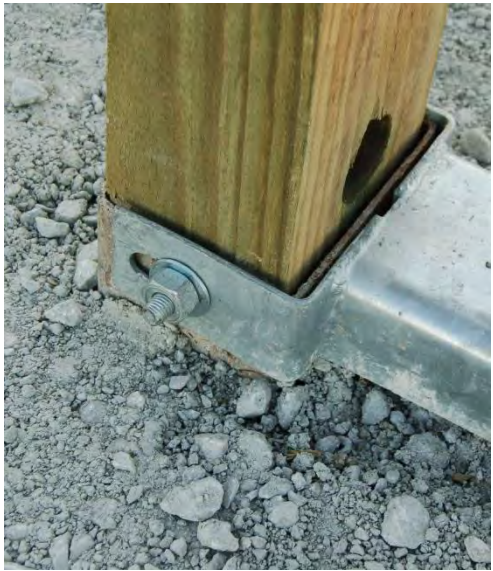
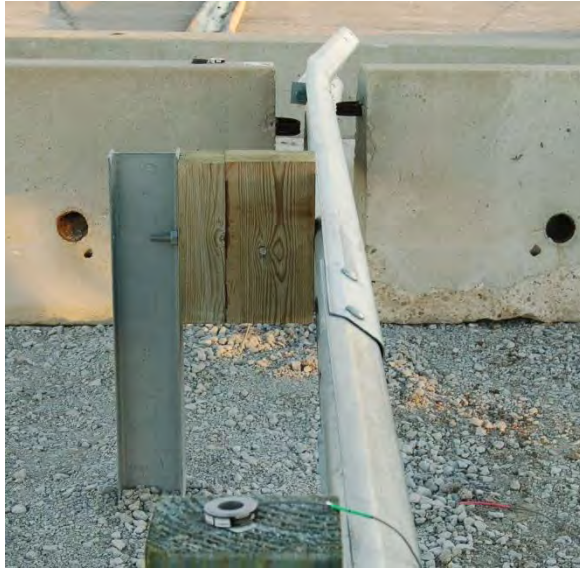
Figure 55. Post-Impact Photographs, Test No. DSAP-1

During test no. DSAP-1, the nylon strap used in the connection joint between the pull cable and upstream end of the guardrail ruptured. As a consequence, the anchorage was only partially loaded, and no damage occurred to the wood posts or the post-to-rail connection.

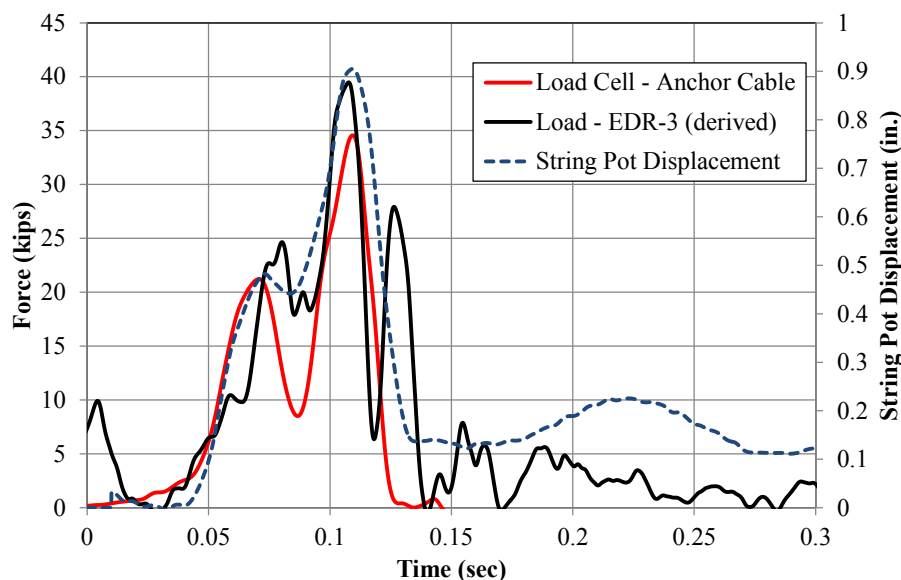
Figure 56. Force vs. Time and Displacement vs. Time, Test No. DSAP-2

The force versus time and the deflection versus time curves for test no. DSAP-2 were processed from transducer data. Event start times for the load cells, accelerometer, and string pot data were approximated, and the processed data are shown in Figure 56. Technical difficulties with the pull cable load cell rendered pull cable tension data unusable. The results from all transducers used during the test are provided in Appendix C. As illustrated in the force versus time curve, two peak forces of about 21 kip (93 kN) and 35 kip (156 kN) occurred at around 0.06 sec and 0.10 sec, respectively. Two local maximum displacements of about 0.5 in. (13 mm) and 0.9 in. (23 mm) were measured by the string potentiometer connected to the base of the end post. These two local peak displacements occurred at nearly the same time as two local force peaks. Time-sequential photographs are shown in Figures 56 and 57. Post-impact photographs are shown in Figure 58.

The maximum load sustained by the end anchorage was between 35 and 40 kip (156 and 178 kN). A reasonable limit for estimating the capacity of an end anchorage would thus be 35 kip (156 kN). The anchor cable load versus downstream foundation tube displacement is shown in Figure 60. The loading curve of the anchor was linear through 0.40 in. (10 mm). The maximum load of 35 kip (156 kN) occurred at nearly the same time as the maximum deflection of 0.90 in. (23 mm). The anchor rebounded 0.75 in. (19 mm) in the soil, with a maximum permanent set deflection of 0.15 in. (4 mm). It should be noted that the rebound force curve was not relevant, because the anchor cable load cell disengaged from the soil foundation tube after the BCT post fractured and the bearing plate was released.

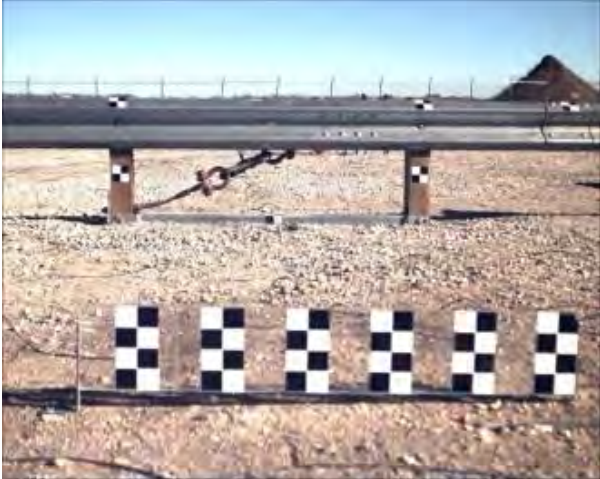
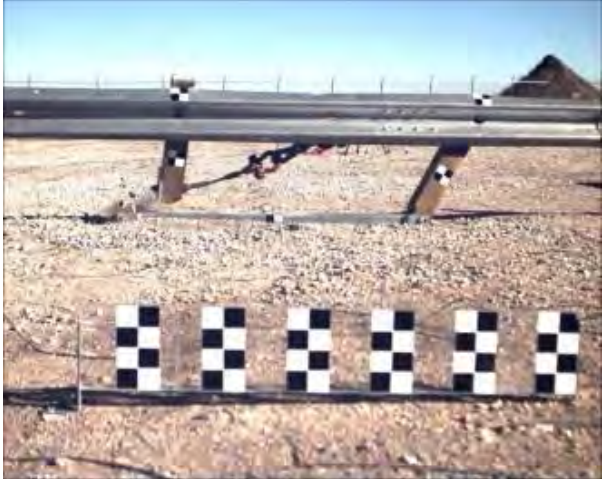
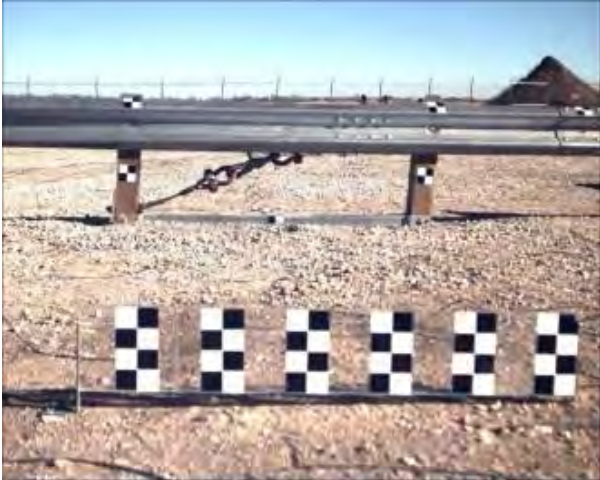
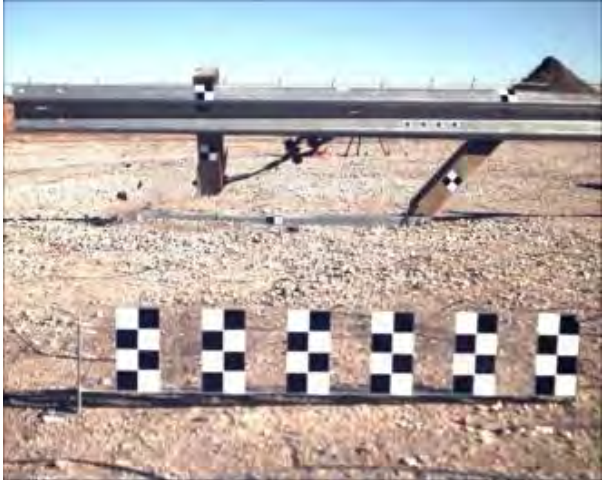
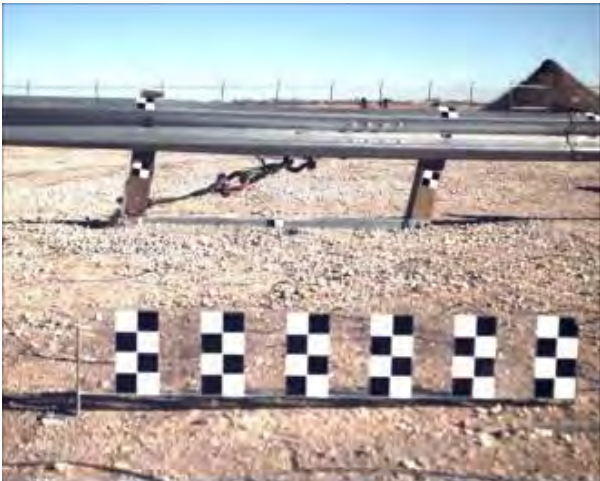
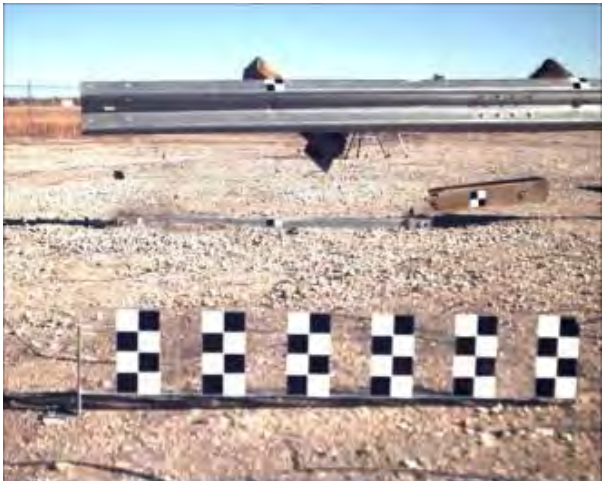
Figure 57. Time-Sequential Photographs – Front View, Test No. DSAP-2

Test no. DSAP-2 was conducted as a repeat of test no. DSAP-1; since, the nylon strap that was used to connect the pull cable to the anchor cable ruptured during the first test. As the pull cable started to be tensioned in test no. DSAP-2, the rail was pulled upstream, causing the two wood BCT posts to deflect upstream. The pull force was almost immediately transferred to the two foundation tubes, which rotated through the soil. When the cable anchor was tensioned, a downward vertical force component was applied to the rail. This force deformed the upper side of the rail slot at the connection with each of the two BCT posts due to the contact with the post bolt. The end BCT post fractured at the ground line first, followed immediately after by the other BCT post. After the fracture of the two BCT wood posts, the W6x8.5 (W152x12.6) steel

post and the wood blockout twisted upstream. When the rail finally released away from the bolted connection, the steel post came back to its original untwisted configuration. The rail was eventually pulled downstream until it was brought to a stop by a steel chain connected to its upstream end and anchored to a concrete barrier.

For test no. DSAP-2, several important observations were made. The increased tension in the anchor cable caused the farthest downstream anchor post to fracture first. The post was pulled upward and upstream by the releasing anchor cable, but it remained attached to the rail following fracture until it had rotated nearly 90 degrees. The second post from the downstream end also fractured at nearly the same time, but the post largely rotated around the BCT hole toward the ground level, and the post released away from the rail during fracture. Neither post was split due to the BCT loading through the post bolts.

The upward motion of the downstream BCT post after fracture was likely the result of the angle of the anchor cable between its attachment point on the W-beam and the BCT post. As the anchor cable tension increased, the angle of the cable resulted in a vertical force and a shear load applied longitudinally to the post. The lifting load from the cable pulling on the post was clearly visible at 0.120 sec into test no. DSAP-2, as shown in Figures 57 and 58.

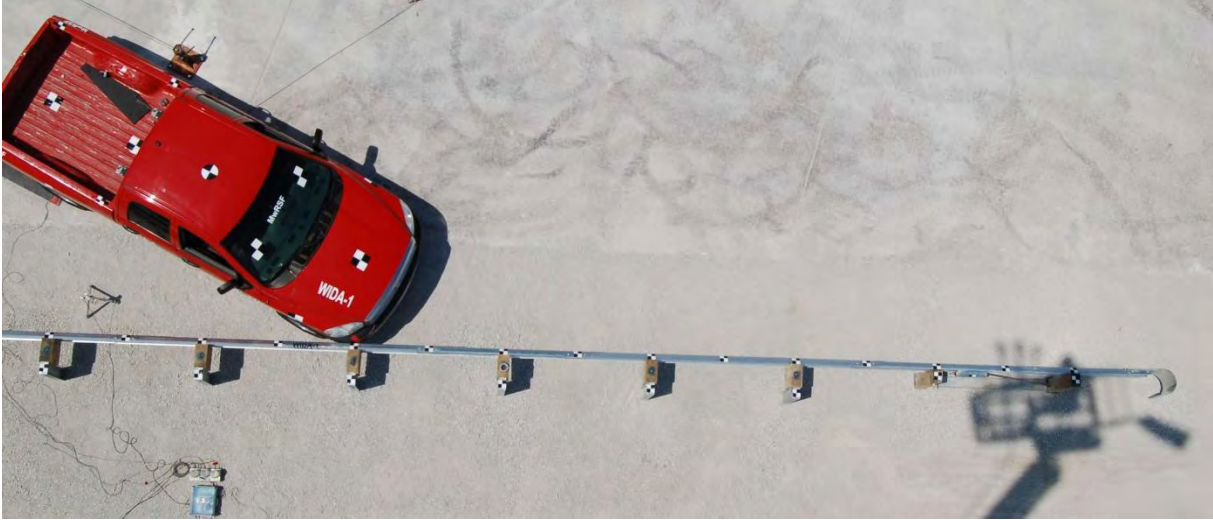
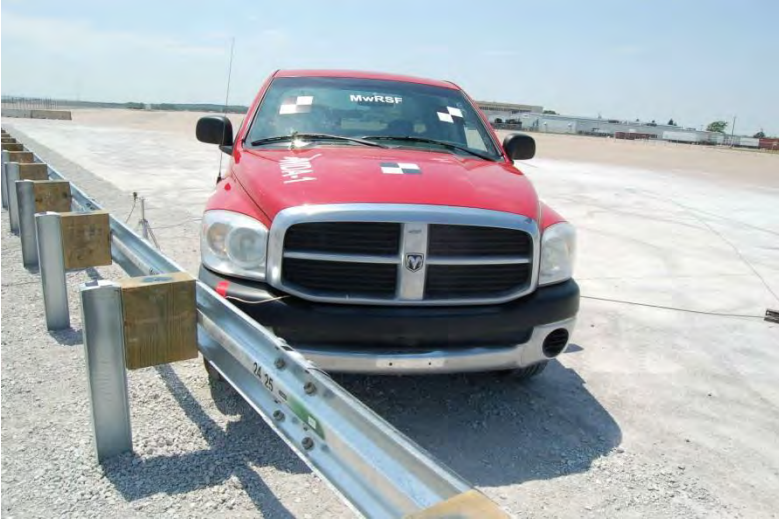
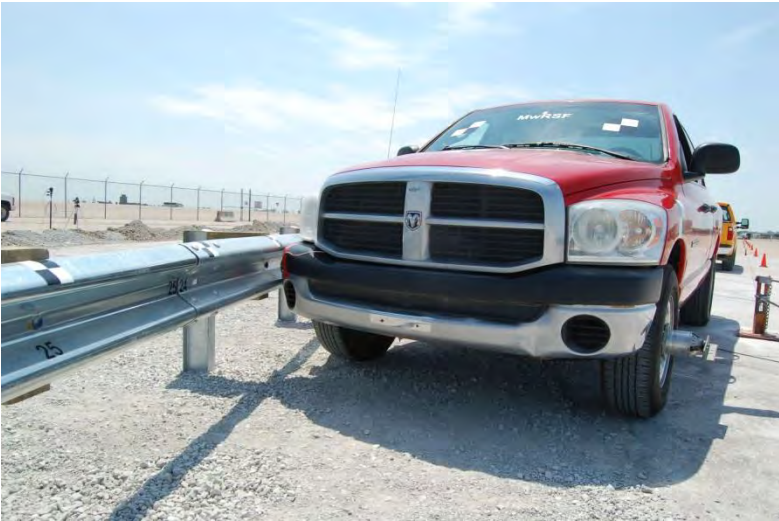
Figure 134. Impact Location, Test No. WIDA-1

Initial vehicle impact was to occur at the centerline of post no. 24, as shown in Figure 134, which was selected using LS-DYNA analysis to identify the end of the LON, as described in section 9.1.2. The actual point of impact was 1 in. (25 mm) upstream from post no. 24, or the sixth post upstream from the downstream end of the barrier. A sequential description of the impact events is contained in Table 12. The vehicle came to rest facing downstream, located 232 ft – 1 in. (70.7 m) downstream from initial impact point and 5 ft – 3 in. (1.6 m) laterally behind the traffic-side face of the guardrail. The vehicle trajectory and final position are shown in Figures 129 and 135.

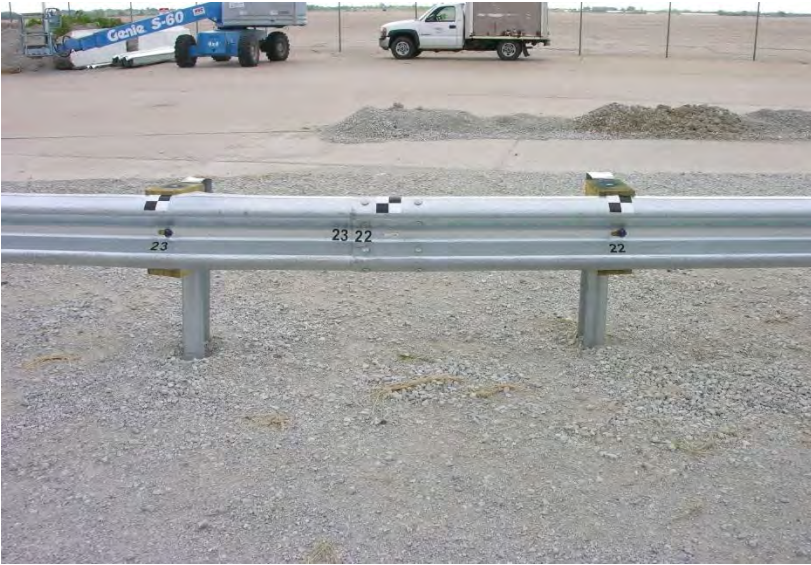
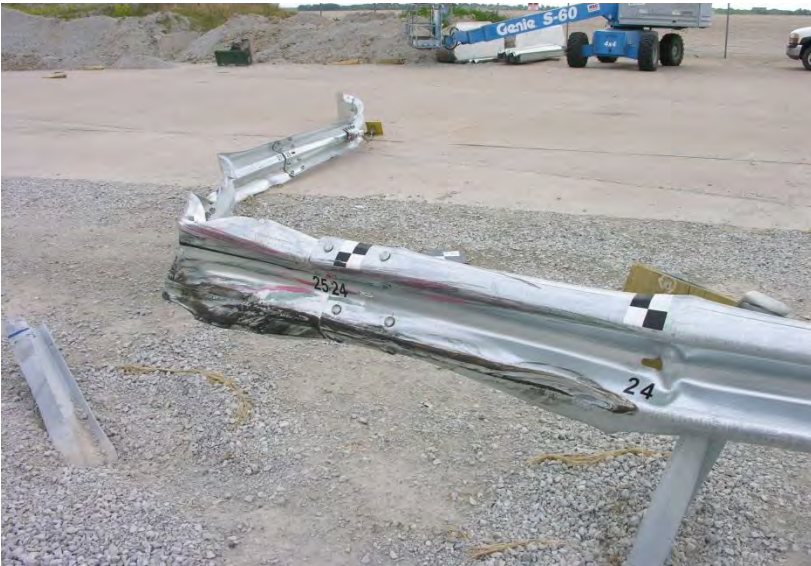
Figure 138. Details of Rail Damage, Test No. WIDA-1

The rail buckled at post no. 25, post no. 27, and 27¼ in. (692 mm) downstream of post no. 28, as shown in Figure 138. Kinks in the top and/or bottom corrugations of the rail were found between post nos. 22 and 29, as shown in Figure 136. Flattening and folding of the bottom corrugation of the W-beam rail occurred between post nos. 24 and 29. The bottom corrugation was folded upward at two main locations downstream of the initial impact point. The first location where the rail folded started at 6 in. (152 mm) from post no. 24, and extended downstream for 40¼ in. (1,022 mm), while the second location started 23 in. (584 mm) downstream of post no. 27 and ended 7 in. (178 mm) downstream of post no. 29. The bottom corrugation of the rail was also flattened at two locations. The first flattened segment started 6 in.

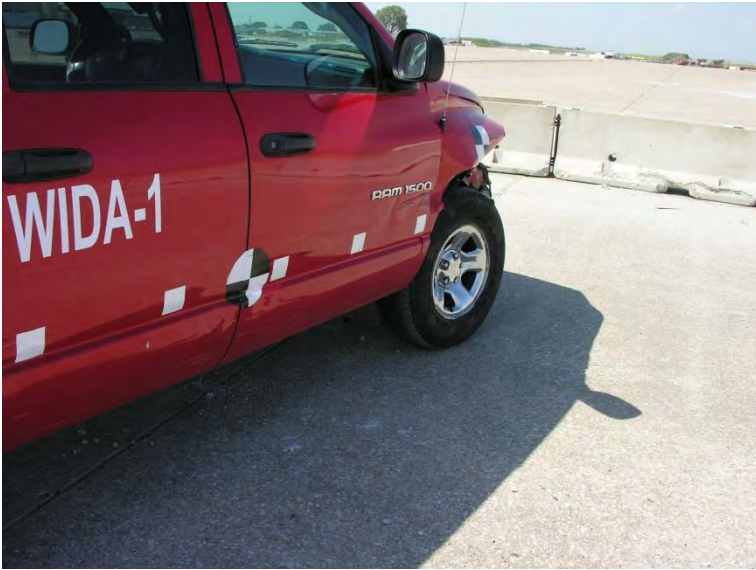
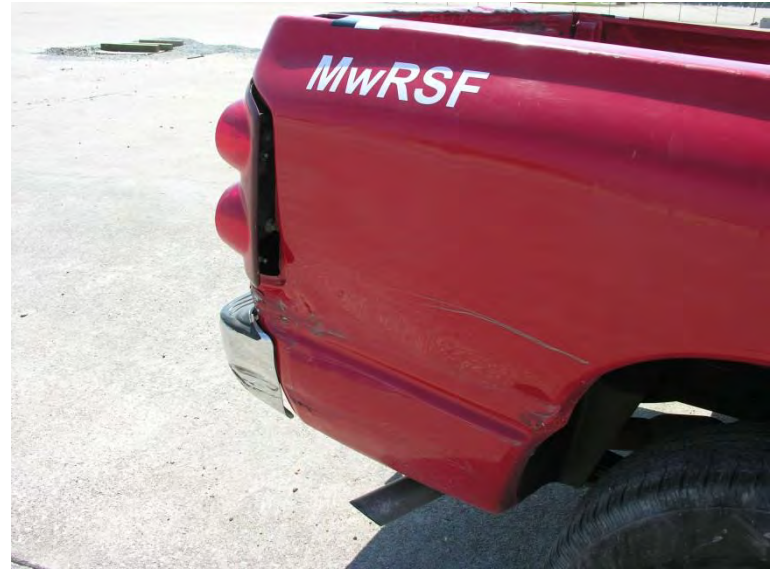
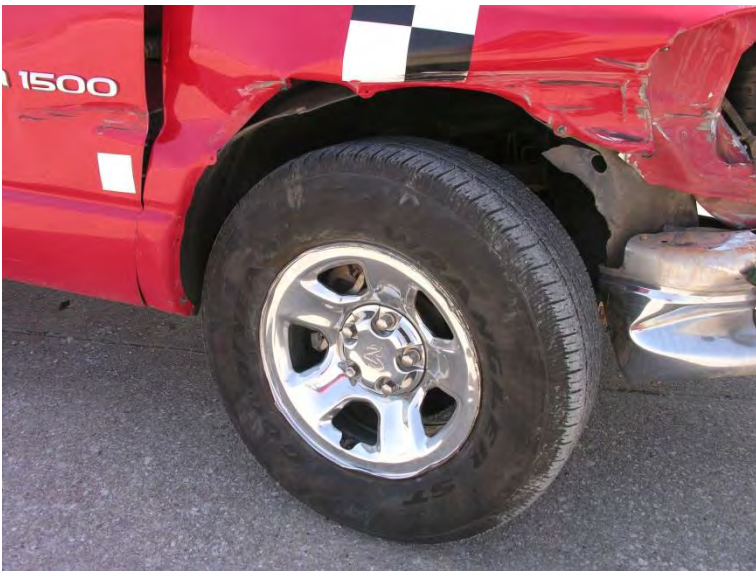
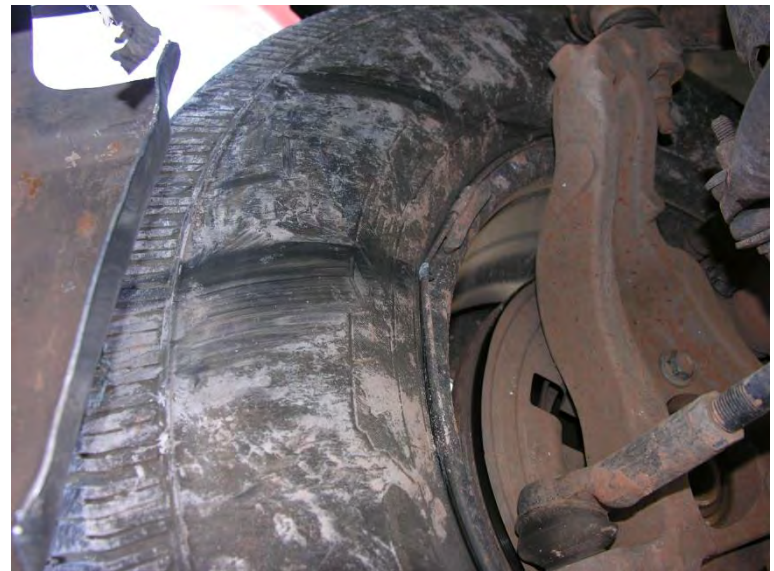
Figure 143. Vehicle Damage, Test No. WIDA-1

The damage to the vehicle was moderate, as shown in Figures 142 through 144. The maximum occupant compartment deformations are listed in Table 13 along with the deformation limits established in MASH for various areas of the occupant compartment. Note that none of the MASH established deformation limits were violated. Complete occupant compartment and vehicle deformations and the corresponding locations are provided in Appendix H.

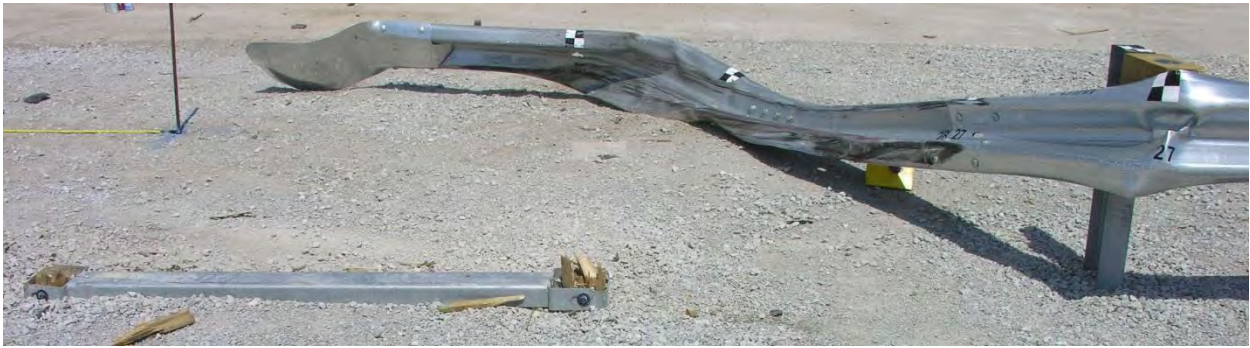
Figure 152. System Damage, Test No. WIDA-2

Damage to the barrier was extensive, as shown in Figures 152 through 156. Barrier damage consisted of deformed W-beam rail and guardrail posts, disengaged rail and wood blockouts, contact marks on posts and guardrail, and fractured end anchorage BCT posts. The length of vehicle contact along the barrier, which spanned from the actual impact point, was approximately 12 ft – 5 in. (3.8 m), at 4 in. (102 mm) upstream from the midspan between post nos. 27 and 28, to 5 in. (127 mm) upstream from the end of the guardrail.

Kinks in the top corrugation of the rail were found between post nos. 28 and 29, as shown in Figures 152 through 156. Flattening of the bottom corrugation of rail started at 4 in. (102 mm) upstream from post no. 28 and extended through 6 in. (152 mm) upstream from post no. 29. The bolt pulled through the W-beam rail slots at the post connections between post nos. 27 and 29, as shown in Figure 153. The W-beam rail buckled at post no. 27, and plastic deformation occurred on the top side of the W-beam rail slot at post nos. 27 through 29, as shown in Figure 154. The upper-front corner of the wood blockout at post no. 27 was fractured off and a $\frac{3}{8}$ -in (10-mm) gap formed between the blockout and the front flange of the post. A $\frac{1}{2}$ -in. (13-mm) soil gap formed

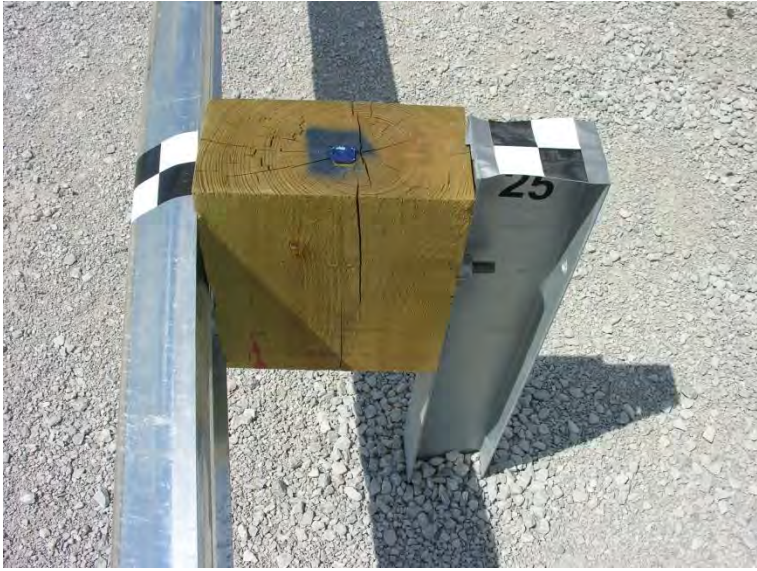
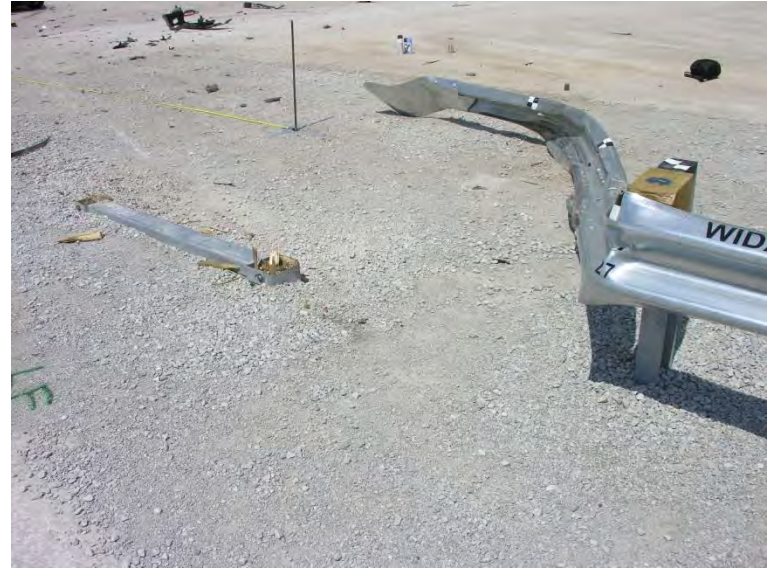
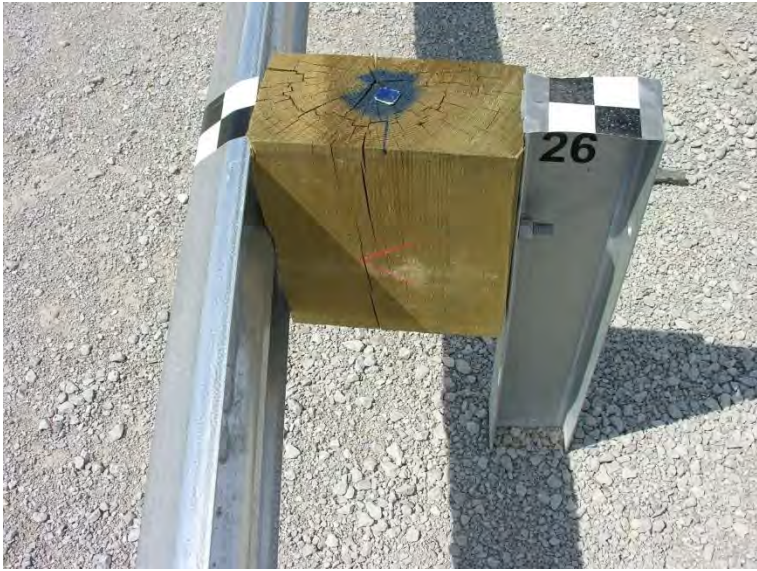
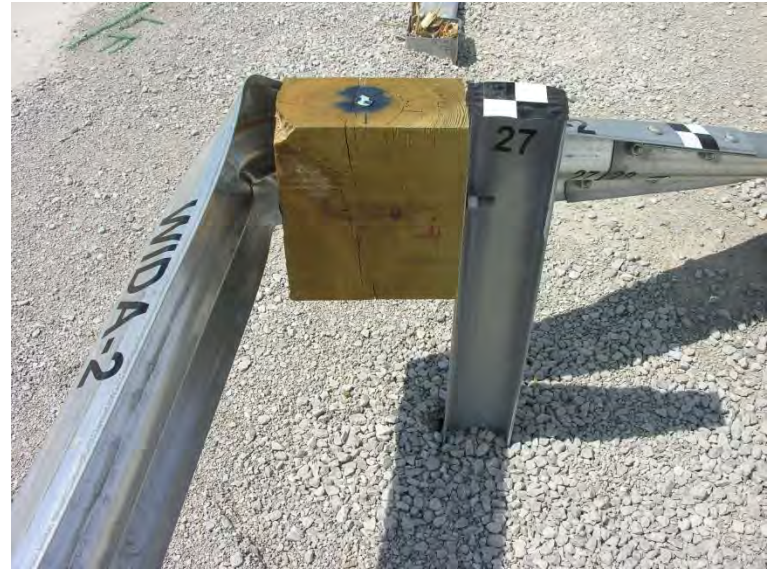
Figure 155. System Damage at Post Nos. 25 through 29, Test No. WIDA-2

in front of post no. 27, as shown in Figure 155. Post no. 28 fractured into three pieces beginning at the bolt connection to the rail through the ground line. Post no. 29 fractured at the ground line.

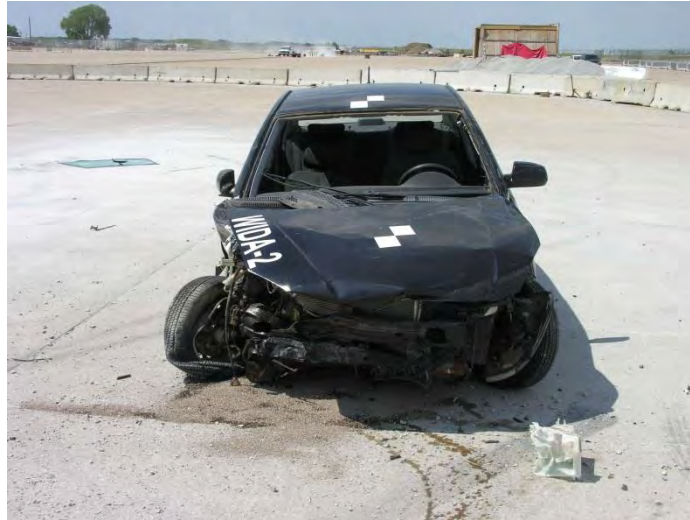
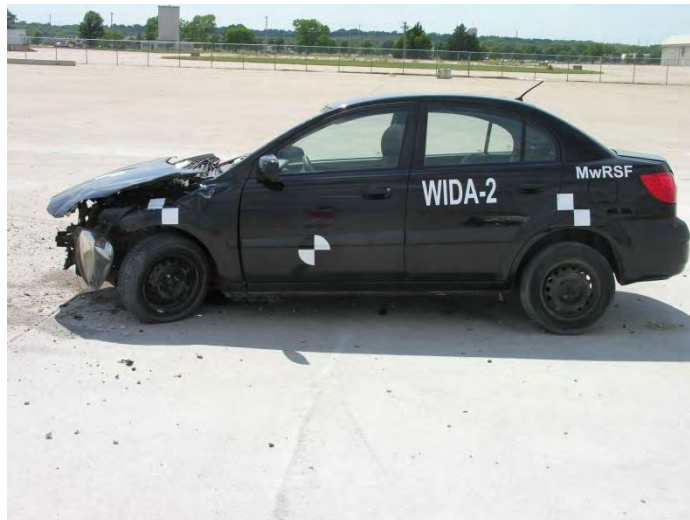
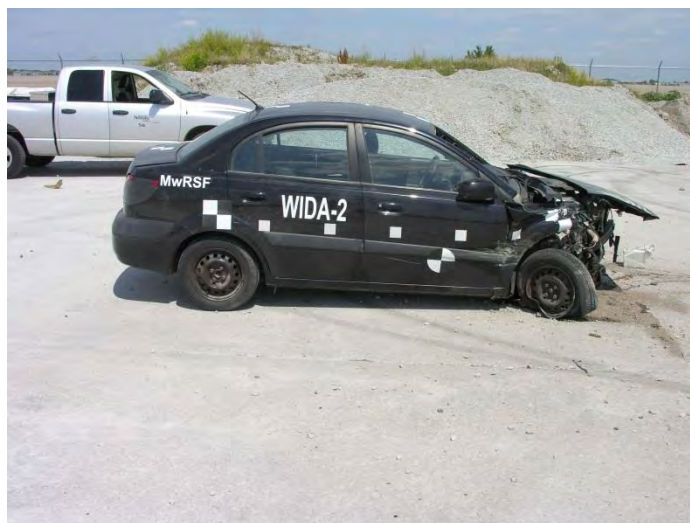
Figure 157. Vehicle Damage, Test No. WIDA-2

The damage to the vehicle was extensive, as shown in Figures 157 through 161. The maximum occupant compartment deformations are listed in Table 17 along with the deformation limits established in MASH for various areas of the occupant compartment. Note that none of the MASH established deformation limits were violated. Complete occupant compartment and vehicle deformations and the corresponding locations are provided in Appendix H.

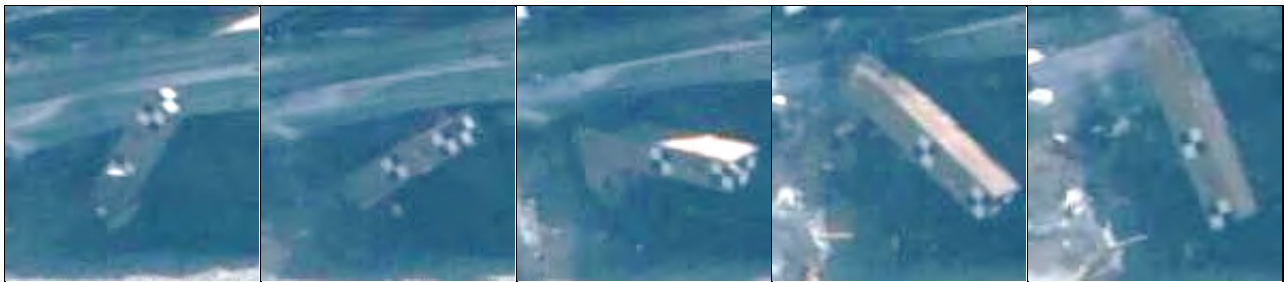
Figure 163. Spinning of Downstream Anchor End Post, Test No. WIDA-2

Inspection of video, barrier damage, and vehicle damage indicated that the impacting tire slid under the anchor cable. This evidence was provided by the sudden rotation of the end wood post after it fractured at its base as a consequence of a direct impact with the vehicle's front

bumper. Although the end post was already tilted more than 45 degrees with respect to its initial vertical configuration, it abruptly began to rotate as a consequence of a pull force applied by the bearing plate, which was still in contact with the fractured post base. The sequence of this rotation event is shown in Figure 163. The sudden tensioning of the anchor cable indicated that the right-front tire wedged under the cable. Further, the wedging under the cable anchor may have been facilitated by a preexisting outward tilt angle of the wheel after it snagged on the previous BCT wood post. In fact, a post-impact investigation showed a large deformation of the external side of the right-front rim, thus indicating considerable snag occurred on the wood post immediately upstream from the end post. This first snag event may have been the cause for the disengagement of the lower suspension arm from the vehicle frame. As a consequence of the damage to the corresponding suspension, the right-front wheel may have been deformed toward the barrier prior to impact with the second BCT post and anchor cable.

Further, evidence suggests that after initially sliding on the top of the wheel, the cable likely slid on the inner side of the tire. In fact, had the cable been in contact with the outer side of the wheel, it would have been immediately pushed backward, and the bearing plate would have been unable to contact the vehicle's front end and right-front side.

Numerical simulations indicated that a simple-support connection between the W-beam rail and the end post would increase the penetration of the cable anchor into the wheel well. Thus, this type of connection is not recommended. Future design improvements should consider

either shielding the anchor cable from the tire of the impacting vehicle or allowing the bearing plate to promptly release after the end post fractures. The latter option would eliminate the potential for the vehicle's front end to become being entangled with the cable once it is free to move upon fracture of the end post.
