**Roadside Safety
Pooled Fund**

**Texas A&M
Transportation
Institute**

Test Report No. 609731-5&6
Test Report Date: August 2021

EVALUATION OF MODIFIED MINNESOTA SWING-AWAY MAILBOX

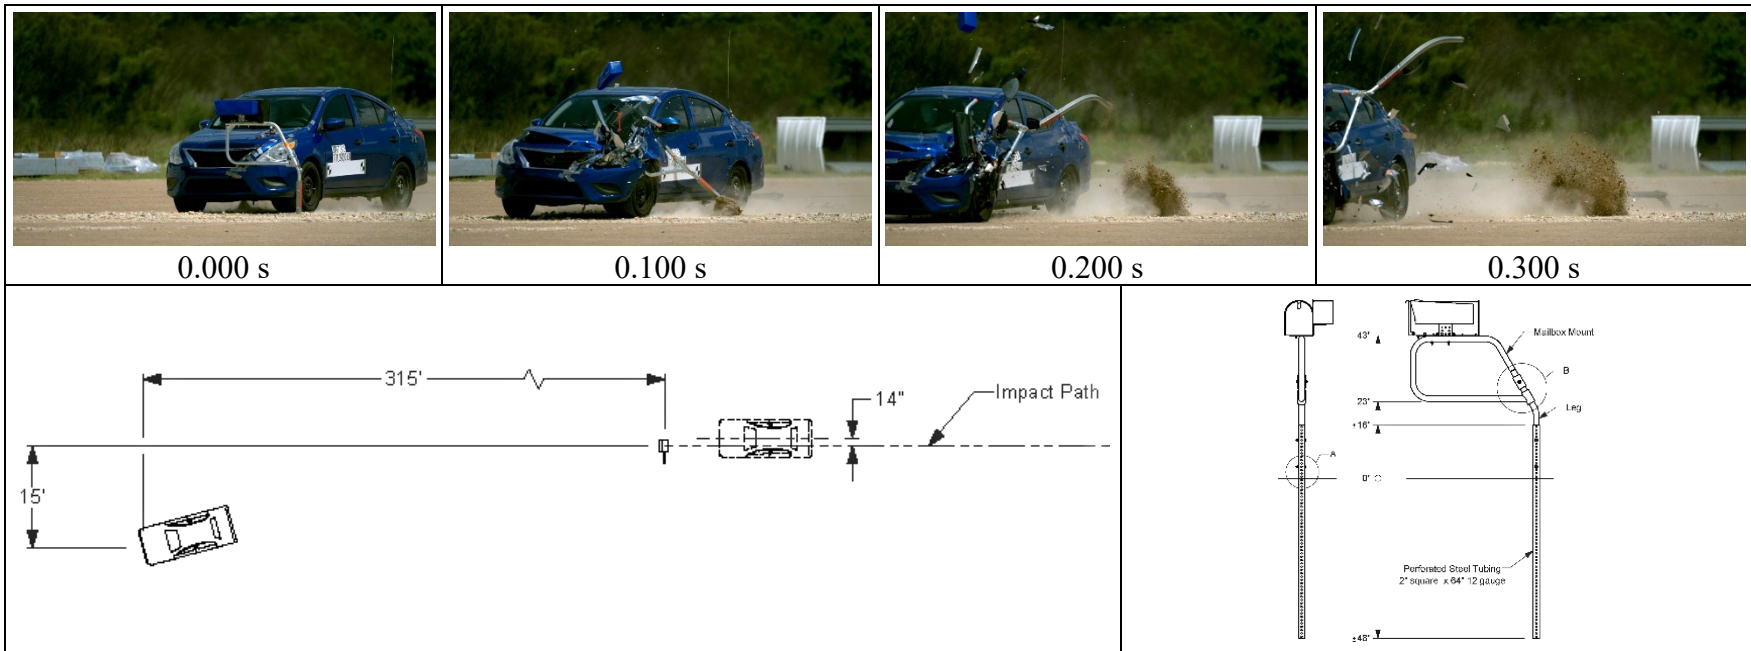
Figure 5.3 shows the damage to the mailbox. The perforated steel tubing pulled completely out from the ground, and the entire mailbox assembly landed 319 ft downstream and 30 ft to the left of impact, except for the newspaper box, which disconnected from the mailbox at impact. The mailbox was deformed, and the top portion of the mailbox mount opened and separated from the leg.

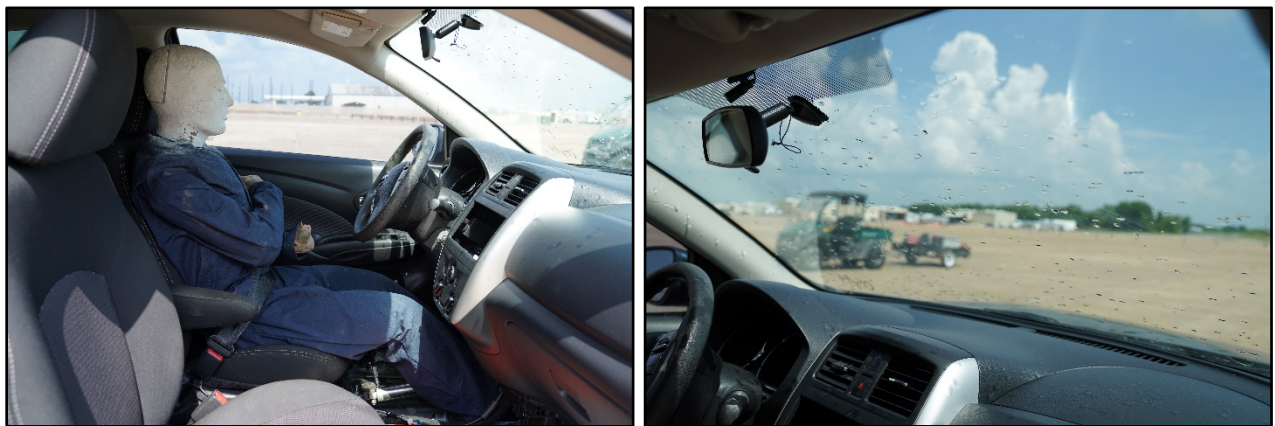
Figure 6.4. Interior of Test Vehicle after Test No. 609731-6.

Figure 6.3 shows the damage sustained by the vehicle. The front bumper, hood, and grill were damaged. The hood sustained two deformation areas; one 4 inches \times 6 inches \times 1.25 inches deep to the right of centerline, and another 8 inches \times 8 inches \times 2.5 inches deep 19 inches to the left of centerline. The windshield was not cracked, shattered, or torn. No fuel tank damage was observed. Maximum exterior crush to the vehicle was 4.0 inches in the front plane at the front at bumper height. No occupant compartment deformation or intrusion was observed. Figure 6.4 shows the interior of the vehicle. Tables D.3 and D.4 in Appendix D.1 provide exterior crush and occupant compartment measurements.
