Test Report No. 619541-01-1 & 2

MASH TL-3 EVALUATION OF SIGN POSTS WITH FLASHING BEACON EQUIPMENT

Sponsored by
Roadside Safety Pooled Fund

November 2024

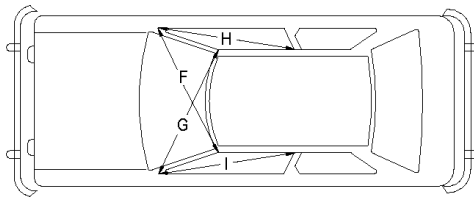
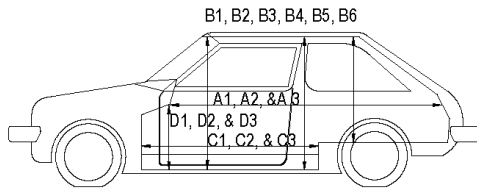
Figure C.2. Exterior Crush Measurements for Test 619541-01-1.

Before	After (inches)	Differ.
A1	67.50	67.50	0.00
A2	67.25	67.25	0.00
A3	67.75	67.75	0.00
B1	40.50	40.50	0.00
B2	39.00	39.00	0.00
B3	40.50	40.50	0.00
B4	36.25	33.25	-3.00
B5	36.00	33.25	-2.75
B6	36.25	36.00	-0.25
C1	26.00	26.00	0.00
C2	0.00	0.00	0.00
C3	26.00	26.00	0.00
D1	9.50	9.50	0.00
D2	0.00	0.00	0.00
D3	9.50	9.50	0.00
E1	51.50	51.50	0.00
E2	51.00	51.00	0.00
F	51.00	51.00	0.00
G	51.00	51.00	0.00
H	37.50	37.50	0.00
I	37.50	37.50	0.00
J*	51.00	51.00	0.00
