Test Report No. TRNo. 618911-01-1 - 3

EVALUATION OF A FOUR BOLT SLIP BASE FOR BREAKAWAY LUMINAIRE SUPPORTS WITH VARIOUS POLE CONFIGURATIONS

Sponsored by The Roadside Safety Pooled Fund

TEXAS A&M TRANSPORTATION INSTITUTE PROVING GROUND

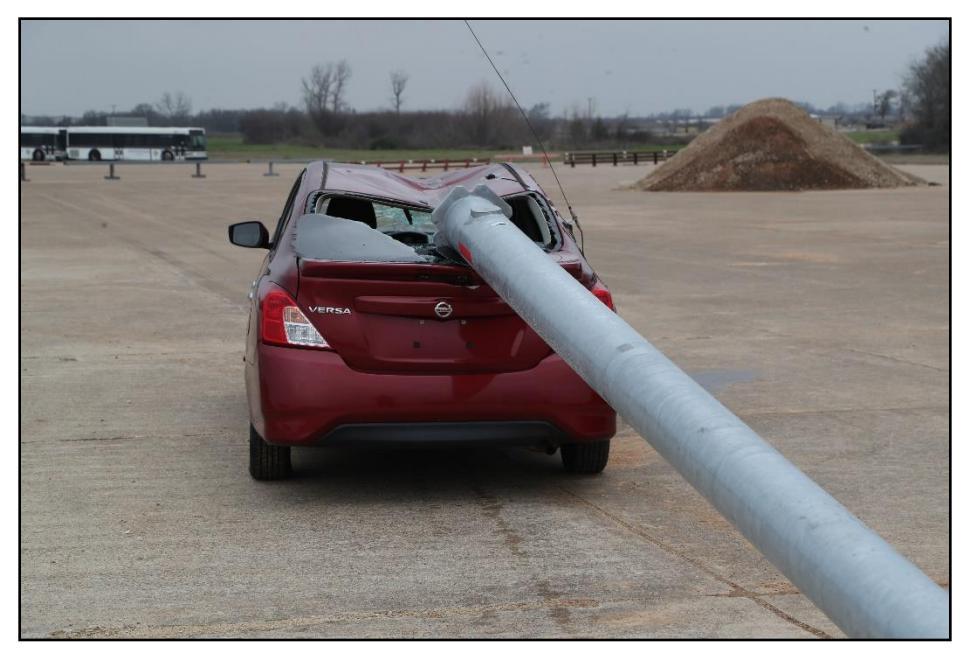
Figure 7.8. Rear Impact Side of Test Vehicle after Test 618911-01-1.

Side Windows	Side windows remained intact		
Maximum Exterior Deformation	12 inches at the front bumper		
VDS	12FC5		
CDC	12FCAW6		
Fuel Tank Damage	None		
Description of Damage to Vehicle:	The bumper, grill, hood, radiator, and roof were crushed. The front windshield was fractured, and the rear window glass was shattered. A section of the carpet inside the occupant compartment was ripped near the rear window. There was a small dent in the sheet metal under the rear windshield. There was a dent on the trunk lid and a cracked rear spoiler.

Due to the 6.3 inch dent in the roof and the penetration of the base of the luminaire pole through the back glass, this test failed to meet evaluation criteria D of *MASH* for support structures. Figure 7.11 summarizes the results of *MASH* Test 618911-01-1.

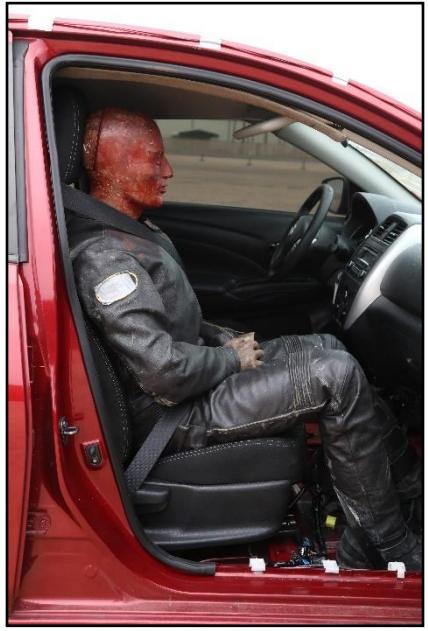
Figure 7.9. Overall Interior of Test Vehicle after Test 618911-01-1.

Test Parameter	Specification	Measured
Roof	≤4.0 inches	6.3 inches
Windshield	≤3.0 inches	0 inches
A and B Pillars	≤5.0 overall/≤3.0 lateral inches	0 inches
Foot Well/Toe Pan	≤9.0 inches	0 inches
Floor Pan/Transmission Tunnel	≤12.0 inches	0 inches
Side Front Panel	≤12.0 inches	0 inches
Front Door (above Seat)	≤9.0 inches	0 inches
Front Door (below Seat)	≤12.0 inches	0 inches

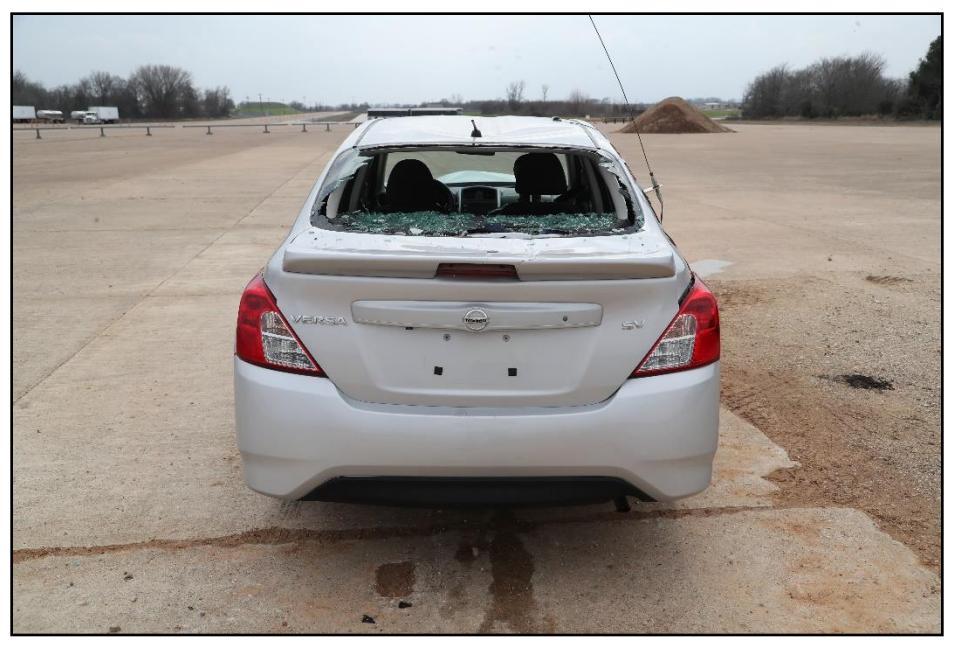
Figure 8.8. Rear of Test Vehicle after Test 618911-01-2.

Side Windows	Side windows remained intact
Maximum Exterior Deformation	13 inches at the front bumper
VDS	12FC5
CDC	12FCHW6
Fuel Tank Damage	None
Description of Damage to Vehicle:	The hood, bumper, grill, radiator, and cross bar support were bent. There were two cracks at the top of the windshield, with a 33-inch-wide x 5-inch-long x 1.8-inch-deep dent in the roof. There was carpet ripped and two small dents inside the vehicle occupant compartment near where the rear window was shattered. There was a small dent on the trunk lid, and the rear spoiler was cracked.

Due to occupant compartment penetration in the back window from the test article, this test failed to meet evaluation criteria D of *MASH*. Figure 8.10 summarizes the results of *MASH* Test 618911-01-2.

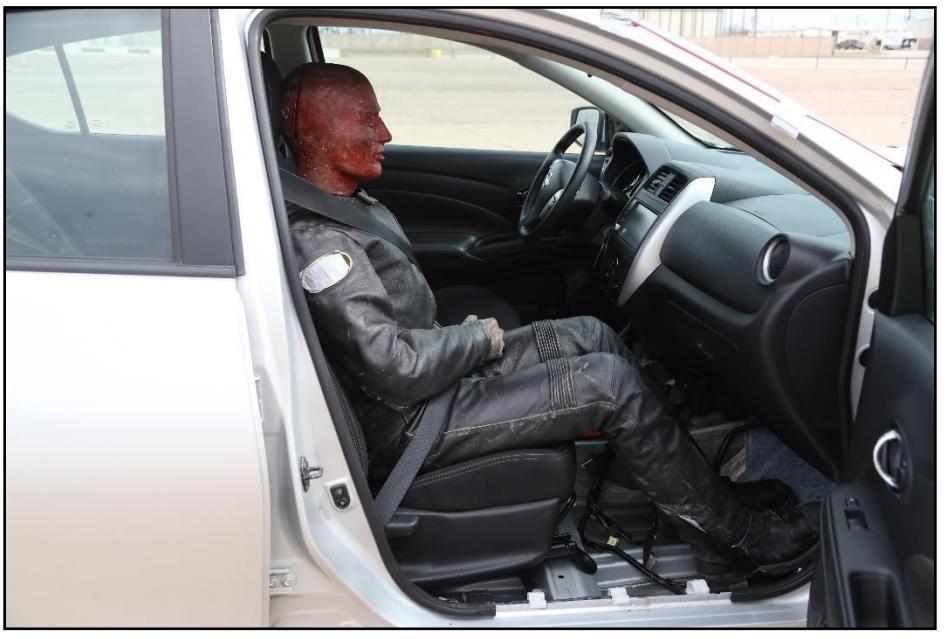
Figure 8.9. Interior of Test Vehicle after Test 618911-01-2.

Test Parameter	Specification	Measured
Roof	≤4.0 inches	1.8 inches
Windshield	≤3.0 inches	0 inches
A and B Pillars	≤5.0 overall/≤3.0 inches lateral	0 inches
Foot Well/Toe Pan	≤9.0 inches	0 inches
Floor Pan/Transmission Tunnel	≤12.0 inches	0 inches
Side Front Panel	≤12.0 inches	0 inches
Front Door (above Seat)	≤9.0 inches	0 inches
Front Door (below Seat)	≤12.0 inches	0 inches

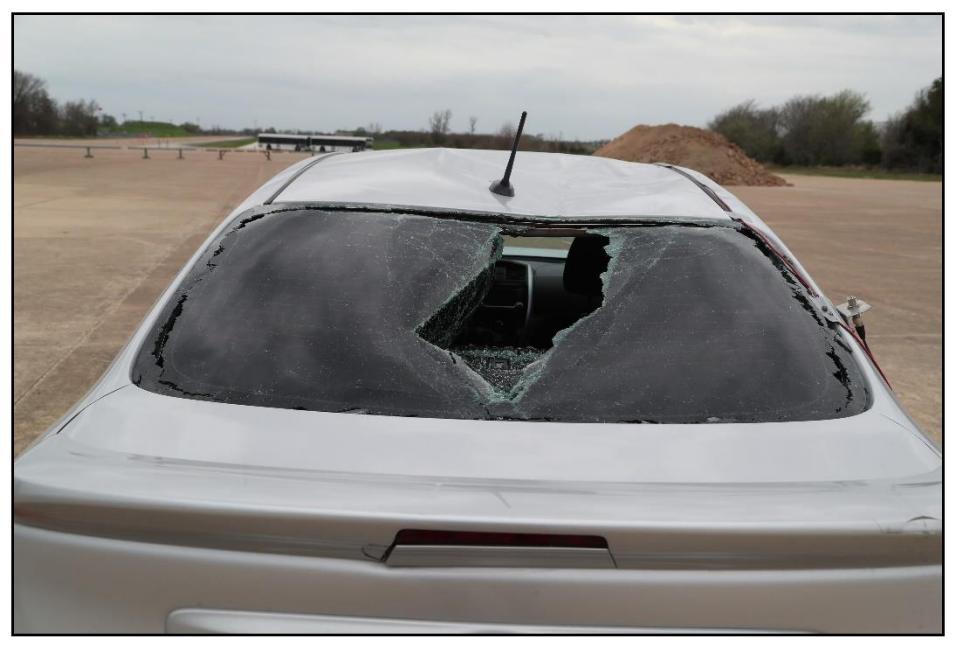
Figure 9.8. Rear of Test Vehicle after Test 618911-01-3.

Side Windows	Side windows remained intact		
Maximum Exterior Deformation	9 inches at the front bumper		
VDS	12FC4		
CDC	12FCHW4		
Fuel Tank Damage	None		
Description of Damage to Vehicle:	The roof was damaged with a max depth of 2.8 inches. The front windshield was cracked but no holes were present. The back windshield was shattered but there was no indication of occupant compartment penetration. The bumper, grill, and hood were damaged.

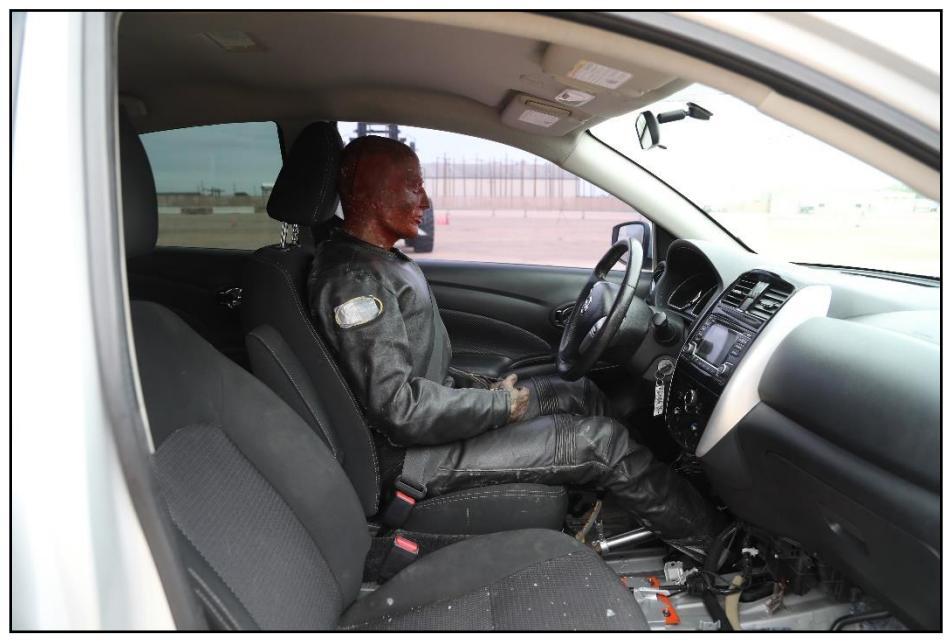
Figure 9.9. Overall Interior of Test Vehicle after Test 618911-01-3.

Test Parameter	Specification	Measured
Roof	≤4.0 inches	2.8 inches
Windshield	≤3.0 inches	0.0 inches
A and B Pillars	≤5.0 overall/≤3.0 inches lateral	0.0 inches
Foot Well/Toe Pan	≤9.0 inches	0.0 inches
Floor Pan/Transmission Tunnel	≤12.0 inches	0.0 inches
Side Front Panel	≤12.0 inches	0.0 inches
Front Door (above Seat)	≤9.0 inches	0.0 inches
Front Door (below Seat)	≤12.0 inches	0.0 inches
