Test Report No. 616401-01

MULTI-DIRECTIONAL BASE DESIGN FOR STEEL BEAM NON-PROPRIETARY LARGE SIGN SUPPORTS

Sponsored by Roadside Safety Pooled Fund

TEXAS A&M TRANSPORTATION INSTITUTE PROVING GROUND

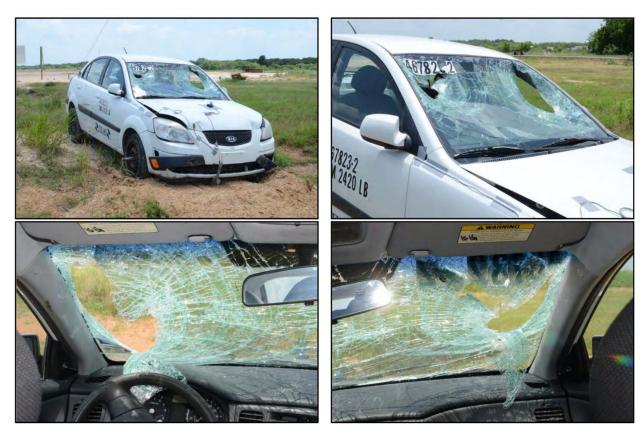
Figure 2-2. Direct Embedded Wood Support Temporary Guide Sign System 3-61 Test Vehicle Failure Damage (3)

The objective of this research was to develop support systems for temporary installations of guide signs. The report includes crash tests conducted on two wooden sign support designs and one steel sign support design. Both utilized large aluminum signs. The first support tested, shown in Figure 2-1, consisted of three 6-inch \times 8-inch, Grade 1, Southern Yellow Pine wood supports. The supports were spaced 33 inches apart and were weakened with 4-inch diameter holes located 4 inches and 18 inches above grade. An 8-ft \times 16-ft wide (128 square ft) aluminum sign was supported. This design passed the *MASH* 3-60 low speed test (19 mi/hr) at 0 degrees but failed the *MASH* 3-61 high speed test (62 mi/hr) at 0 degrees due to windshield penetration. Figure 2-2 shows the vehicle damage from the *MASH* test 3-61.

After analyzing the failure, researchers proposed a design including a ¼-inch diameter cable to restrict the rotation of the support towards the vehicle upon impact. This support system was evaluated with *MASH* test 3-61 conditions at the 0-degree impact angle. The modification resulted in no occupant compartment intrusion and passed the evaluation criteria. Next, *MASH* test 3-62 at the 0-degree impact angle was conducted on the modified support system. The modified system also passed *MASH* test 3-62 evaluation criteria. Figure 2-3 shows a drawing of the successful modified design.

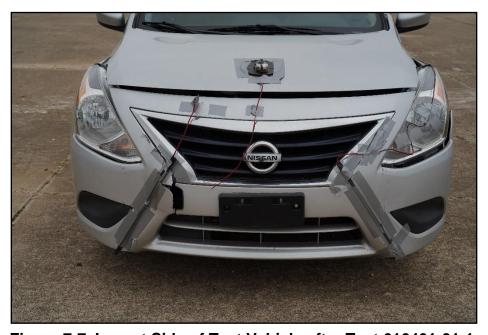
Figure 7-7. Impact Side of Test Vehicle after Test 616401-01-1.

Figure 7-7 through Figure 7-9 show the damage sustained by the vehicle. and Figure 7-10 shows the interior of the test vehicle. Table 7.6 and Table 7.7 provide details on the occupant compartment deformation and exterior vehicle damage. Figures C.2 and C.3 in Appendix C.1 provide exterior crush and occupant compartment measurements.

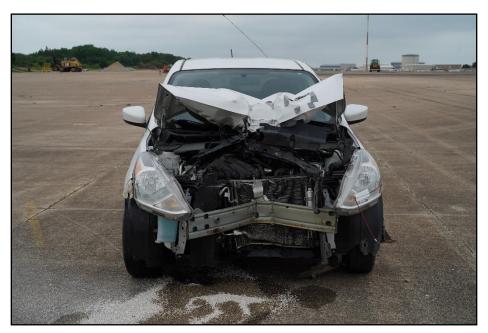
Figure 8-7. Impact Side of Test Vehicle after Test 616401-01-2.

Figure 8-7 through Figure 8-9 show the damage sustained by the vehicle. Figure 8-10 shows the interior of the test vehicle. Table 8.6 and Table 8.7 provide details on the occupant compartment deformation and exterior vehicle damage. Figures D.2 and D.3 in Appendix D.1 provide exterior crush and occupant compartment measurements.

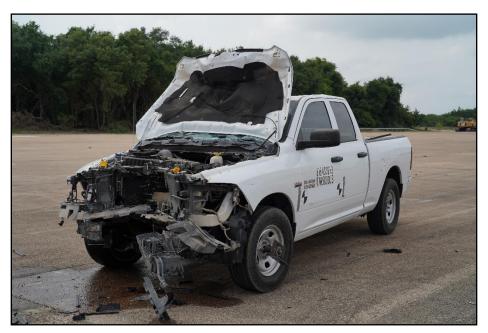
Figure 9-7. Impact Side of Test Vehicle after Test 616401-01-3.

Side Windows	Side windows remained intact
Maximum Exterior Deformation	15 inches in the front plane at the front bumper
VDS	12FC5
CDC	12FCHW5
Fuel Tank Damage	None
Description of Damage to Vehicle:	There were multiple tears on the exterior of the vehicle. The hood had a 3-inch wide × 19-inch long tear. The roof had a 1-inch wide × 10-inch long tear in the center near the front, a 1-inch wide × 2-inch long tear on the front right near the center, a 2-inch wide × 7-inch long tear on the front left near the center, and 5.5-inch wide × 17-inch long rip near the rear. The front bumper released from the vehicle, and the grill and radiator were fractured and deformed, which caused the fan to push into the engine block. The right and left headlights released from the vehicle, and the hood latch released, resulting in the hood flying into the windshield. The windshield was severely fractured and deformed 5 inches into occupant compartment, and the rear windshield was shattered.

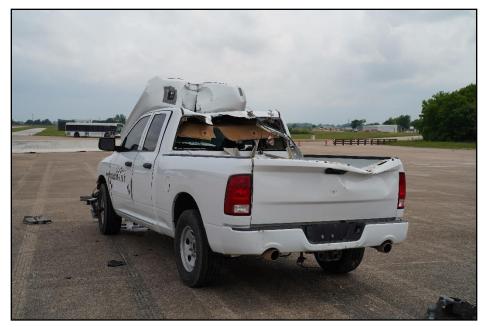
Figure 9-8. Rear of the Test Vehicle after Test 616401-01-3.

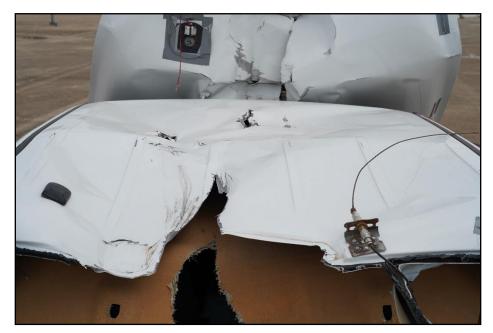
Figure 9-9. Roof of the Test Vehicle after Test 616401-01-3.

Figure 9-11 summarizes the results of *MASH* Test 616401-01-3. Due to the 6.5 inch deformation in the roof exceeding the *MASH* limit of 4 inches, and the penetration of the test article through the roof, the guide sign with large sign supports failed to meet *MASH* Criteria D for *MASH* test 3-62.

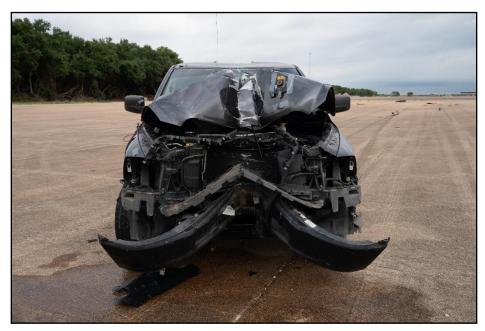
Figure 10-7. Impact Side of Test Vehicle after Test 616401-01-9.

Side Windows	Side windows remained intact
Maximum Exterior Deformation	9 inches in the front plane at the front bumper
VDS	12FC5
CDC	12FCAW3
Fuel Tank Damage	None
Description of Damage to Vehicle:	The windshield had a 3-inch wide × 1.5-inch long tear on the lower left side 5 inches from its base near the center along with a 1 inch deformation in the windshield. There were multiple tears on the exterior of the vehicle. The roof had a 1.3-inch wide × 19-inch long tear 25 inches from the front of the windshield and 21 inches across from the left front door, an 18-inch wide × 1.5-inch long tear 24 inches from front of windshield 25 inches across from left front door, and a 7-inch wide × 1.3-inch long tear at the rear 17 inches away from left rear door. The bumper, grill, hood, radiator, and support were damaged, and the bumper frame and mounting brackets were bent. Both headlights were fractured, and the oil pan and drive shaft were dented.

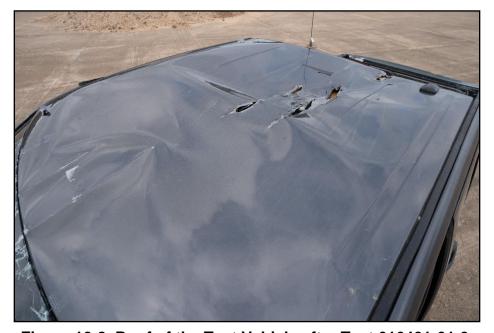
Figure 10-8. Roof of the Test Vehicle after Test 616401-01-9.

Figure 10-12 summarizes the results of *MASH* Test 616401-01-9. Due to the penetration of the installation into the roof the guide sign with large sign supports failed to meet *MASH* Criteria D for *MASH* test 3-62.

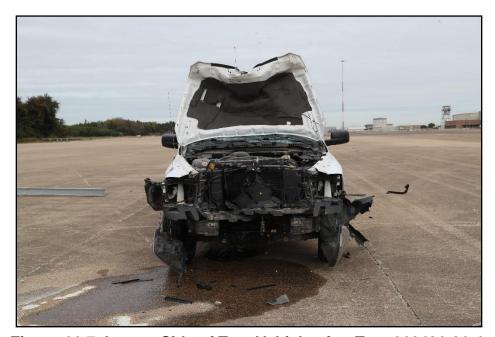
Figure 11-7. Impact Side of Test Vehicle after Test 616401-01-4.

Side Windows	Side windows remained intact
Maximum Exterior Deformation	13 inches in the front plane above the bumper
VDS	12FC3
CDC	12FCHW3
Fuel Tank Damage	None
Description of Damage to Vehicle:	The roof was damaged, with a 30-inch long \times 30-inch wide \times 1.3-inch deep dent, a 5-inch long \times 0.8-inch wide tear 8 inches from the left rear door and 22 inches from the back of the cab, a 3.3-inch long \times 0.8-inch wide tear 13 inches from the left rear door and 19 inches from the back of the cab, and a 5-inch long \times 1-inch wide tear in the roof at the brake light, which was shattered. The headlights and tailgate released from the vehicle. The bumper, grill, radiator, and supports were deformed, causing the fan to push into the motor. The hood released from the latch and flew into the windshield, fracturing it and causing a deformation with a maximum depth of 3 inches.

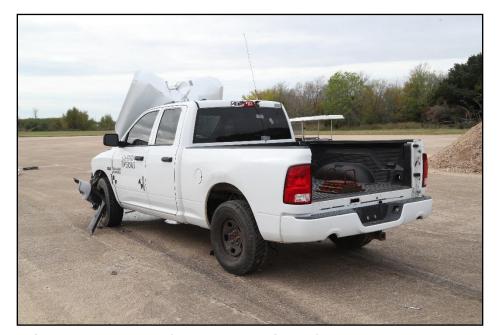
Figure 11-8. Rear of the Test Vehicle after Test 616401-01-4.

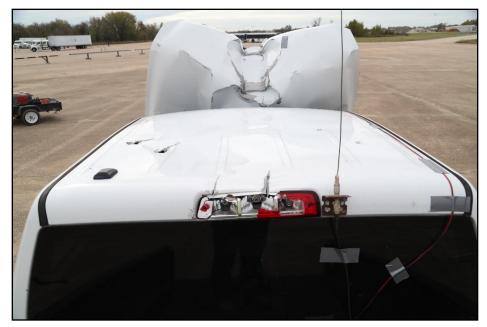
Figure 11-9. Roof of the Test Vehicle after Test 616401-01-4.

Figure 11-11 summarizes the results of *MASH* Test 616401-01-4. Due to the penetration of the post into the vehicle's roof, the guide sign with large sign supports failed to meet evaluation criteria D for *MASH* test 3-62.

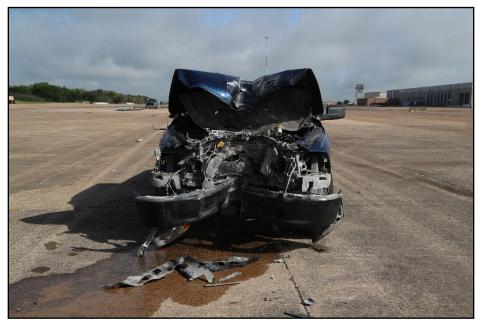
Figure 12-7. Impact Side of Test Vehicle after Test 616401-01-8.

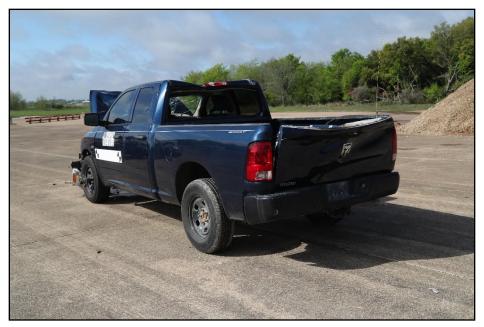
Figure 12-8. Rear of the Test Vehicle after Test 616401-01-8.
