Test Report No. 618901-01-2-1:7

**PORTABLE SIGN SUPPORTS FOR ALUMINUM SIGNS WITH  
VARIATIONS ON MOUNTING HEIGHT**

Sponsored by  
**The Roadside Safety Pooled Fund**

**TEXAS A&M TRANSPORTATION INSTITUTE PROVING GROUND**

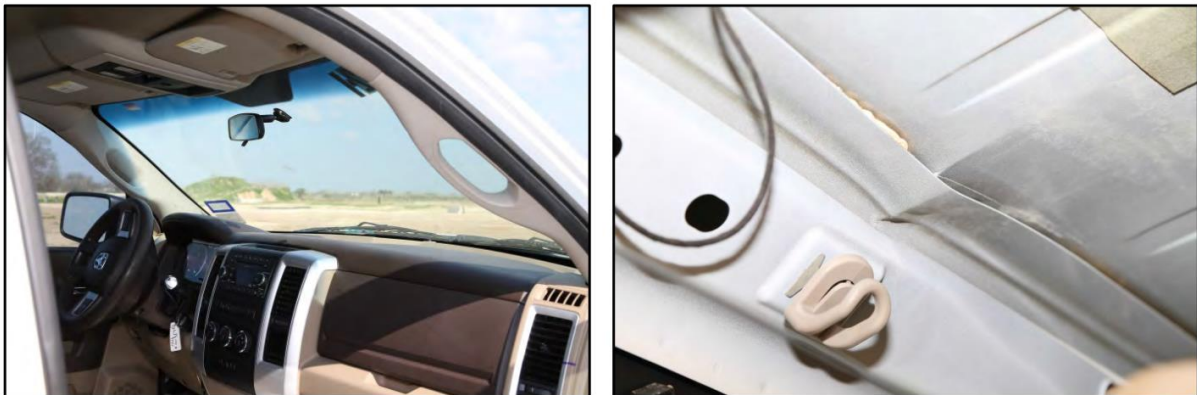
**Figure 2.8. Temporary High-Mounting Sign Support, Option A Test 3-72, 90-degree Impact Vehicle Interior Damage (2)**

Figure 2.7 shows the damage sustained by the vehicle. On the rear of the roof, there was a 16-inch scratch that ended in a 5-inch tear on the outer surface. The cut did not extend into the passenger compartment. The interior roof around the cut was dented approximately one inch, as shown in Figure 2.8. No other occupant compartment deformation or intrusion was noted.

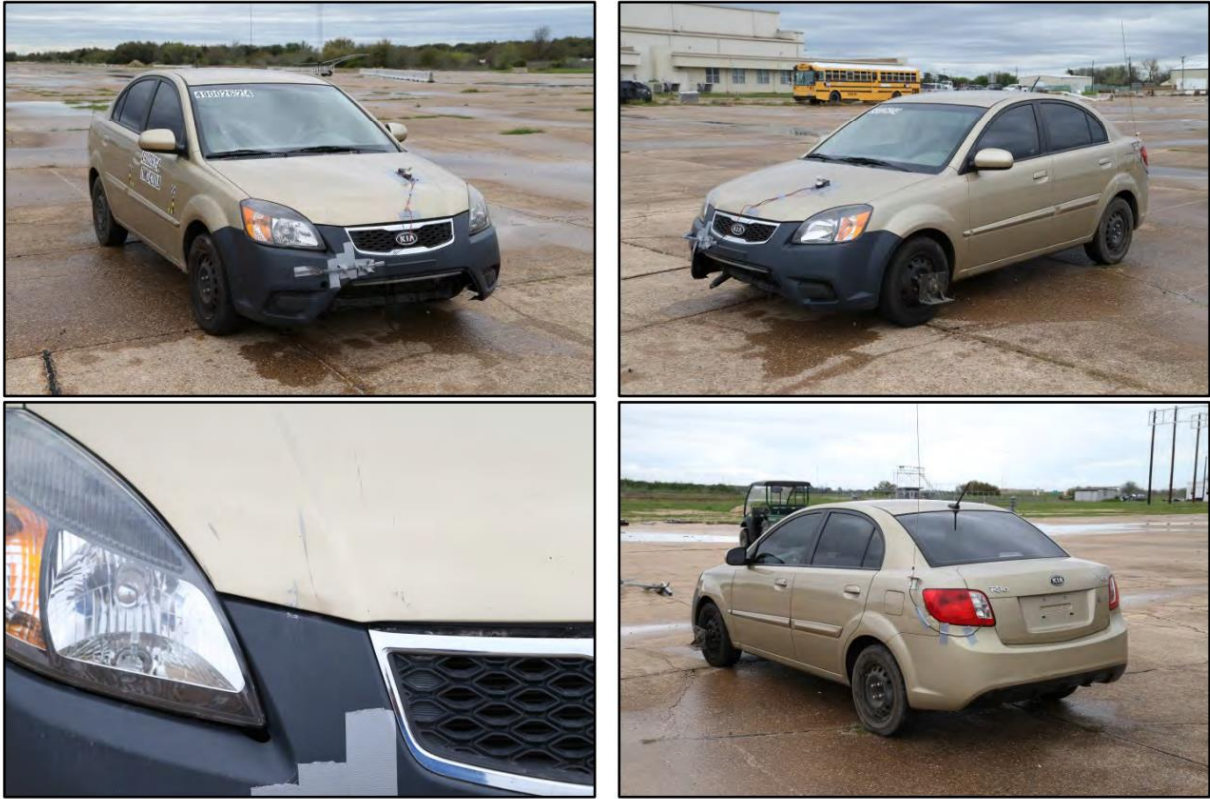
**Figure 2.20. Temporary High-Mounting Sign Support, Option B Test 3-71, 90-degree Impact Vehicle Damage (2)**

In *MASH* test 3-71 (test 4900026-2-4), the 1100C small car, traveling at an impact speed of 60.9 mi/h, contacted the Option B temporary work zone sign support 10 inches to the right of centerline of the vehicle at an impact angle of 90 degrees. The fuse plates connecting the middle and upper section of the support successfully activated. Figure 2.17 and Figure 2.18 present sequential photographs of the test. Figure 2.19 shows the damage to the Option B temporary work zone sign support. Figure 2.20 shows the damage sustained by the vehicle. No occupant compartment deformation or intrusion was noted.

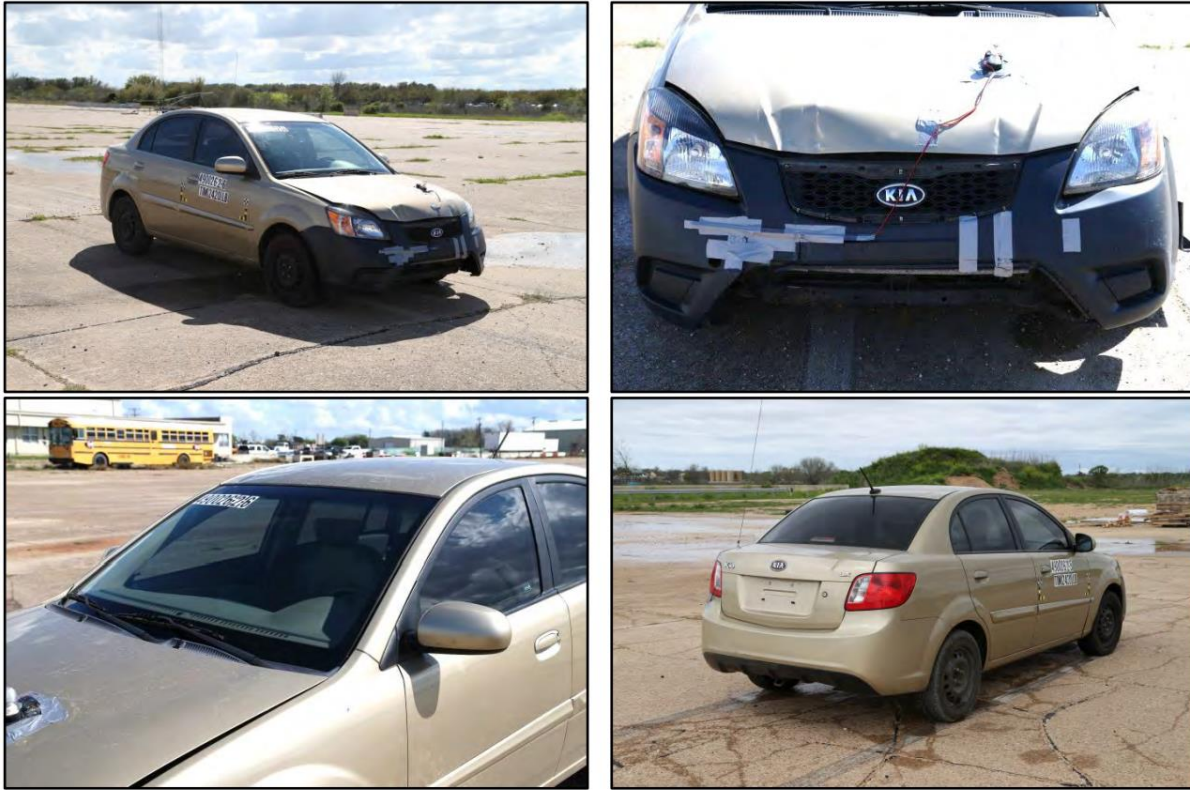
**Figure 2.24. Temporary High-Mounting Sign Support, Option B Test 3-71, 0-degree Impact Vehicle Damage (2)**

In *MASH* test 3-71 (test 4900026-2-6), the 1100C contacted the Option B temporary work zone sign support 10 inches to the right of centerline of the vehicle at an impact angle of 0 degrees while traveling at an impact speed of 61.7 mi/h. Figure 2.21 and Figure 2.22 present sequential photographs during the test. Figure 2.23 shows the damage to the Option B temporary work zone sign support. Figure 2.24 shows the damage sustained by the vehicle. No occupant compartment penetration, deformation, or intrusion was noted.

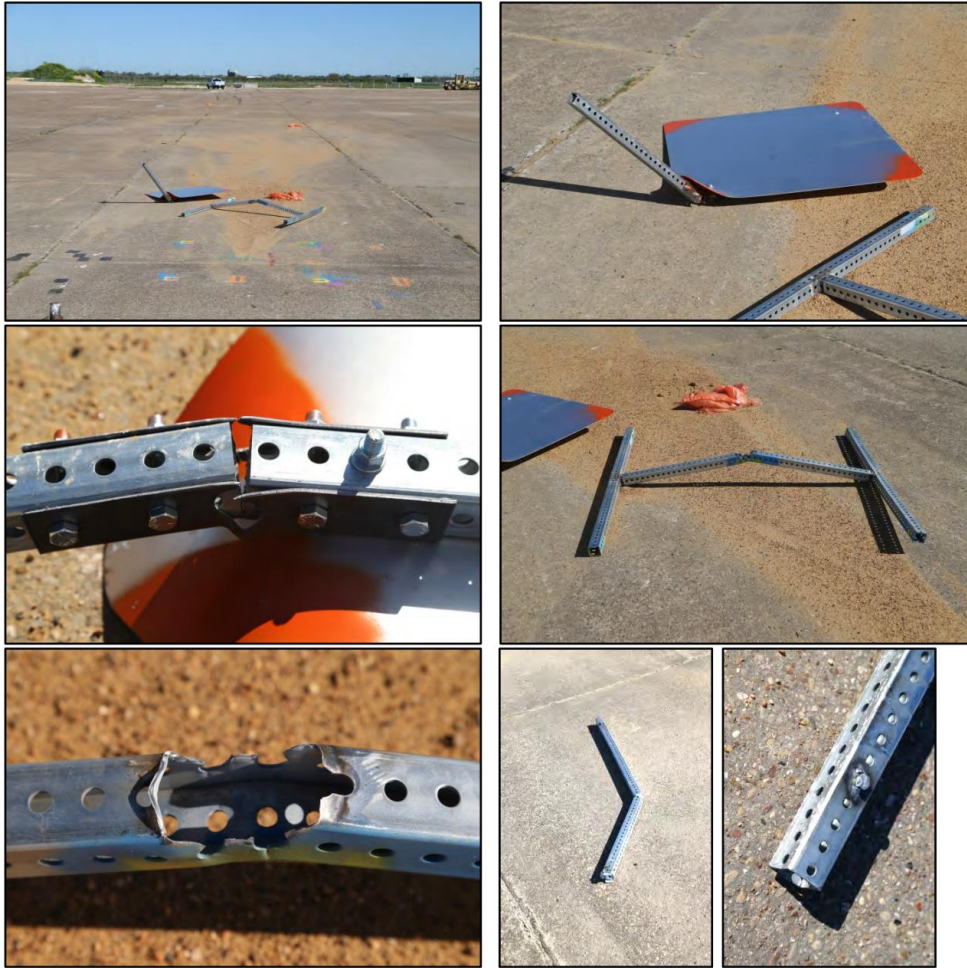
**Figure 2.27. Temporary High-Mounting Sign Support, Option B Test 3-72, 0-degree Impact System Damage (2)**

In *MASH* test 3-72 (test 4900026-2-8), The 2270P pickup truck contacted the Option B temporary work zone sign support 10 inches to the left of centerline of the vehicle at an impact angle of 0 degrees while traveling at an impact speed of 62.1 mi/h. Figure 2.25 and Figure 2.26 present sequential photographs during the test. Figure 2.27 shows the damage to the Option B temporary work zone sign support. Figure 2.28 shows the damage sustained by the vehicle. No occupant compartment deformation or intrusion was noted.

Figure 2.31 provides a summary of the results of test 3-71 with a 0-degree impact. There was no secondary contact between the sign panel and the roof of the vehicle. Figure 2.32 provides a summary of the results of test 3-72 with a 0-degree impact. The lower section of the vertical support fractured but did not penetrate or show potential for penetrating the vehicle. No occupant compartment deformation or intrusion was noted.

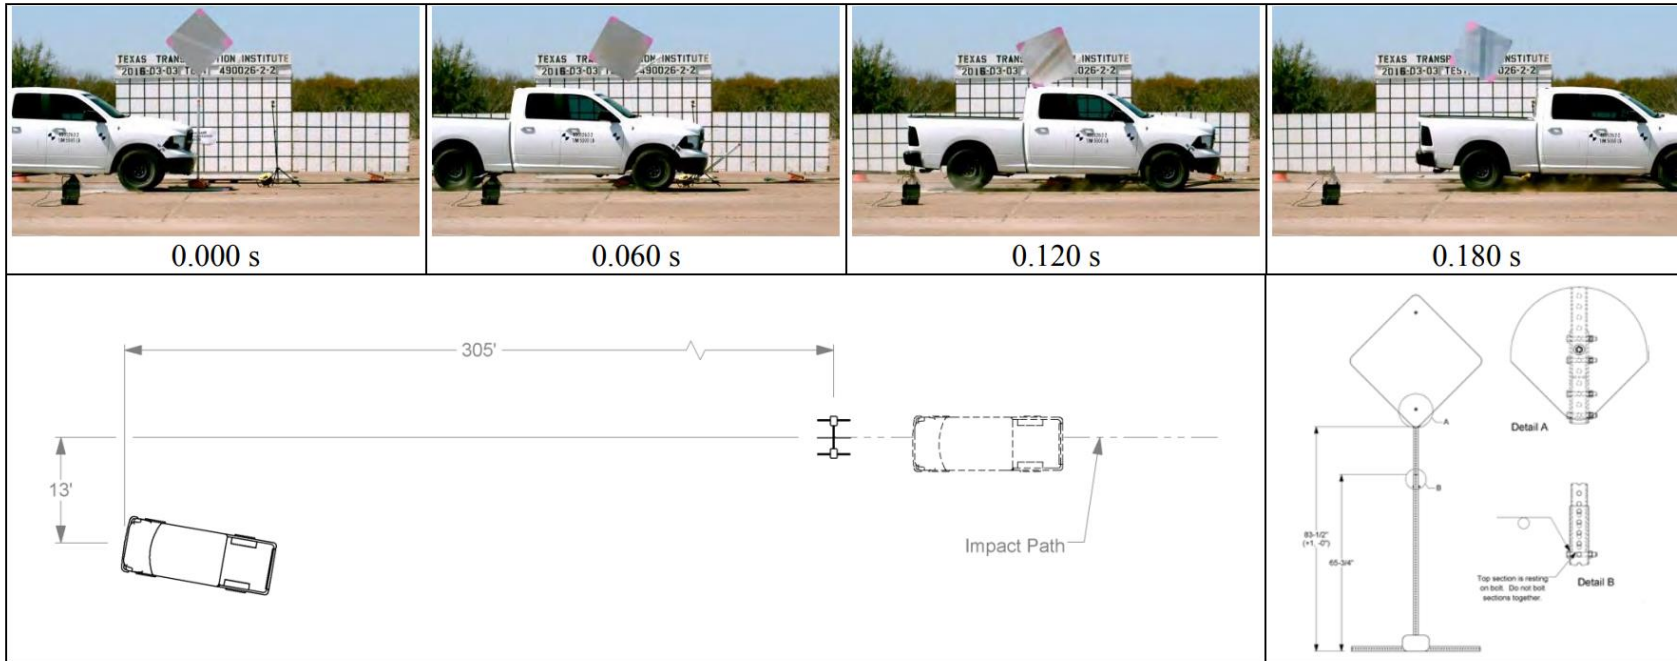
**Figure 2.29. Temporary High-Mounting Sign Support, Option B Test 3-72, 90-degree Impact Results (2)**

Figure 2.29 provides a summary of the results of test 3-72 with a 90-degree impact. The fuse plate between the upper and middle sections of the vertical support

VDS..... 12FL1  
 CDC..... 12FLEN1  
 Max. Exterior Deformation..... 2.5 inches  
 OCDI..... RR0000000  
 Max. Occupant Compartment Deformation..... None

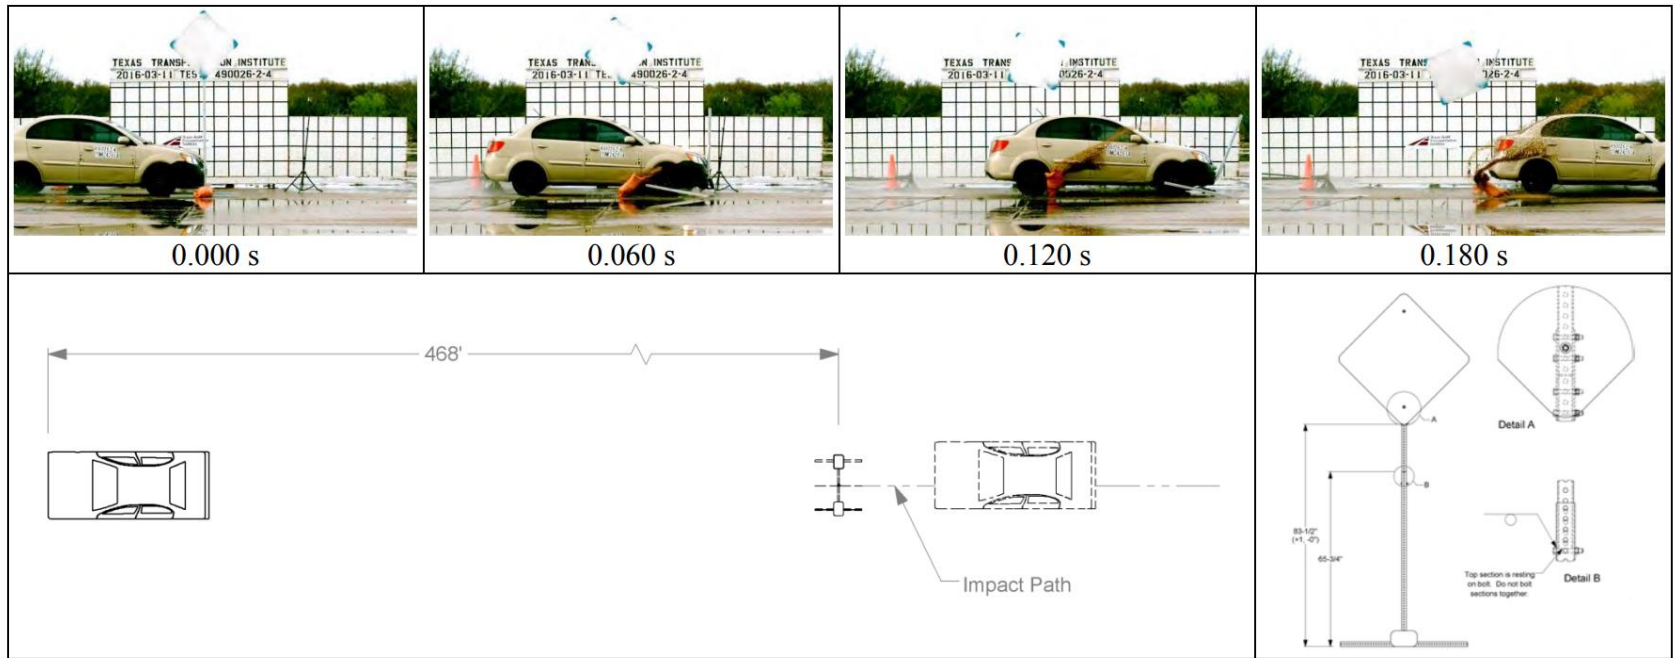
**Figure 2.30. Temporary High-Mounting Sign Support, Option B Test 3-71, 90-degree Impact Results (2)**

Figure 2.30 provides a summary of the results of test 3-71 with a 90-degree impact. The fuse plate between the upper and middle sections of the vertical support activated as designed. There was no secondary contact between the sign panel and the roof of the vehicle.

VDS ..... 12FR1  
 CDC ..... 12FREN1  
 Max. Exterior Deformation ..... None  
 OCDI ..... RF0000000  
 Max. Occupant Compartment Deformation ..... None

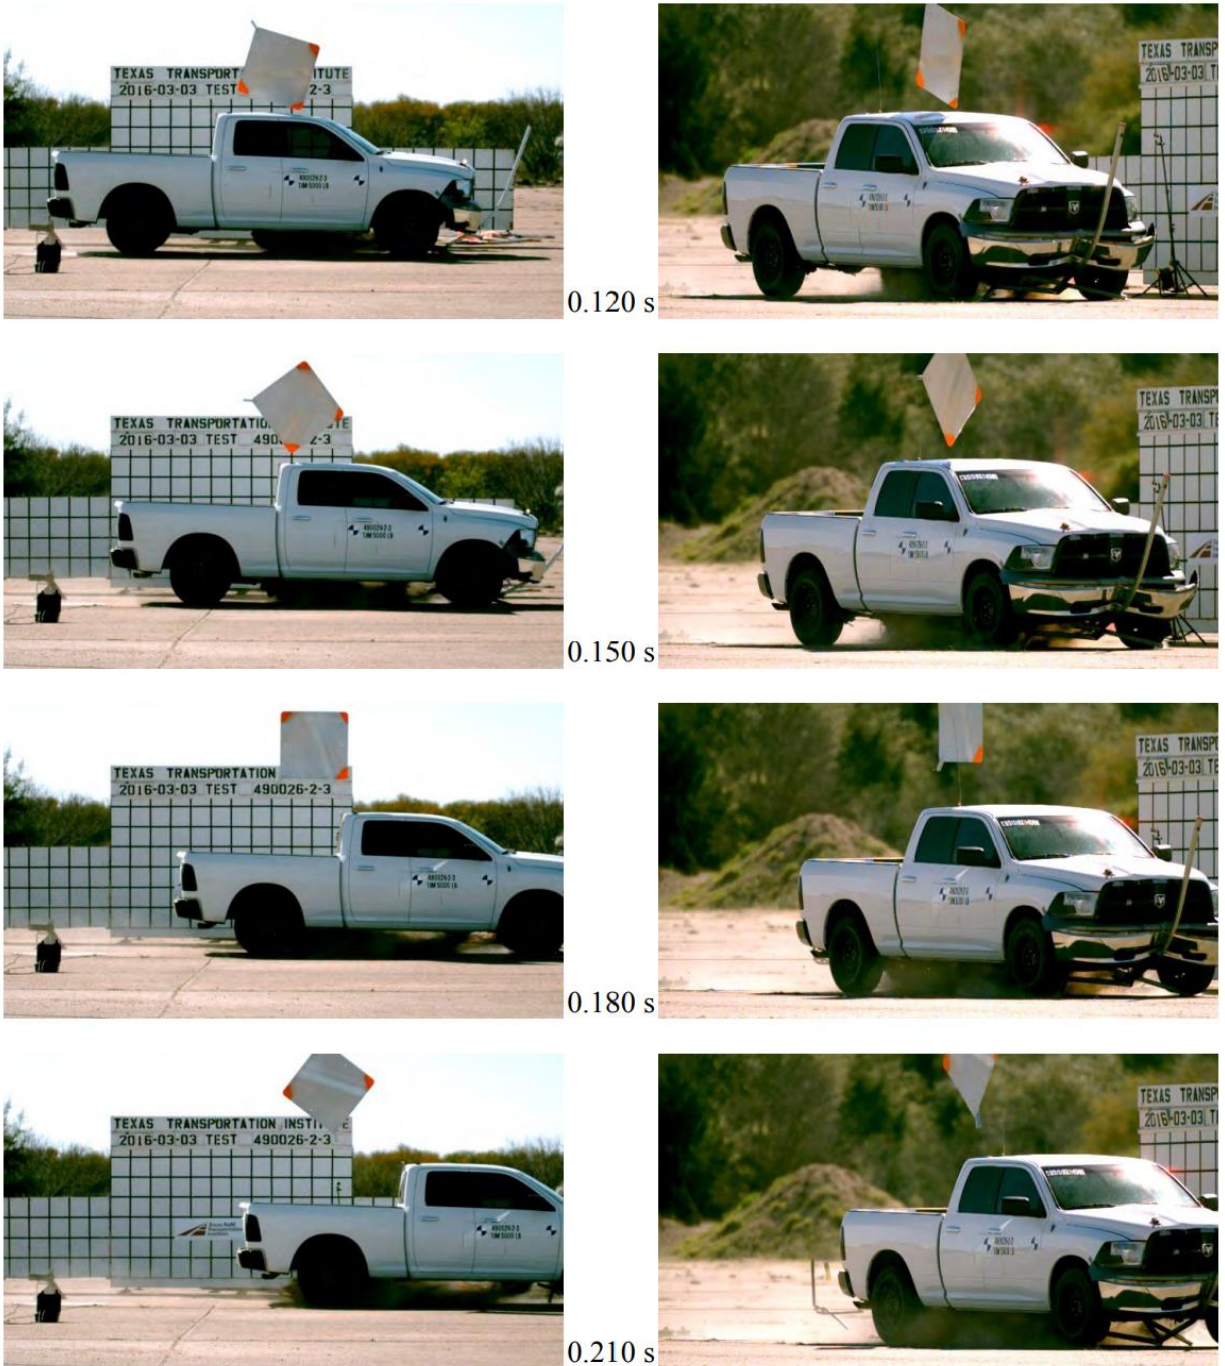
**Figure 2.37. Temporary High-Mounting Sign Support, Option C Test 3-72, 90-degree Impact Sequential Photos (Continued) (2)**

In *MASH* test 3-72 (test 4900026-2-3), the 2270P pickup truck, traveling at an impact speed of 62.5 mi/h, contacted the Option C temporary work zone sign support with the centerline of the front bumper at an impact angle of 90 degrees. Figure 2.36 and Figure 2.37 present sequential photographs during the test. Figure 2.38 shows the damage to the Option C temporary work zone sign support. Figure 2.39 shows the

damage sustained by the vehicle. There was a 3-inch-long dent on the outer surface of the front of the roof of the cab, but no occupant compartment deformation or intrusion was noted.

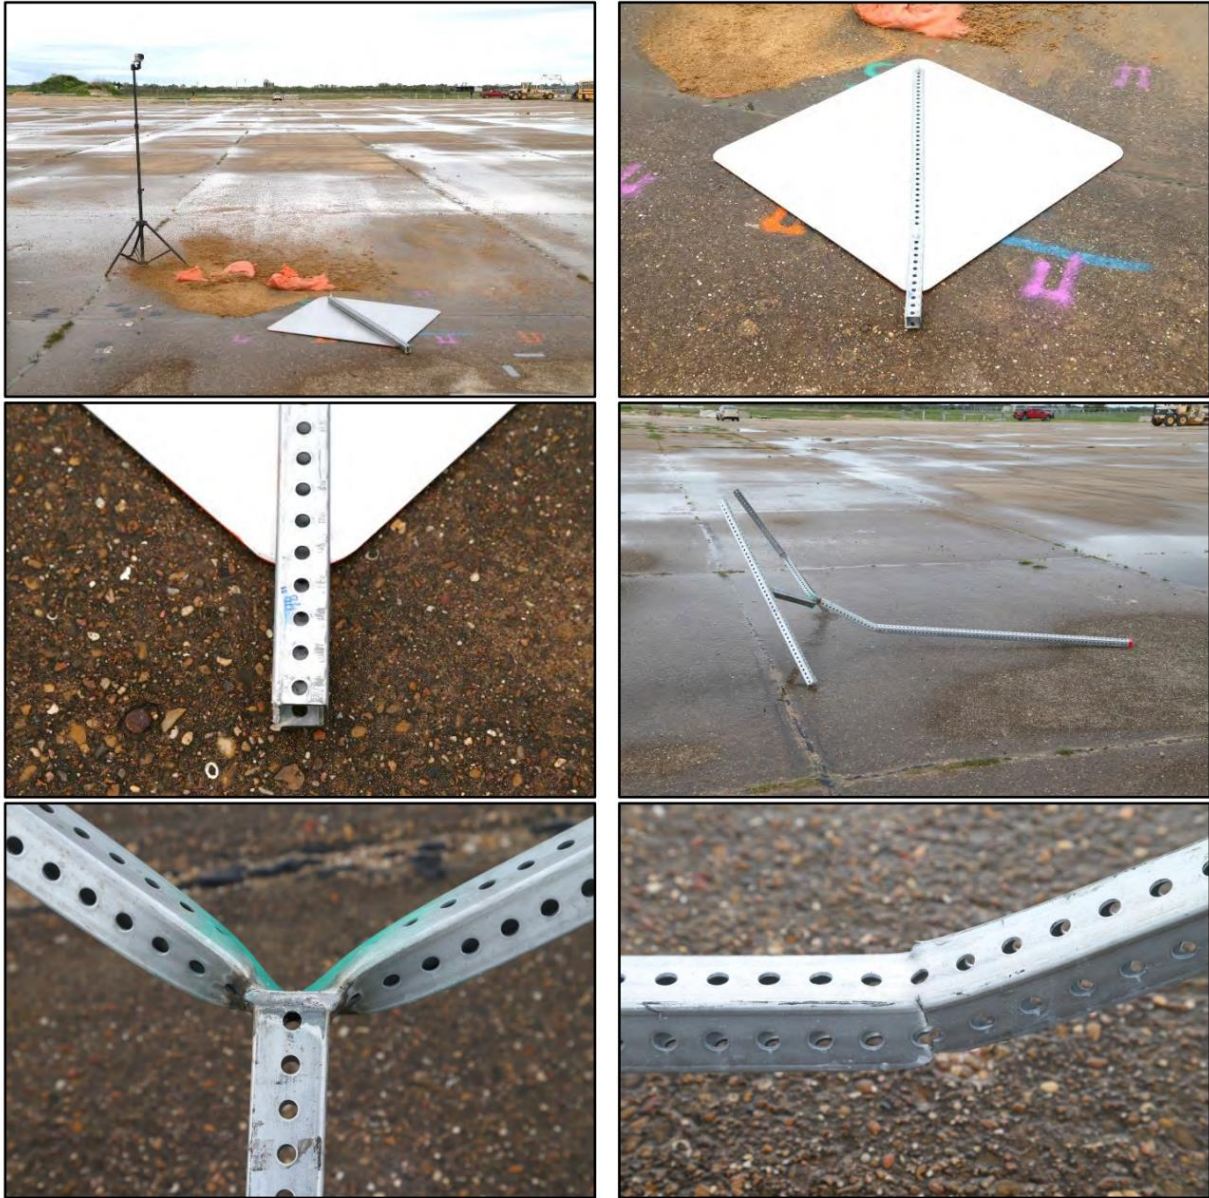
**Figure 2.42. Temporary High-Mounting Sign Support, Option C Test 3-71, 90-degree Impact System Damage (2)**

In *MASH* test 3-71 (test 4900026-2-5), the 1100C small car, traveling at an impact speed of 61.5 mi/h, contacted the Option C temporary work zone sign support 10 inches to the left of centerline of the vehicle at an impact angle of 90 degrees. Figure 2.40 and Figure 2.41 present sequential photographs of the test. Figure 2.42 shows the damage to the Option C temporary work zone sign support. Figure 2.43 shows the damage sustained by the vehicle. The 1100C vehicle sustained only scrapes to the bumper and hood with no measurable exterior vehicle deformation. No occupant compartment deformation or intrusion was noted.

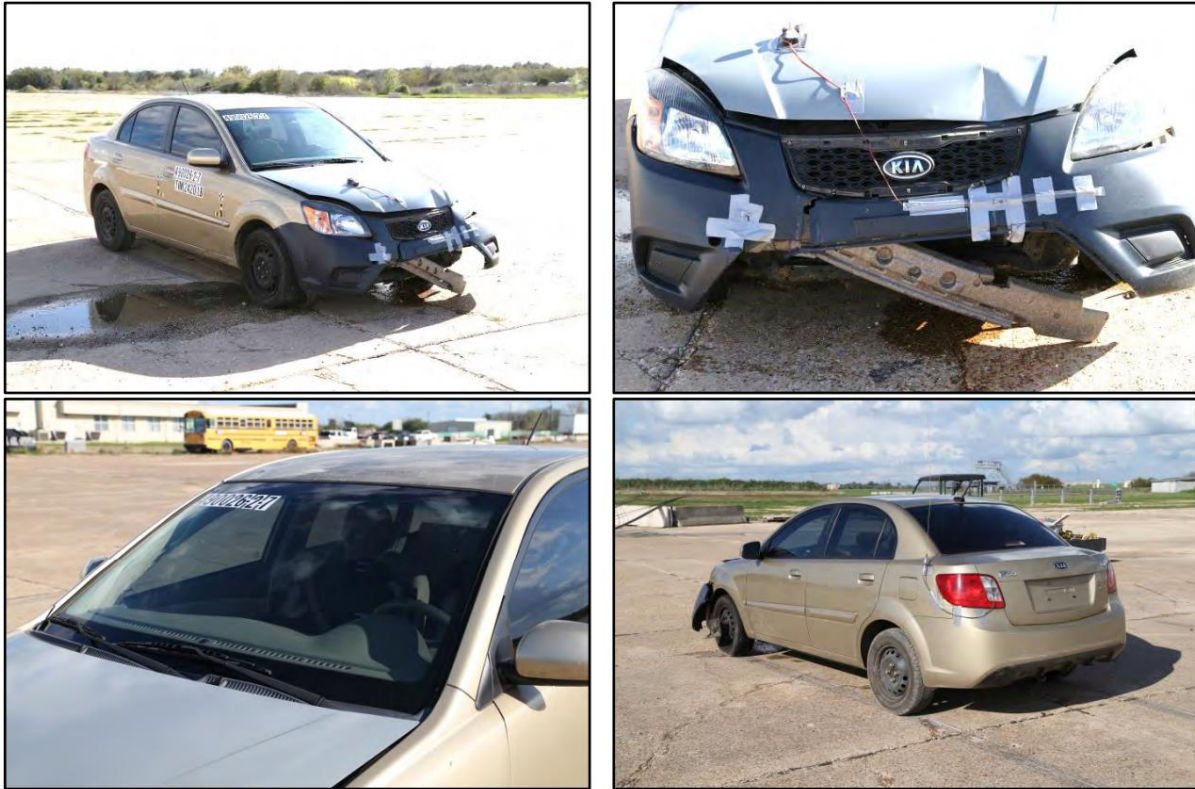
**Figure 2.47. Temporary High-Mounting Sign Support, Option C Test 3-71, 0-degree Impact Vehicle Damage (2)**

In *MASH* test 3-71 (test 4900026-2-7), the 1100C small car, traveling at an impact speed of 61.9 mi/h, contacted the Option C temporary work zone sign support 10 inches to the left of centerline of the vehicle at an impact angle of 0 degrees. Figure 2.44 and Figure 2.45 present sequential photographs during the test. Figure 2.46 shows the damage to the Option C temporary work zone sign support. Figure 2.47 shows the damage sustained by the vehicle. The 1100C vehicle sustained only scrapes to the bumper and hood with no measurable exterior vehicle deformation. No occupant compartment deformation or intrusion was noted.

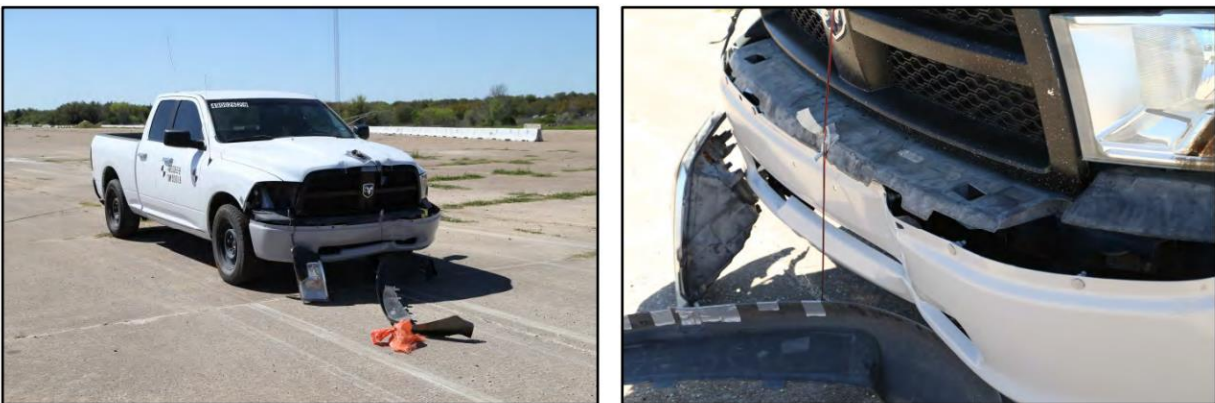
**Figure 2.51. Temporary High-Mounting Sign Support, Option C Test 3-72, 0-degree Impact Vehicle Damage (2)**

In *MASH* test 3-72 (test 4900026-2-9), the 2270P pickup truck, traveling at an impact speed of 62.9 mi/h, contacted the Option C temporary work zone sign support 10 inches to the left of centerline of the vehicle at an impact angle of 0 degrees. Figure 2.48 and Figure 2.49 present sequential photographs of the test. Figure 2.50 shows the damage to the Option C temporary work zone sign support. Figure 2.51 shows the damage sustained by the vehicle. No occupant compartment deformation or intrusion was noted.

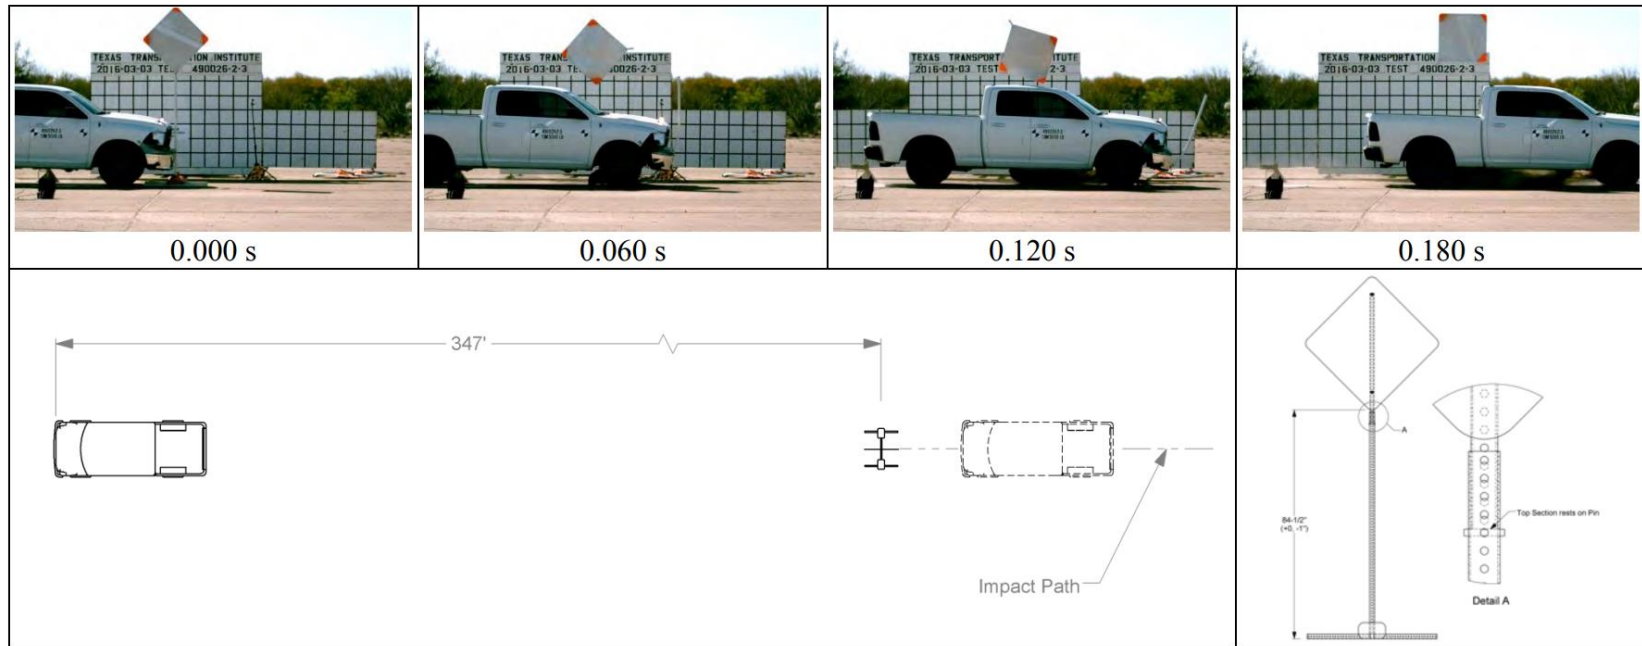
**Figure 2.52. Temporary High-Mounting Sign Support, Option C Test 3-72, 90-degree Impact Results (2)**

Figure 2.52 provides a summary of the results of test 3-72 with a 90-degree impact. The sign panel contacted the roof; however, it did not cause any tears or penetration. The resulting roof deformation was within MASH criteria.

VDS..... 12FC1  
 CDC ..... 12FCEN1  
 Max. Exterior Deformation..... 6.0 inches  
 OCDI ..... RR0000000  
 Max. Occupant Compartment Deformation ..... None

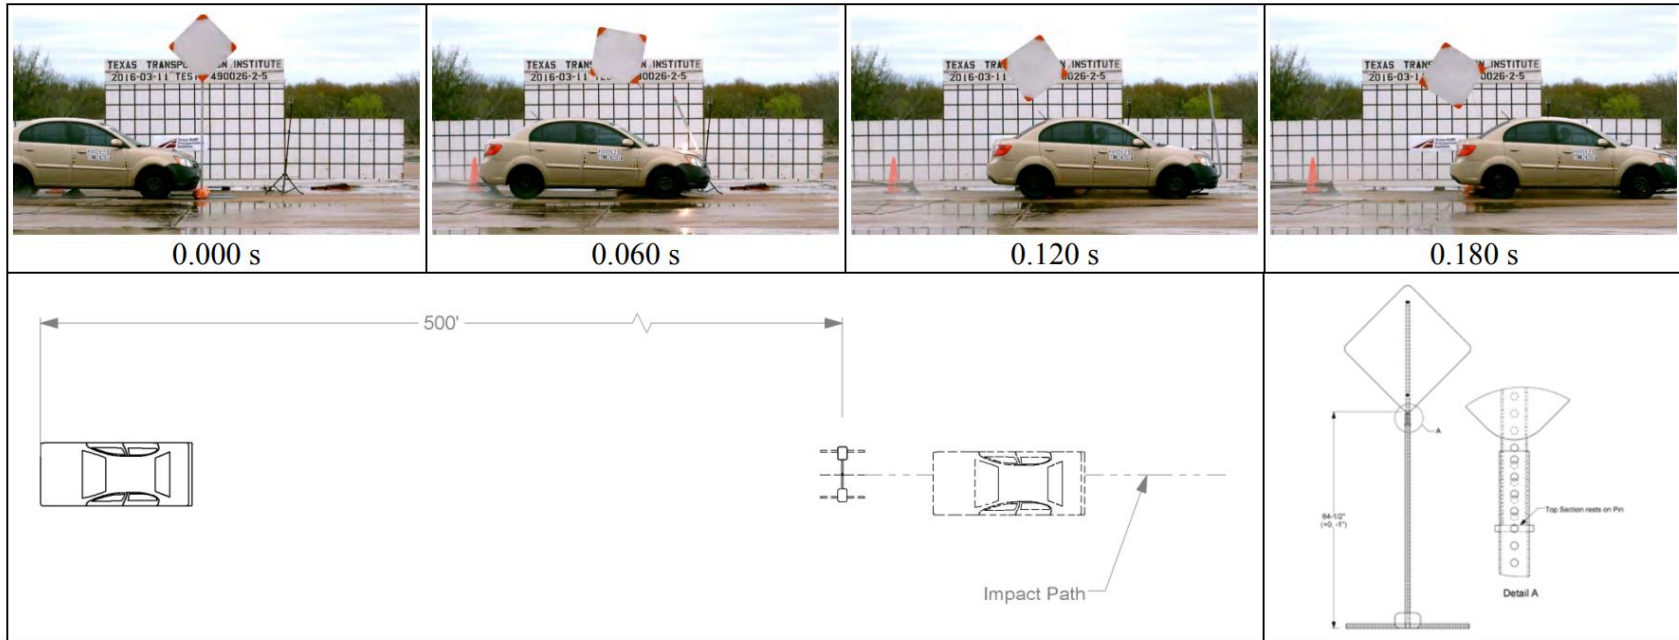
**Figure 2.53. Temporary High-Mounting Sign Support, Option C Test 3-71, 90-degree Impact Results (2)**

Figure 2.53 provides a summary of the results of test 3-71 with a 90-degree impact. The support structure contacted the bumper and hood, but the sign panel did not contact the roof of the vehicle.

VDS .....12FL1  
 CDC.....12FLEN1  
 Max. Exterior Deformation.....None  
 OCDI.....LF0000000  
 Max. Occupant Compartment Deformation.....None

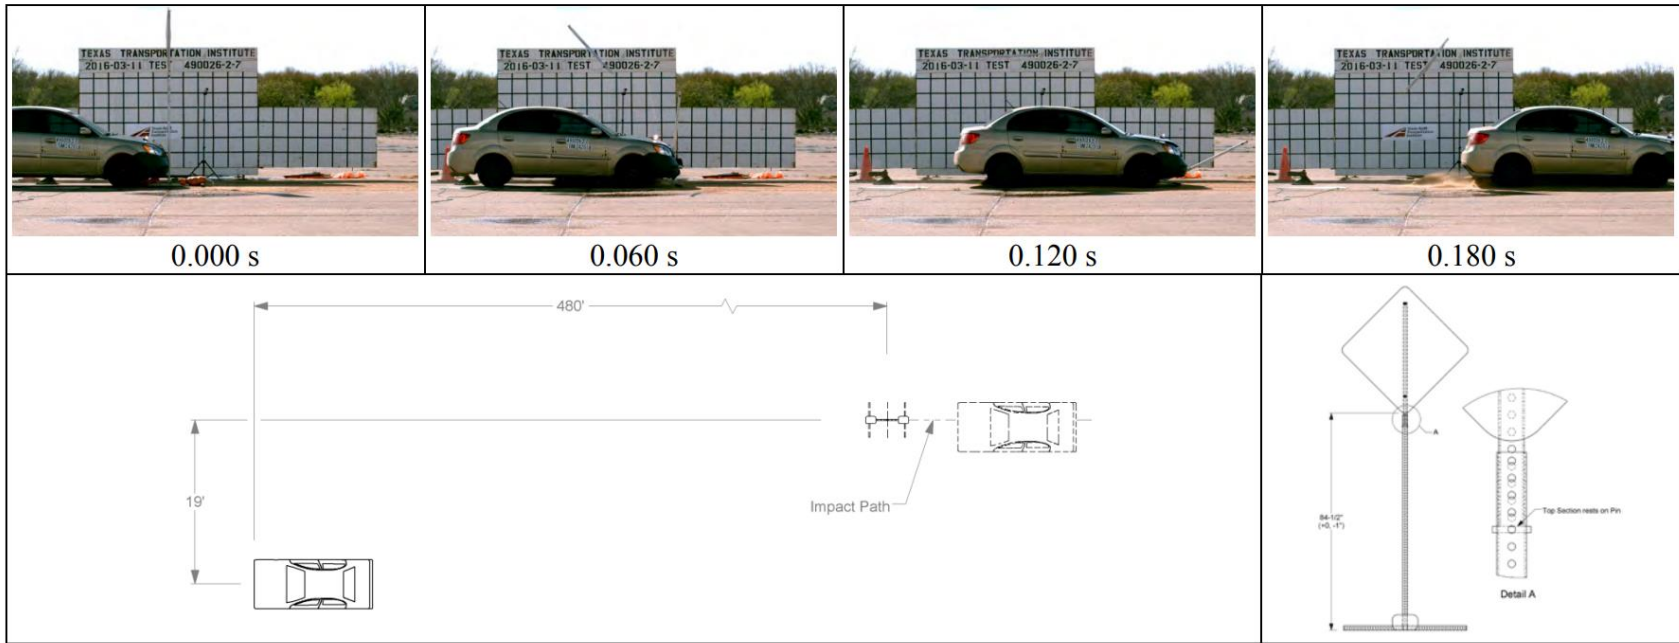
**Figure 2.54. Temporary High-Mounting Sign Support, Option C Test 3-71, 0-degree Impact Results (2)**

Figure 2.54 provides a summary of the results of test 3-71 with a 0-degree impact. The support structure contacted the bumper and hood, but the sign panel did not contact the roof of the vehicle.

VDS ..... 12FL1  
 CDC ..... 12FLEN1  
 Max. Exterior Deformation..... None  
 OCDI..... LF0000000  
 Max. Occupant Compartment Deformation ..... None

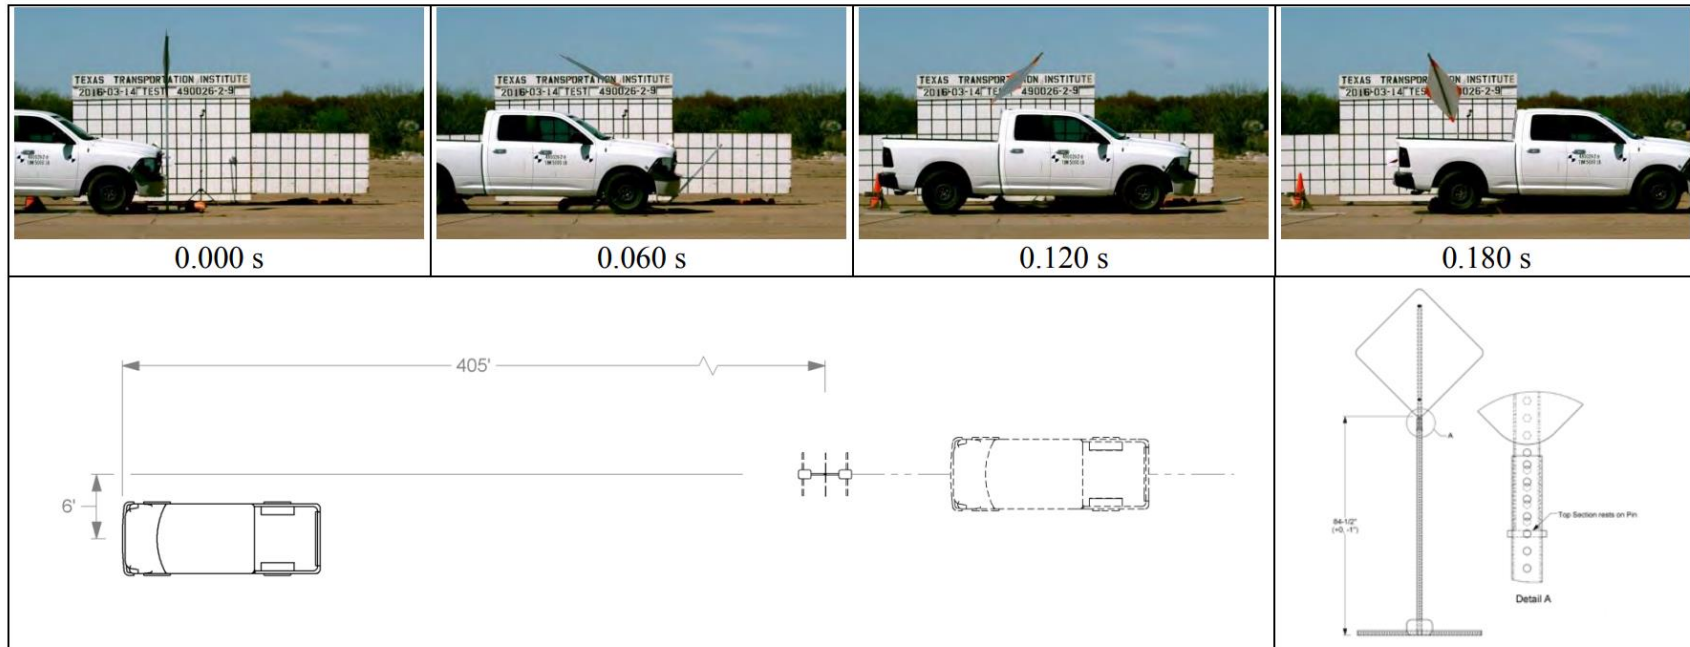
**Figure 2.55. Temporary High-Mounting Sign Support, Option C Test 3-72, 0-degree Impact Results (2)**

Figure 2.55 provides a summary of the results of test 3-72 with a 0-degree impact. The sign panel did not contact the roof.

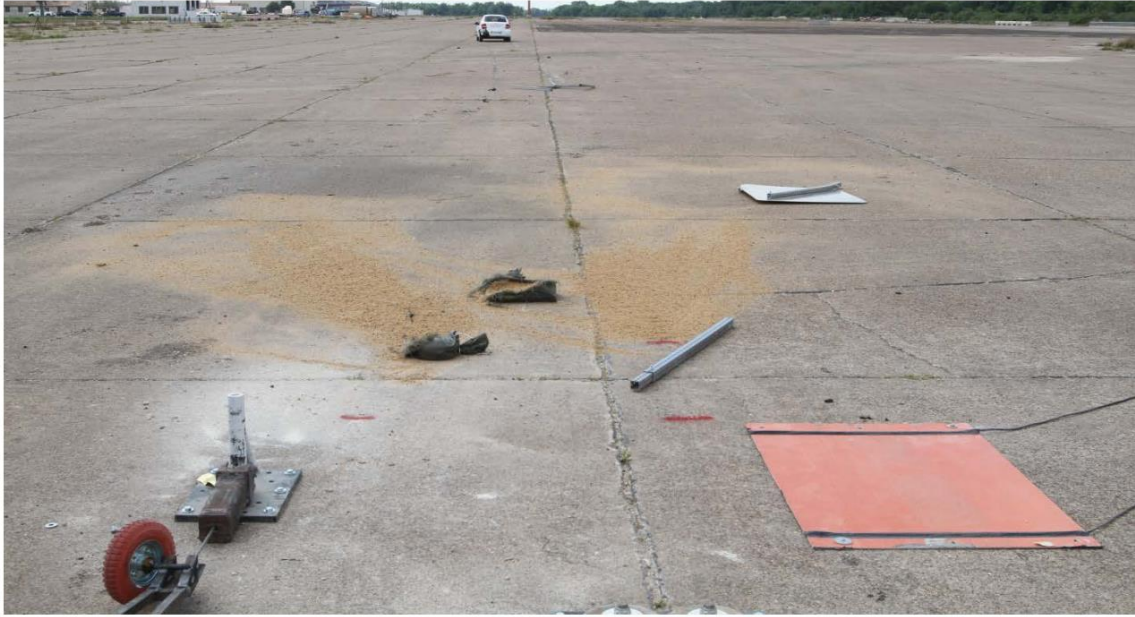
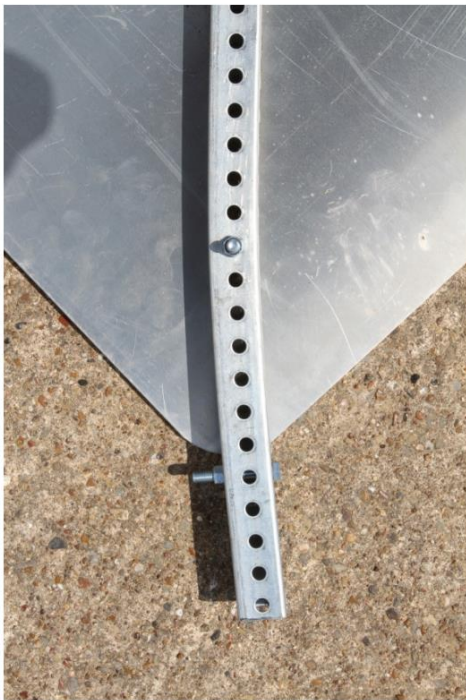
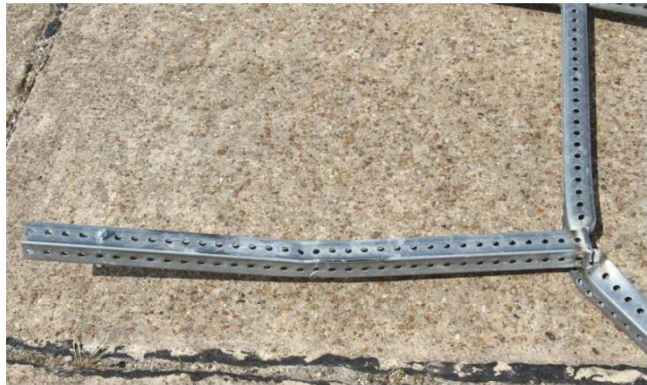
**Figure 2.61. High-Mounting-Height Temporary Single Sign Support, Modified Design 2 Test 3-71, 90-degree Impact System Damage (3)**

In test 3-71, the temporary sign support yielded to the vehicle and the bottom slip connection activated as designed. The upper slip connection activated only after the released support rotated almost 180 degrees. A summary of the results from test 3-71 with a 90-degree impact point is presented in Figure 2.68.

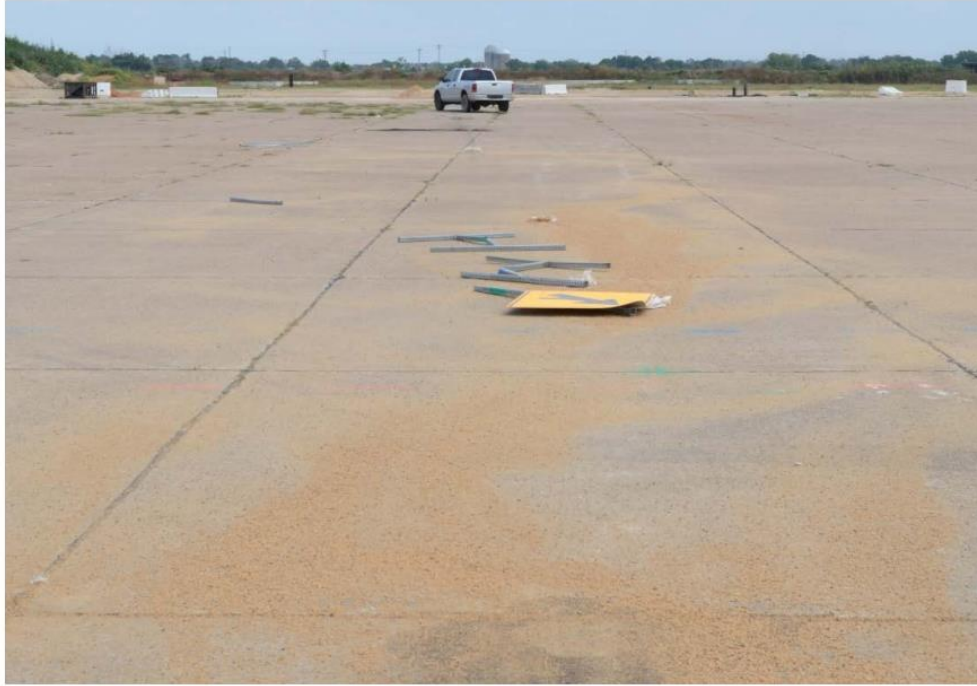
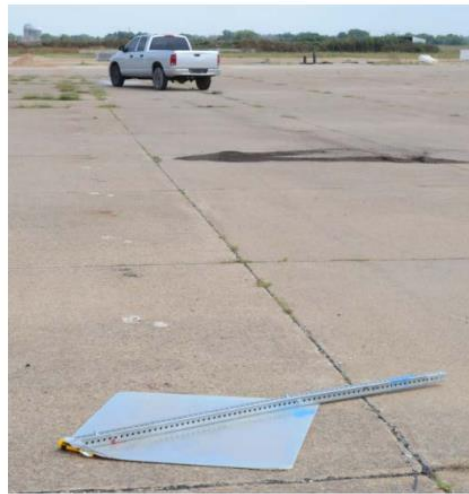
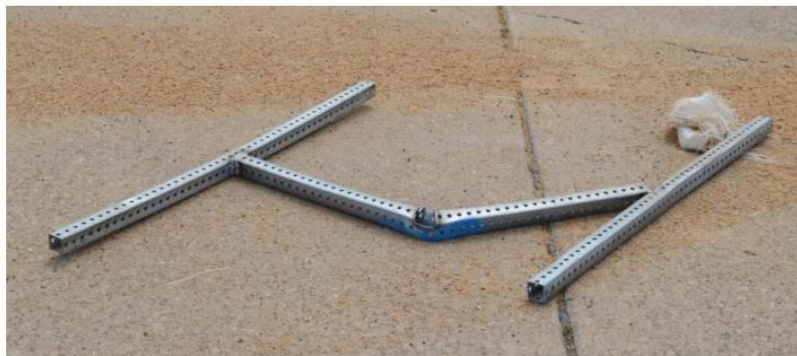
**Figure 2.65. High-Mounting-Height Temporary Single Sign Support, Modified Design 2 Test 3-72 System Damage (3)**

Figure 2.65 shows damage to the sign support systems. The lower telescopic slip connection activated on both test articles as designed. The 2270P vehicle sustained a small dent in the bumper, hood, and grill due to the initial impact with the 90-degree oriented sign support. A secondary impact of the edge of the aluminum sign panel caused a 29-inch-long cut in the roof of the pickup truck. Additionally, the roof was deformed over an area measuring 51 inches in length and 40 inches in width. The 2270P vehicle sustained a small dent in the bumper, hood, and grill, due to the initial impact with the 0-degree oriented sign support. Figure 2.66 and Figure 2.67 show photographs of the exterior and interior of the vehicle after the test.

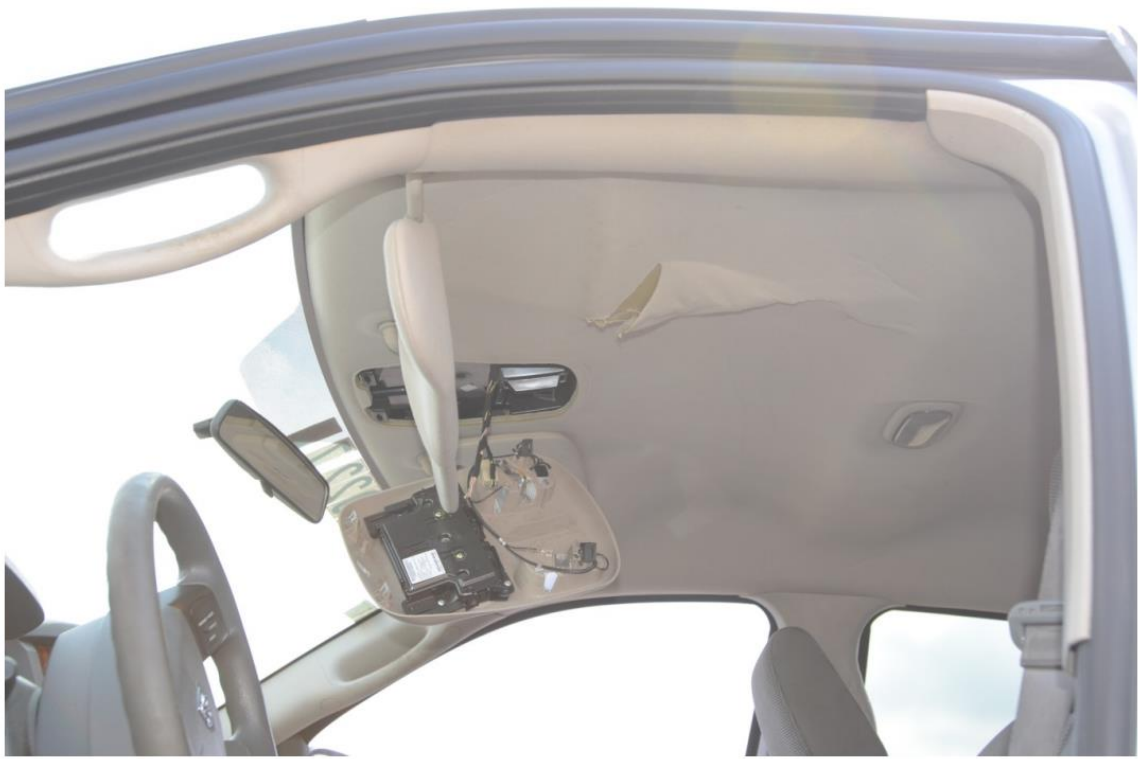
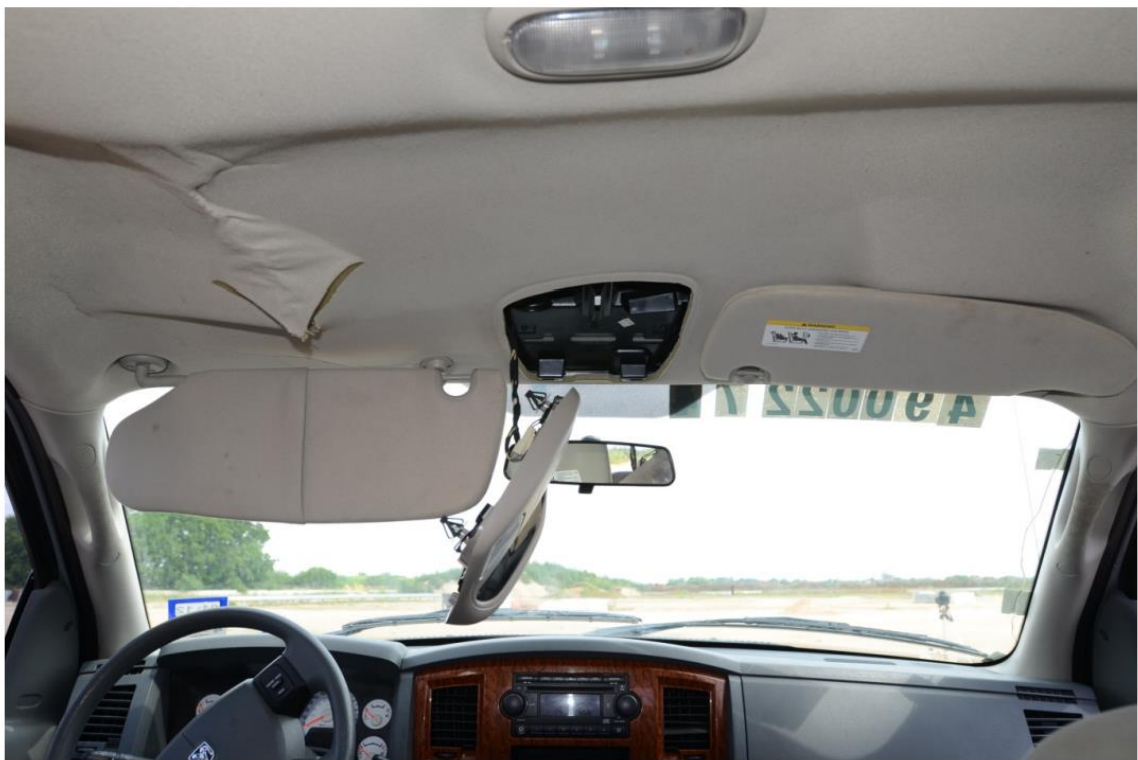
**Figure 2.67. High-Mounting-Height Temporary Single Sign Support, Modified Design 2 Test 3-72 Vehicle Interior Damage (3)**

In both 3-72 tests, the telescopic slip connection activated as designed and released the sign support assembly from its base. In the impact with the sign system oriented at 0 degrees, the released sign panel assembly did not contact the vehicle, and all MASH criteria were satisfied. However, during the impact with the sign system oriented at 90 degrees, the edge of the sign panel contacted, deformed, and cut the roof of the vehicle. It was evident from review of the high-speed video and inspection of the vehicle and sign panel that the corner of the sign panel penetrated the occupant compartment. MASH states that “detached elements, fragments, or other debris from the test article should not penetrate or show potential for penetrating the occupant compartment...” Therefore, the impact with the sign system oriented at 90-degrees did not satisfy Occupant Risk Criterion “D” of *MASH*.

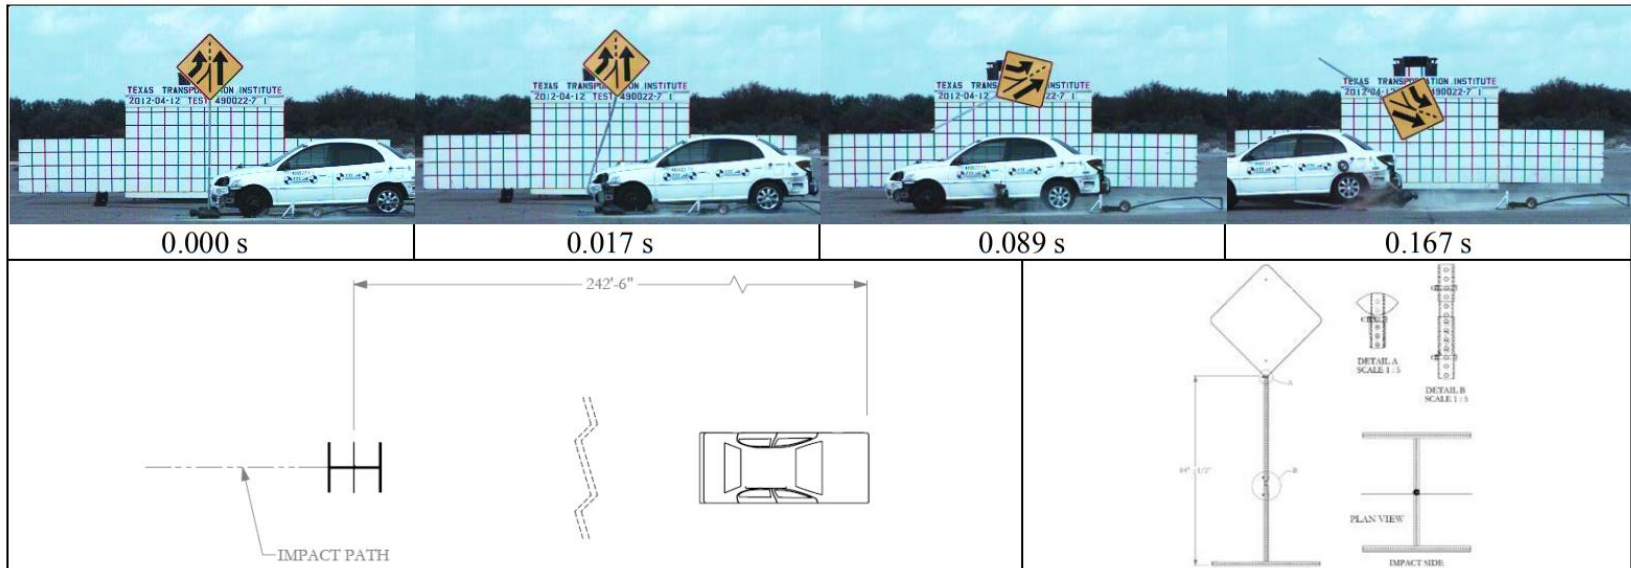
**Figure 2.68. High-Mounting-Height Temporary Single Sign Support, Modified Design 2 Test 3-71, 90-degree Impact Results (3)**

VDS ..... 12FD1  
 CDC ..... 12FDEN1  
 Max. Exterior Deformation..... None  
 OCDI..... FS0000000  
 Max. Occupant Compartment Deformation..... None
