Test Report No. 618901-01-2-1:7

**PORTABLE SIGN SUPPORTS FOR ALUMINUM SIGNS WITH  
VARIATIONS ON MOUNTING HEIGHT**

Sponsored by  
**The Roadside Safety Pooled Fund**

**TEXAS A&M TRANSPORTATION INSTITUTE PROVING GROUND**

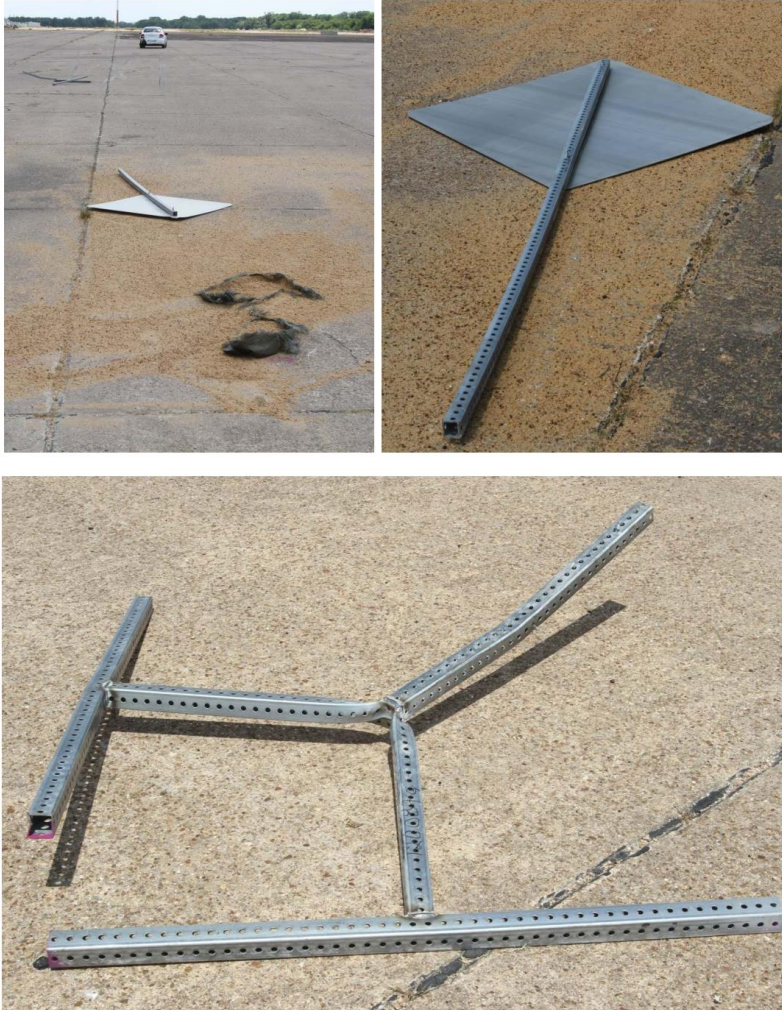
**Figure 2.75. High-Mounting-Height Temporary Single Sign Support, Modified Design 4 Test 3-71, 0-degree Impact System Damage (3)**

In *MASH* test 3-71, the 1100C vehicle, traveling at an impact speed of 62.4 mi/h, contacted the sign support at an impact angle of 90 degrees, with the right front quarter point aligned with the centerline of the support. Figure 2.74 presents sequential photographs of the test period. The telescopic slip connection activated as designed and released the vertical support and sign panel from the base. The vertical sleeve and middle brace in the H-base to which it was attached were both deformed. Figure 2.75 shows damage to the sign support system. The 1100C vehicle sustained minimal damage during the impact with the temporary single sign support. Figure 2.76 shows photographs of the exterior of the vehicle.

The temporary sign support yielded to the vehicle and the bottom slip connection activated as designed. There was no secondary contact between the test article and the vehicle. A summary of the results from Test 3-71 with a 0-degree impact is presented in Figure 2.77.

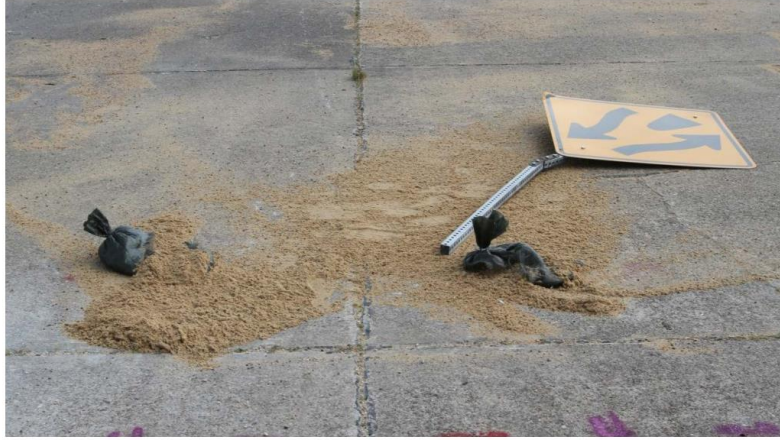
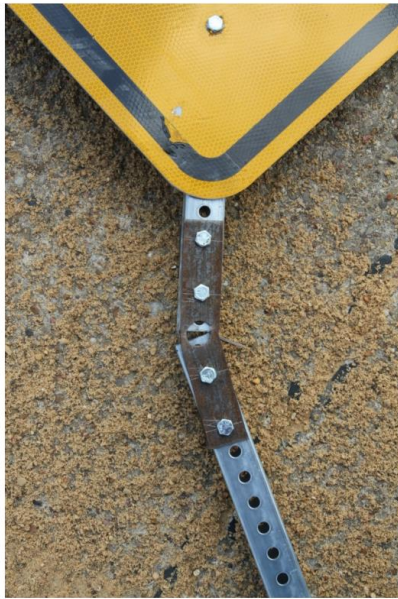
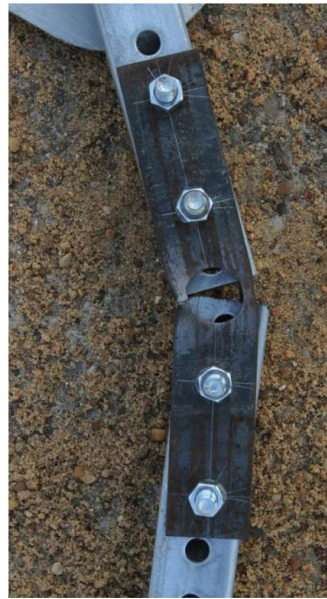
**Figure 2.82. High-Mounting-Height Temporary Single Sign Support, Modified Design 8 Test 3-71, 90-degree Impact System Damage (3)**

Figure 2.82 shows damage to the sign support system. The lower telescopic slip connection and fuse plates activated as designed. The 1100C vehicle did not sustain any additional damage during the impact with the temporary single sign support. Figure 2.83 shows photographs of the exterior of the vehicle.

The temporary sign support yielded to the vehicle and the bottom slip connection activated as designed. The fuse plates fractured on their tension sides as designed. There was no secondary contact between the test article and the vehicle. A summary of the results from Test 3-71 with a 90-degree impact is presented in Figure 2.84.

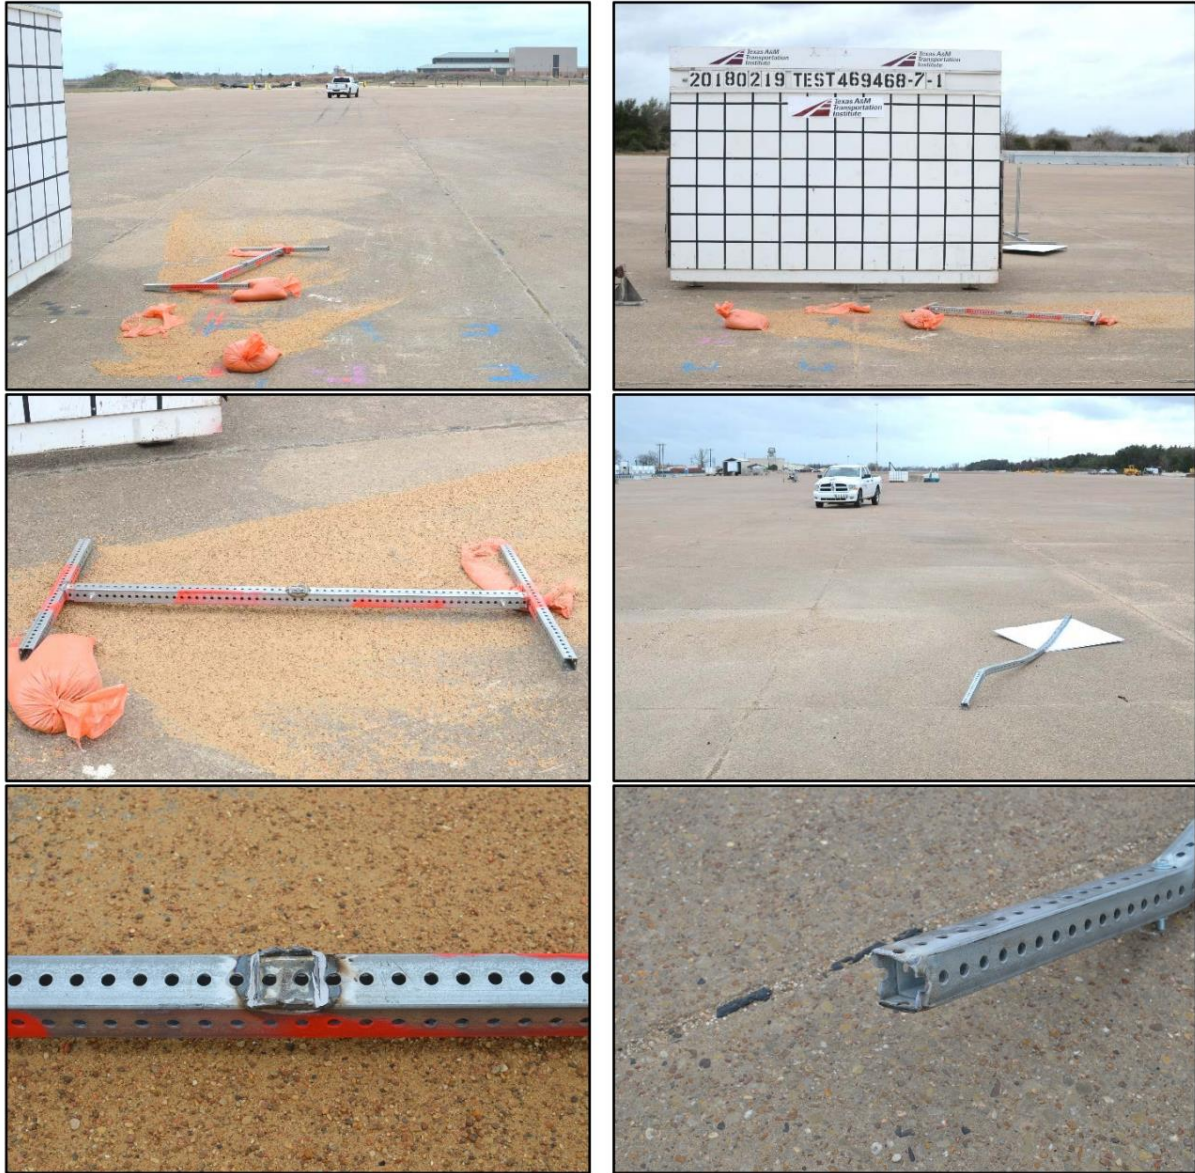
**Figure 2.89. Skid-Mounted Single-Post Perforated Steel Tube Temporary Sign Support Test 3-72, 0-degree Impact System Damage (4)**

Figure 2.89 shows the damage to the skid-mounted single perforated steel tube temporary sign support system. Figure 2.90 shows the damage sustained by the vehicle. A very small depression in the left side of the bumper and hood were observed. The windshield was cracked at the upper left corner, and the edge of the roof just above this location was slightly dented. The windshield also had a slight indentation, but no hole or tear was observed in the windshield. No occupant compartment deformation or intrusion was observed.

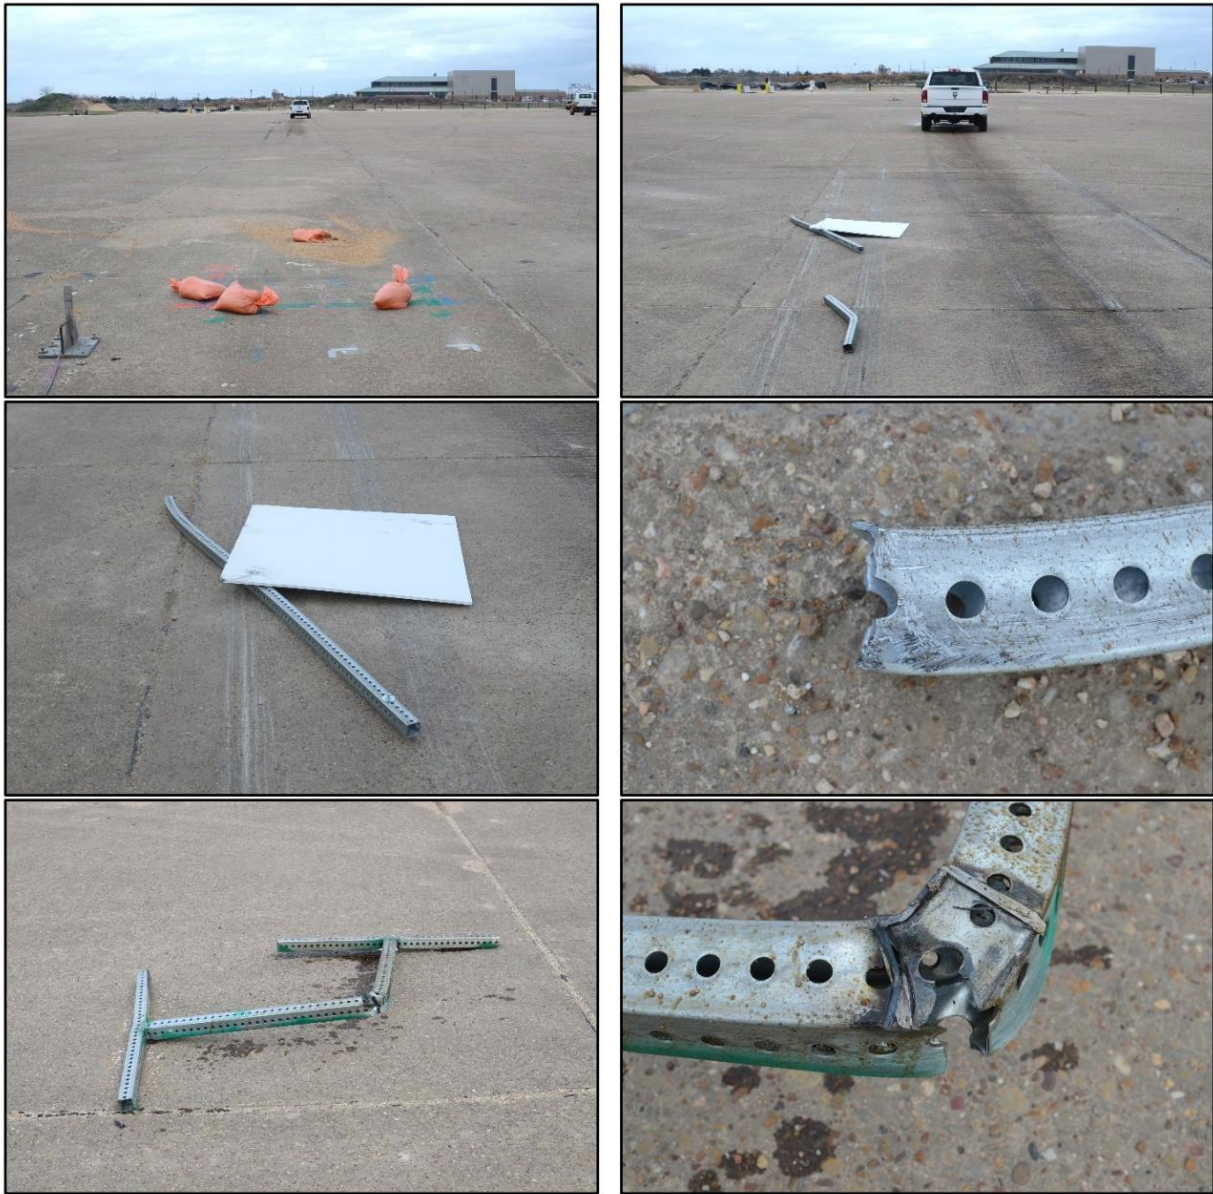
**Figure 2.94. Skid-Mounted Single-Post Perforated Steel Tube Temporary Sign Support Test 3-72, 90-degree Impact System Damage (4)**

Figure 2.94 shows the damage to the skid-mounted single perforated steel tube temporary sign support system. Figure 2.95 shows the damage sustained by the vehicle. The windshield was cracked with a maximum deformation of 2.0 inches. No holes or tears occurred in the windshield. An indentation and a small cut in the oil pan were observed. No other occupant compartment deformation or intrusion was noted.

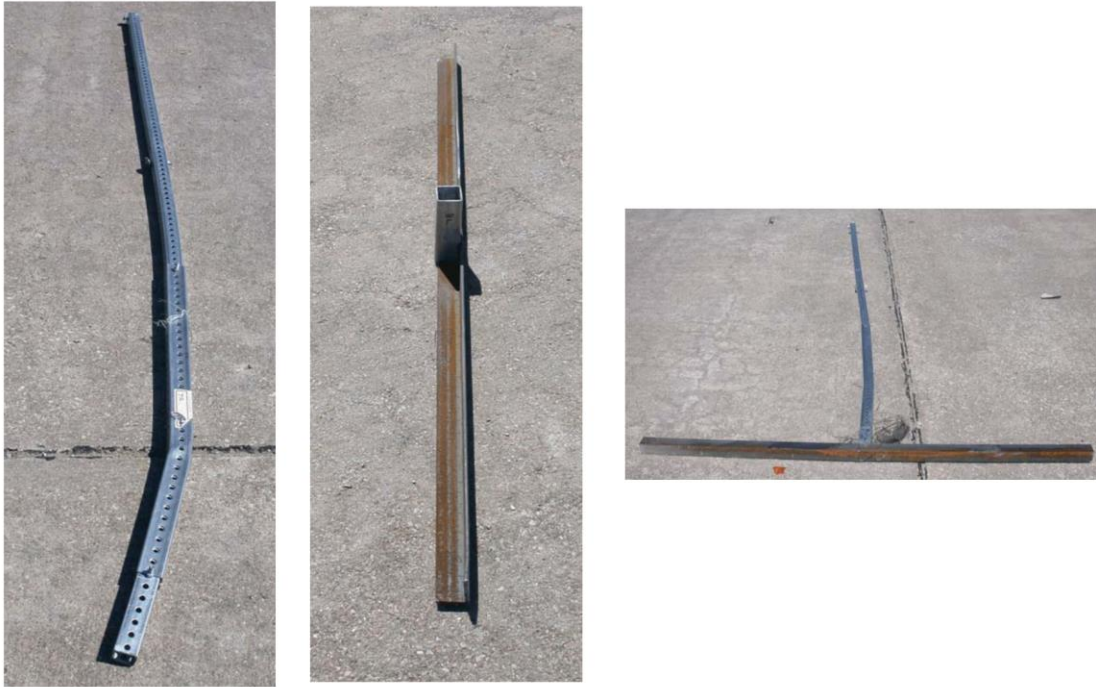
**Figure 2.100. Michigan's 4x5 Portable Sign Support Test 3-71 System Damage (5)**

Damage to System Nos. 7 and 8 is shown in Figure 2.100. Exterior vehicle damage is shown in Figure 2.101. Detached elements and debris from System No. 7 penetrated the right region of the windshield and the right side of the roof. Detached elements and debris from System No. 8 deformed the upper middle region of the windshield. Systems 7 and 8 failed to meet NCHRP Report 350 (6) evaluation criteria due to the hole in the windshield and occupant compartment deformation. Figure 2.102 and Figure 2.103 summarize the testing results.

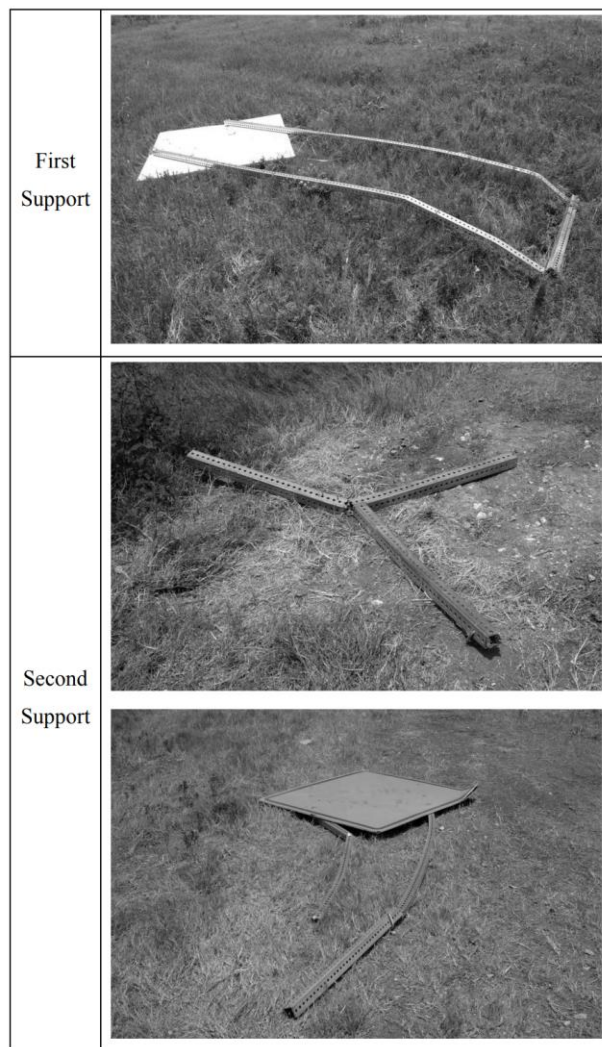
**Figure 2.105. Work Zone Sign Support Test 3-71 System Damage (7)**

The 1997 Geo Metro, traveling at a speed of 63.0 mi/h (101.4 km/h), impacted the first support head-on at 0 degrees. Upon impact with the first support, both uprights deformed around the front of the vehicle and subsequently released from the skids through fracture of the welds. The sign panel and its supports rotated toward the vehicle and contacted the roof. As the vehicle traveled forward, the panel and supports carried up and over the vehicle. The vehicle then impacted the second sign support system at 90 degrees. Upon impact with the second support, the leg on the impact side of the support began to deform and pulled the sign panel downward towards the vehicle. The corner of the sign panel contacted the windshield just below the roof edge, shattering the windshield and deforming the roof. Figure 2.105 shows the damaged test article. The vehicle sustained damage to the front bumper, hood, windshield, and roof, as shown in Figure 2.106. Maximum occupant compartment deformation was 8 inches in the windshield. Therefore, the sign support did not meet the NCHRP Report 350 evaluation criteria.

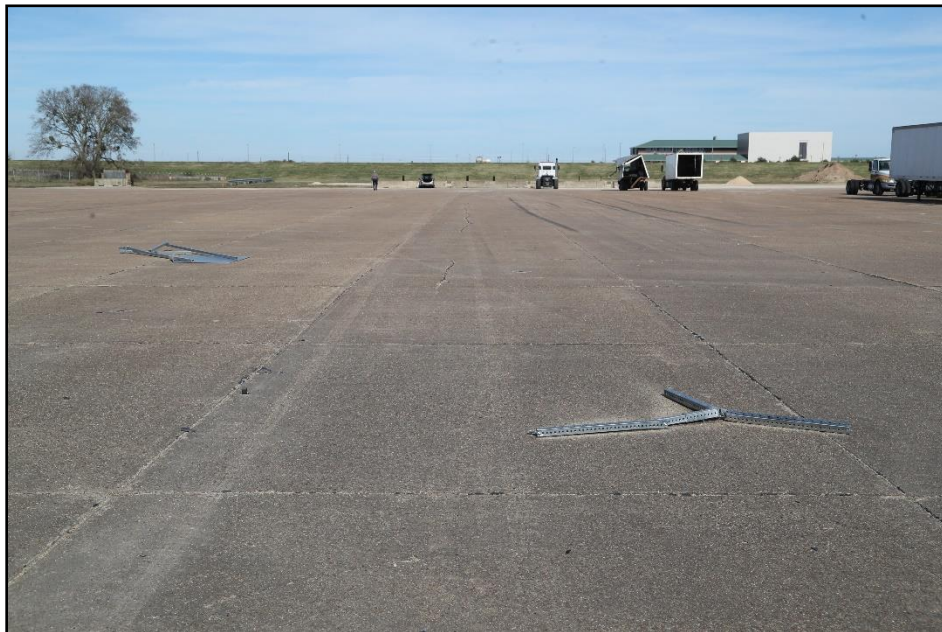
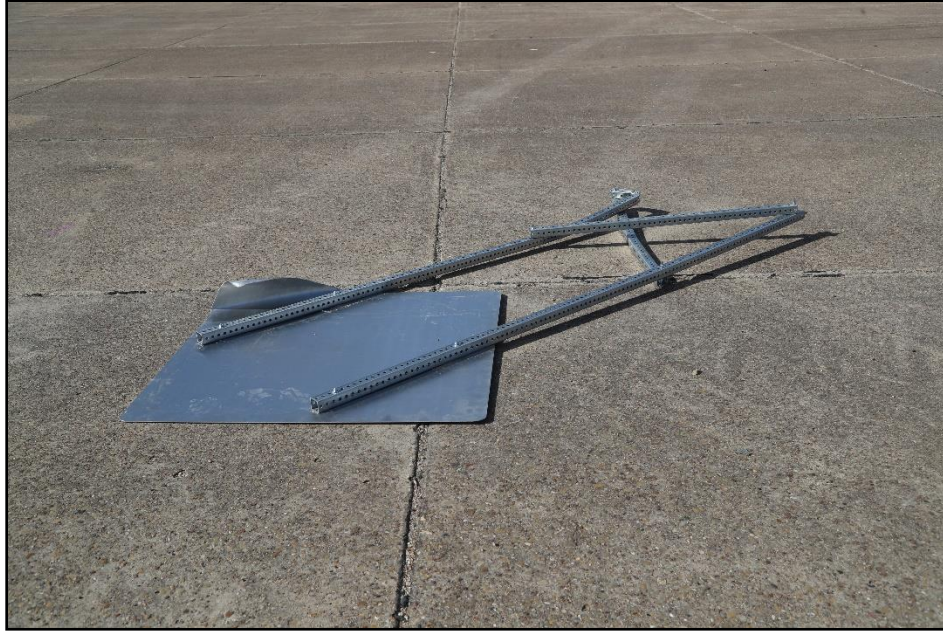
The sign stand came to rest 195 feet downstream and 43.8 feet left of impact. Posts were released from the legs and the sign was dented on one corner.

Figure 6.5 and Figure 6.6 show the damage to the Tall Sign Supports for Aluminum Signs.

**Figure 6.5. Debris Field after Test 618901-01-2-1.**

**Figure 6.6. Tall Sign Supports for Aluminum Signs at Resting Position after Test 618901-01-2-1.**

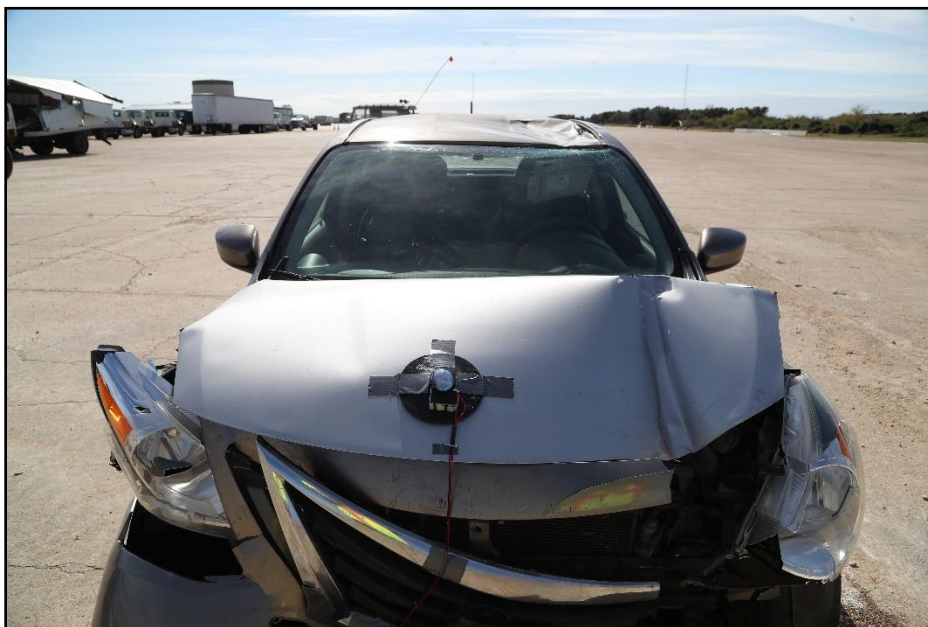
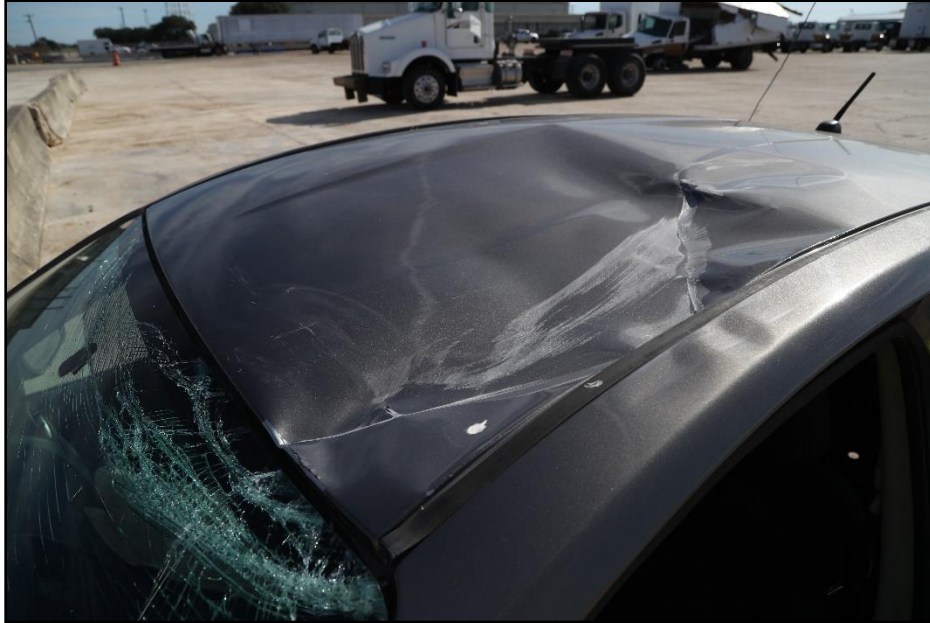
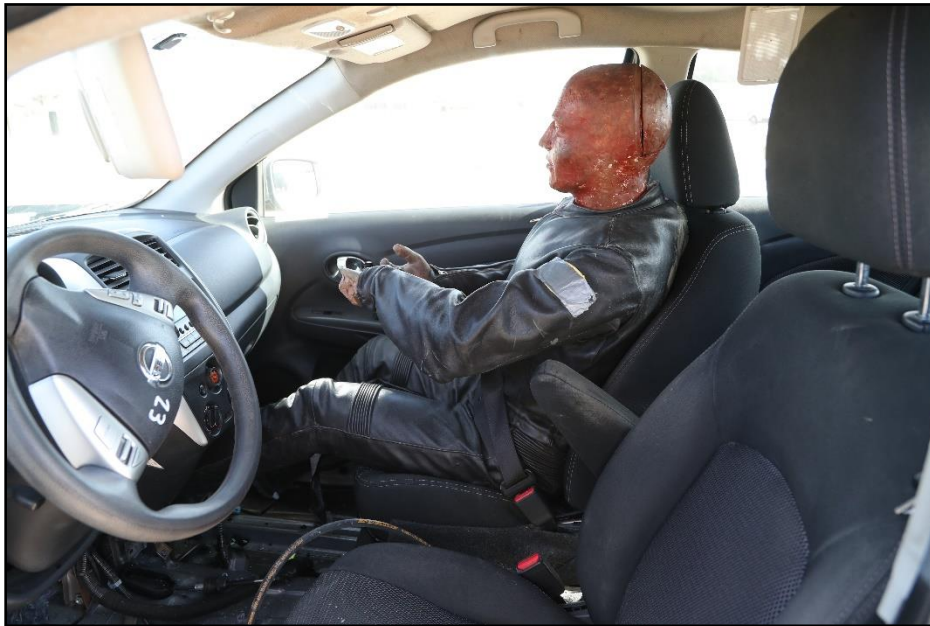
Figure 6.7 and Figure 6.8 show the damage sustained by the vehicle. Figure 6.9 shows the interior of the test vehicle. Table 6.6 and Table 6.7 provide details on the occupant compartment deformation and exterior vehicle damage. Figures E.2 and E.3 in Appendix E.1 provide exterior crush and occupant compartment measurements.

**Figure 6.7. Front of Test Vehicle after Test 618901-01-2-1.**

**Figure 6.8. Roof of Test Vehicle after Test 618901-01-2-1.**

**Figure 6.9. Overall Interior of Test Vehicle after Test 618901-01-2-1.**

Side Windows	Side windows remained intact
Maximum Exterior Deformation	2.5 inches in the roof
VDS	12FC2
CDC	12FCHN2
Fuel Tank Damage	None
Description of Damage to Vehicle:	There was a 17-inch long×2-inch wide × 1-inch deep dent in the hood and a 24-inch long × 22-inch wide × 2.5-inch deep dent in the roof on the driver’s side. The windshield was cracked at the top near the roof. After the vehicle was clear of the test article, it made a secondary contact with a portable concrete barrier, which caused additional damage to the front the vehicle than was present after impact with the target installation.

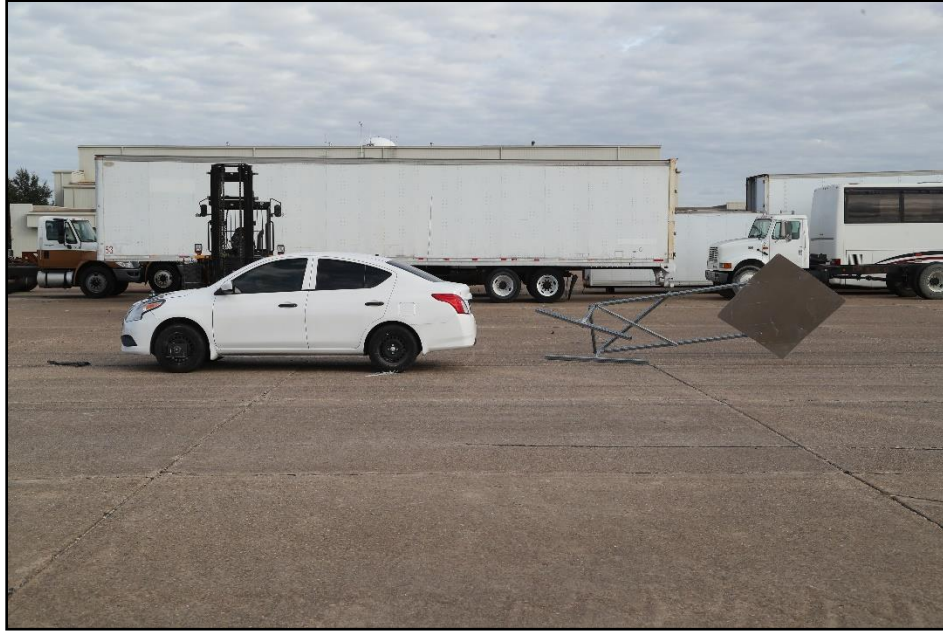
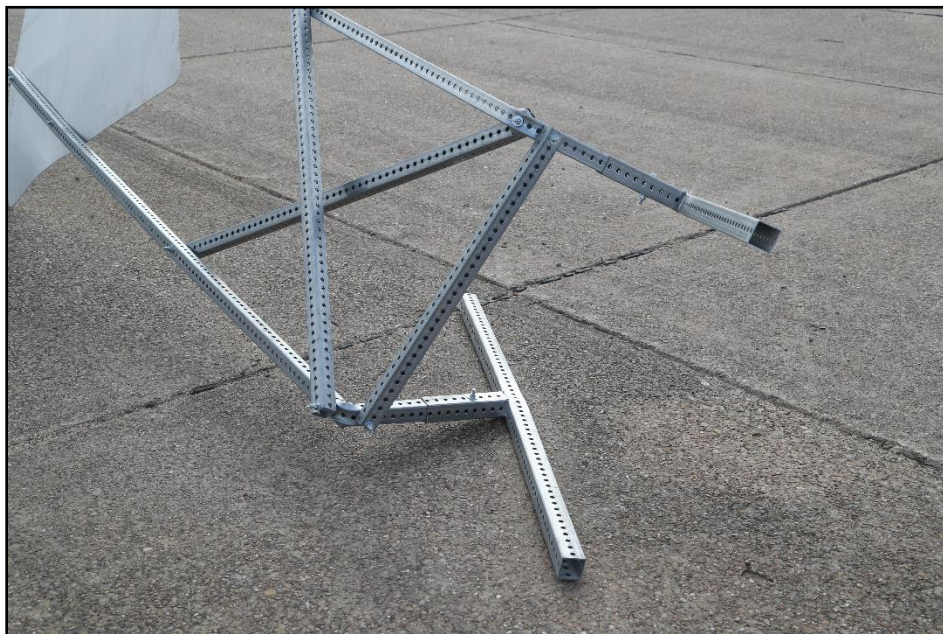
The test article came to rest 315 feet downstream of impact. The sign was slightly bent on two corners. The post was bent near the base on both legs, and the welds between the post and legs were cracked.

Figure 7.5 and Figure 7.6 show the damage to the Tall Sign Supports for Aluminum Signs.

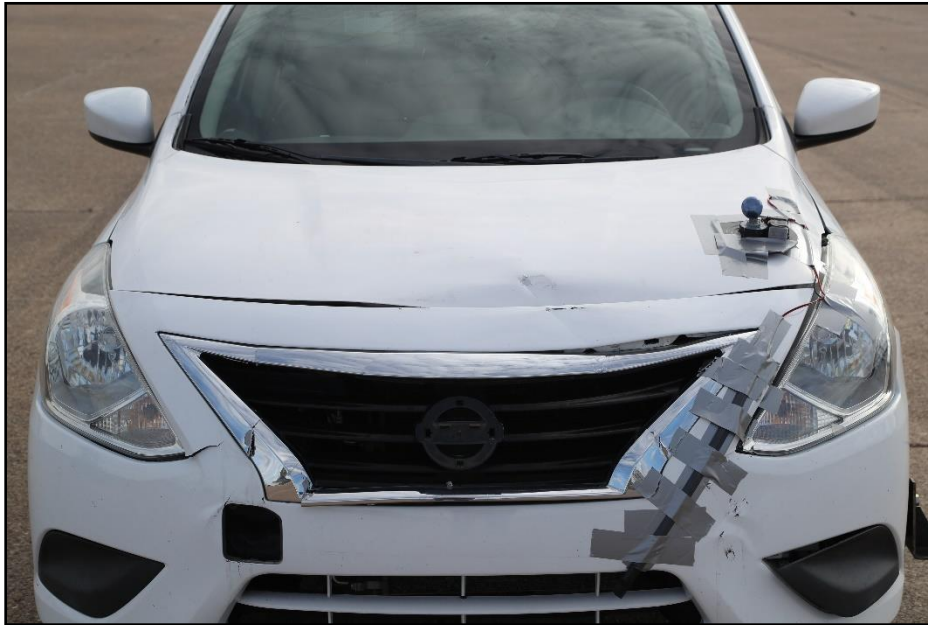
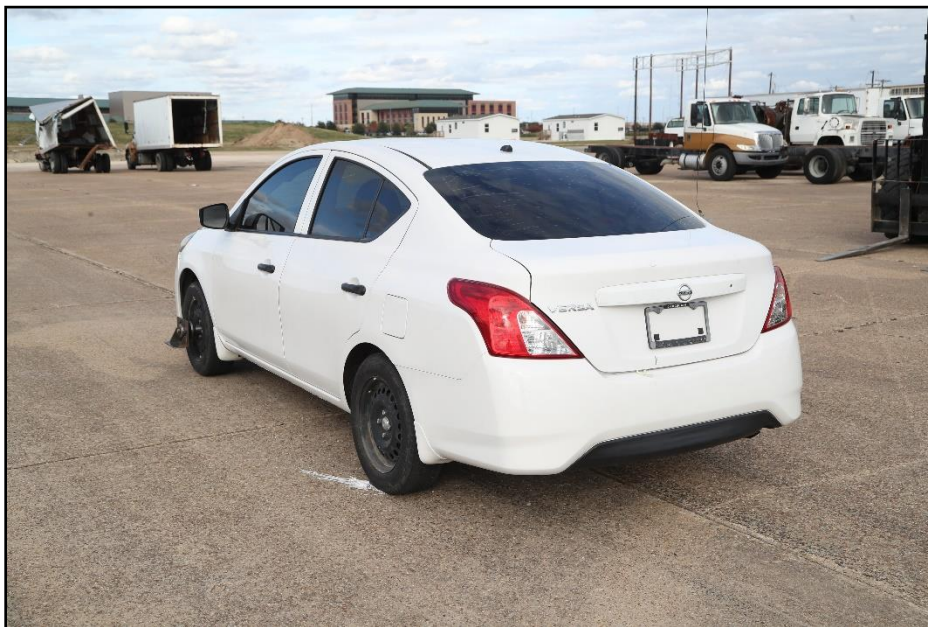
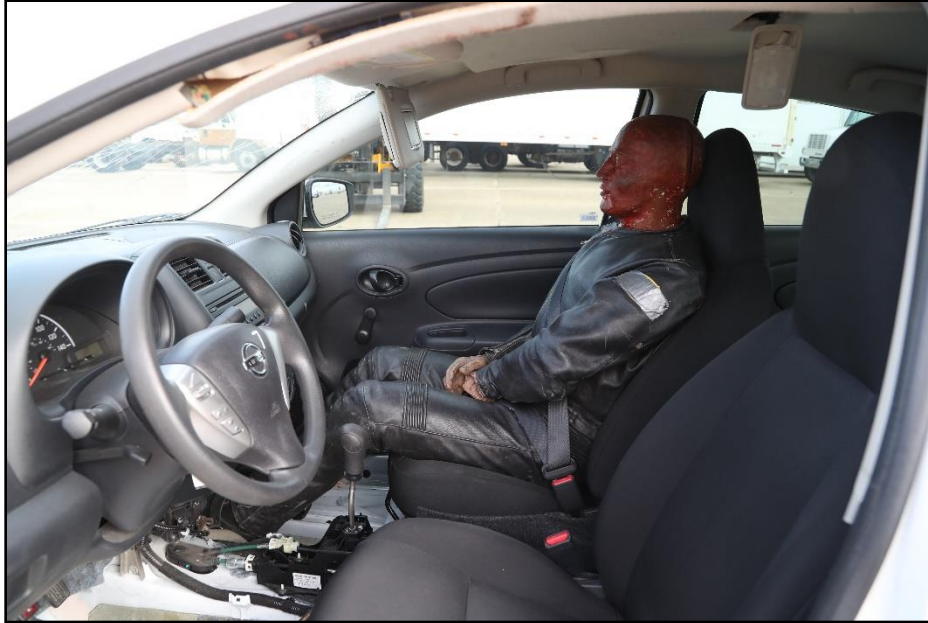
Figure 7.7 and Figure 7.8 show the damage sustained by the vehicle. Figure 7.9 shows the interior of the test vehicle. Table 7.6 and Table 7.7 provide details on the occupant compartment deformation and exterior vehicle damage. Figures F.2 and F.3 in Appendix F.1 provide exterior crush and occupant compartment measurements.

Side Windows	Side windows remained intact
Maximum Exterior Deformation	1.8 inches in the roof
VDS	12FC1
CDC	12TCHN1
Fuel Tank Damage	None
Description of Damage to Vehicle:	There was a 24-inch long × 11-inch wide × 1.8-inch deep dent in the roof on the passenger side and a 9-inch long × 9-inch wide × 0.3-inch deep dent in the roof on the driver's side. There was a small dent in the hood and the grill and windshield were cracked.

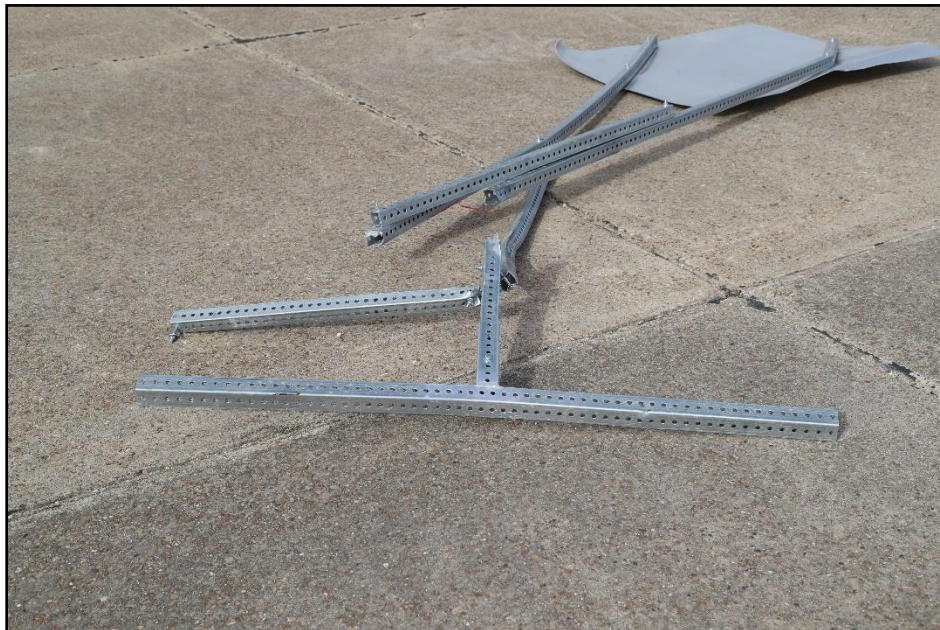
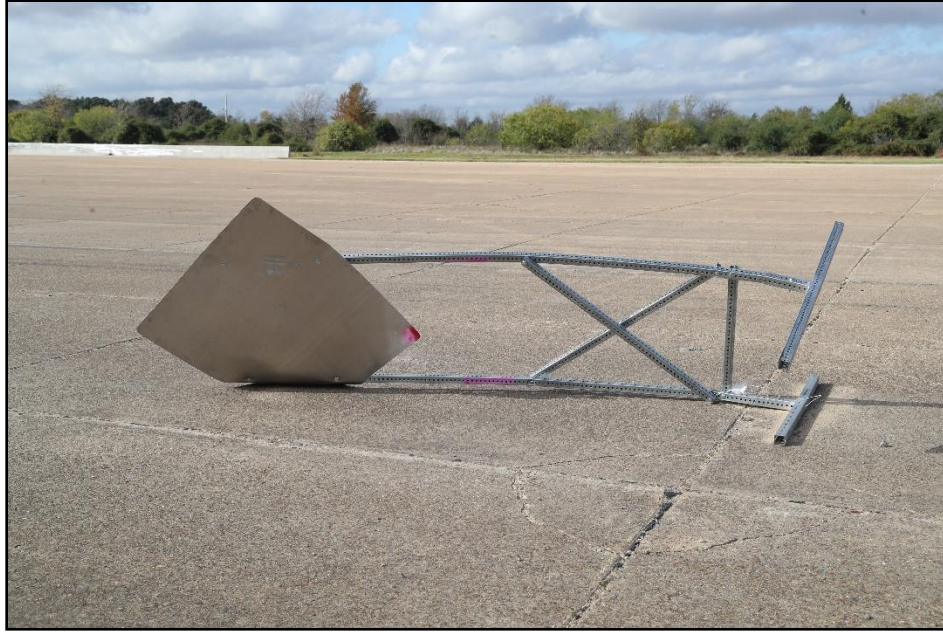
The first impacted sign came to rest 255 feet downstream and 28 feet left of impact. Both posts fractured and released from the legs of the installation. One leg released from the installation and came to rest 362 feet downstream and 41 feet to the left of impact. The horizontal crossmember released from one post, and the bolt on the other post was significantly deformed but remained attached to the lower portion of the post. The sign panel was deformed, with one of the posts deformed just below the bottom attachment bolt. The second impacted sign came to rest 314 feet downstream and 22 feet to the right of impact. The sign was deformed, and the posts were bent slightly inward between the horizontal crossmember and the legs.

Figure 8.5 and Figure 8.6 show the damage to the Tall Sign Supports for Aluminum Signs.

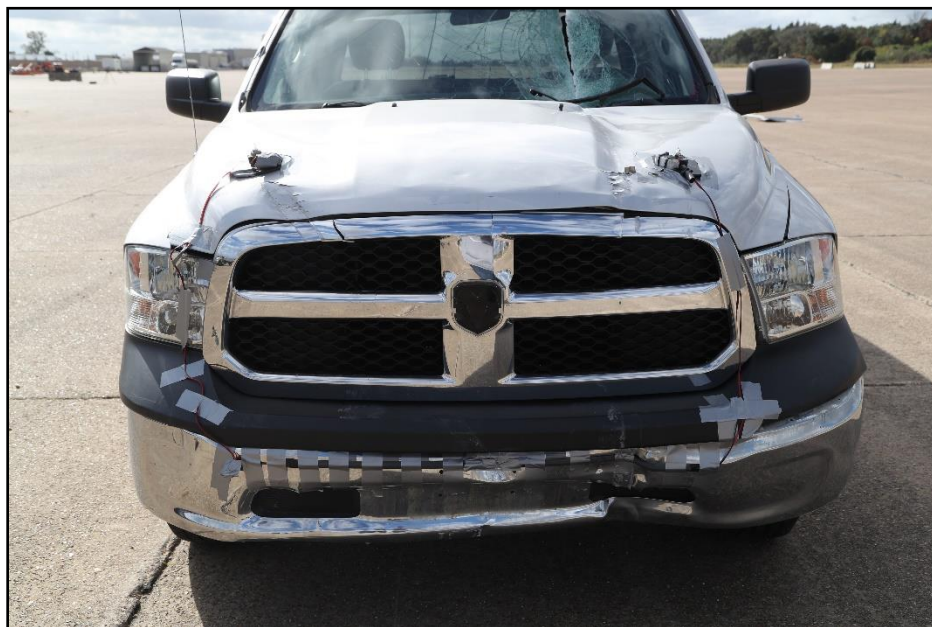
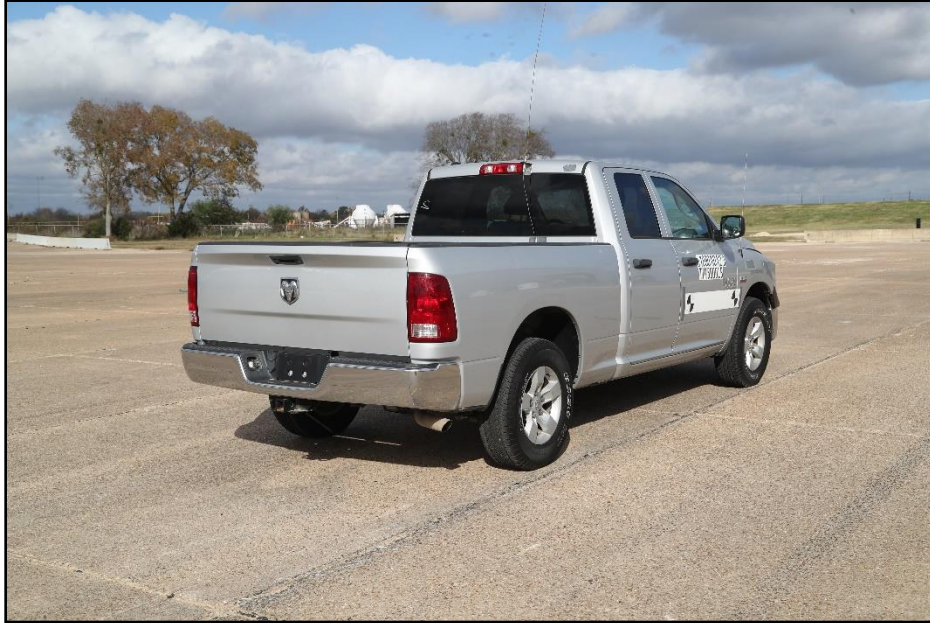
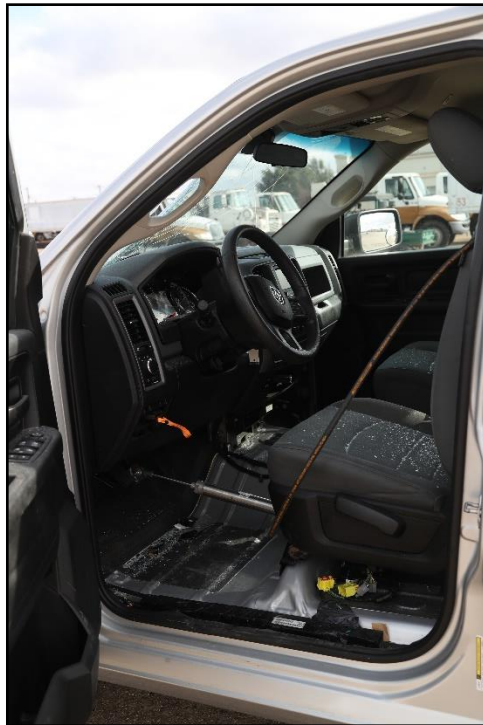
Figure 8.7 and Figure 8.8 show the damage sustained by the vehicle. Figure 8.9 shows the interior of the test vehicle. Table 8.6 and Table 8.7 provide details on the occupant compartment deformation and exterior vehicle damage. Figures G.2 and G.3 in Appendix G.1 provide exterior crush and occupant compartment measurements.

Side Windows	Side windows remained intact
Maximum Exterior Deformation	0.5 inches in the hood and windshield
VDS	12FC1
CDC	12FCGN6
Fuel Tank Damage	None
Description of Damage to Vehicle:	The bumper, grill, hood, and windshield were damaged. There was a 9-inch long × 5-inch wide × 0.5-inch deep dent in hood on driver's side, and a 27-inch long × 0.5-inch wide × 0.5-inch deep hole where the sign went through the windshield, which also cut the dash and damaged the instrument gauges.

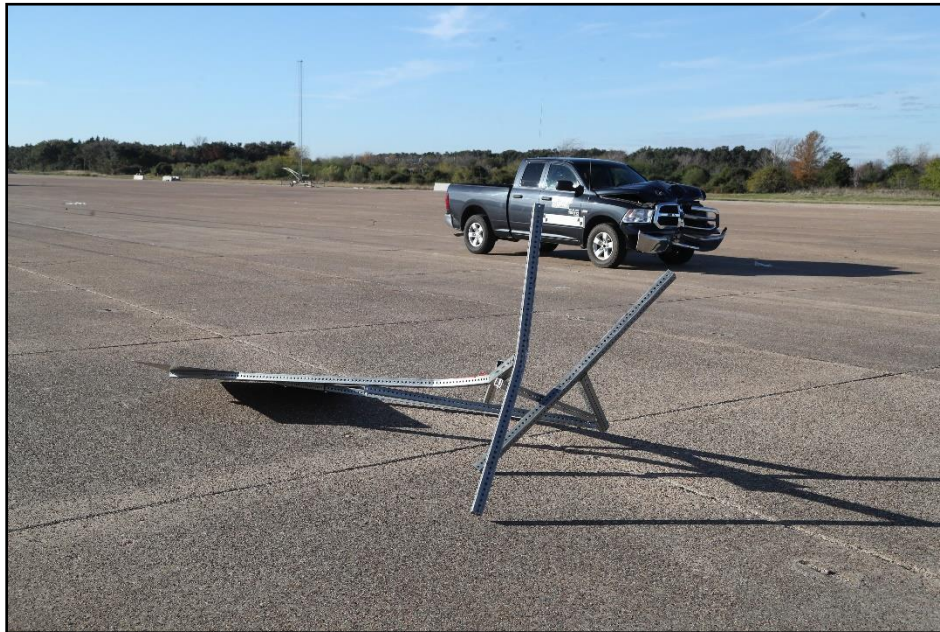
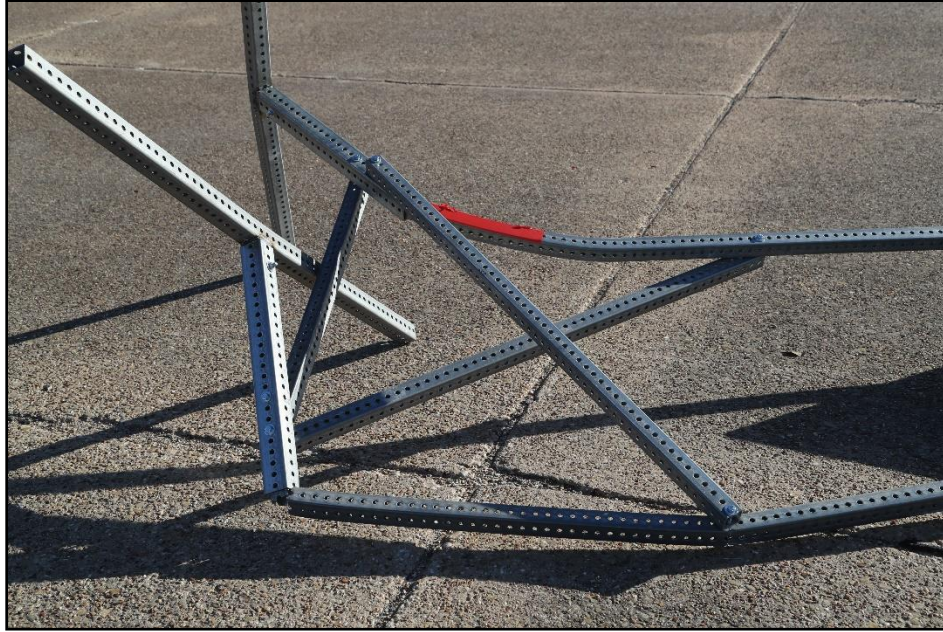
The sign landed 375 feet downstream and 10 feet to the right from impact to the center of the sign. The base of the sign deformed, and the downstream post fractured just above the connection to the leg.

Figure 9.5 and Figure 9.6 show the damage to the Tall Sign Supports for Aluminum Signs.

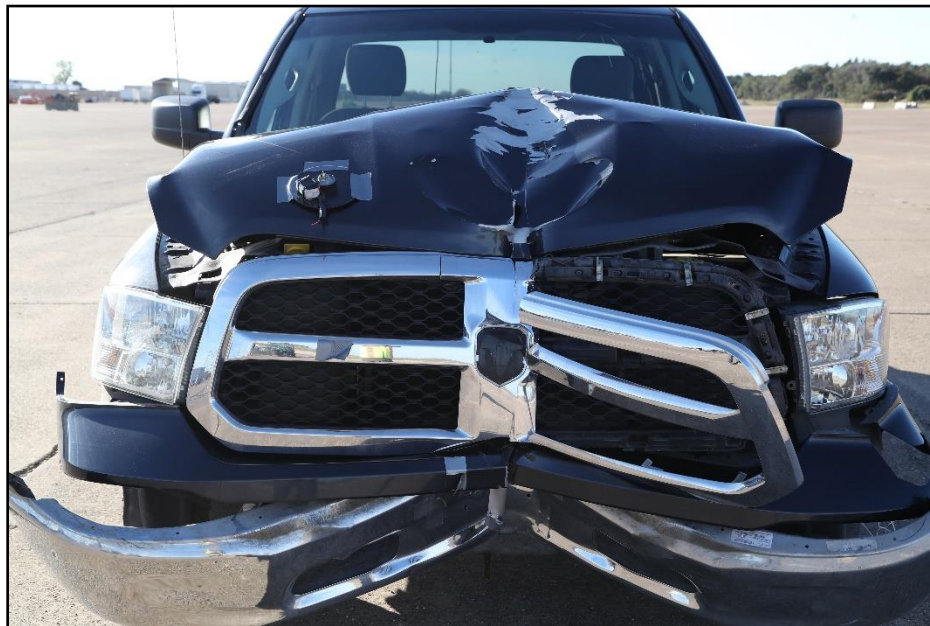
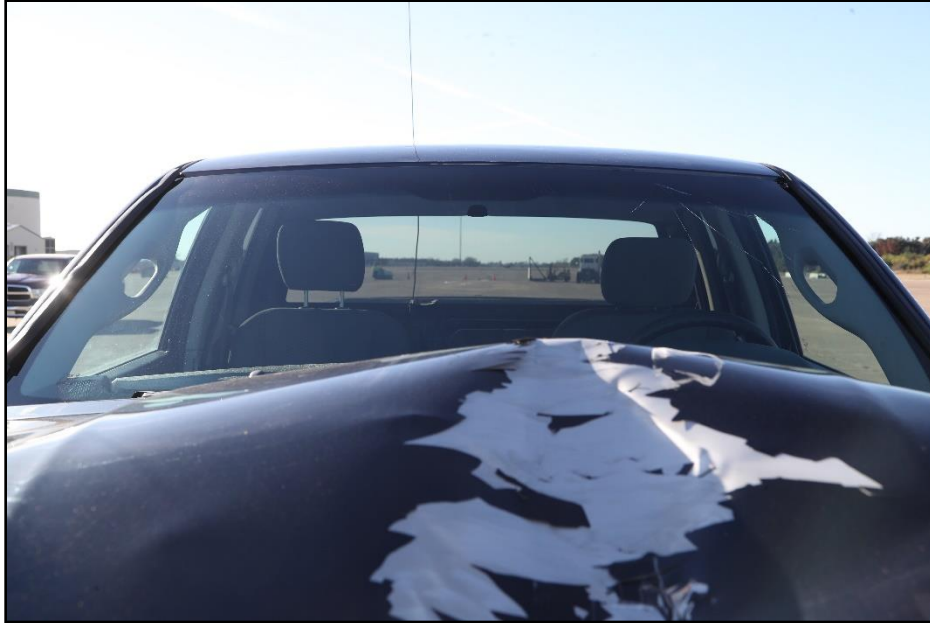
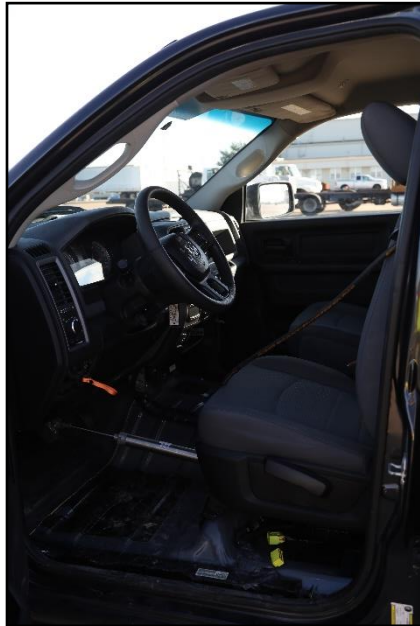
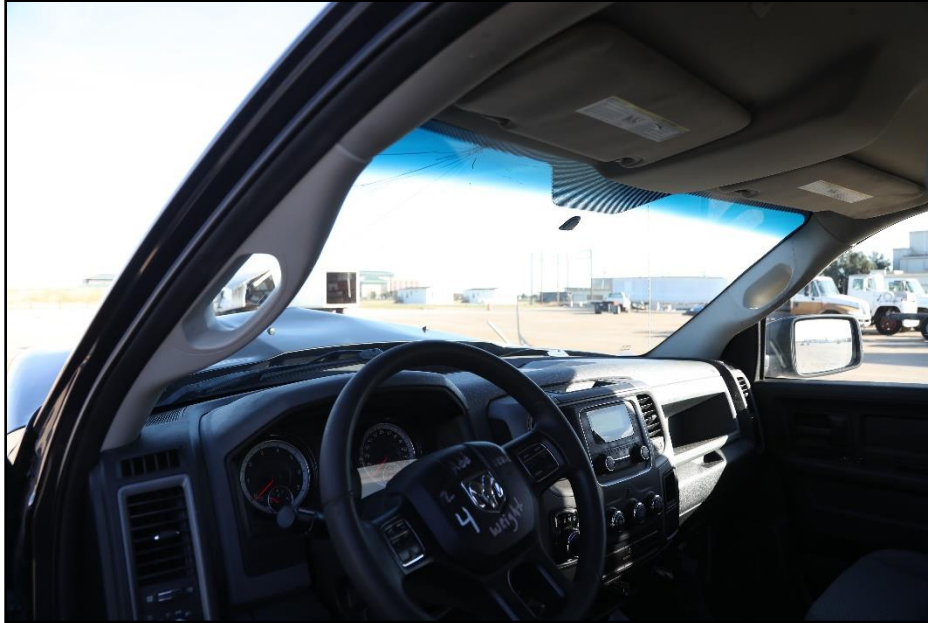
Figure 9.7 and Figure 9.8 show the damage sustained by the vehicle. Figure 9.9 and Figure 9.10 show the interior of the test vehicle. Table 9.6 and Table 9.7 provide details on the occupant compartment deformation and exterior vehicle damage. Figures H.2 and H.3 in Appendix H.1 provide exterior crush and occupant compartment measurements.

Side Windows	Side windows remained intact
Maximum Exterior Deformation	3 inches in the front bumper
VDS	12FC3
CDC	12FCMN3
Fuel Tank Damage	None
Description of Damage to Vehicle:	There was a 9-inch long × 6-inch wide × 3-inch deep dent in the bumper and a 7-inch long × 3-inch wide × 1.5-inch deep dent in the front center of the hood. There was a 12-inch long × 4-inch wide × 0.5-inch deep dent in the roof at the front left-hand side and a 14-inch long × 9-inch wide × 0.5-inch deep dent in the roof at the front right-hand side. There was a 10-inch long gash in the middle of the hood near the windshield. There were also cracks at the top portion of the windshield, but no holes.

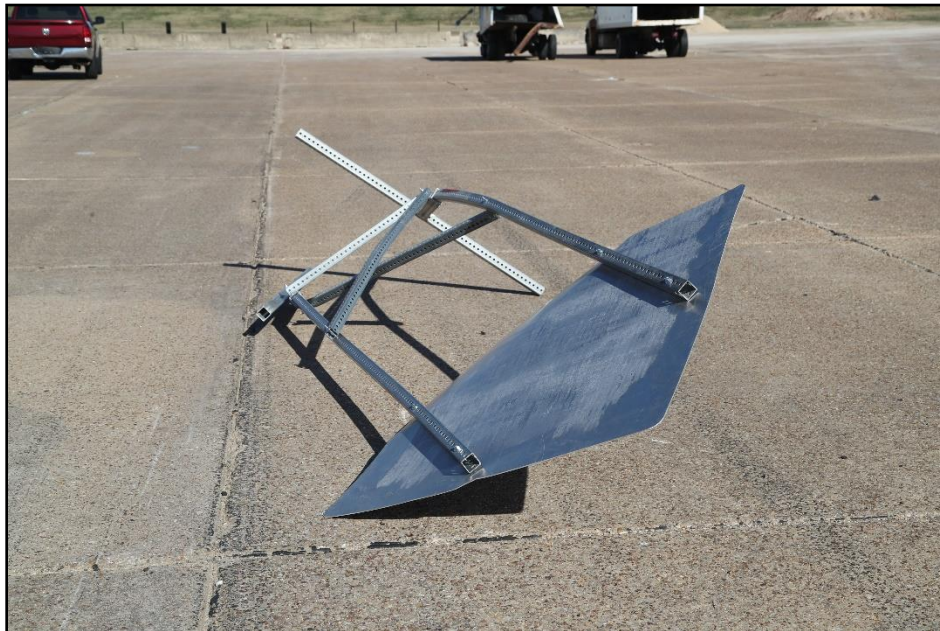
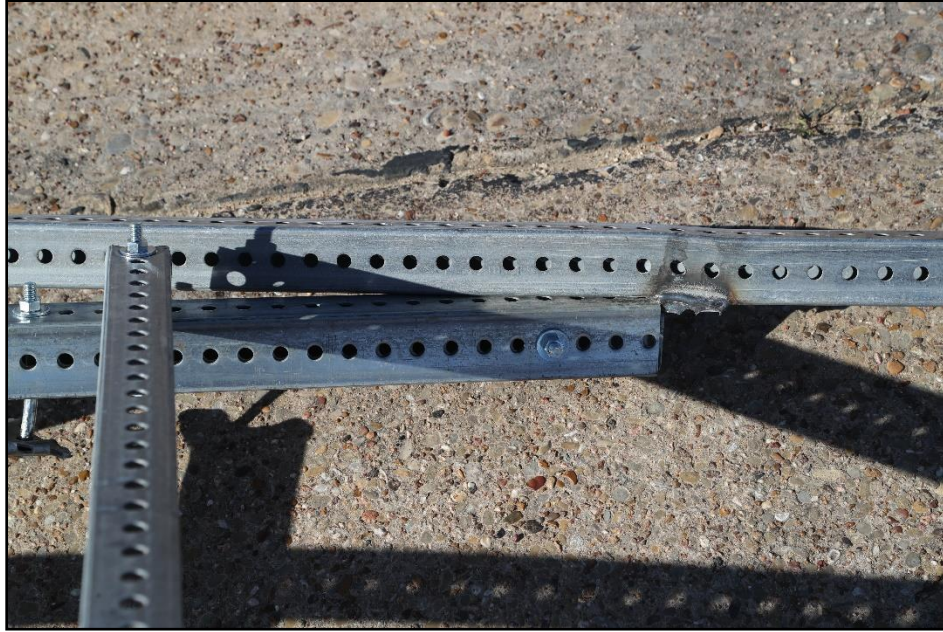
The sign landed 270ft downstream and 8 feet to the right. One of the legs was knocked askew, and the post was damaged above its connection to the left. leg The sign was bent on the lower corner.

Figure 10.5 and Figure 10.6 show the damage to the Tall Sign Supports for Aluminum Signs.
