Test Report No. 618901-01-2-1:7

**PORTABLE SIGN SUPPORTS FOR ALUMINUM SIGNS WITH  
VARIATIONS ON MOUNTING HEIGHT**

Sponsored by  
**The Roadside Safety Pooled Fund**

**TEXAS A&M TRANSPORTATION INSTITUTE PROVING GROUND**

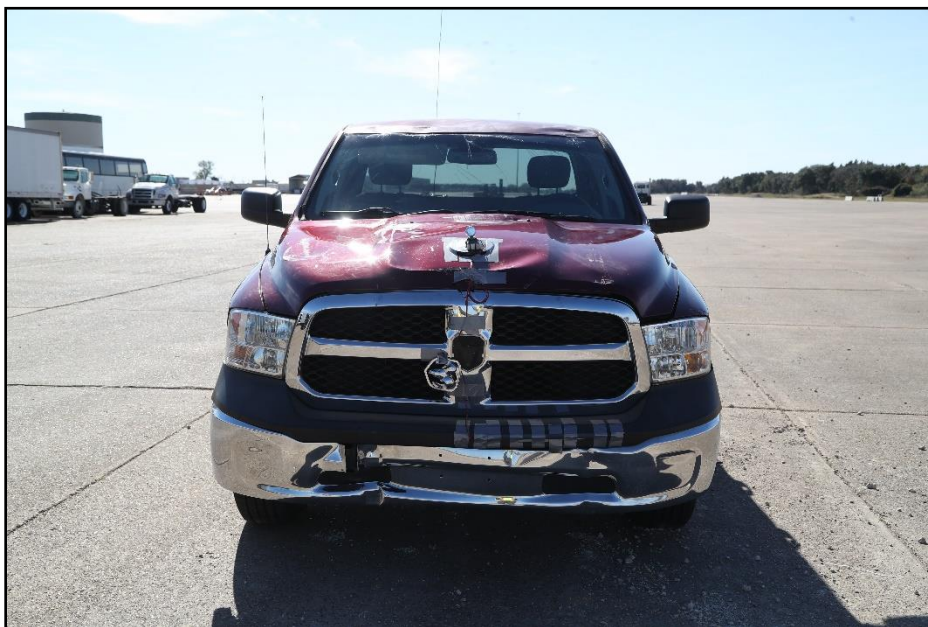
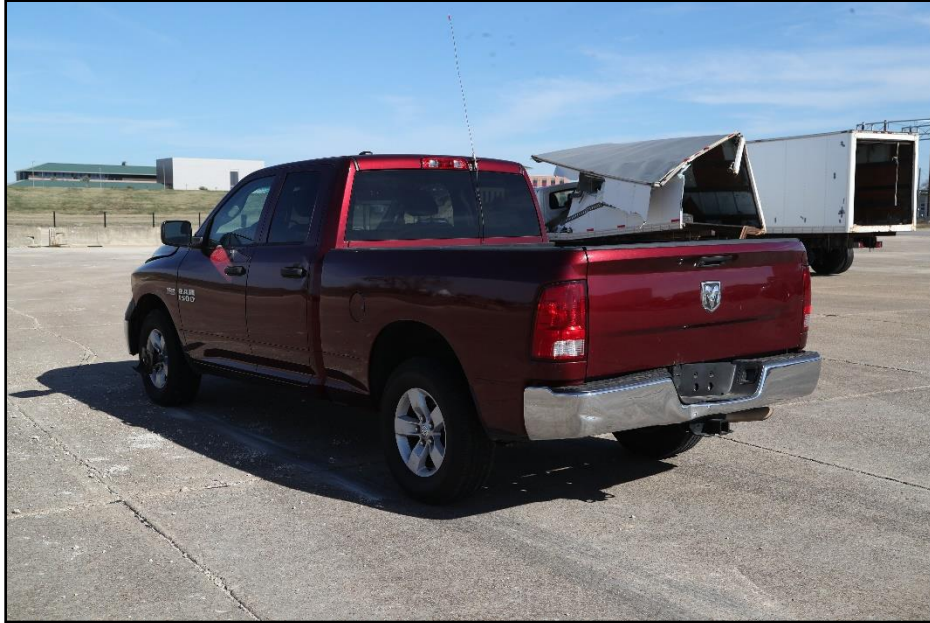
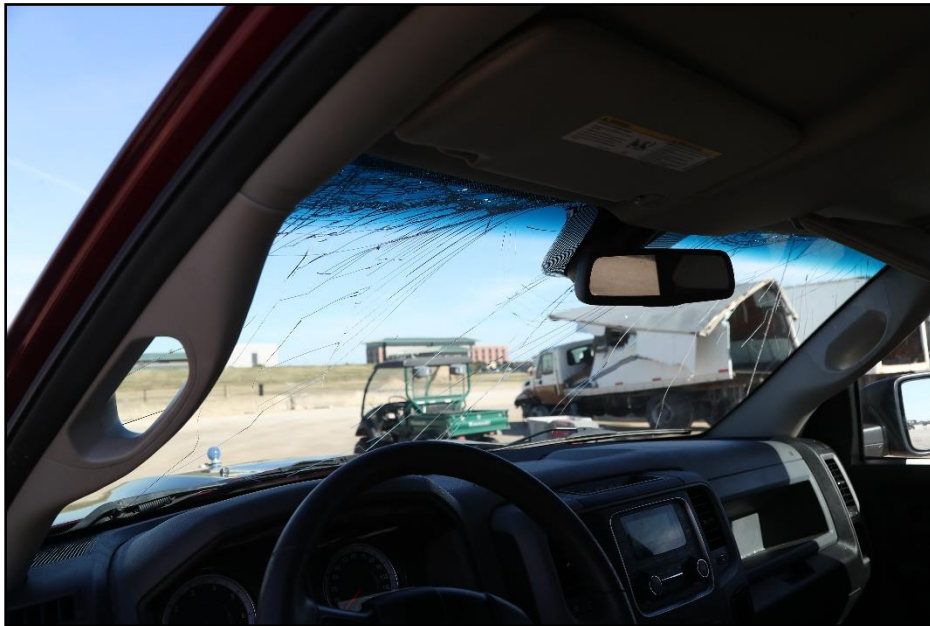
Figure 10.7 and Figure 10.8 show the damage sustained by the vehicle. Figure 10.9 shows the interior of the test vehicle. Table 10.6 and Table 10.7 provide details on the occupant compartment deformation and exterior vehicle damage. Figures I.2 and I.3 in Appendix I.1 provide exterior crush and occupant compartment measurements.

Side Windows	Side windows remained intact
Maximum Exterior Deformation	11 inches in the front bumper
VDS	12FC1
CDC	12FCHN1
Fuel Tank Damage	None
Description of Damage to Vehicle:	The bumper, grill, hood, radiator, and support were damaged. There were windshield cracks on the driver's side. At the front center of the hood there was a 7 inch long tear. There was a 1-inch long × 0.5-inch wide puncture in the hood, 15 inches up and 3 inches from the centerline toward the driver's side. There was a 4-inch wide × 11-inch deep dent in the bumper, and the hood buckled up.

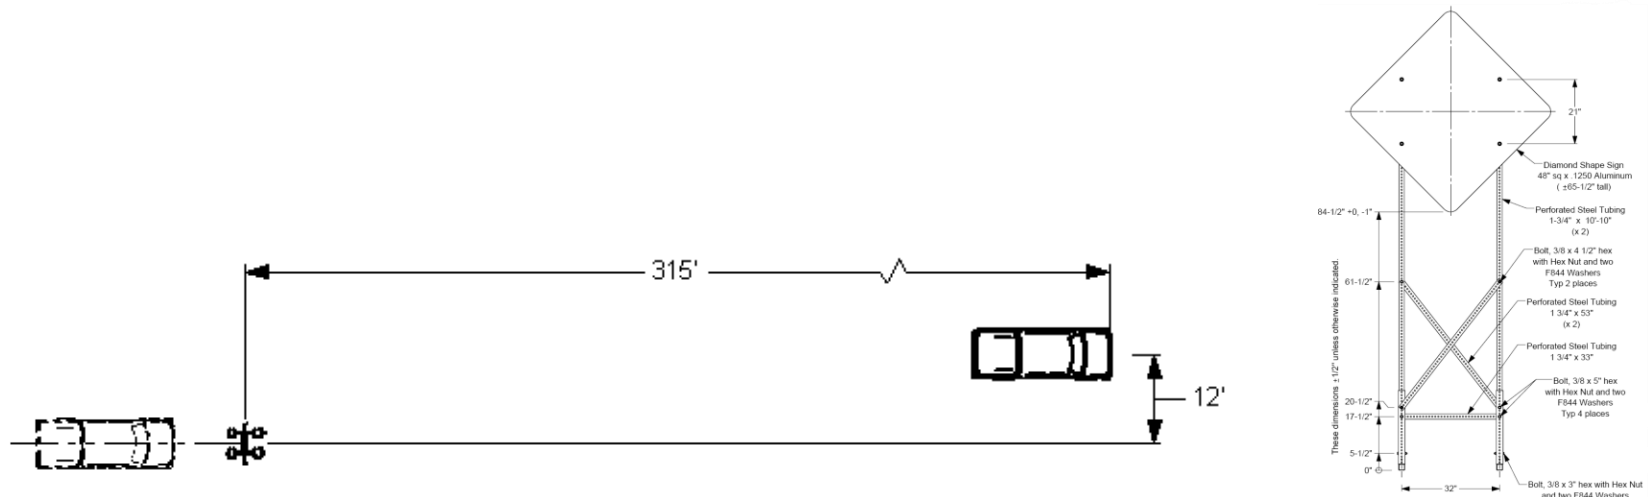
Figure 10.10. Summary of Results for MASH Test 3-72 on Tall Sign Supports for Aluminum Signs.

IMPACT CONDITIONS	
Impact Speed:	62.2 mi/h
Impact Angle:	90°
Impact Location:	Centerline of sign aligned with centerline of vehicle
Kinetic Energy:	649.8 kip-ft
EXIT CONDITIONS	
Exit Speed:	61.3mi/h
Stopping Distance:	315 ft downstream 12 ft to the left
VEHICLE DAMAGE	
VDS:	12FC1
CDC:	12FCHN1
Max Exterior Deformation:	11 inches in the front bumper
Max Occupant Compartment Deformation:	No occupant compartment deformation

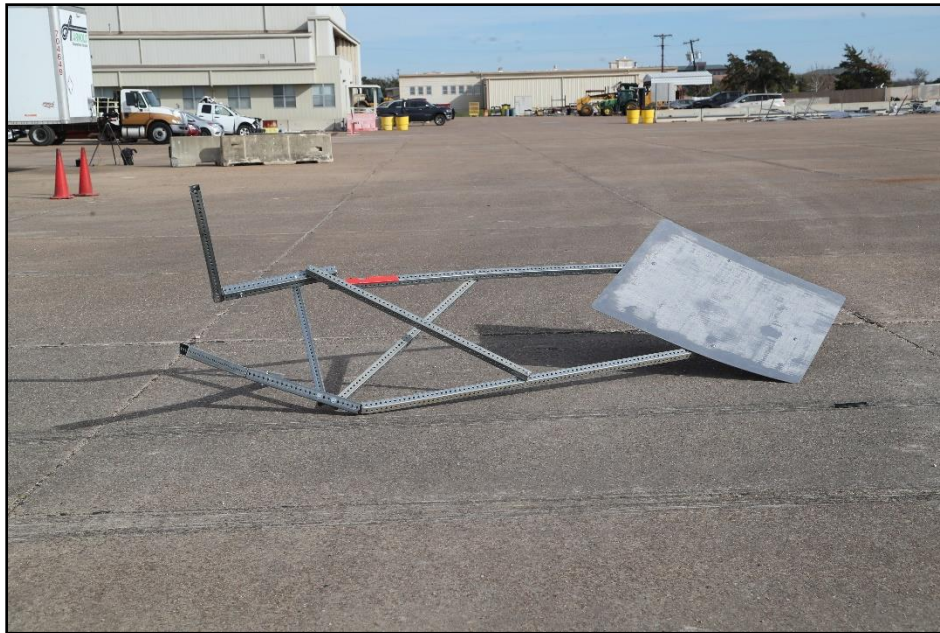
**Figure 11.5. Tall Sign Supports for Aluminum Signs at Resting Position after Test 618901-01-2-6.**

The sign landed 188 feet downstream of impact. The impacted support fractured where it connects to the leg, and the leg was dislodged from the installation. The other leg tore, and the sign was slightly deformed.

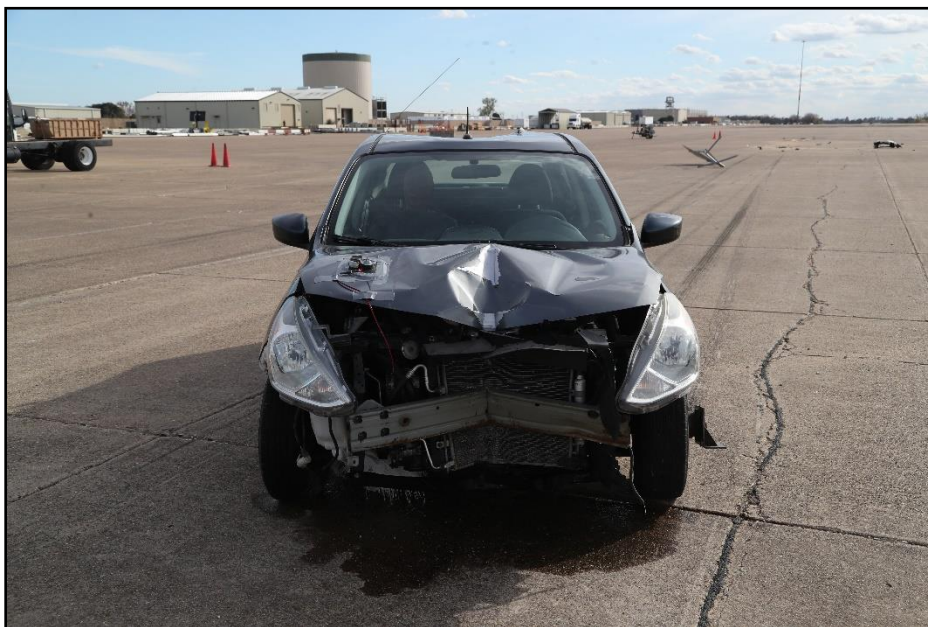
**Figure 11.7. Front of Test Vehicle after Test 618901-01-2-6.**

Side Windows	Side windows remained intact
Maximum Exterior Deformation	11.5 inches at front bumper
VDS	12FC2
CDC	12FCGN2
Fuel Tank Damage	None
Description of Damage to Vehicle:	There was a 12-inch long × 0.3-inch deep slice in roof on the driver's side with a 48-inch long × 24-inch wide × 2.8-inch deep dent in the roof. The radiator and fan were pushed against the engine block. The bumper, grill, hood, and support were damaged.

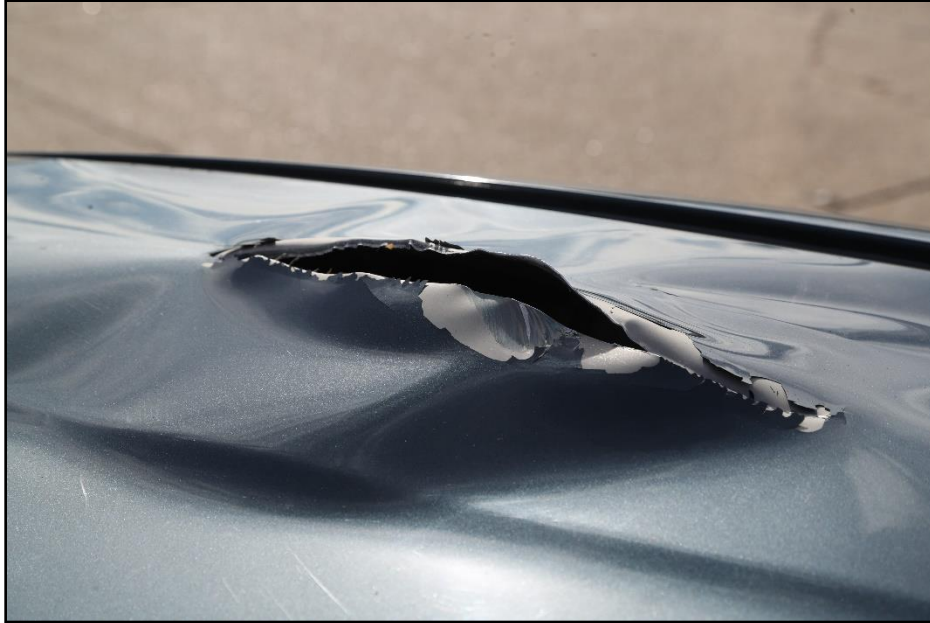
**Figure 11.8. Closeup of Tear in Roof of Test Vehicle after Test 618901-01-2-6.**

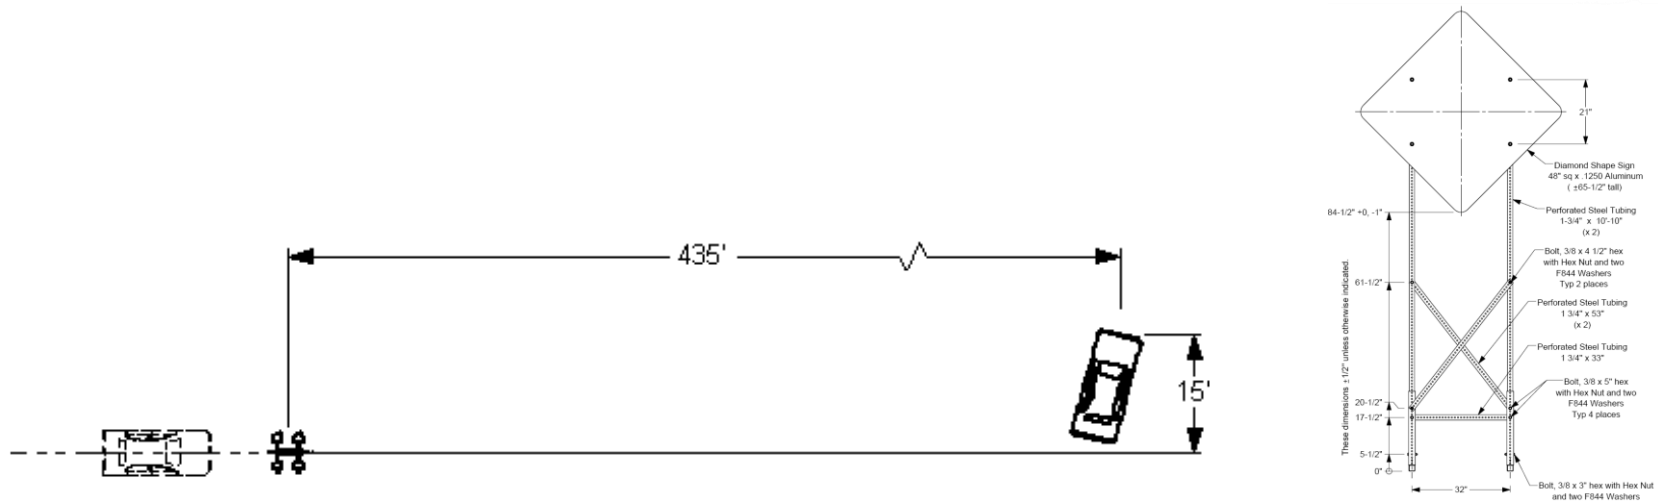
Figure 11.10. Summary of Results for MASH Test 3-71 on Tall Sign Supports for Aluminum Signs.

IMPACT CONDITIONS	
Impact Speed:	63.9 mi/h
Impact Angle:	90°
Impact Location:	Centerline of sign aligned with centerline of vehicle
Kinetic Energy:	334.8 kip-ft
EXIT CONDITIONS	
Exit Speed:	57.9 mi/h
Stopping Distance:	304 ft downstream 12 ft to the left
VEHICLE DAMAGE	
VDS:	12FC2
CDC:	12FCGN2
Max Exterior Deformation:	11.5 inches
Max Occupant Compartment Deformation:	2.8 inches in the roof with tears in the roof

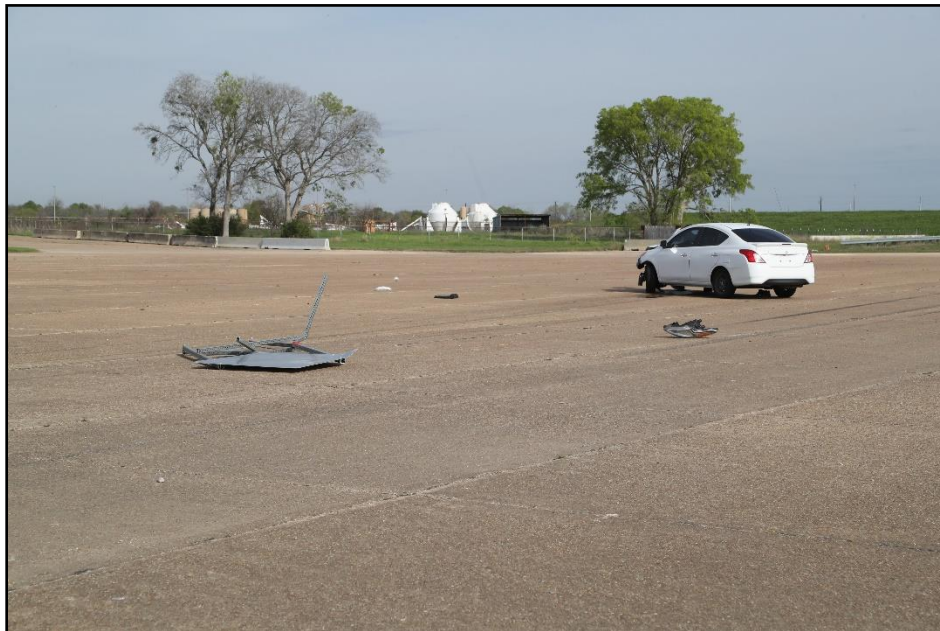
**Figure 12.5. Tall Sign Supports for Aluminum Signs at Resting Position after Test 618901-01-2-7.**

The test article came to rest 375 feet downstream of impact. The impacted post and the sign were bent, and the other post was fractured. The leg on the non-impact post released, and the half of the leg on the impacted post fractured and released from the installation.

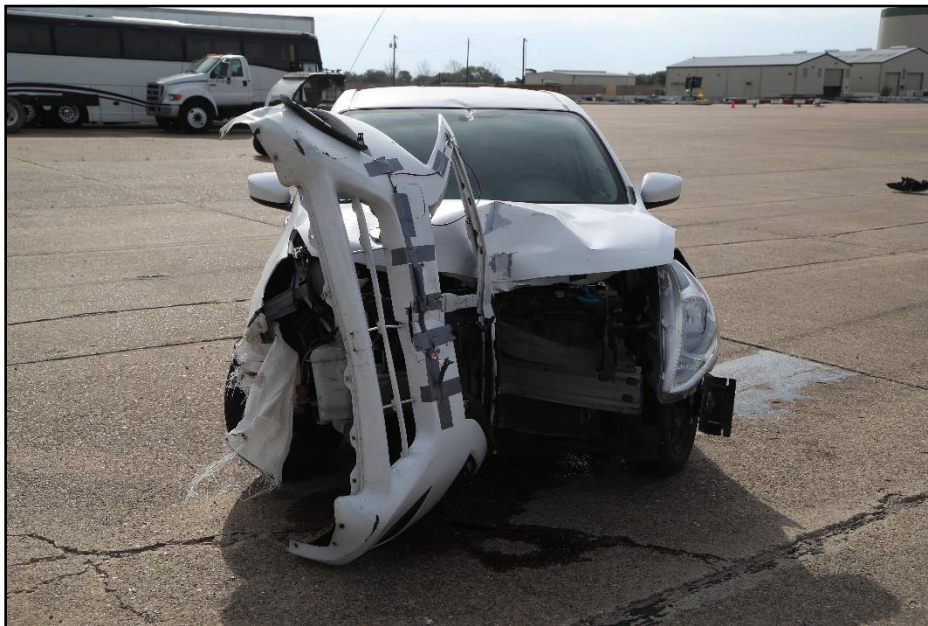
**Figure 12.7. Front of Test Vehicle after Test 618901-01-2-7.**

Side Windows	Side windows remained intact
Maximum Exterior Deformation	12 inches at front bumper
VDS	12FC3
CDC	12FCMW3
Fuel Tank Damage	None
Description of Damage to Vehicle:	There was a 3-inch long × 0.3-inch wide hole in the top of the center of the windshield caused by the sign. The hood, bumper, grill, radiator, and support were damaged, with a small dent in the front center of the roof.

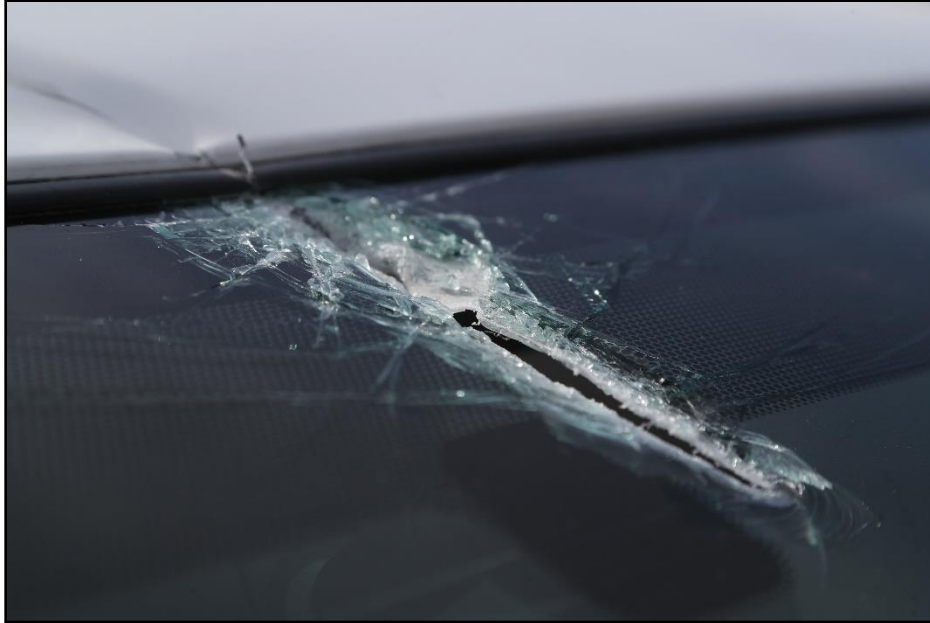
**Figure 12.8. Closeup of Tear in Windshield of Test Vehicle after Test 618901-01-2-7.**

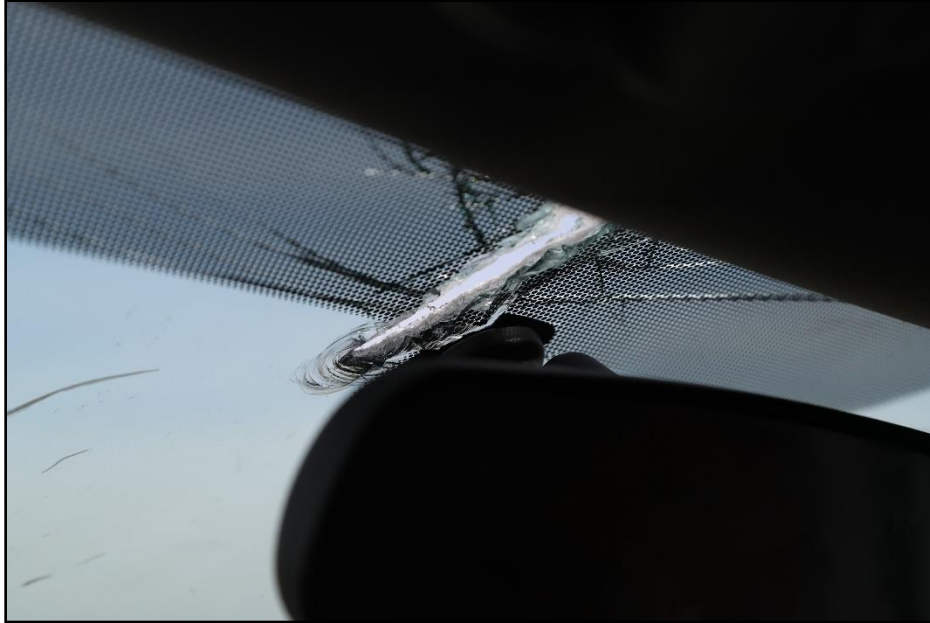
**Figure 12.10. Interior of Test Vehicle at the Windshield Damage after Test 618901-01-2-7.**

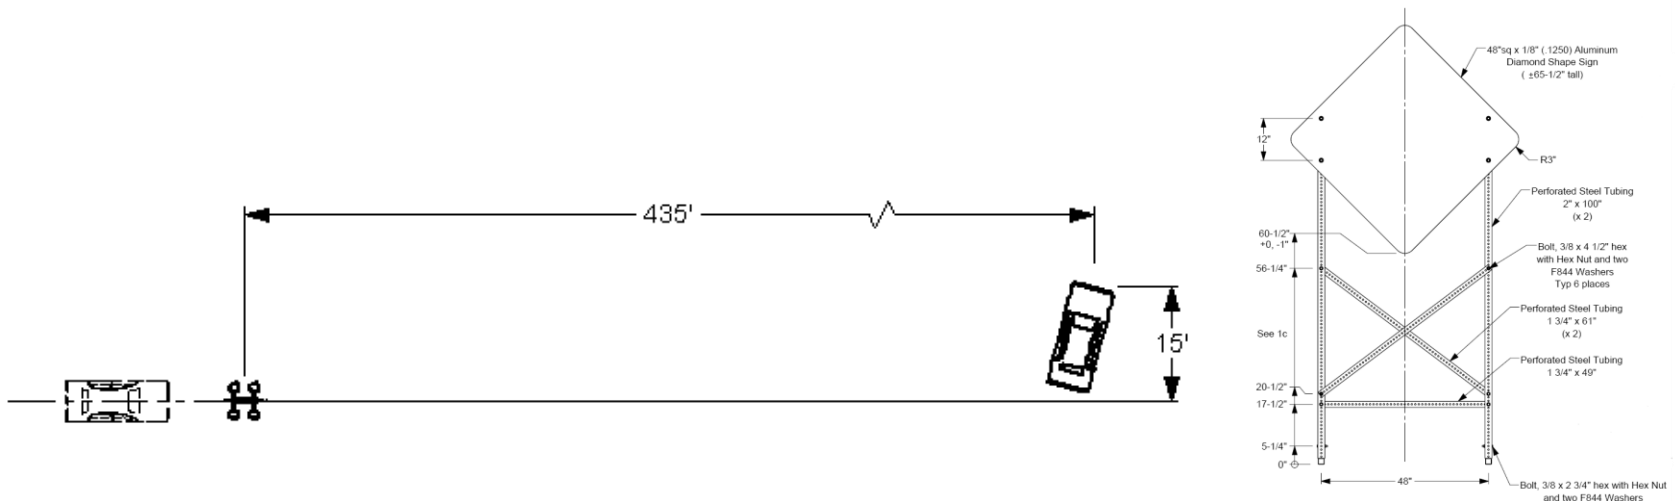
Figure 12.11. Summary of Results for MASH Test 3-71 on Tall Sign Supports for Aluminum Signs.

<b>VDS:</b>	12FC3
<b>CDC:</b>	12FCMW3
<b>Max Exterior Deformation:</b>	12 inches
<b>Max Occupant Compartment Deformation:</b>	Penetration of test article through windshield. No other deformation

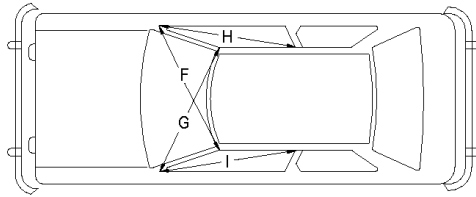
**Figure J.3. Occupant Compartment Measurements for Test 618901-01-2-6.**

Before	After (inches)	Differ.
A1	67.50	67.50	0.00
A2	67.25	67.25	0.00
A3	67.75	67.75	0.00
B1	40.50	40.50	0.00
B2	39.00	37.00	-2.00
B3	40.50	39.75	-0.75
B4	36.25	35.75	-0.50
B5	36.00	33.25	-2.75
B6	36.25	35.75	-0.50
C1	26.00	26.00	0.00
C2	0.00	0.00	0.00
C3	26.00	26.00	0.00
D1	9.50	9.50	0.00
D2	0.00	0.00	0.00
D3	9.50	9.50	0.00
E1	51.50	51.50	0.00
E2	51.00	51.00	0.00
F	51.00	51.00	0.00
G	51.00	51.00	0.00
H	37.50	37.50	0.00
I	37.50	37.50	0.00
J*	51.00	51.00	0.00

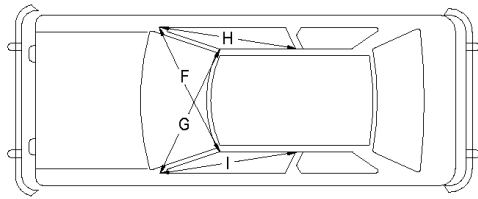
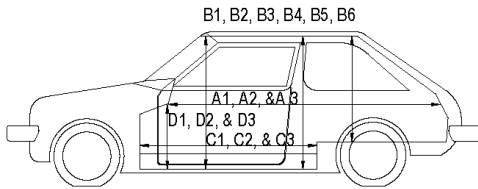
**Figure K.3. Occupant Compartment Measurements for Test 618901-01-2-7.**

Before	After (inches)	Differ.
A1	67.50	67.50	0.00
A2	67.25	67.25	0.00
A3	67.75	67.75	0.00
B1	40.50	40.50	0.00
B2	39.00	39.00	0.00
B3	40.50	40.50	0.00
B4	36.25	36.25	0.00
B5	36.00	36.00	0.00
B6	36.25	36.25	0.00
C1	26.00	26.00	0.00
C2	0.00	0.00	0.00
C3	26.00	26.00	0.00
D1	9.50	9.50	0.00
D2	0.00	0.00	0.00
D3	9.50	9.50	0.00
E1	51.50	51.50	0.00
E2	51.00	51.00	0.00
F	51.00	51.00	0.00
G	51.00	51.00	0.00
H	37.50	37.50	0.00
I	37.50	37.50	0.00
J*	51.00	51.00	0.00
