## SKID-MOUNTED SUPPORT SYSTEM FOR TEMPORARY GUIDE SIGNS

**Test Report No. 0-6782-2**

TEXAS A&M TRANSPORTATION INSTITUTE  
COLLEGE STATION, TEXAS

1. Report No. FHWA/TX-14/0-6782-2		2. Government Accession No.		3. Recipient's Catalog No.	
4. Title and Subtitle SKID-MOUNTED SUPPORT SYSTEM FOR TEMPORARY GUIDE SIGNS				5. Report Date August 2014

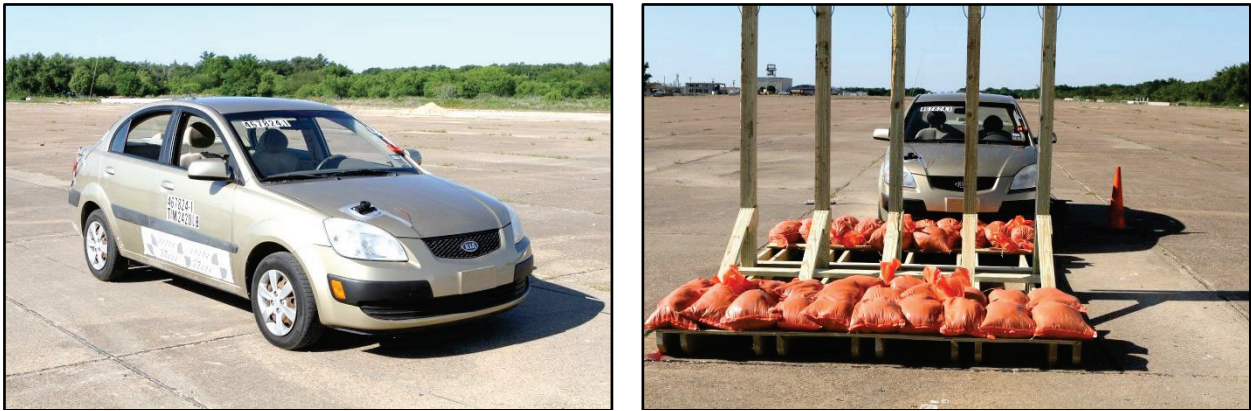
**Figure 4.3. Vehicle before Test No. 467824-1.**

A 2008 Kia Rio, shown in Figure 4.3, was used for the crash test. Test inertia weight of the vehicle was 2440 lb, and its gross static weight was 2605 lb. The height to the lower edge of the vehicle bumper was 8.0 inches, and the height to the upper edge of the bumper was 21.0 inches. Table C1 in Appendix C gives additional dimensions and information on the test vehicle. The vehicle was directed into the installation using a cable reverse tow and guidance system, and was released to be freewheeling and unrestrained just prior to impact.

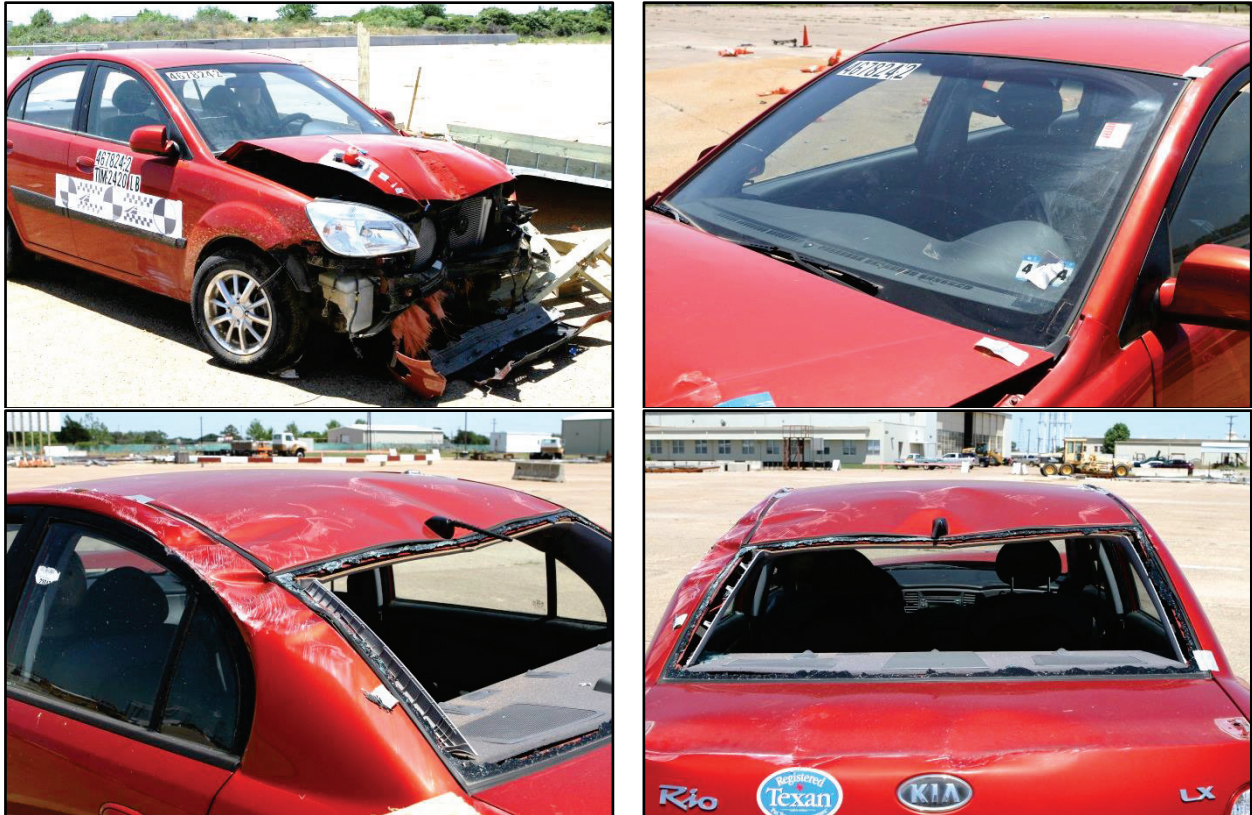
Figure 4.9. Vehicle after Test No. 467824-2.

Figure 4.9 shows the damage that the vehicle sustained during the test, which included the front bumper, radiator and support, hood, left and right front fenders, left rear quarter panel, right front door, right rear quarter panel, and the trunk lid. The front of the vehicle was deformed inward 10 inches. The roof was pushed downward in the rear passenger area and the rear glass broke. Maximum occupant compartment deformation was 2.0 inches over the center of the rear passenger area. Tables D2 and D3 of Appendix D show the exterior crush and occupant compartment measurements.

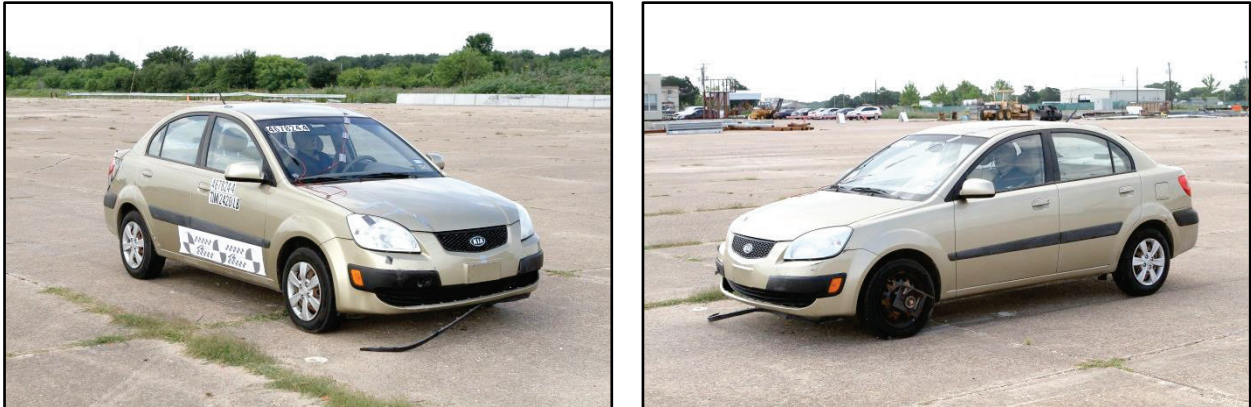
Figure 4.14. Vehicle after Test No. 467824-4.

Figure 4.14 shows the damage that the vehicle sustained during the test, which included only cosmetic damage in the form of scratches to the front bumper. No measureable exterior crush to the vehicle was noted. No occupant compartment deformation occurred. Tables G2 and G3 in Appendix G give exterior crush and occupant compartment measurements.

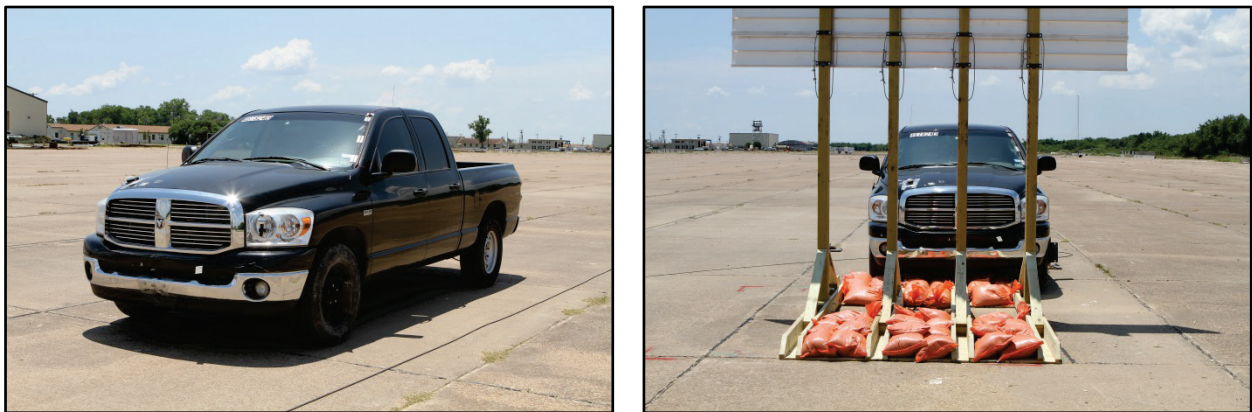
Figure 4.16. Vehicle before Test No. 467824-3.

Figure 4.16 shows a 2008 Dodge Ram 1500 pickup truck was used for the crash test. The test inertia weight of the vehicle was 5016 lb, and the gross static weight was 5016 lb. The height to the lower edge of the vehicle bumper was 16.0 inches, and the height to the upper edge of the bumper was 27.75 inches. Tables H1 and H2 in Appendix H gives additional dimensions and information on the vehicle. The vehicle was directed into the installation using a cable reverse tow and guidance system, and was released to be freewheeling and unrestrained just prior to impact.

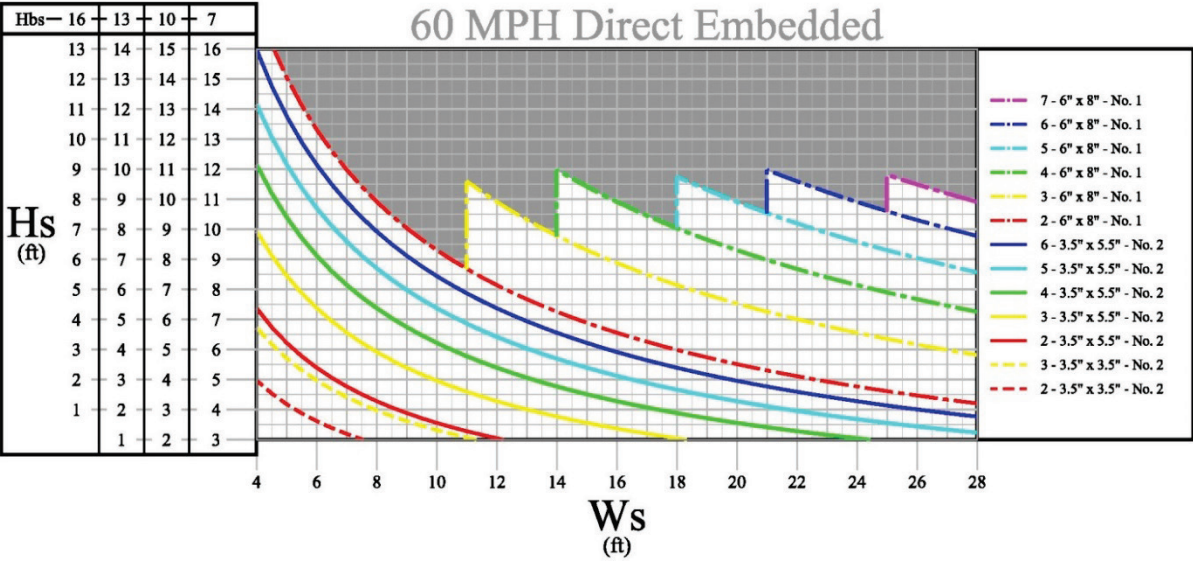
Figure 5.2. Design Chart for Direct Embedded Wood Support System with S4S Posts (60 mph Design Wind Speed).

Figure 5.1 and Figure 5.2 present the post selection charts for a 60-mph design wind speed for rough sawn and S4S lumber, respectively. The x-axis of the charts is sign panel width and the y-axis of the charts is sign panel height. Note that different height axes are available for use depending on the mounting height of the sign with respect to the local terrain. Different axes are available for sign mounting heights of 7, 10, 13, and 16 ft. The nominal mounting height of a large guide sign is 7 ft with respect to the roadway surface. Because roadside terrain typically includes slopes and ditches to provide required hydraulic capacity, the actual mounting height from the local ground to the bottom of the sign panel is often greater than the nominal mounting height. This actual mounting height dictates the required moment capacity of the support post.

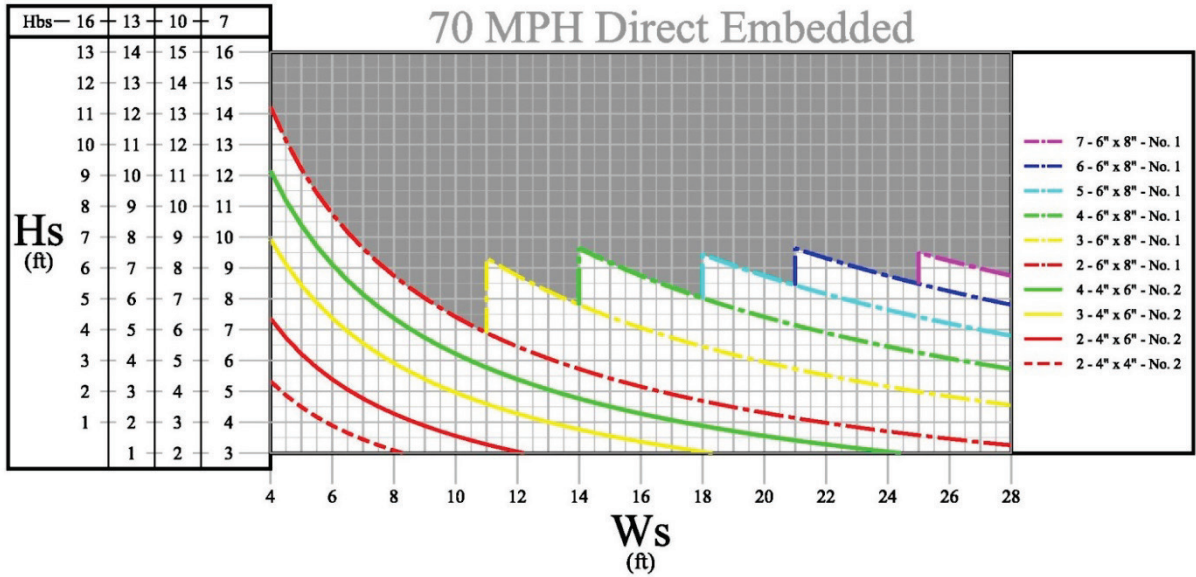
**Figure 5.3. Design Chart for Direct Embedded Wood Support System Rough Sawn Posts (70 mph Design Wind Speed).**

Figure 5.3 and Figure 5.4 present similar design charts for a 70-mph design wind speed for rough sawn and S4S posts, respectively. The following example illustrates the use of the design charts.

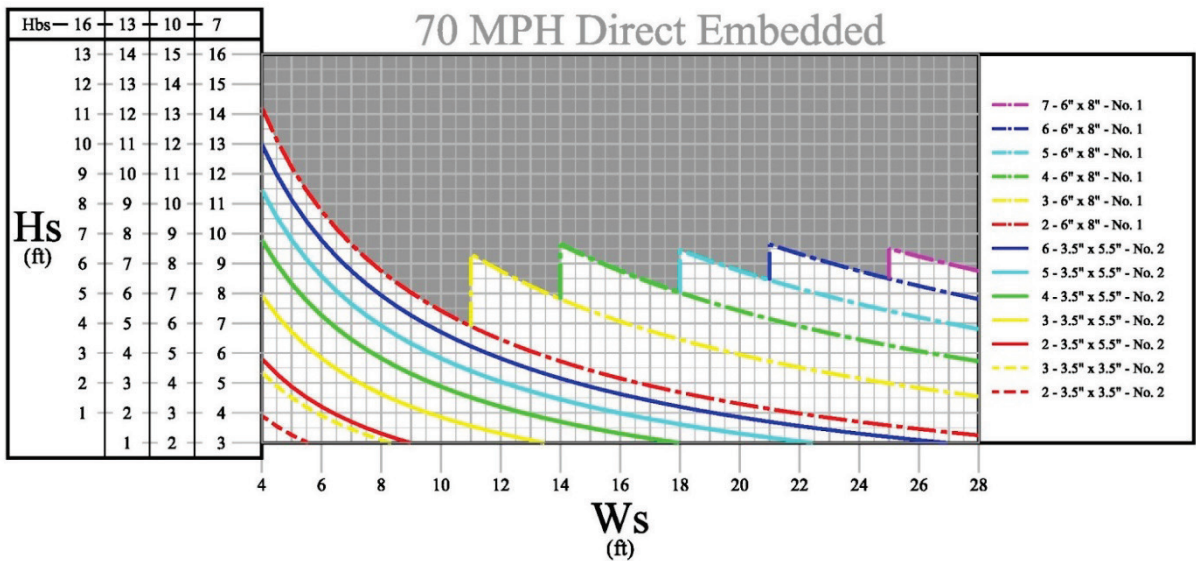
**Figure 5.4. Design Chart for Direct Embedded Wood Support System with S4S Posts (70 mph Design Wind Speed).**

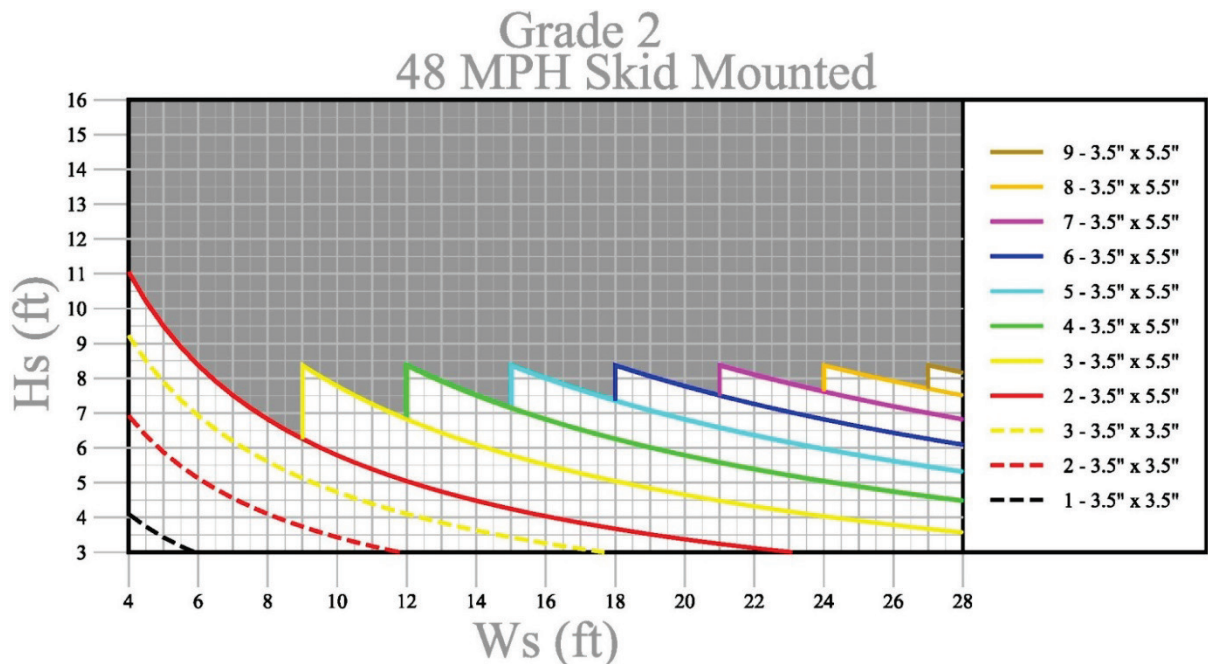
**Figure 5.5. Design Chart for Post Selection for Skid-Mounted Sign Support System.**

Figure 5.5 presents the post selection chart for a 48-mph design wind speed. The x-axis of the chart corresponds to sign panel width and the y-axis of the chart corresponds to sign panel height. Note that unlike the direct embedded wood sign support system, only one height axis is required. This is because the skid-mounted system is constructed with a specific mounting height of 7½ ft, and is assumed to be placed on terrain that is relatively flat.

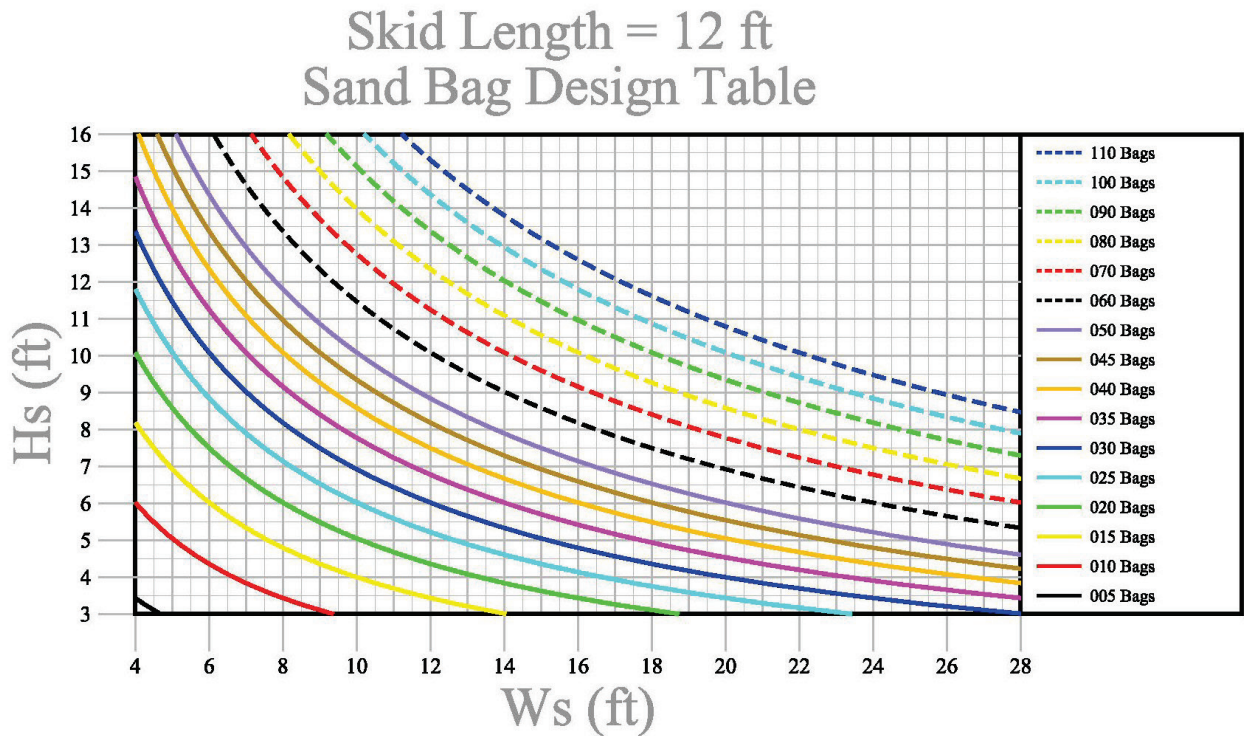
**Figure 5.6. Design Chart for Ballast Required for Skid-Mounted Sign Support System.**

Figure 5.6 presents the ballast selection chart for the skid-mounted temporary guide signs. This chart indicates the total number of 40-lb sand bags required for a specified sign area. Note that the number of sand bags indicated in the chart is the total amount required, and this amount would be equally divided on each side of the skids. With reference to Figure 5.6, it can be seen that 45 sand bags are required for the 8-ft tall  $\times$  12-ft wide sign panel used in the above example.

Recommended embedment depths were developed for both the direct embedded wood and steel support systems. Additionally, ballast requirements were determined for the skid-mounted sign support system to prevent overturning of the skid-mounted system during a design wind event. The design wind speed used for designing the skid-mounted system was based on a mean recurrence interval of 2 years, which was considered a reasonable duration for projects in which the skid-mounted sign support system for guide signs is considered applicable.

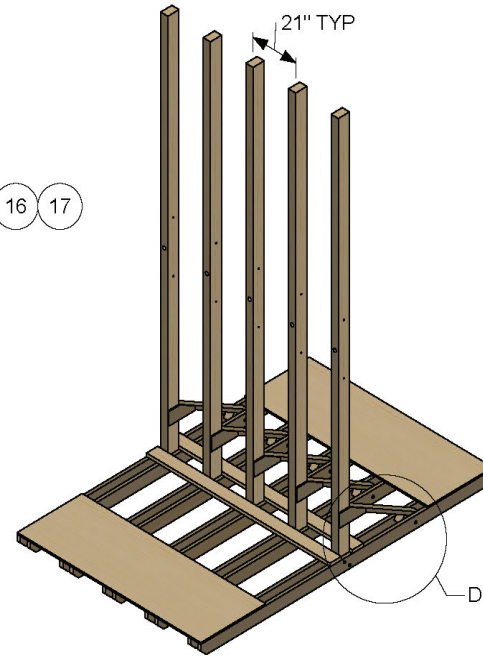
Project 467824 1-2	Large Temporary Sign	2014-05-09
Drawn By GES	Scale 1:50	Sheet 5 of 7
Frame Assembly

### Frame Assembly

**Detail D**  
Scale 1 : 10  
TYP x 5

Frame Assembly Parts		
#	Part Name	QTY.
13	Wood Frame	1
14	Washer, 3/8 flat	30
15	Bolt, 3/8 x 7-1/2 hex	15
16	Washer, 3/8 lock	15
17	Nut, 3/8 hex	15
18	Deck Screws as needed*

\*Use Deck Screws or other screws designed for outdoor use. Minimum size #8 for 2" screws and #9 for 3" screws. Drywall screws are not acceptable.

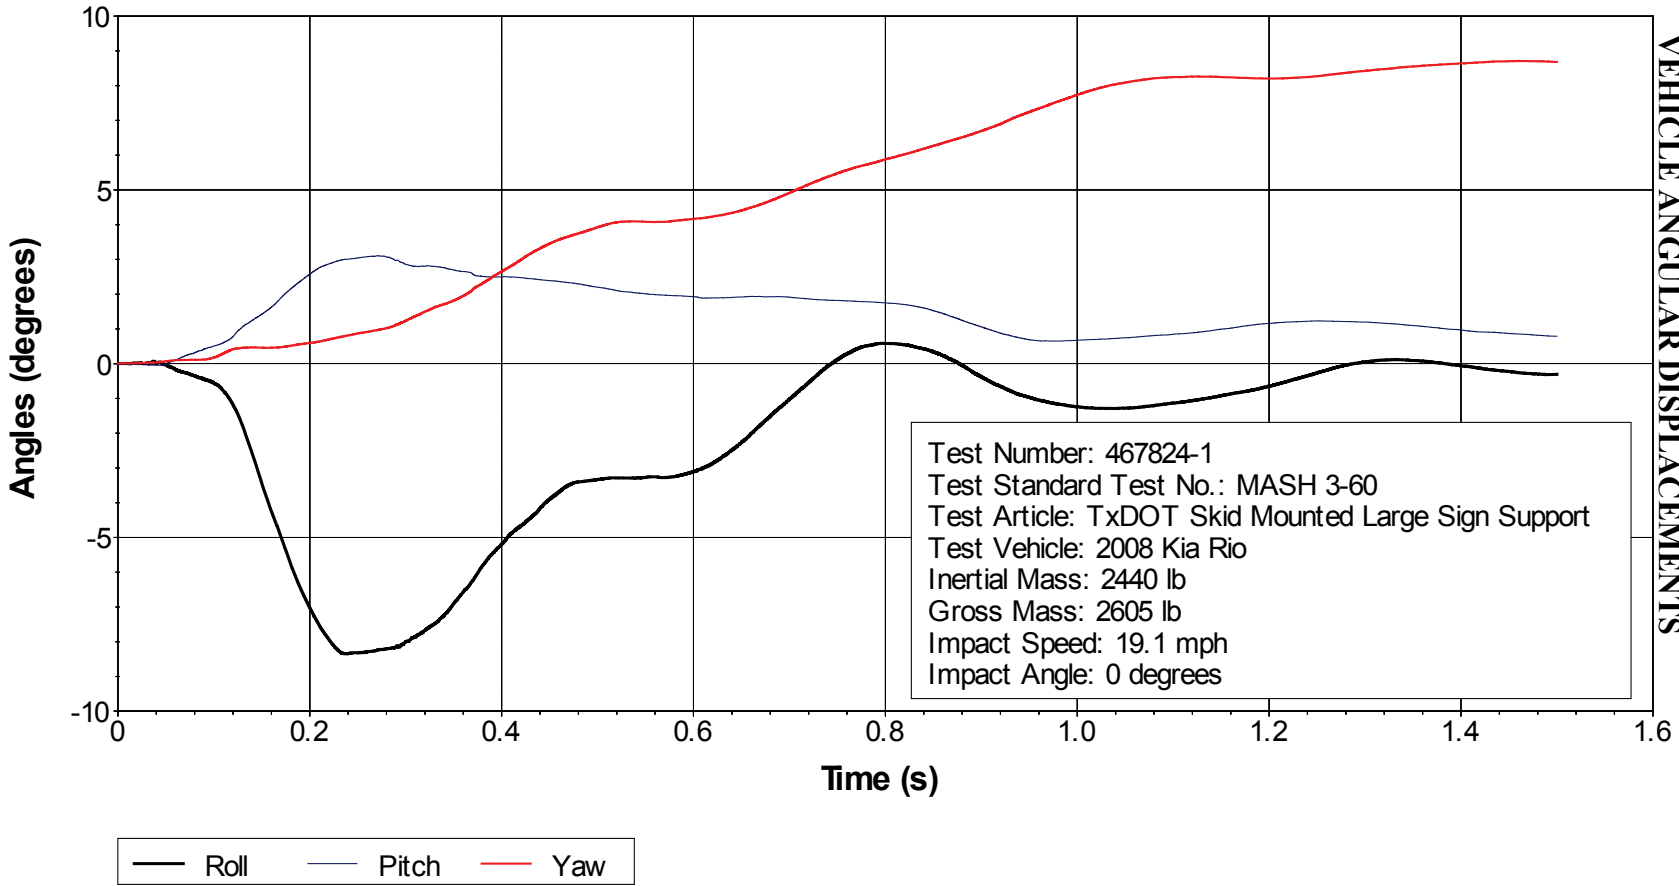
Figure C2. Vehicle Angular Displacements for Test No. 467824-1.

### Roll, Pitch, and Yaw Angles

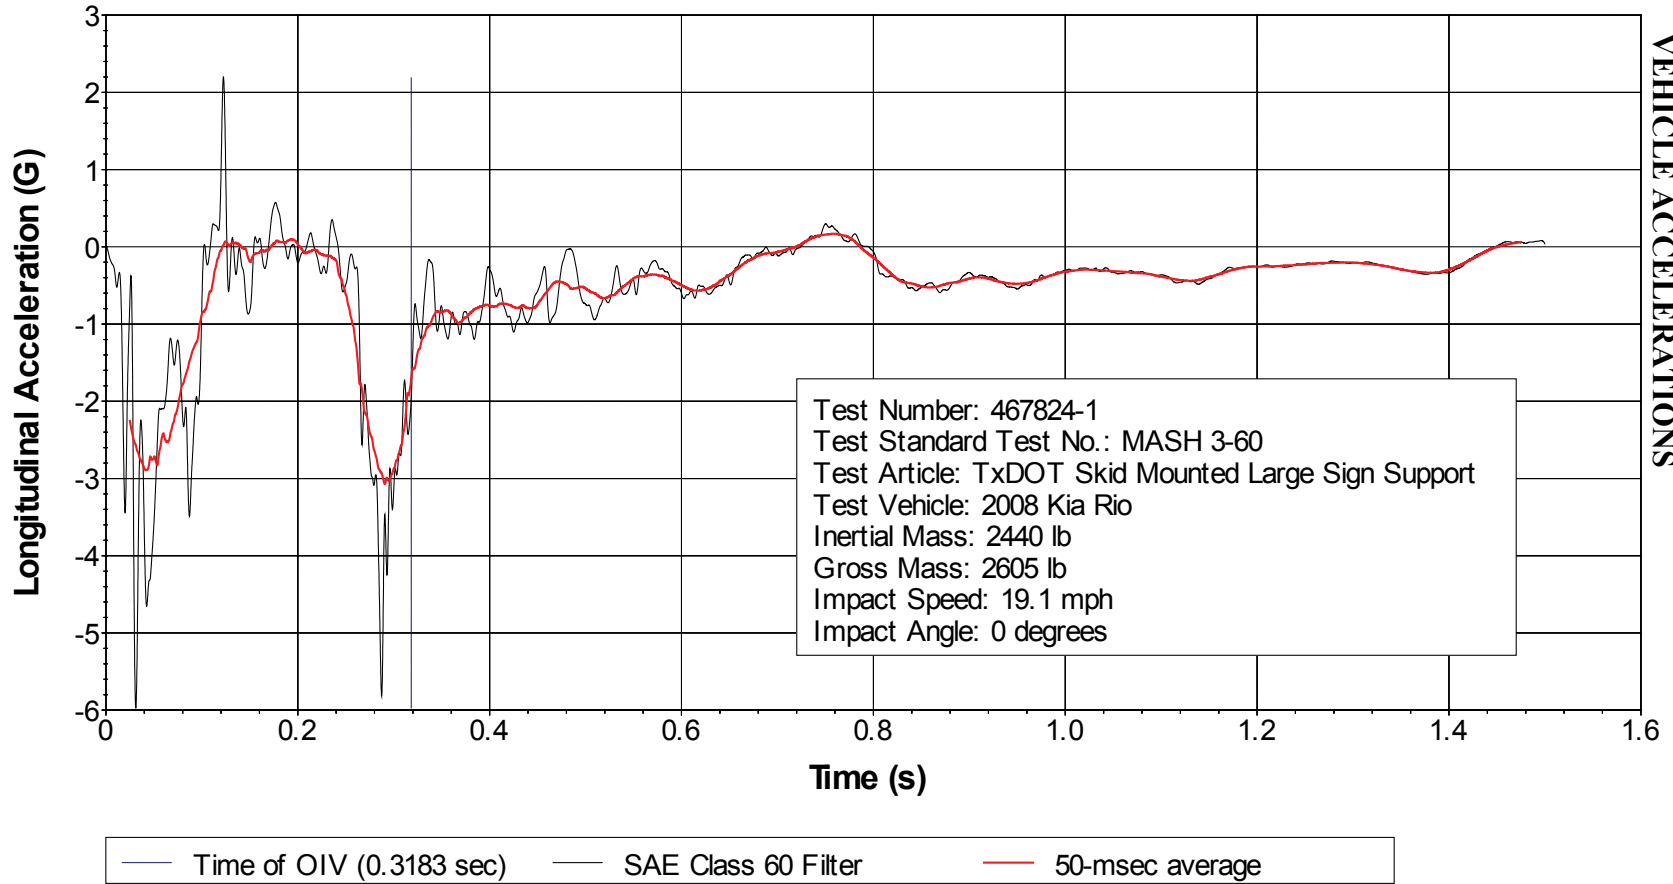
### X Acceleration at CG

Figure C3. Vehicle Longitudinal Accelerometer Trace for Test No. 467824-1 (Accelerometer Located at Center of Gravity).

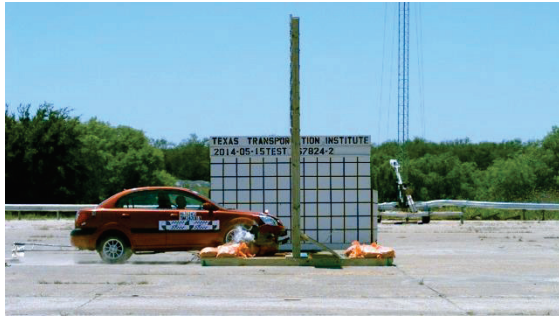
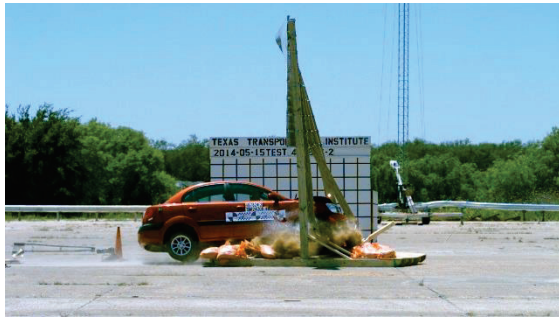
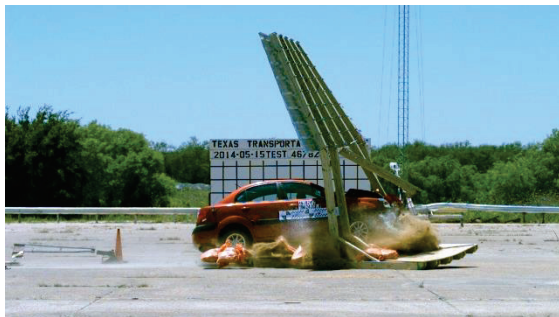
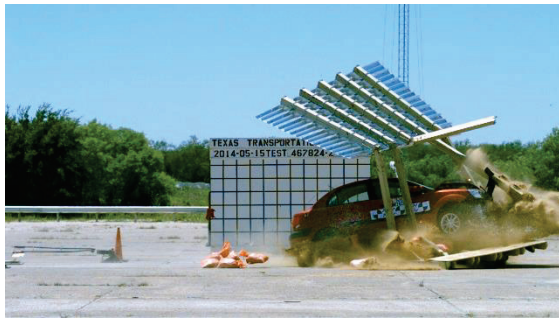
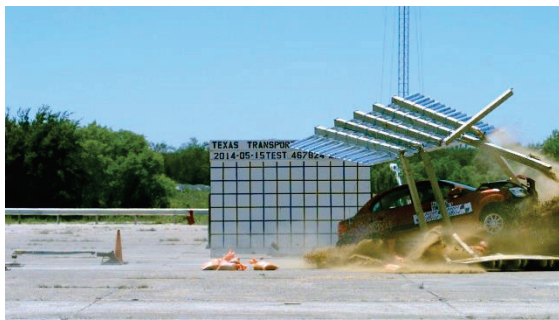
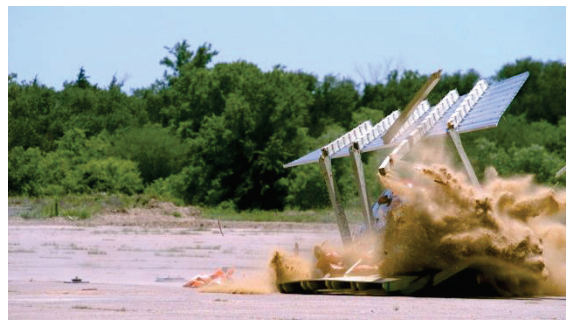
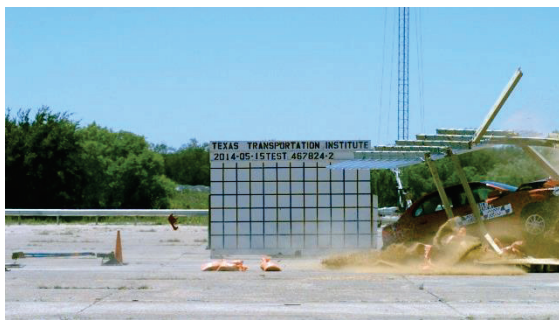
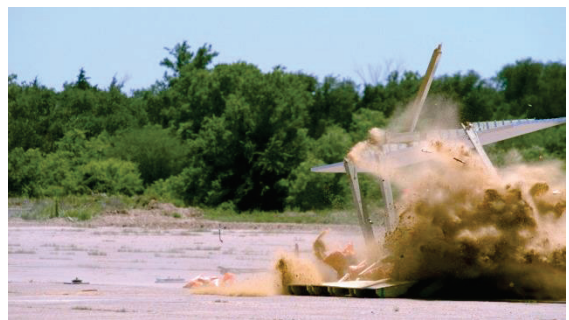
**Figure D1. Sequential Photographs for Test No. 467824-2 (Perpendicular and Oblique Views).**

**Figure D1. Sequential Photographs for Test No. 467824-2 (Perpendicular and Oblique Views) (Continued).**

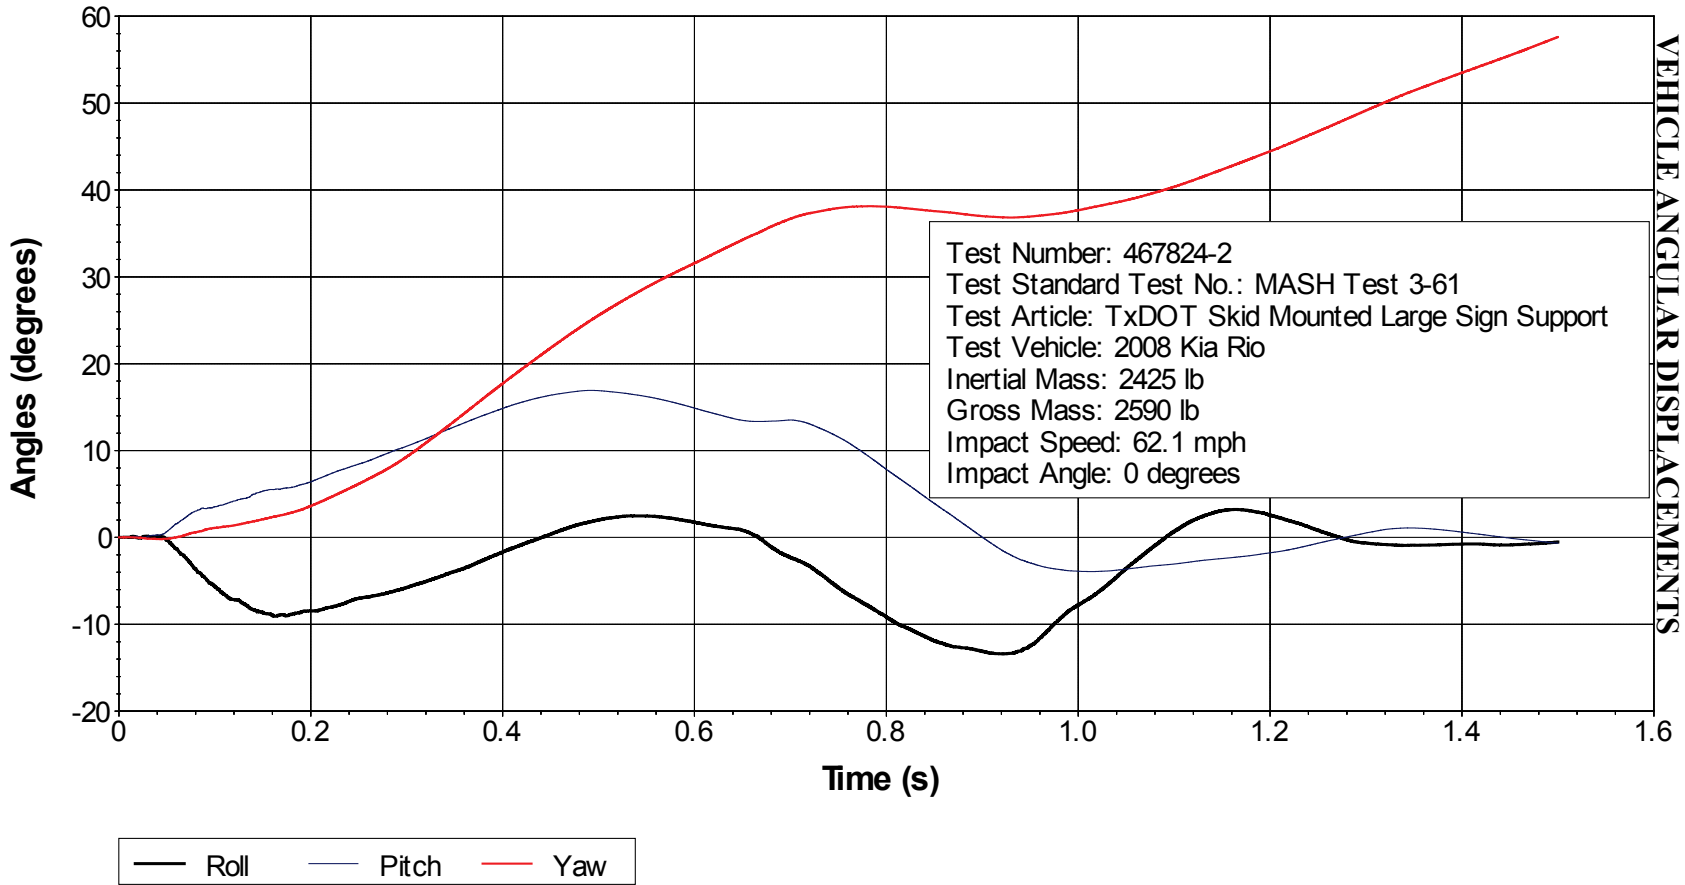
Figure D2. Vehicle Angular Displacements for Test No. 467824-2.

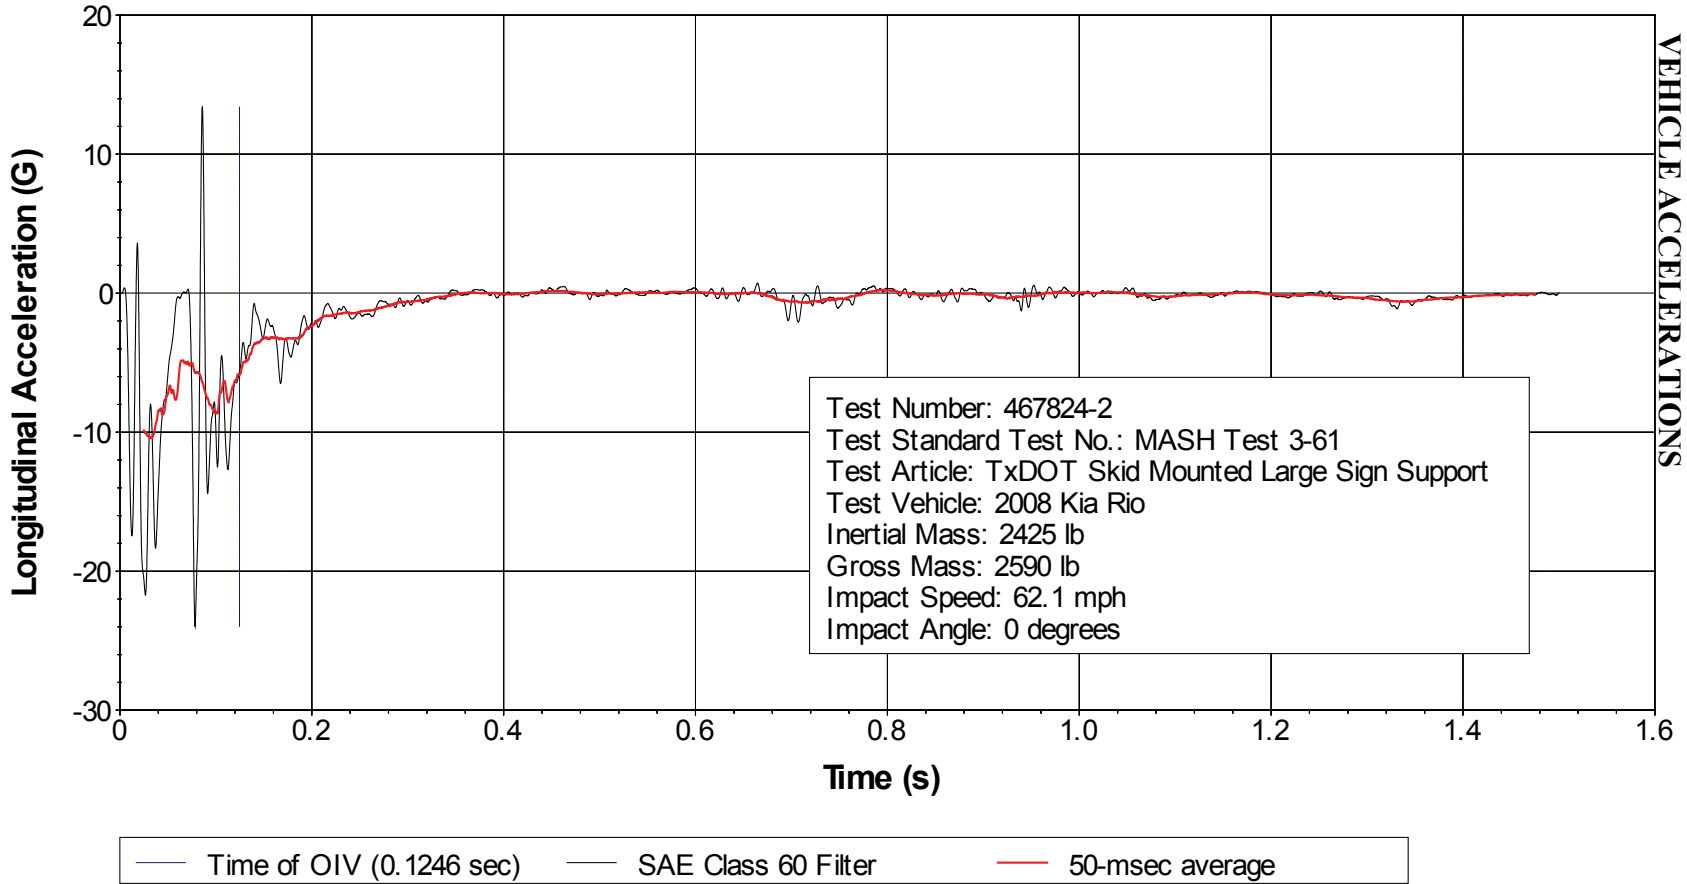
Figure D3. Vehicle Longitudinal Accelerometer Trace for Test No. 467824-2 (Accelerometer Located at Center of Gravity).

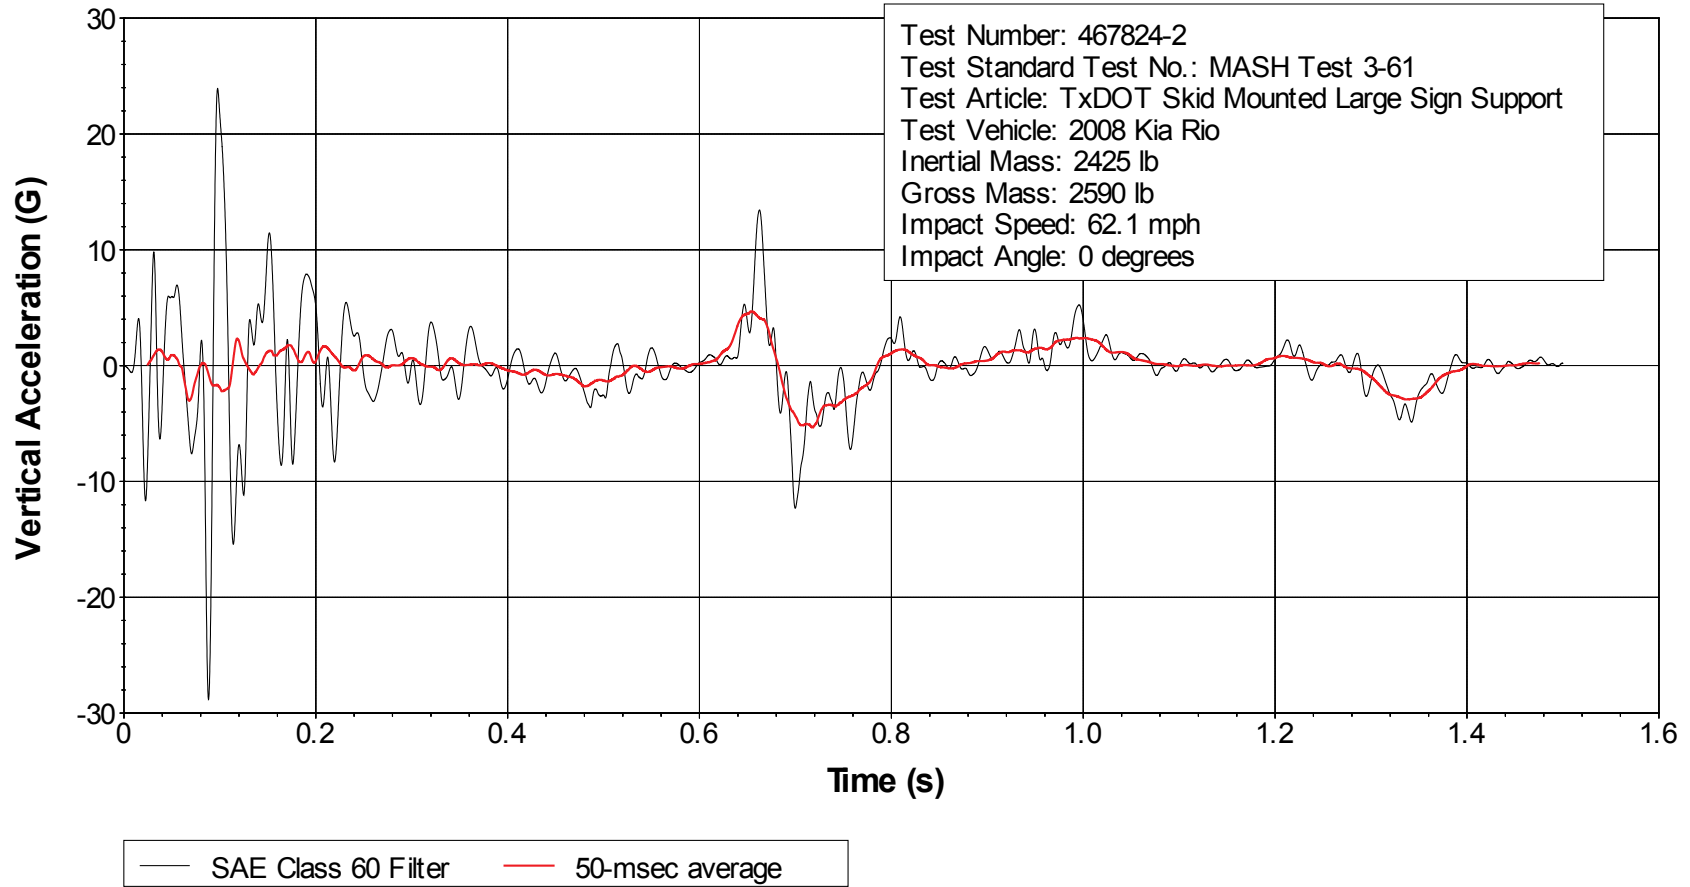
**Figure D8. Vehicle Vertical Accelerometer Trace for Test No. 467824-2 (Accelerometer Located Rear of Center of Gravity).**

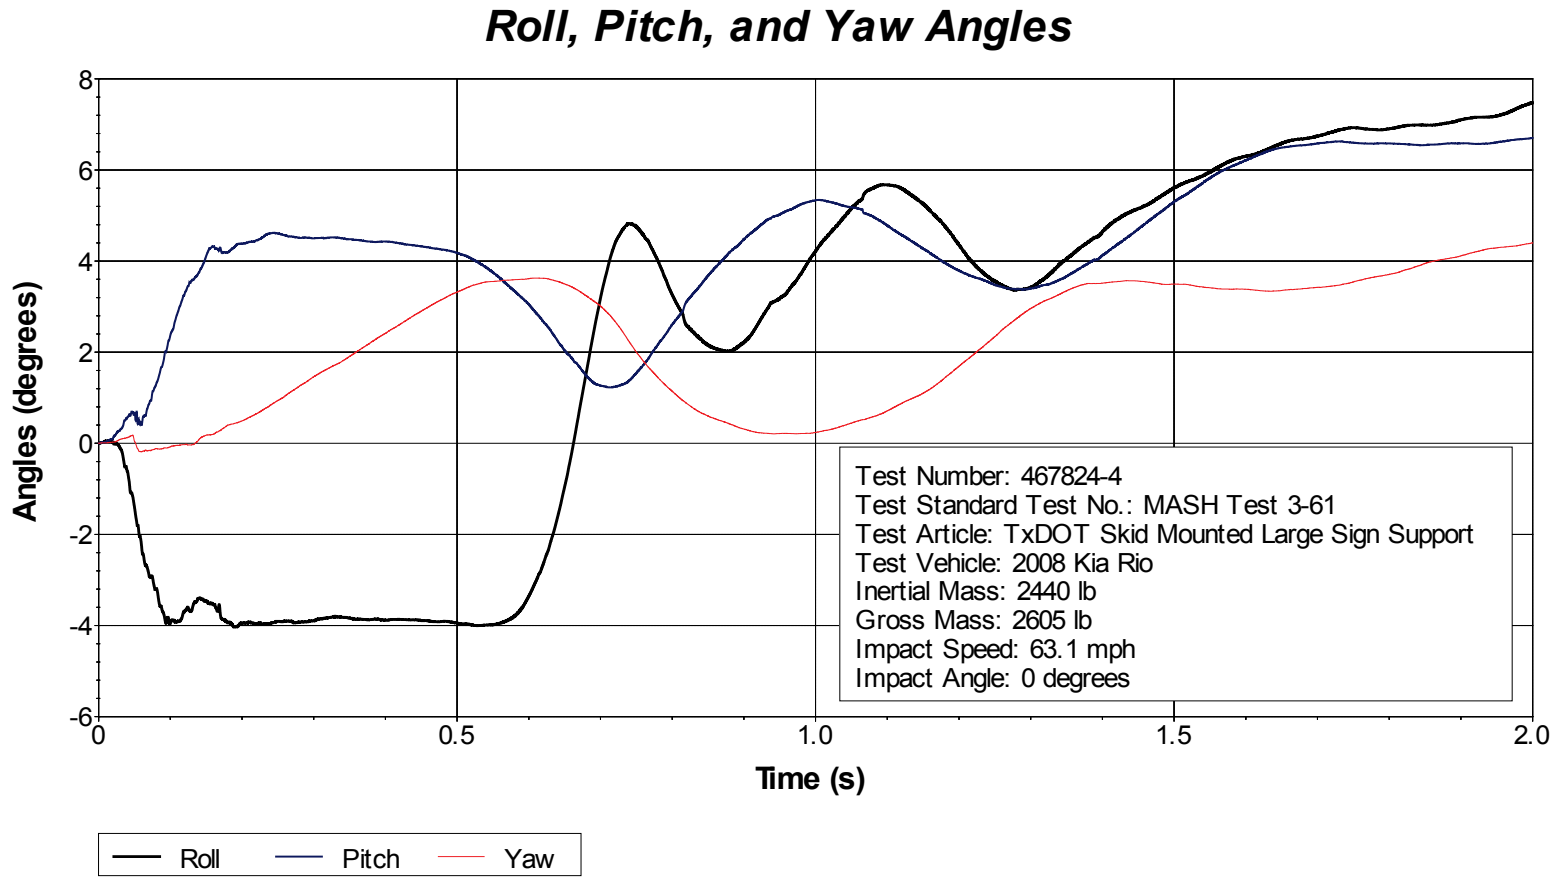
Figure G2. Vehicle Angular Displacements for Test No. 467824-4.

Axes are vehicle-fixed.  
Sequence for determining orientation:

1. Yaw.
2. Pitch.
3. Roll.

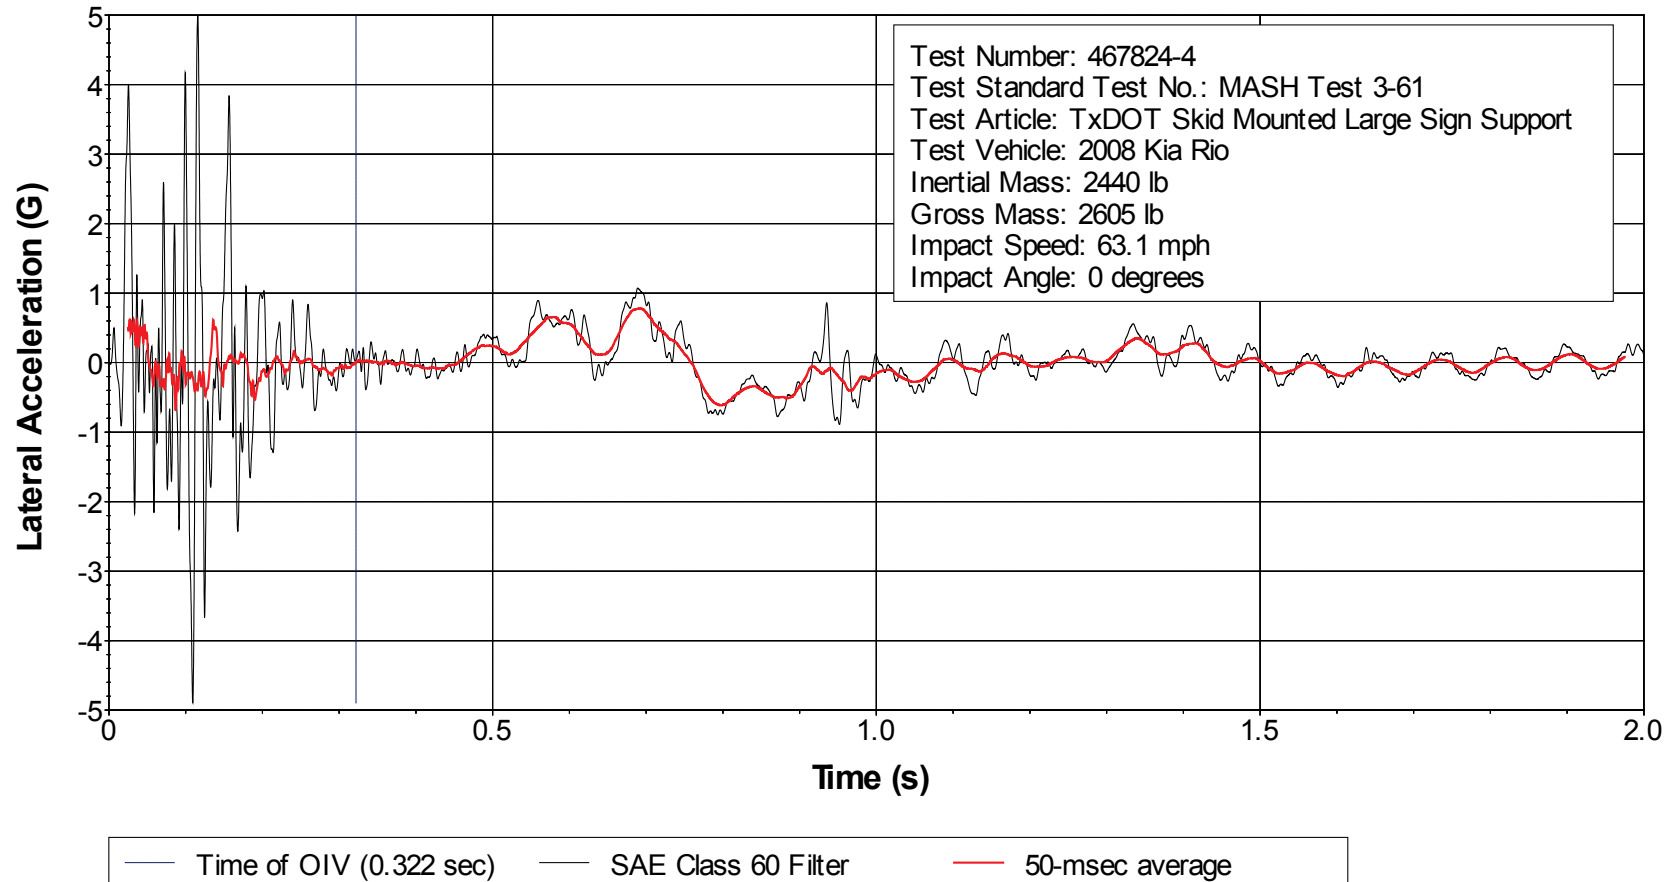
### Y Acceleration at CG

**Figure G4. Vehicle Lateral Accelerometer Trace for Test No. 467824-4 (Accelerometer Located at Center of Gravity).**

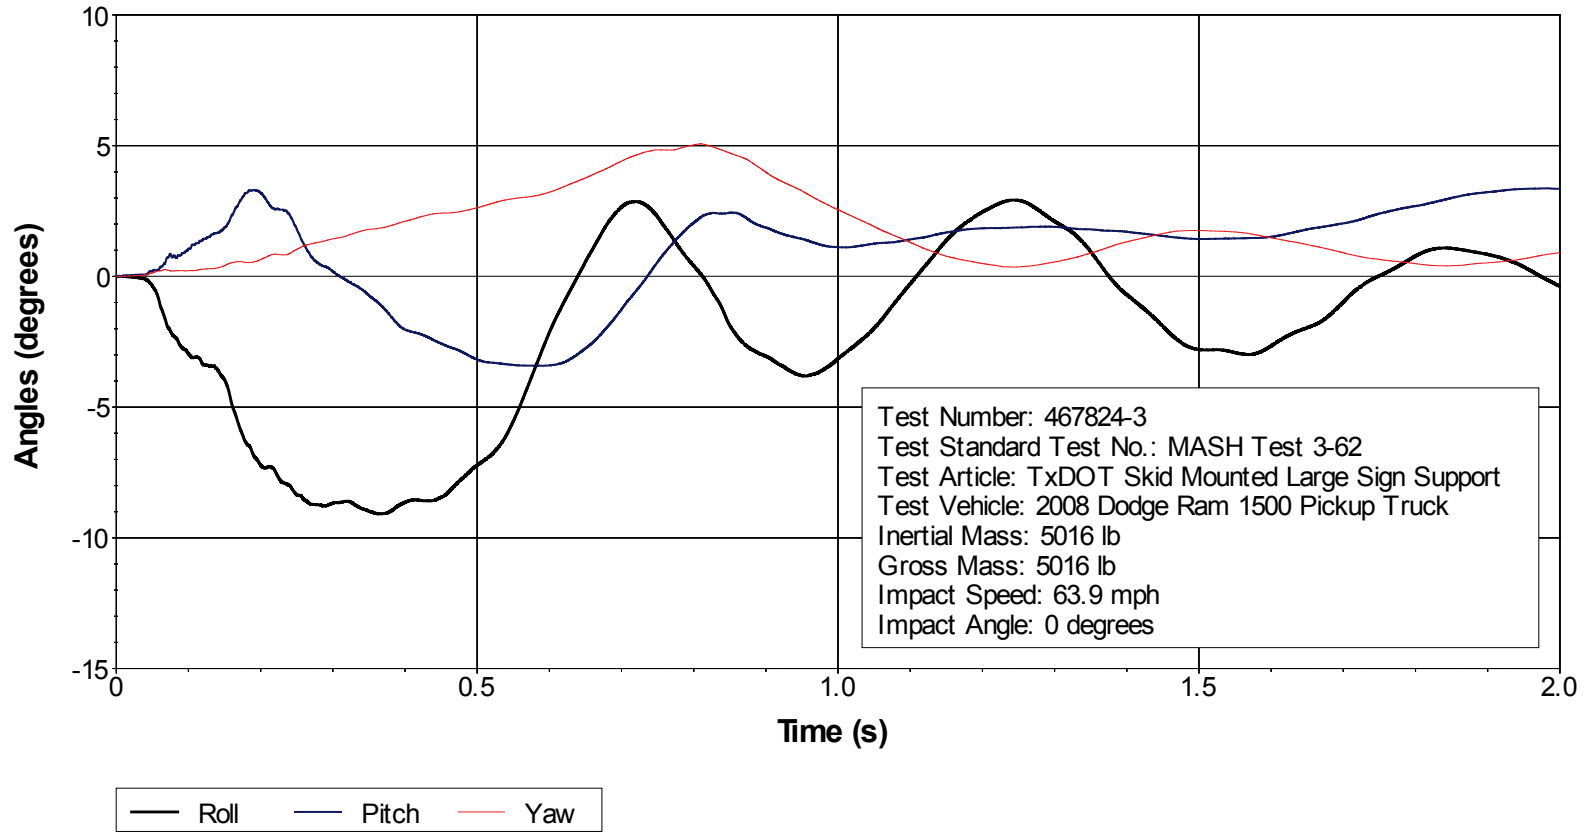
**Roll, Pitch, and Yaw Angles**

Axes are vehicle-fixed.  
 Sequence for determining orientation:

1. Yaw.
2. Pitch.
3. Roll.

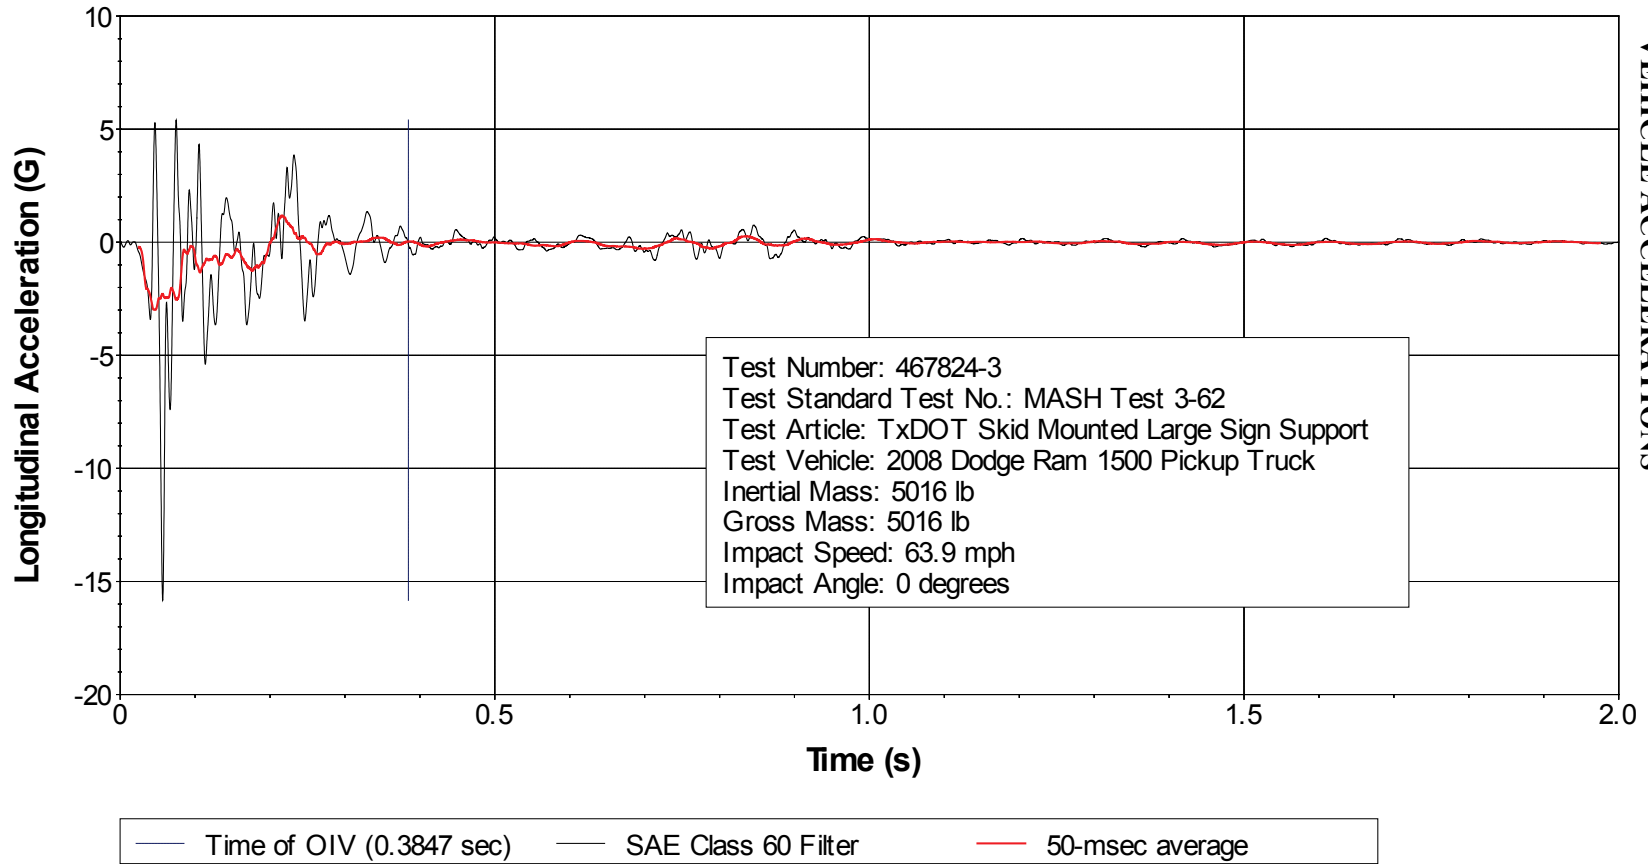
### X Acceleration at CG

**Figure H3. Vehicle Longitudinal Accelerometer Trace for Test No. 467824-3 (Accelerometer Located at Center of Gravity).**
