## SKID-MOUNTED SUPPORT SYSTEM FOR TEMPORARY GUIDE SIGNS

**Test Report No. 0-6782-2**

TEXAS A&M TRANSPORTATION INSTITUTE  
COLLEGE STATION, TEXAS

1. Report No. FHWA/TX-14/0-6782-2		2. Government Accession No.		3. Recipient's Catalog No.	
4. Title and Subtitle SKID-MOUNTED SUPPORT SYSTEM FOR TEMPORARY GUIDE SIGNS				5. Report Date August 2014

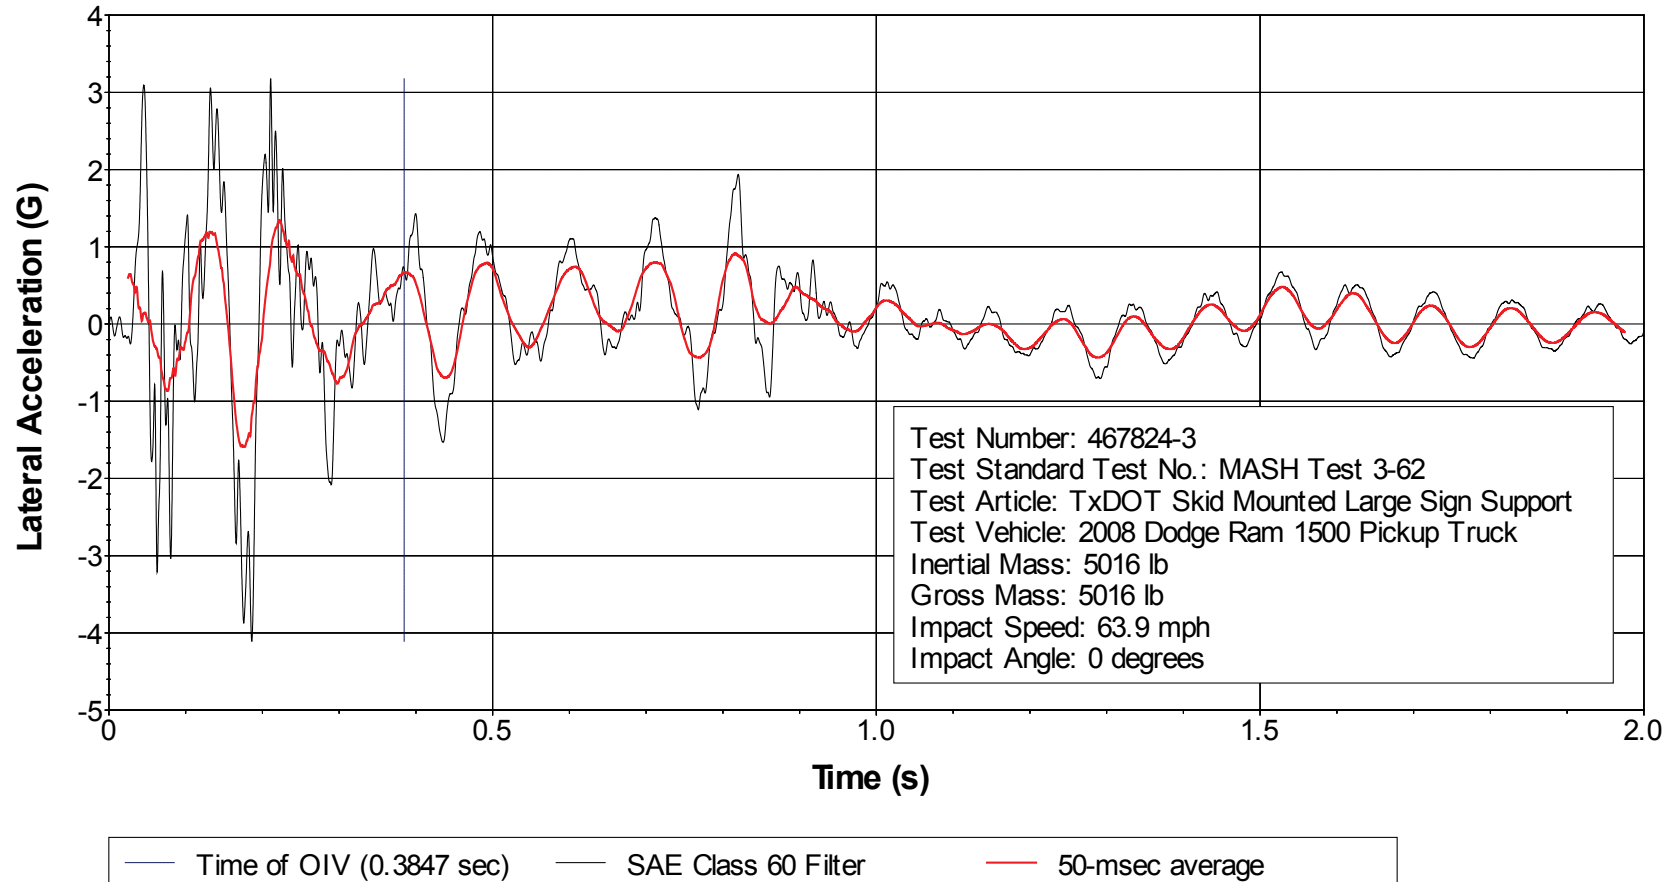
### Y Acceleration at CG

**Figure H4. Vehicle Lateral Accelerometer Trace for Test No. 467824-3 (Accelerometer Located at Center of Gravity).**
